**MICROBIAL CORROSION OF COMMON
PIPING MATERIALS IN THE PWV AREA**

**Advanced Engineering and Testing Services
Division of Materials Science and Technology, CSIR**

**WRC Report No. 432/1/99
ISBN 1 86845 477 0
ISBN SET NO 1 86845 479 7**

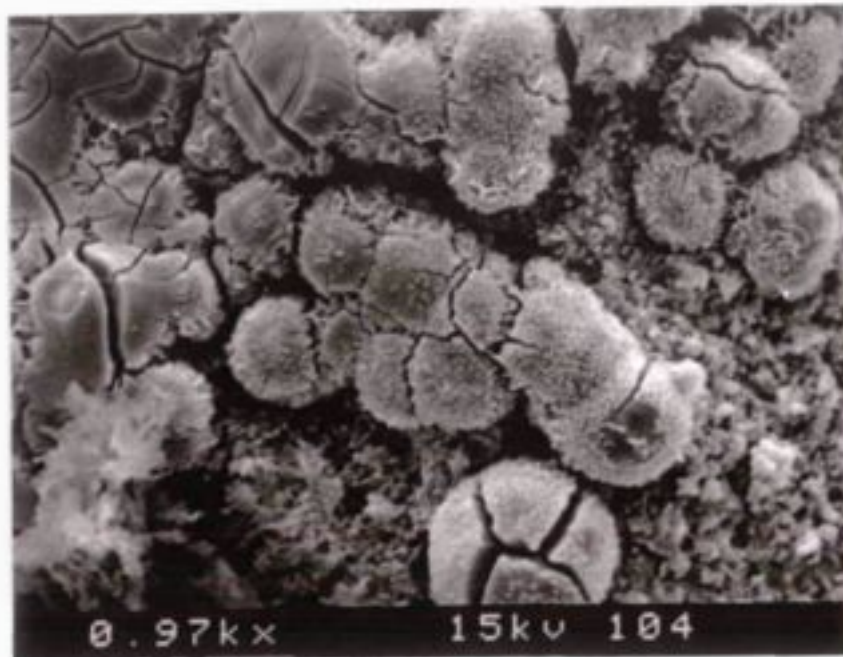
Figure 5: Corrosion product and crystals on the MS coupon surface.

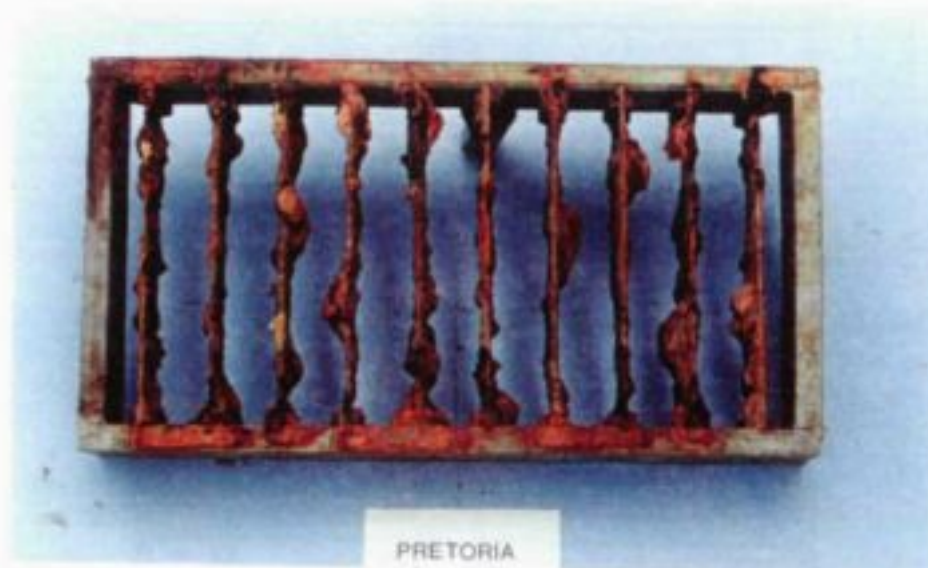
Both test and control mild steel coupons were covered by large orange/brown tubercles after the 20 month exposure period. These tubercles started to form at the edges of the coupons and gradually built up towards the centre. An example of a rack of coupons covered with tubercles is shown in Figure 20. On removal of the tubercles, a black corrosion product was present underneath. On acidification with HCl, this product released hydrogen sulphide. The metal beneath was shiny and pitted. EDS analyses of the corrosion product revealed that the black product contained high levels of iron (Fe) and sulphur (S), which probably existed as FeS. High sulphur peaks were found for both test and control coupons. Figures 21 and 22 are typical EDS traces. In general, the test

Figure 20: Tubercles on MS test coupons after 20 months exposure.

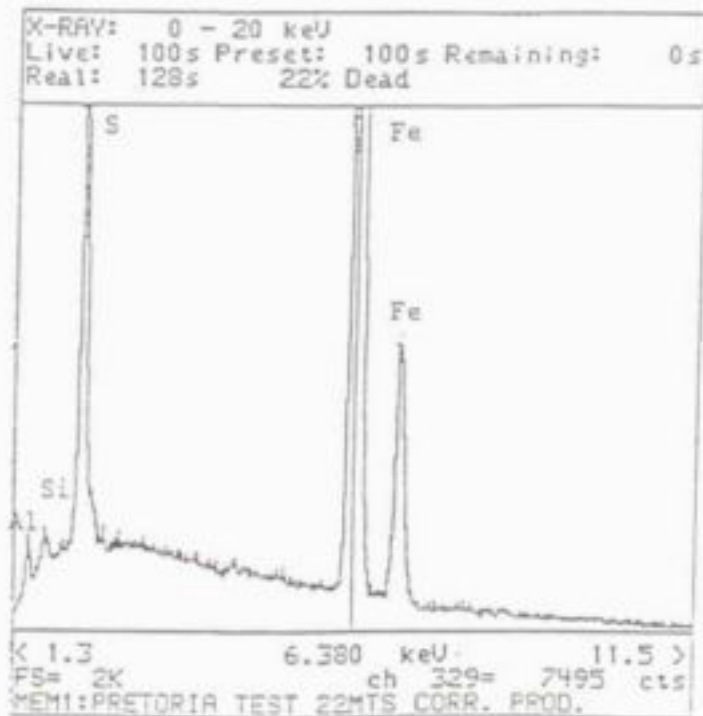
coupons had a higher sulphur peak than the control coupons. Figure 23 shows a typical EDS trace for an analysis of the surface of the corrosion product. The presence of the normal chemical constituents of water are shown.

Figure 21: EDS trace of black corrosion product on a MS coupon after 20 months exposure at the Pretoria site (test).

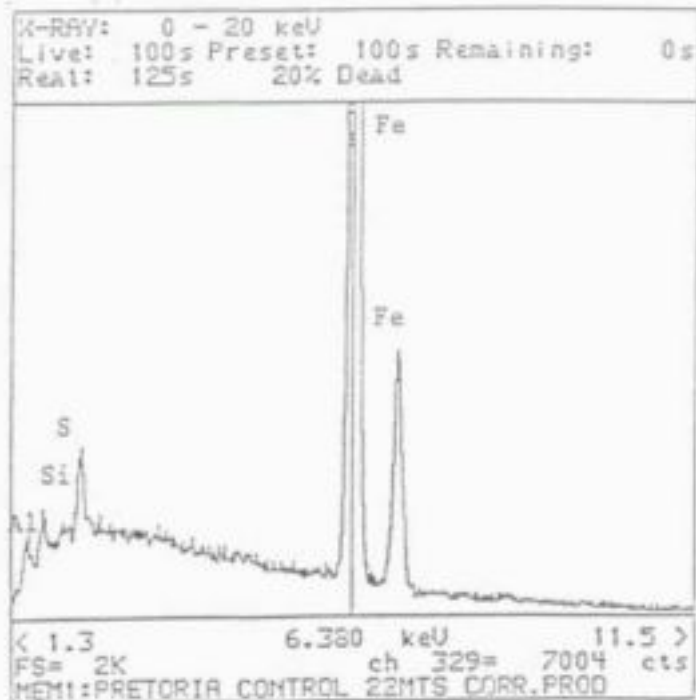
Figure 22: EDS trace of black corrosion product on a MS coupon after 20 months exposure at the Pretoria site (control).

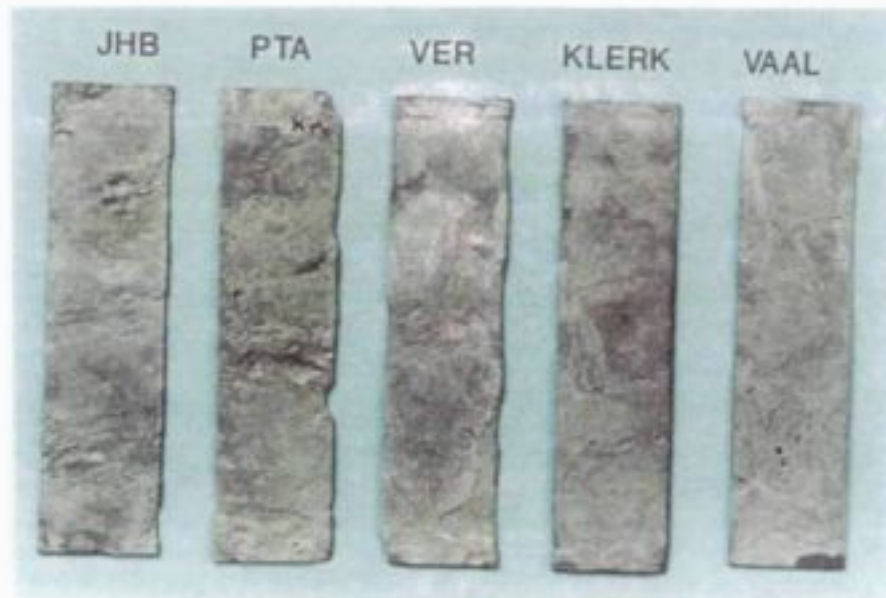
Figures 29 and 30 show the condition of the mild steel test and control coupons after 20 months exposure. The most severely corroded coupons were those at the Pretoria site. At this site, shallow pitting at the edge of the coupons was initiated after 2 months exposure in the test tanks. On the control coupons, pitting was first observed after 3 months. The pitting worsened with exposure time, the pits becoming deeper and wider. Penetration at the edges occurred after 9 months on both test and control coupons (Figure 31). The pitted area mostly coincided with the areas where tubercles had formed (Figure 32). Pitting of the surface metal was observed after 6 months as groups of shallow pits sometimes connected together (Figure 33). On both test and control coupons, these pits deepened at a slower rate than the edge pits, with

penetration occurring after 20 months. The area of the coupon which slotted into the plastic exposure rack, underwent severe crevice corrosion.

At the other sites, the same pattern of attack was observed i.e. pitting corrosion initiating on the edges and then moving to the centre. At the Vaal and Johannesburg sites, edge attack was initiated after 6 months with penetration occurring after 12 months at the Vaal site and 15 months at the Johannesburg site. In the case of the Vereeniging and Klerksdorp sites, edge attack at the former site initiated after 9 months and at the latter after 15 months. Both were penetrated at the 20 month removal period. In general, the control coupons were slightly more severely attacked than the test coupons.

Figure 29: Condition of MS test coupons after 20 months exposure.

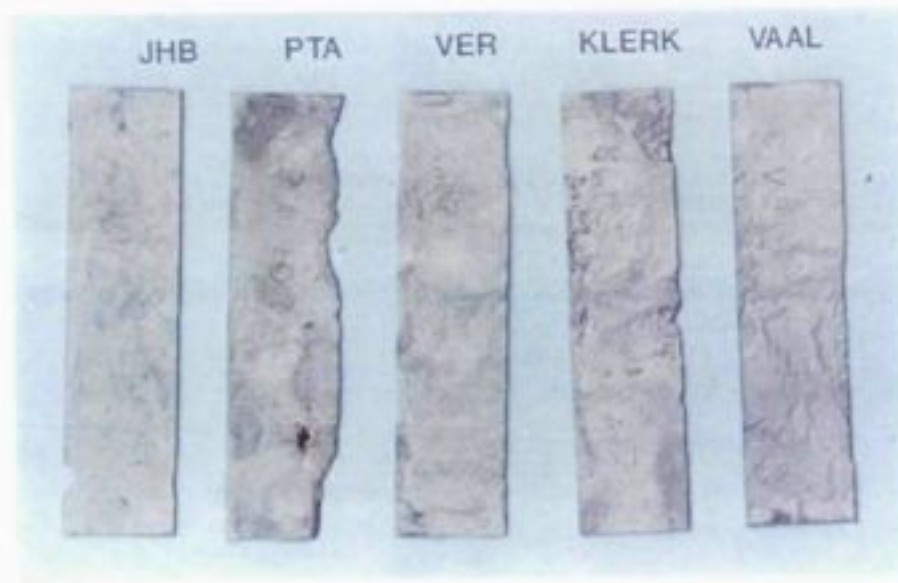
Figure 30: Condition of MS control coupons after 20 months exposure.

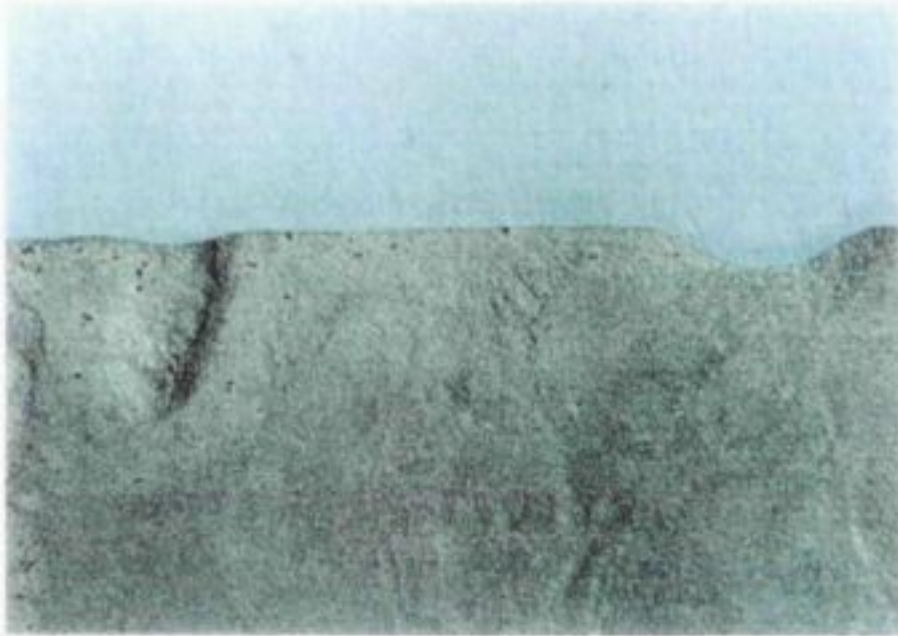
Figure 31: Penetration of a pit at the edge of a MS coupon.

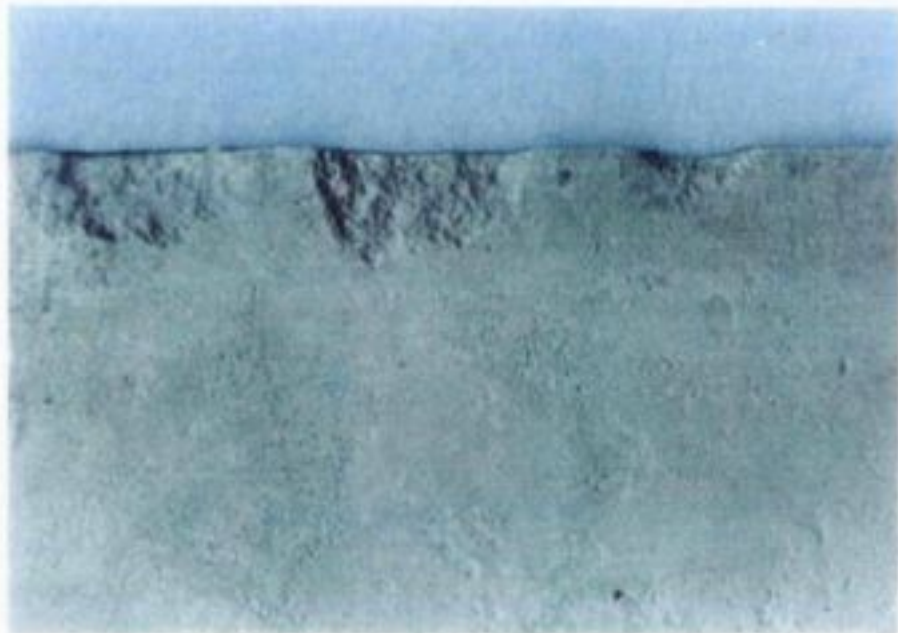
Figure 32: Pitting attack at the edge of a MS coupon after removal of the tubercles.

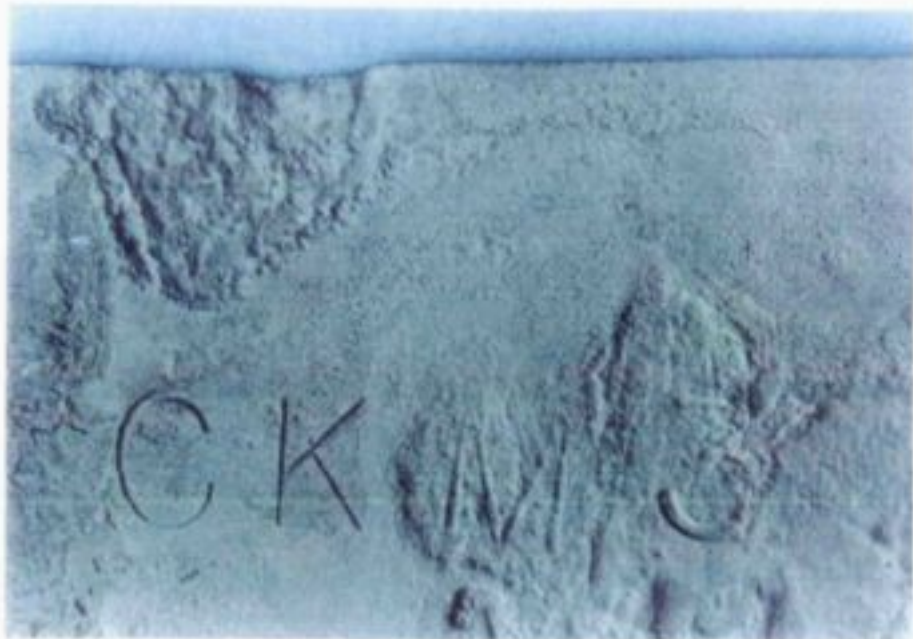
Figure 33: Shallow pitting attack on the surface of a MS coupon.
