Water history

Molteno – ‘Old boy’ of Cape Town still in service despite chequered start

Despite its shaky start, the Molteno Reservoir remains a key part of the City of Cape Town’s water supply more than 130 years after its initial construction. Arne Singels traces the history of the reservoir and lifts lessons from its construction for today’s water engineers.

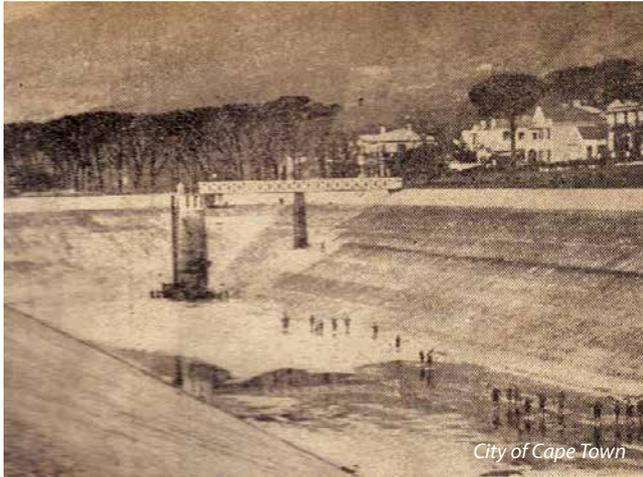
This sketch of the reconstruction of Molteno Reservoir appeared in the press in 1885.

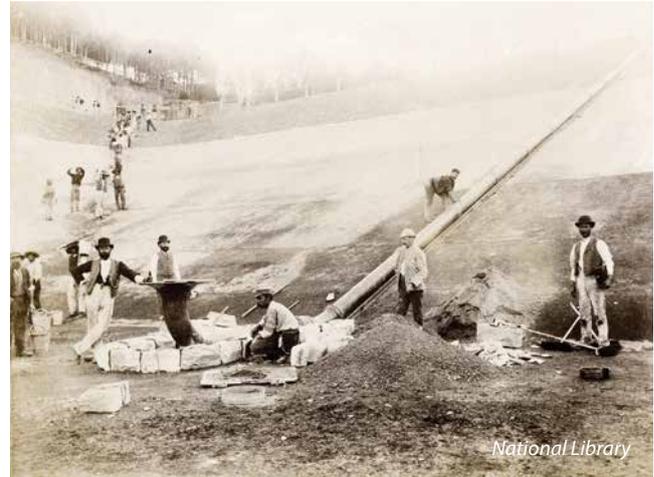
The Molteno Reservoir being repaired following its failure in 1882.

whatever reason is not watertight, than to do the work ab initio. Regarding the water tightness of the reservoir he states that he is convinced that most of the leakage occurred through the floor and was due to unsuitable material for a pressure of about 14 m of water. The 610 mm puddle that was used in the floor was inferior, half-worked and could hardly be distinguished from the floor material.

Wood also found that the bursting of the reservoir along the culvert was caused by the over-excavation through the undisturbed ground under the embankment for the culvert. After the construction of the tunnel, the surrounding space had been filled in by labourers who worked without proper supervision and executed the work poorly. This caused the settling of the puddle-core and the occurrence of cracks which resulted in the leakage.

He recommended that 610 mm-thick Portland cement concrete be used to line the floor of the reservoir and the slopes to a level of 2.44 m above the floor. For the next 6.7 m, 460 mm-thick concrete

was to be placed on the slopes up to 4.5 m below Top Water Level. Above this the embankment slopes had to be cut back by about 910 mm, the original puddle had to be reworked and replaced, a 300 mm layer of gravel placed and stone pitching added. This was then to be blinded with gravel.

A cut-off wall was to be built around the culvert and a second cut-off 1.22 m thick at the existing puddle trench backed up by a reworked puddle.

Regarding the Eastern culvert and embankment, he proposed that the whole culvert be excavated to invert level and a new one be constructed, founded and surrounded by concrete. The old valve shaft was to be demolished and a new one erected with brickwork and cement mortar further into the reservoir.
