THE USE OF NON-POTABLE WATER IN ROAD CONSTRUCTION

Report to the Water Research Commission

Frank Netterberg Construction Materials and Geotechnical Specialist

WRC Report No. 3035/1/22 ISBN 978-0-6392-0493-2

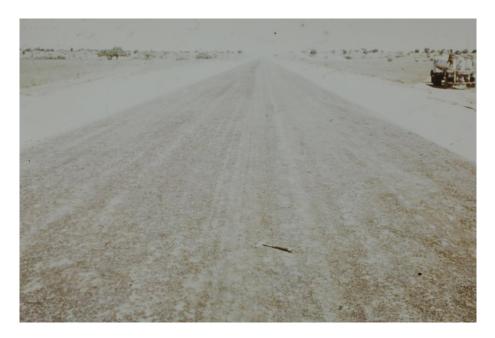
Figure 1.1: Typical mild surface disintegration of primed base course due to crystallisation of salt from brackish compaction water in the base course.

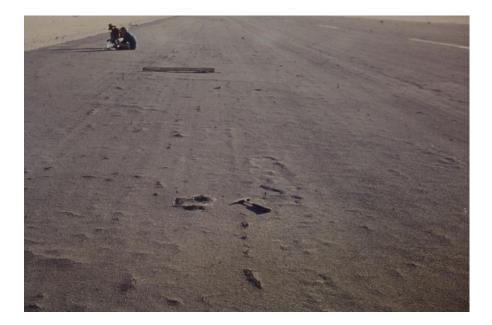
Figure 1.2: Very severe blistering and cracking of triple seal on old Walvis Bay airport due to crystallisation of halite (NaCl) in the upper base due to use of salt water in subbase (Netterberg, 2015)

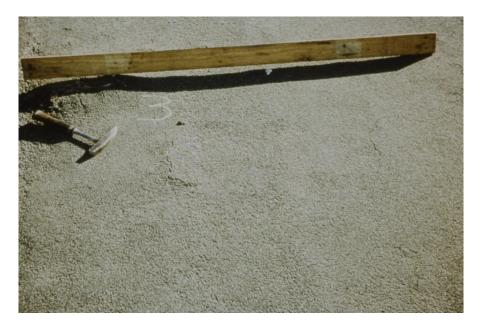
Figure 1.3: Closer view of very severe blister 30 mm high and 400 mm wide on old Walvis Bay airport.

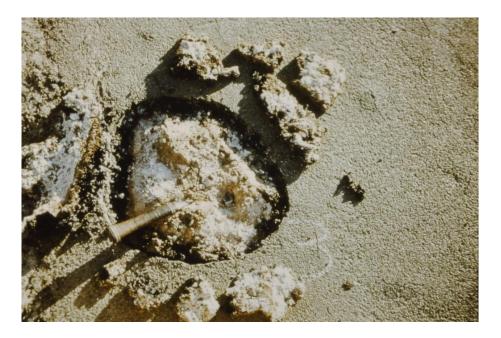
Figure 1.4: On opening the blister much white halite (NaCI) was evident and the full depth of the G3 crushed stone base course could be excavated by hand.

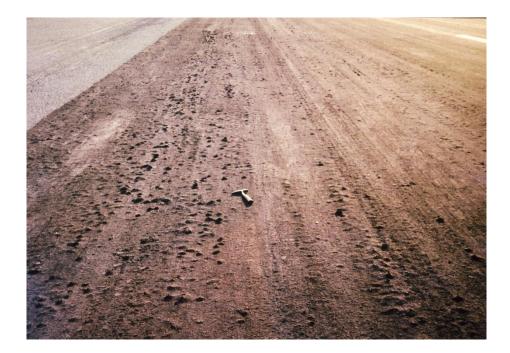
Figure 2.2: Severe blistering of 13 mm Cape seal on Sua Pan airport due to crystallisation of halite in upper base from salt compaction water used in subbase and lower layers (Netterberg and Bennet, 2004).

Due to shortage of funds for rehabilitation the runway was successfully kept in service for over seven years by periodically rolling the blisters flat, brooming off any loose material and patching any scabbed areas. A reseal with another 13 mm Cape seal was only partially successful and the worst section was replaced with interlocking block paving.

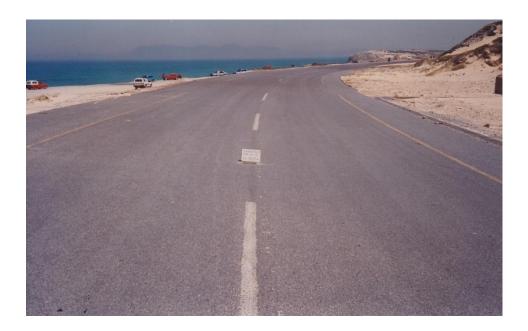
Figure 4.2: View towards Muizenberg of SV 200-300 seawater calcrete base section after 19 years in 1994.

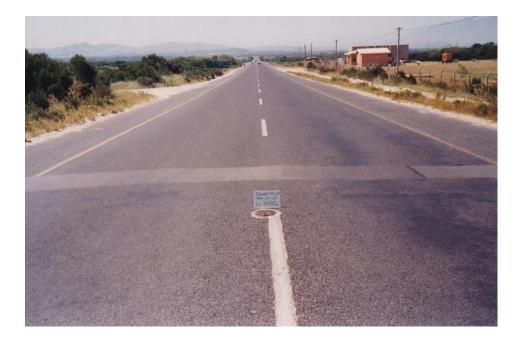
Figure 4.3: View towards Faure interchange of seawater crushed stone base section after 19 years in 1994.

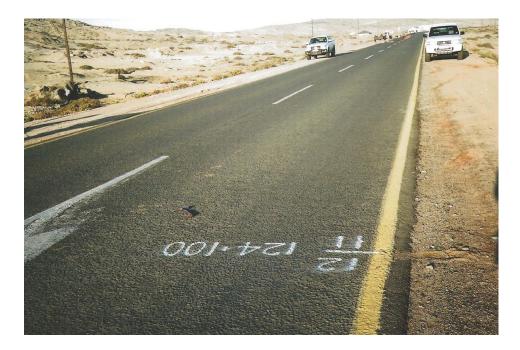
At the final monitoring in 2012 there was little difference between the main seawater section (Figure 4.4) and the freshwater control section and only two rejuvenation sprays and no resealing had been carried out in 36 years.

Figure 4.4: After 36 years without a reseal : Section 11 (seawater in all layers), view towards Aus.

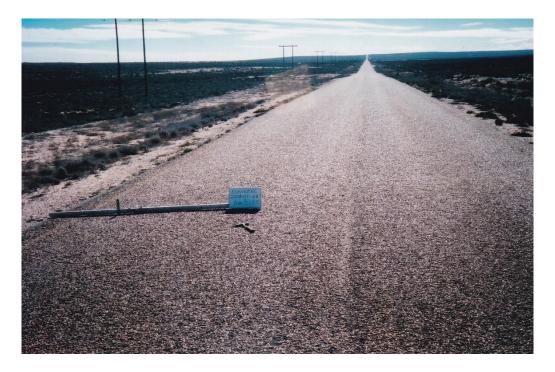
Apart from this only normal maintenance was generally necessary and the general surfacing and pavement condition was always rated as good or very good during subsequent inspections and pavement evaluations up to at least the last one carried out after 28 years by the author in 2008 (Figure 4.5).

Figure 4.5: Typical view towards Kleinzee after 28 years in May 2008 from km 31,5 over km 30-35 segment with mean base EC of 1,35 S/m and subbase EC of 0,79 S/m after compaction with seawater.

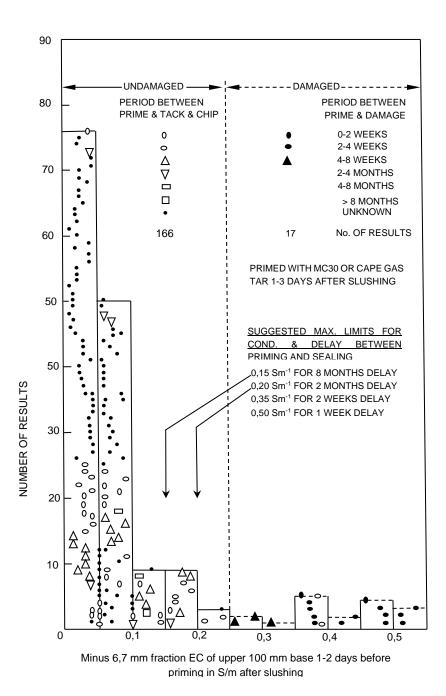
Figure A.3.1. Comparison between paste conductivity of crushed stone base course and prime damage for trunk road 77 Milnerton-Ysterfontein road.

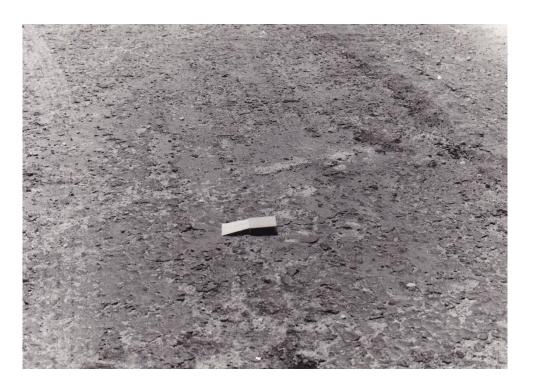
Figure A.4.1. Prime damage on seawater calcrete base

The primer itself was "dry" and had penetrated to a depth of 4-5 mm. Most of the disintegration took place where the base was more finely graded and softish. On the harder areas there was practically no distress. After 13 days some 80% of the seawater section and 40% of the fresh water section were affected. The bases were then broomed (Figure A.4.2.), after which they appeared reasonable and were therefore tacked and chipped without repriming on November, 28 1975, the top spray and the slurry of the Cape seal following within the next five days. During slurrying on December, 03 1975 it was noticed that the edges of the seal had bonded poorly to the base.

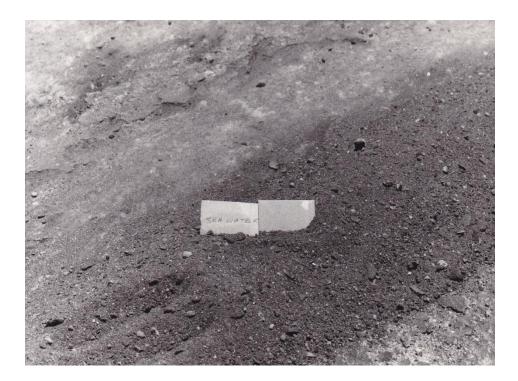
Figure A.4.2. After brooming some of the flaking prime on the seawater calcrete base

The results suggest that a finely graded calcrete base compacted with seawater with a < 6.7 mm EC of 0.5 S/m should be sealed within seven days in hot dry weather if primer damage is to be prevented. After this, damage is likely. Whether the damage was initiated by the shower of rain that fell just before the damage was noticed or whether it would have occurred anyway is uncertain. As the base had been left exposed in an unprimed state for nearly a month during the dry heat of early summer it must have dried out substantially (as suggested by the ratio of top 25 mm EC to the rest of the base of 0,9/0,4). It seems therefore that damage to an unprimed base is not inevitable and that the priming and/or the shower of rain were implicated. It has been observed on a number of roads that salt damage to a primed base occurred soon after rain when this was followed by dry weather. It is suggested that the rain penetrates the primed layer and dissolves the salt in the upper base. When the water evaporates, the salt crystallises and the crystals disrupt the upper base. Why damage did not occur before priming due to the substantial rise in the salt content of the upper 25 mm of base is not clear. Although loosening of the upper part of a gravel base before priming is known (but apparently not a crushed stone base), it is not common and salt damage has repeatedly been observed soon after priming. The priming process may therefore aggravate or precipitate the problem, possibly by means of the dampening water, the reduction of the percentage voids, the increase in temperature due to the black surface, a reduction in solubility of the salt by the organic solvent in the primer, and/or by one or more of these factors promoting the growth of whiskers instead of normal crystals.

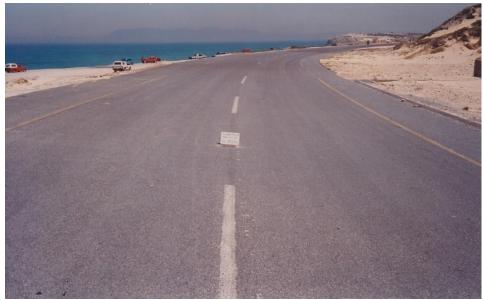
Figure A.4.3. View towards Muizenberg of SV 200-300 seawater calcrete base section after 19 years in 1994

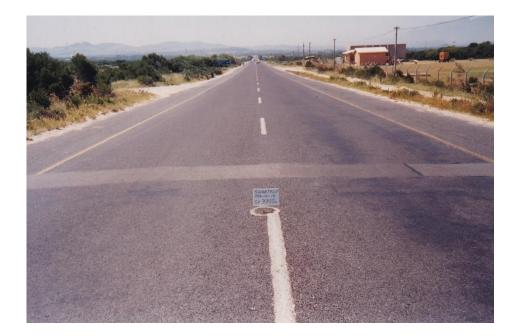
Figure A.4.4. View towards Faure interchange of seawater crushed stone base section after 19 years in 1994. Section SV 3 300 marker plate on centreline placed in1975 shown ringed

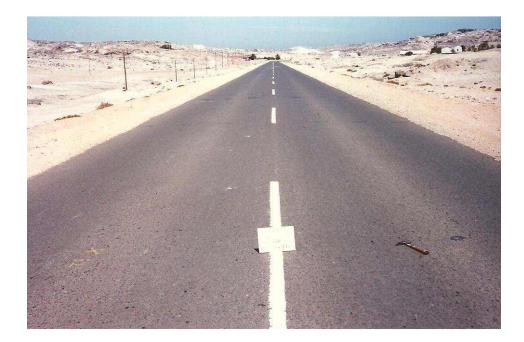
Figure A.6.1: (03 Feb. 1991): Section 10 (5% gypsum + seawater), view towards Lüderitz. No salt blisters, but Degree 1/Extent 5 map to star surface cracking, especially in right lane.

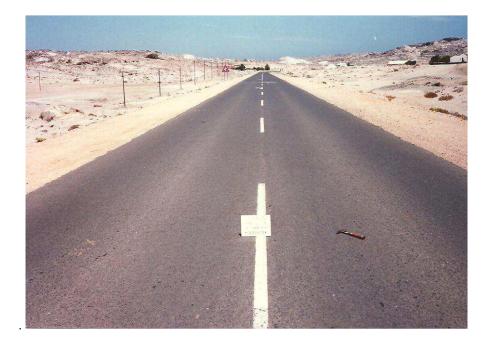
Figure A.6.2 (03 Feb. 1991). Section 11 (Seawater in all layers), view towards Lüderitz. No salt blisters, but Degree 1/Extent 5 map to star surface cracking. Similar cracking occurred on all Lüderitz sections including the controls.

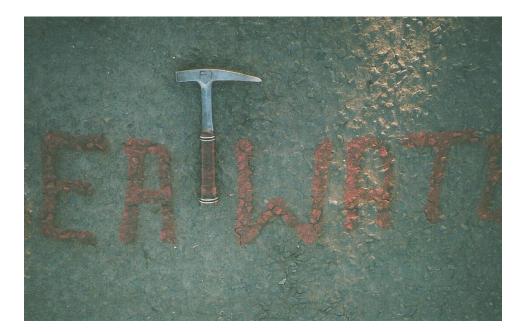
Figure A.6.3 (29 March 2012: Section 11 (Seawater G3 at SV 124 + 070, Right midlane). Close-up view of worst cracking on section (Degree 1/Extent 5 random to star surface, averaging 50 mm length at 100 mm spacing).

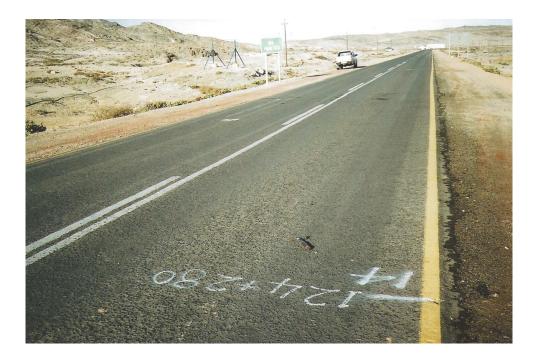
Figure A.6.4. (02 April 2012 after 36 years) : Section 14 (West control) at SV 124+280, left lane, view towards Aus. Best section on experiment. Degree 1/Extent 5 map to star surface cracking all over section. Full width slurry from approx. SV 124 + 261 to + 264.
Rejuvenation or reseal at C priority recommended. Distinct wetness between wheelpaths on this and other sections after rain indicating permeable seal.

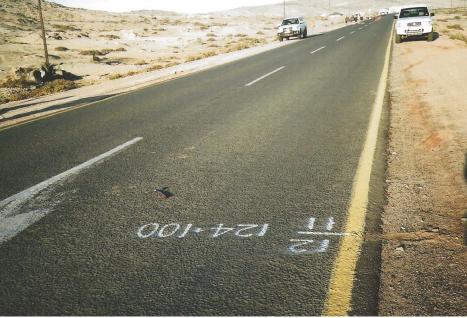
Figure A.6.5 29 March 2012 : Section 11 (Seawater in all layers), Left lane, view towards Aus. No current salt blisters, but scattered (Extent 3) small holes 50 mm diam. possibly representing broken blisters along centreline. Degree 1/Extent 5 map to star surface cracking over whole section. Similar cracking occurred over all the Lüderitz sections to a greater or lesser degree and extent including the control sections. West Control Section 14 (reseal at C priority) only marginally better than Section11 (reseal at B priority).

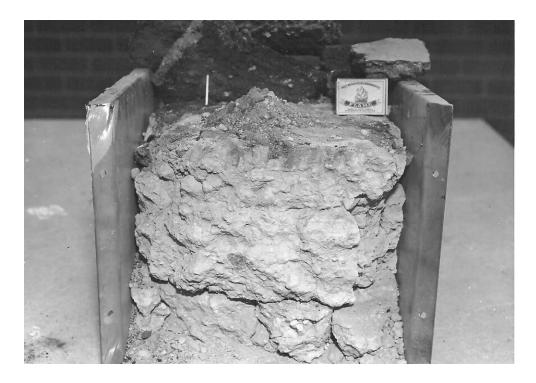
A few months after surfacing it was noticed that a 1,6 km untrafficked section from ch. 181 to 233 was showing distress in the form of blisters about 13 mm high on an average spacing of 0,5 m with a crack on a starburst pattern radiating from the apex of each blister. The star cracks were 150-300 mm long and less than 1 mm wide. On removing the blistered surfacing a layer of "dust" up to 20 mm thick, but averaging 7 mm was found in each case (Figure A.7.1.). Such "dust" was found to have a total salt content of up to 2,2% with1,8% calculated NaCl and the salt was confirmed as halite (NaCl) by X-ray diffraction analysis.

Figure A.7.1. Loose interlayer between asphalt and lime stabilised calcrete base course on intact, undisturbed sample of base and subbase from Oshivello-Oshakati road

The section from ch. 181 to 233 showing blistering and/or cracking of one kind or another was overlaid with an extra 25 mm of asphalt during1968 and opened to traffic

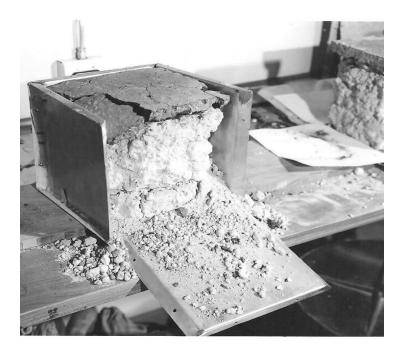
Figure A.7.2. Disintegration due to crystallisation of halite of undisturbed sample of lime stabilised calcrete base course from Oshivello-Oshakati road on standing in the laboratory

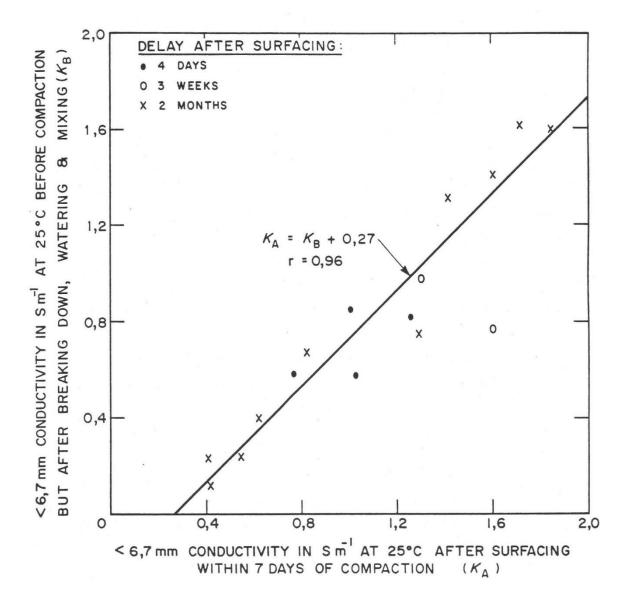
Four days to two months after surfacing a total of 16 samples were taken to check the as-built properties of the base and subbase. In spite of sealing within one week of compaction it was found that the tailings had increased in EC to 0,41-0,63 S/m and the calcretes to 0,76-1,84. representing an average increase of 0,27 S/m (r = 0,96) – Figure A.8.1. Those samples showing the greatest increase all possessed unusually high OMCs (> 20%) and low MDDs (< 1 550 kg/m³) and/or had the lowest moisture contents after surfacing and/or had the highest subbase ECs. The outlier on Figure A.8.1 may also be due to a section which had to be recompacted; this was omitted from the regression analysis. However, the ECs after surfacing of those sections known to have been rewatered and recompacted are not among those plotting to the right of the regression line on Figure A.8.1.

Figure A.8.1: Comparison between salt content of base before compaction and after surfacing on the Kleinzee-Koingnaas Road.

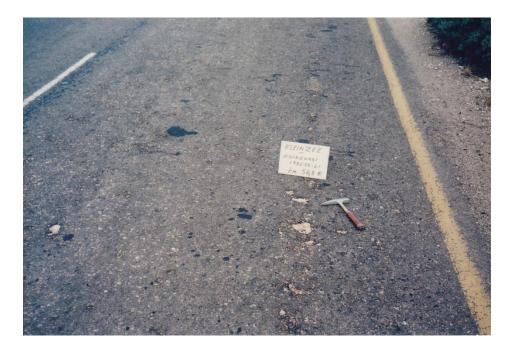
After about two years of service, patching of small, shallow holes in the seal became necessary, peaking after about 3 years (Figure A.8.2). This was mostly due to a small proportion of inferior calcrete chips which

Figure A.8.2. Showing small white surfacing holes ("potholes") and black bleeding spots, white calcrete chips, and a few black patched holes in seal at km 56,8R after 12 years in February 1992 (cumulative total of 342/km holes and patches around this point up to April 1985). Mean EC of km 55-60 segment of calcrete base 0,74 S/m and subbase 1,26 S/m after compaction; Degree/Extent of holes and patches in 1993 3/2; overall pavement condition in 1992/3 fair, (good in 1986 and 2008).

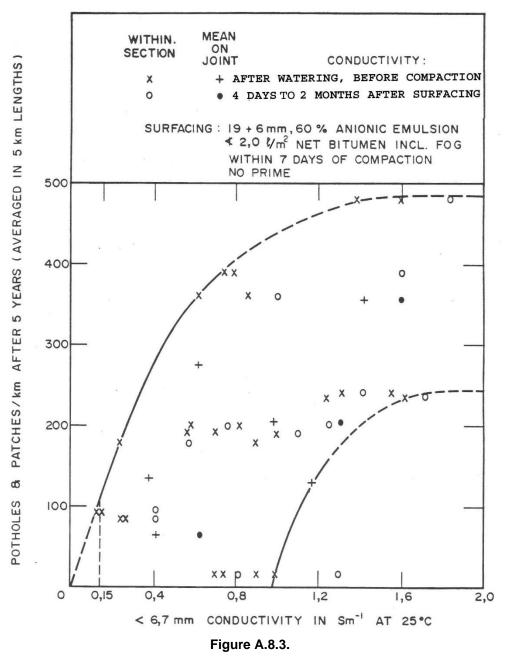
Comparison between salt damage in the form of "potholing" to seal and salt content of basecourse on the Kleinzee Koingnaas road.

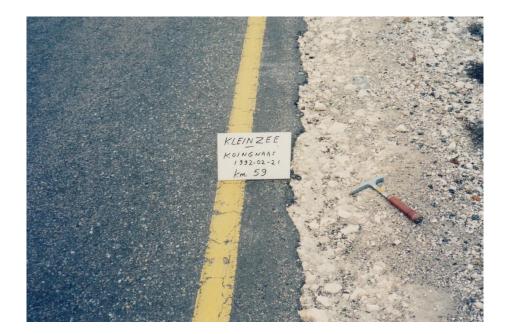
Fretting of the edges of the seal (Figure A.8.4) had been expected and it started within about six months of sealing, even on the relatively less saline tailings section notably at km 17,0 L with an EC before compaction of only 0,24 S/m and after surfacing of 0,57 S/m. The edges of the seal were also loose in places (e.g. at km 18,7 R) and could easily be removed. As the seal was generally sprayed wider than the specified 6,0 m it was thought that this might have been aggravated by inadequate brooming of the base under the edges of the seal. (The shoulders were constructed as part of the base with the same material.)

Figure A.8.4. Showing Degree 2-3 edge breaking at km 59 after 12 years in February 1992 and coarseness and tightness of calcrete gravel base and localised strip of partly disintegrated white calcrete chips (cumulative total of 273 holes and patches/km around this point up to April 1985). Mean EC of km 55-60 segment of base 0,74 S/m and subbase 1,26 S/m after compaction; Degree/Extent of edge breaking 3/3 (3/5 in 1986); overall pavement condition in 1992/3 fair (good in 1986 and 2008).

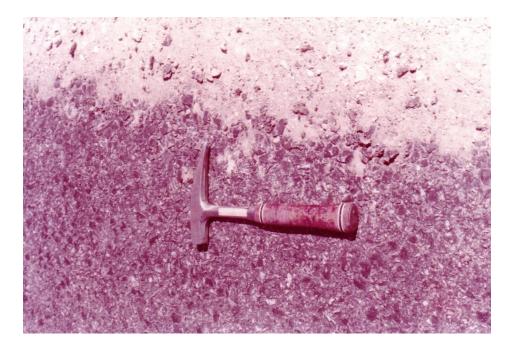
No systematic measurements of shoulder looseness were made. However, the upper part of the shoulders were observed to become loose in places within six months of construction (Figure A.8.5).

Figure A.8.5. Degree 1-3 edge fretting and surface shoulder looseness soon after construction.

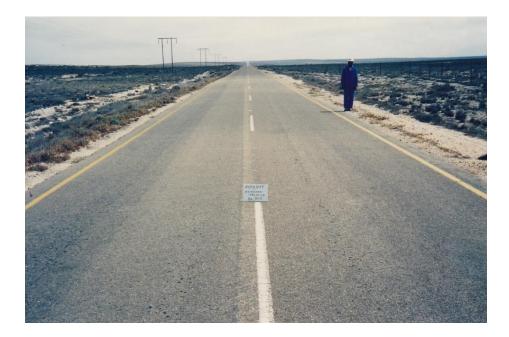
Apart from the patching, "potholing", edge fretting and a few localised shear failures the seal and pavement were thus in good condition (Figures A.8. 6 and 7) and the pavement was expected to easily exceed its design life of 0,05 MESA in 15 years. The traffic carried over the first 10 km had already probably reached this in six years with no significant structural distress to the pavement itself.

Figure A.8.6. Typical view of road towards Kleinzee in good condition after 28 years in February 1992 from km 31,0 over km 30-35 segment with mean calcrete base EC of 1,35 S/m and subbase EC of 0,79 S/m after compaction. Small (20 mm) Degree 4 / Extent 5 black bleeding spots. Overall pavement condition good in 1992/3, 1986 and 2008; edge breaking Degree/Extent 1/5 (4/5 in 1986); number of surfacing holes/patches 1 204 (i.e. 241/km) as at April 1985 (1/5 in 1993, none (0/5) in 2008).

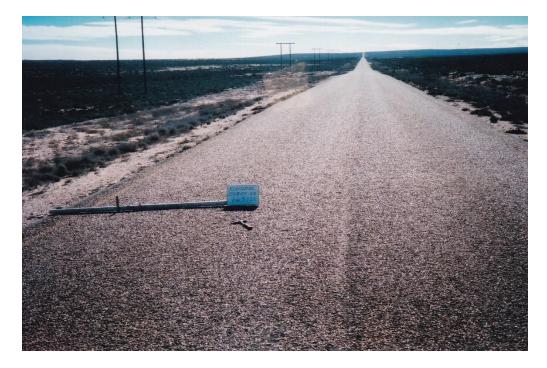
Figure A.8.7. Typical view of road towards Kleinzee after 28 years in May 2008 from km 31,5 over km 30-35 segment with mean base EC of 1,35 S/m and subbase EC of 0,79 S/m after compaction. General pavement condition good (and in 1986 and 1993); no edge breaking (0/5) (1/5 in 1993; edge drops about 10 mm; surfacing holes and patches 0/5 (1/5 in 1993); rutting about 10 mm (1/5); surfacing width 6,8 m.
