**RESEARCH ON THE CORROSION
PERFORMANCE OF VARIOUS
NON-METALLIC PIPING MATERIALS
AND COATINGS IN POTABLE WATER**

**Advanced Engineering and Testing Services
Division of Materials Science and Technology, CSIR**

WRC Report No. 381/1/99

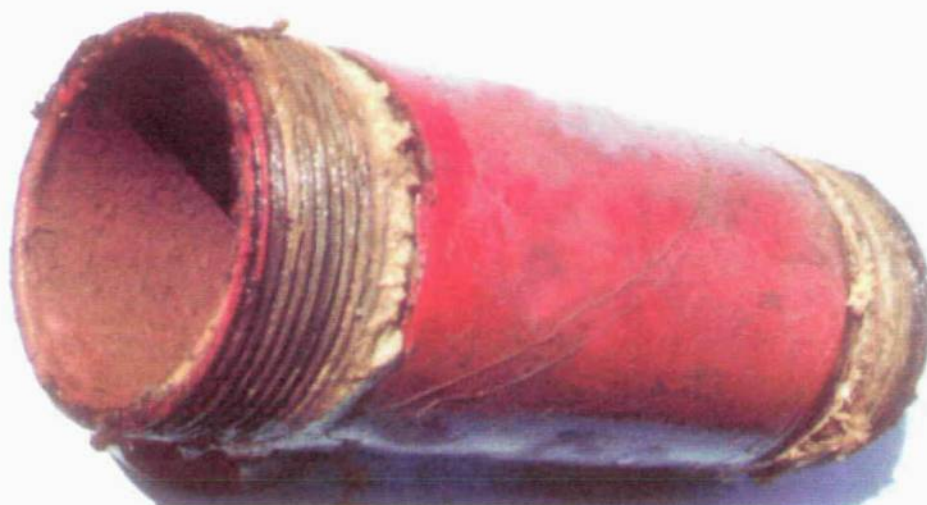
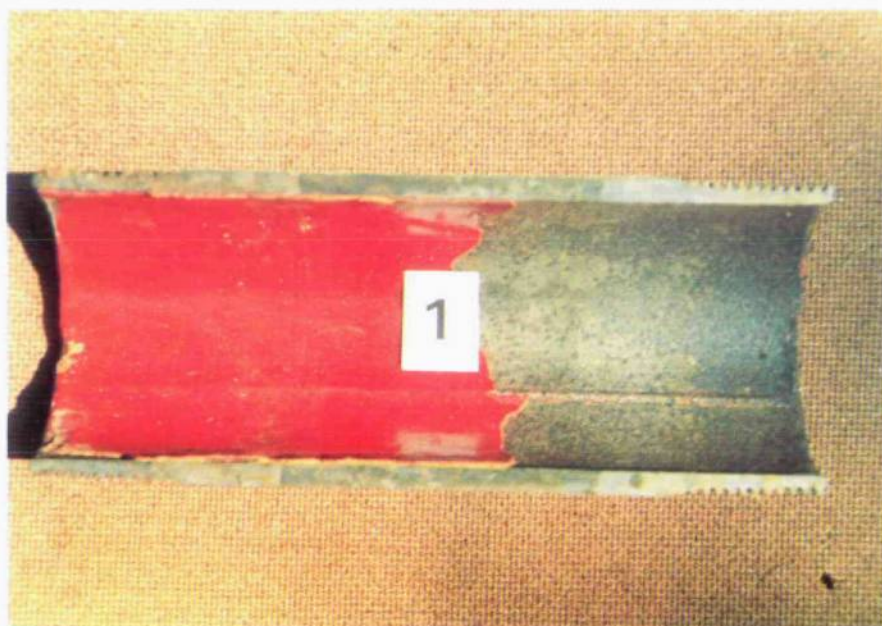
Specimen No.	Adhesion
1	Good
2	Poor dense pattern of black rust spots
3	Very good
4	Intercoat adhesion poor, undercoat to substrate good
5	Good, away from blisters
6	Black liquid in blisters poor Black corrosion under coating Darker black spots under blisters
8	Very poor, red rust under coating
9	Poor, black rust pattern under coating

Specimen No.	Degree of Rusting
1	Ri5
2	Ri1
3	Ri1
4	Ri5
5	Ri4
6	Ri5
8	Ri5
9	Ri5

Figure 1(a): Internal appearance of pipe specimen with non-metallic coating No. 1 before cleaning (X0,54).

Figure 1(b): Surface appearance of non-metallic coating No. 1 and carbon steel substrate after 42 months testing (X0,64)

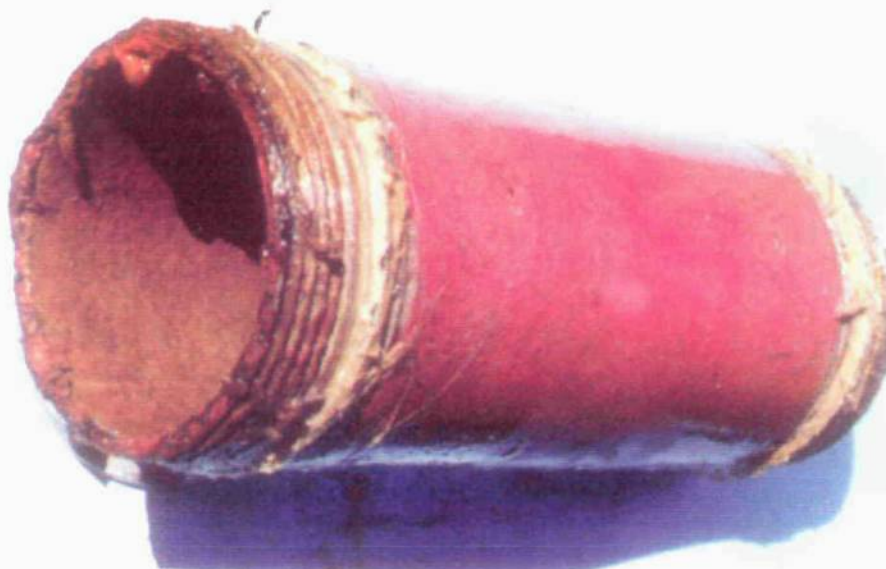
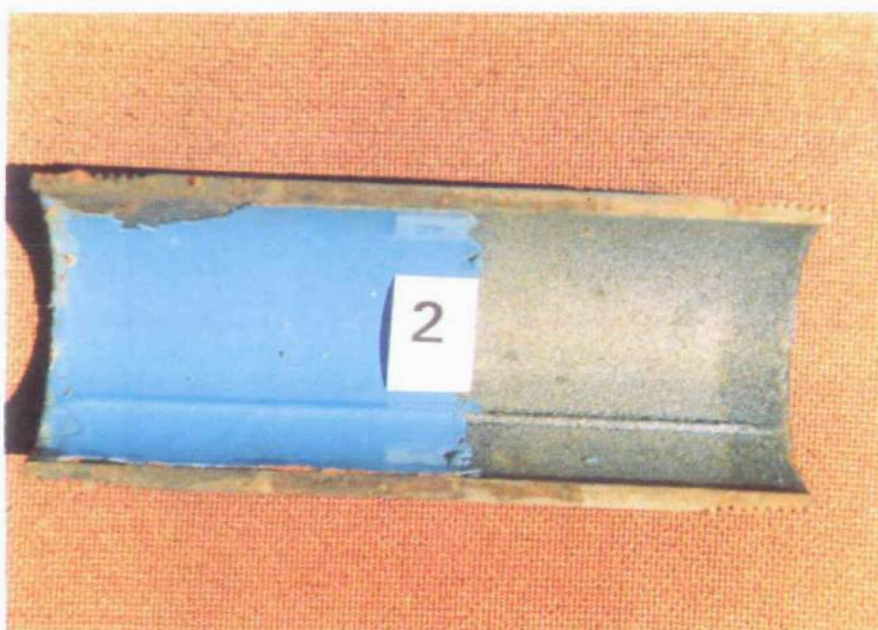
Figure 2(a): Internal appearance of pipe specimen with non-metallic coating No. 2 before cleaning (X0,54).

Figure 2(b): Surface appearance of non-metallic coating No.2 and carbon steel substrate after 42 months testing (X0,64).

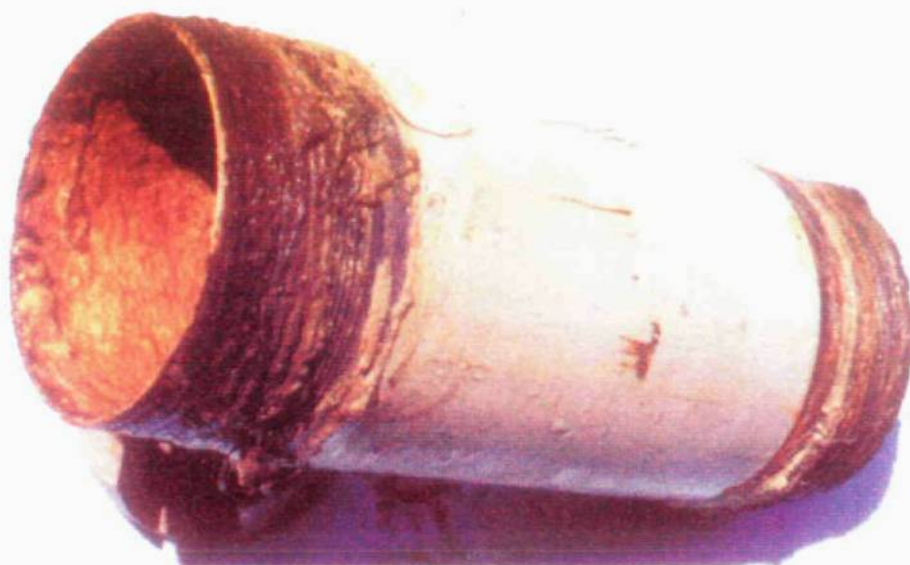
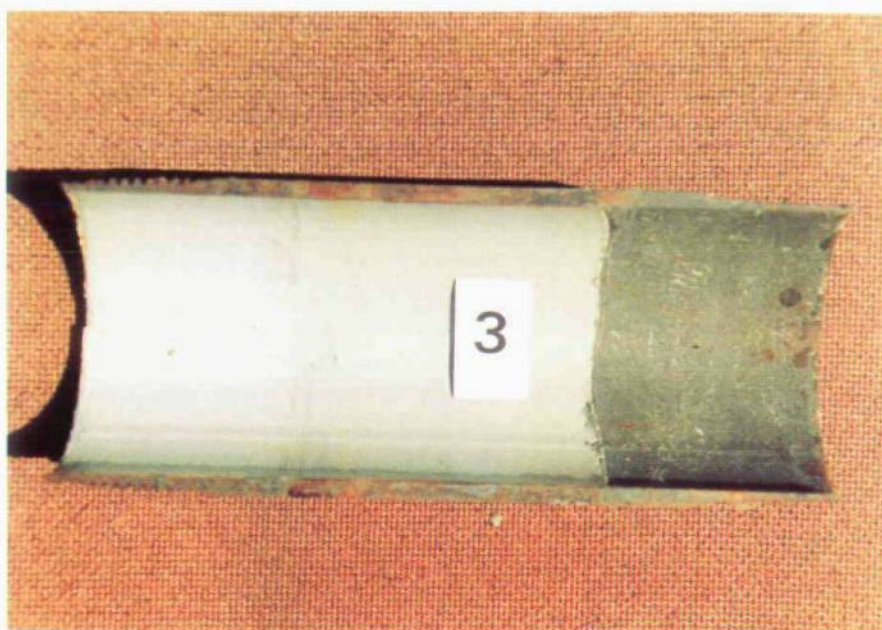
Figure 3(a): Internal appearance of pipe specimen with non-metallic coating No.3 before cleaning (X0,54).

Figure 3(b): Surface appearance of non-metallic coating No.3 and carbon steel substrate after 42 months testing (X0,64).

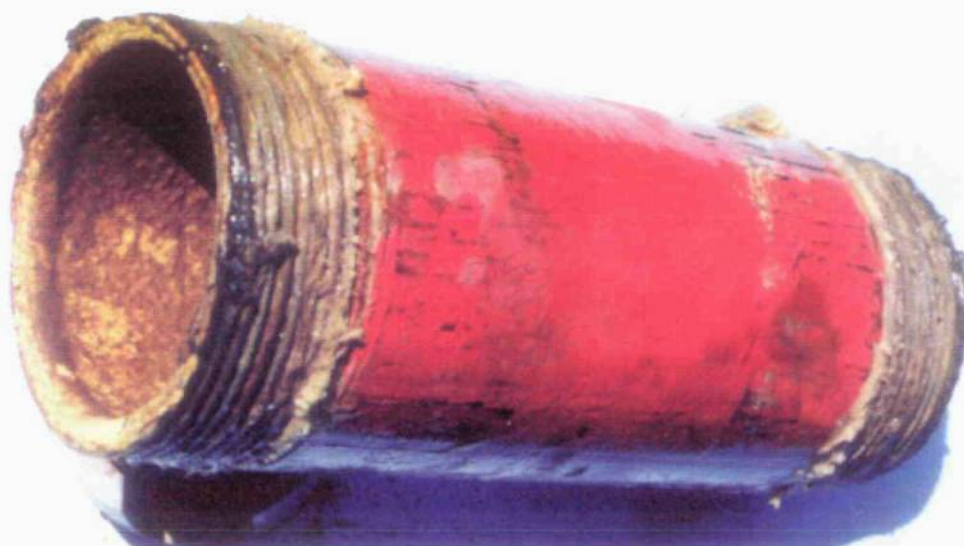
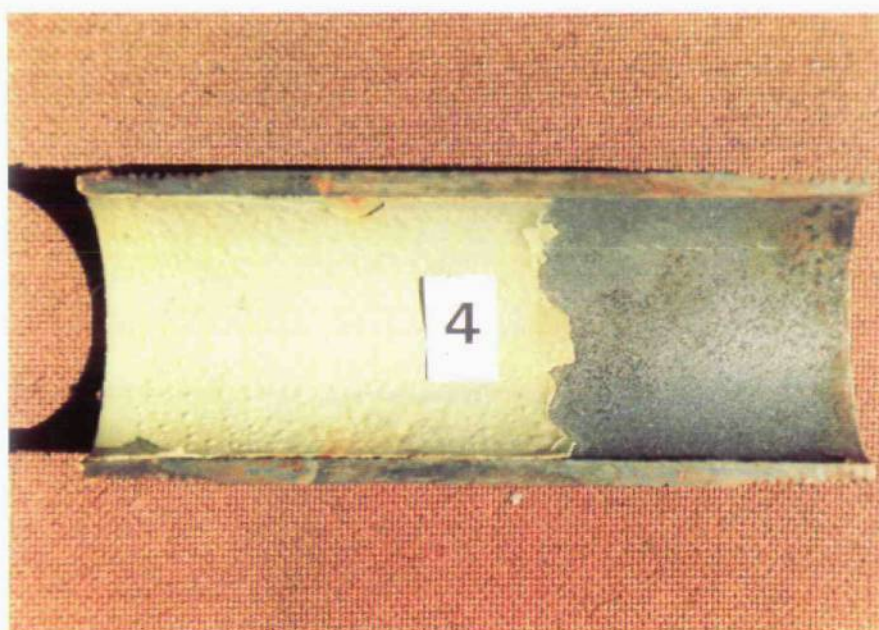
Figure 4(a): Internal appearance of pipe specimen with non-metallic coating No.4 before cleaning (X0,54).

Figure 4(b): Surface appearance of non-metallic coating No.4 and carbon steel substrate after 42 months testing (X0,64).

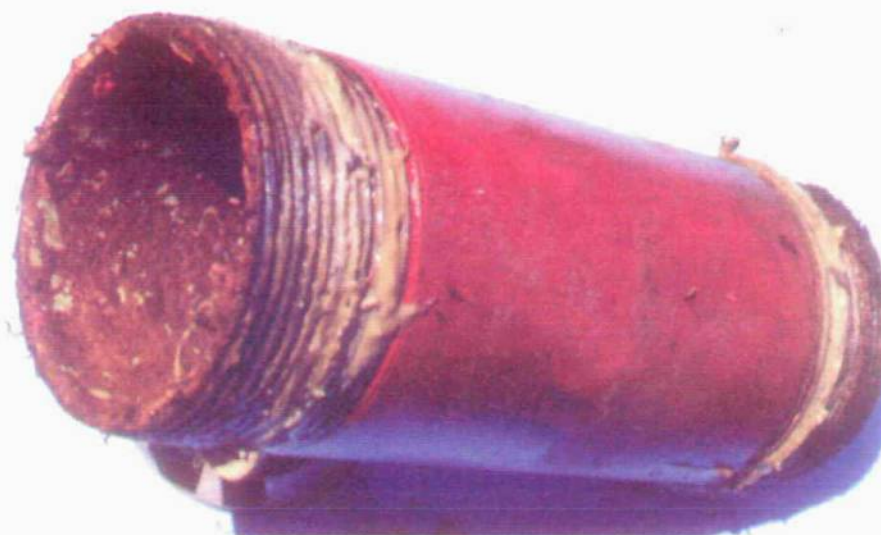
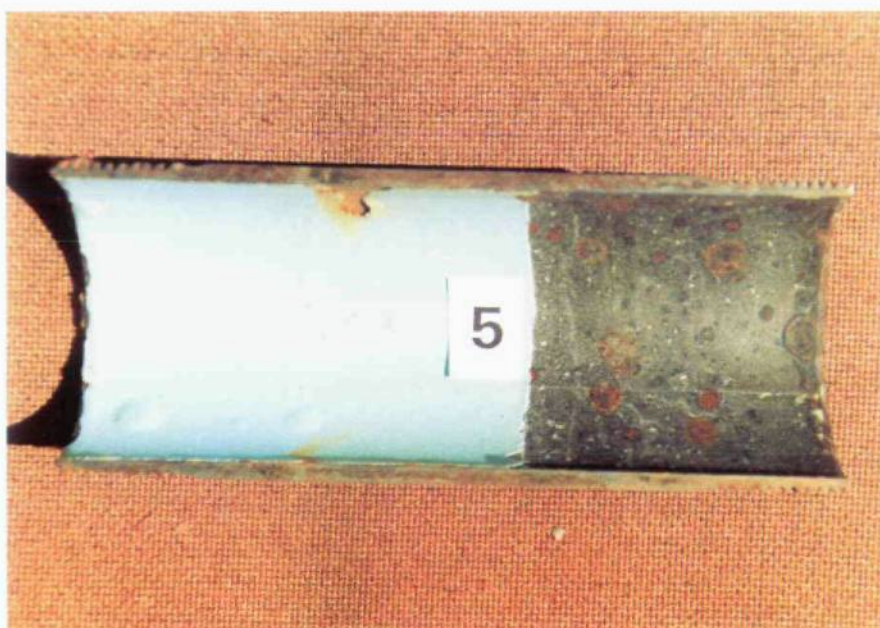
Figure 5(a): Internal appearance of pipe specimen with non-metallic coating No.5 before cleaning.

Figure 5(b): Surface appearance of non-metallic coating No.5 and carbon steel substrate after 42 months testing (X0,64).

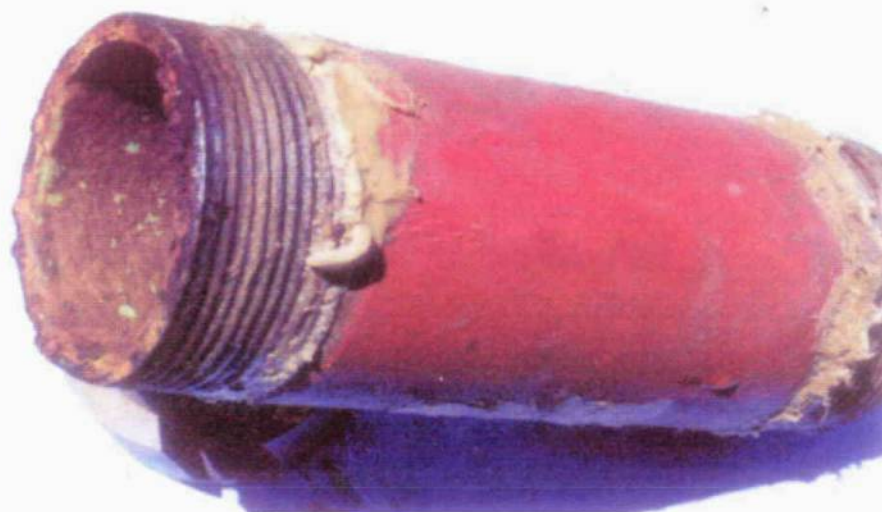
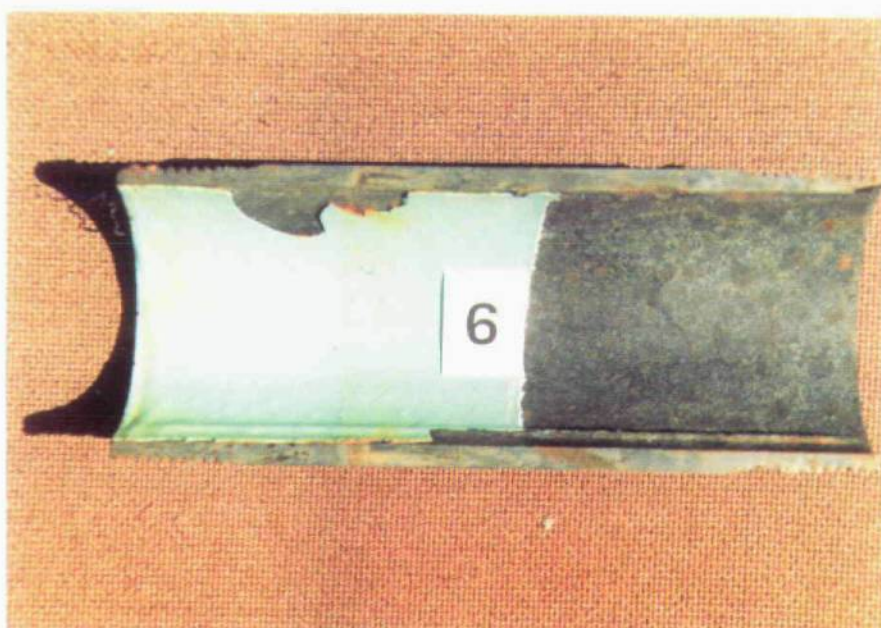
Figure 6(a): Internal appearance of pipe specimen with non-metallic coating No.6 before cleaning. (X0,54)

Figure 6(b): Surface appearance of non-metallic coating No.6 and carbon steel substrate after 42 months testing (X0,64).

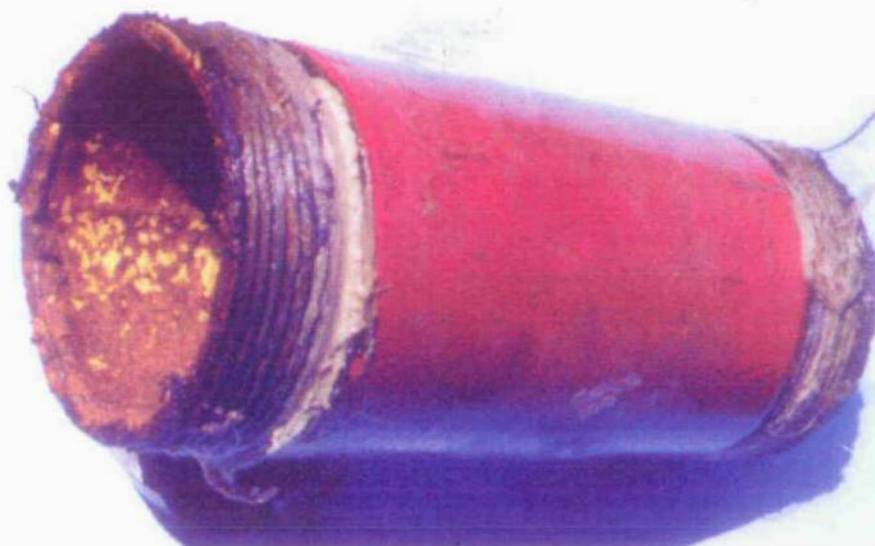
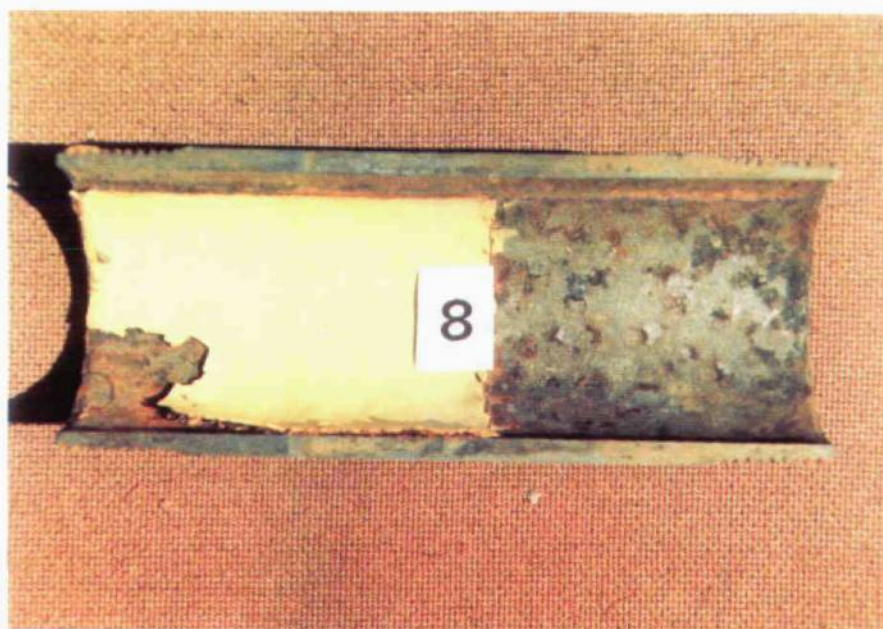
Figure 7(a): Internal appearance of pipe specimen with non-metallic coating No.8 before cleaning (X0,54).

Figure 7(b): Surface appearance of non-metallic coating No.8 and carbon steel substrate after 42 months testing (X0,64).

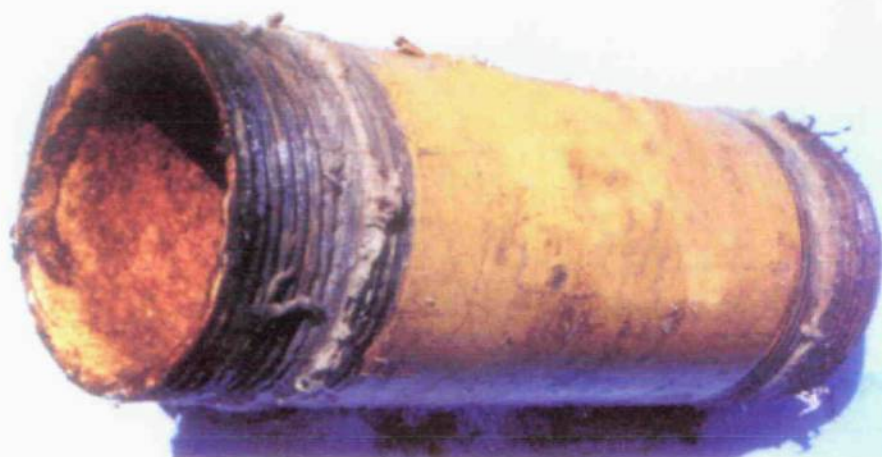
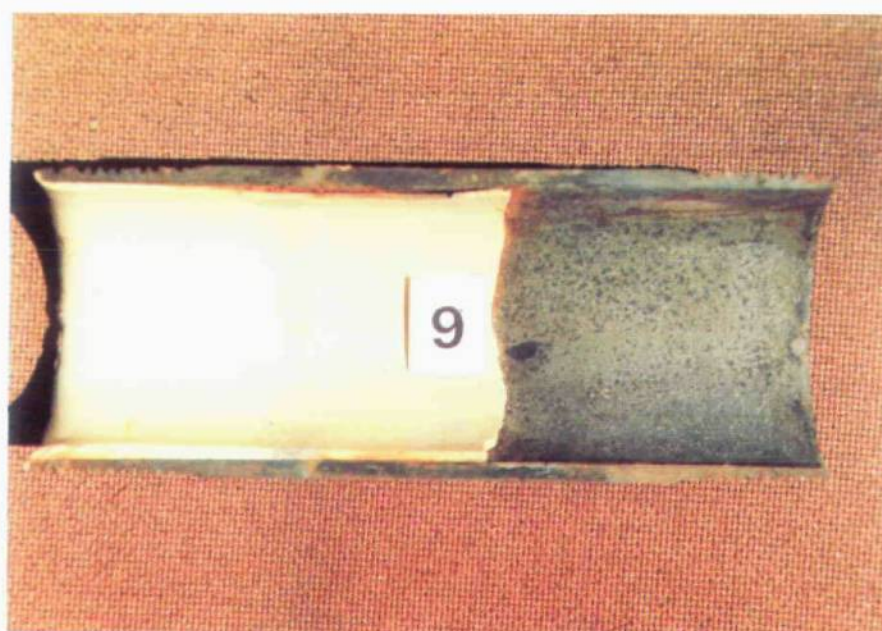
Figure 8(a): Internal appearance of pipe specimen with non-metallic coating No.9 before cleaning (X0,54).

Figure 8(b): Surface appearance of non-metallic coating No.9 and carbon steel substrate after 42 months testing (X0,64).

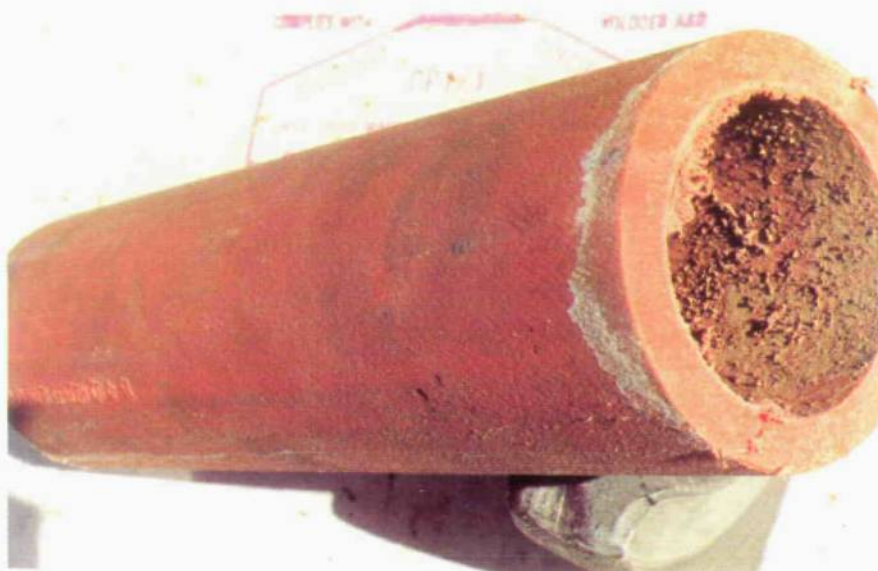
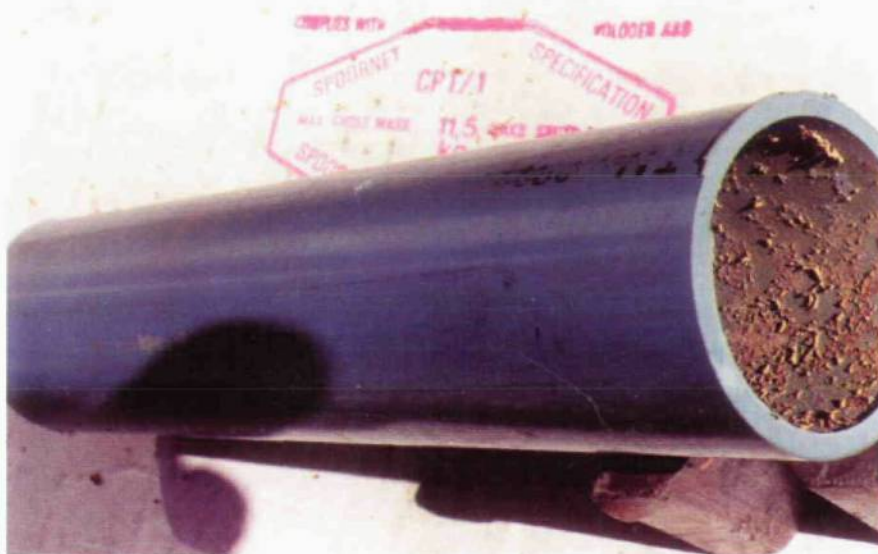
The non-metallic pipe specimens were visually examined for deformation and cracks. Quantitative tensile tests were performed on these specimens up to 18 months only, and the results were compared to results obtained prior to installation. The results of the tensile tests did not indicate significant degradation in the yield strengths of the different pipe specimens after 18 months (Table 11). Brownish surface deposits were evident inside the pipe specimens. The surface products seemed to originate from other carbon steel pipes in the system, and did not seem to have affected the integrity of the non-metallic pipe specimens (Figures 9(a) and 9(b)).

The performance of all the non-metallic piping was satisfactory and no obvious deterioration of these materials could be detected. The presence of surface deposits had no effect on the integrity of the non-metallic piping materials.

Figure 9(a): Non-metallic piping specimen after (polykop) 42 months testing.
(Note: Brown product from metallic pipes).

Figure 9(b): Non-metallic piping specimen (HDPE) after 42 months testing.
(Note: Brown product from metallic pipes).

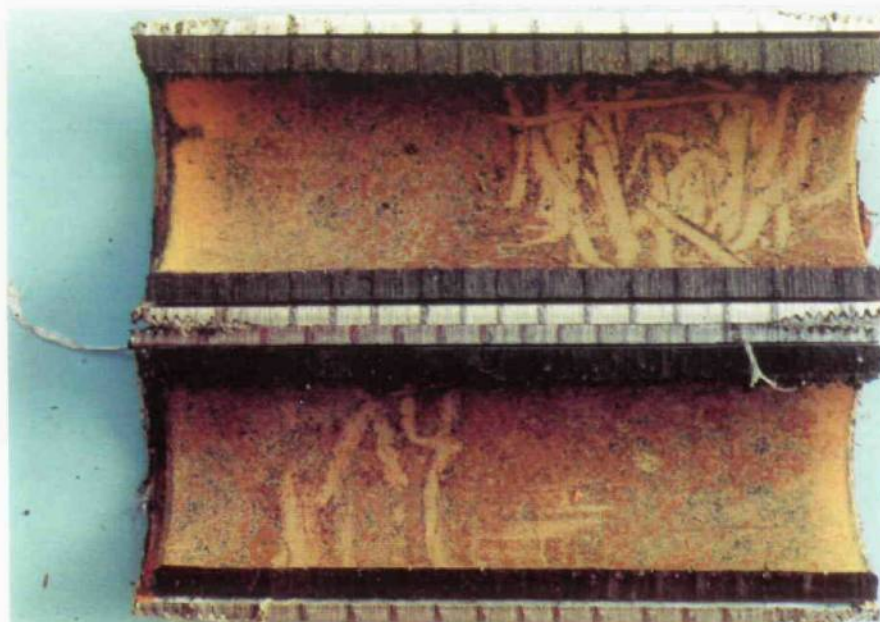
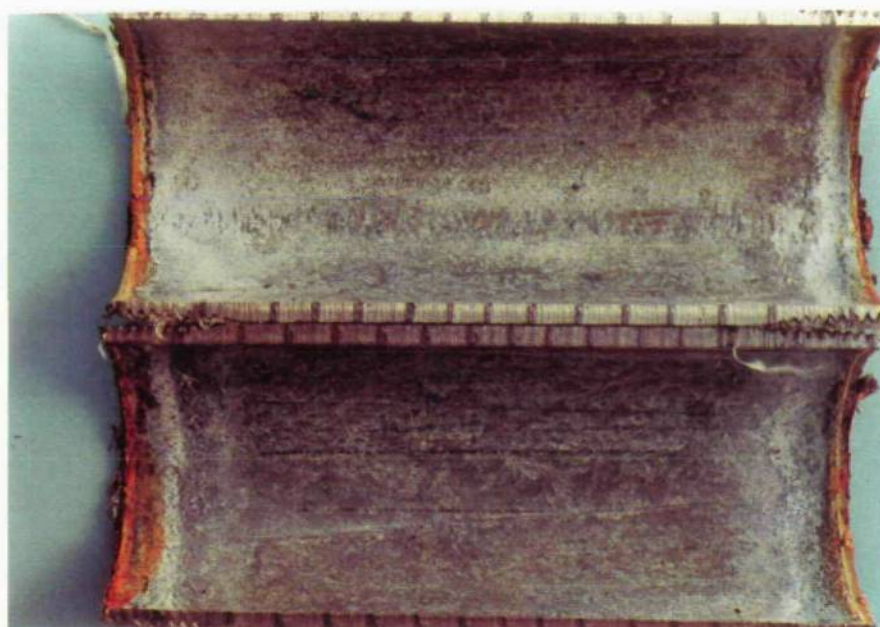
The internal surface appearance of a HDPE-lined carbon steel was examined and brown corrosion product was evident (Figure 10(a)). After the removal of the lining, the surface of the carbon steel substrate was found to be in a good condition. No rust formation or obvious defects except the red corrosion product at the end of the pipe specimen caused by the crevice could be observed (Figure 10(b)).

Figure 10(a): Internal surface of the HDPE lined steel pipe specimen (X0, 67).

Figure 10(b): Internal surface of the carbon steel substrate after the removal of HDPE lining (X0,67). (Note: Some superficial rusting was evident on the edges of the specimen where a crevice existed due to the cutting and the threading of the sample).

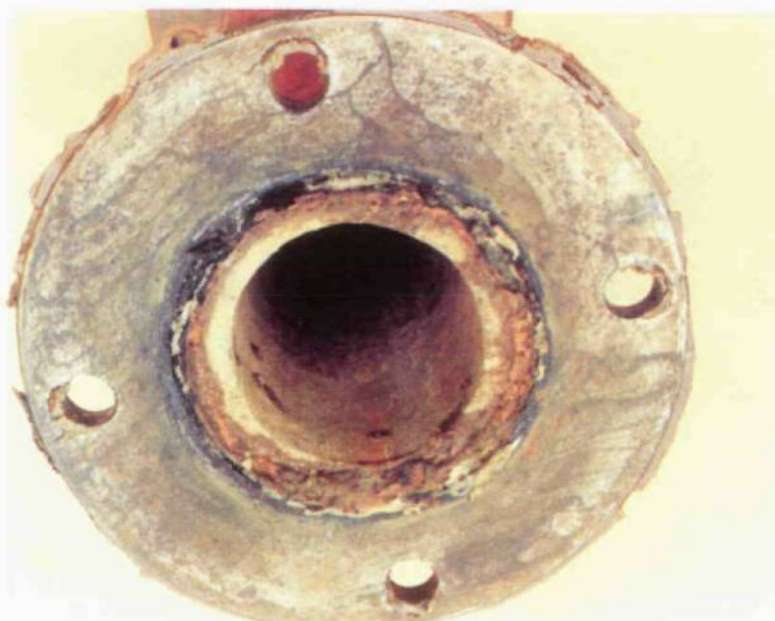
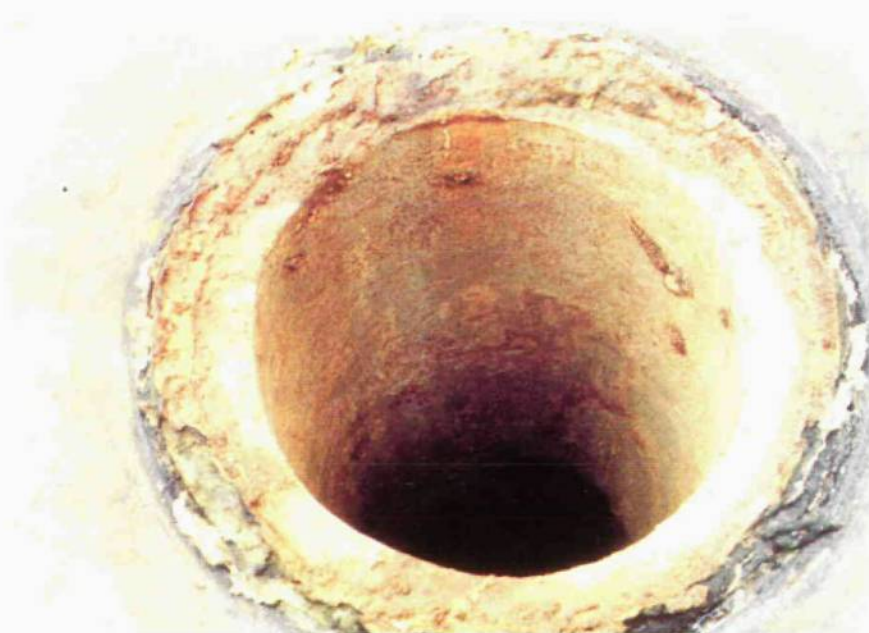
The mortar-lined pipe specimen showed no obvious defects or deterioration except brown corrosion product. The surface was slightly uneven in places (Figures 11(a) and 11(b)).

The mortar lined pipe samples performed very well after 42 months of testing. The presence of corrosion product seemed to have originated from the other pipe materials in the system.

Figure 11(a): Mortar-lined carbon steel pipe end-on (X0,39).

Figure 11(b): Mortar-lined carbon steel pipe showing the condition of the mortar lining (X0,42). No degradation of the cement mortar was noted.

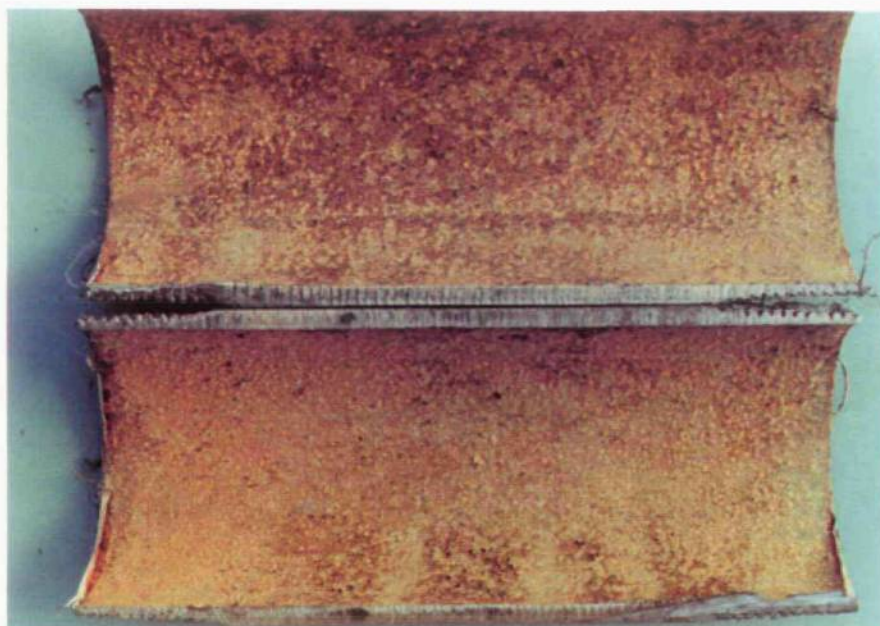
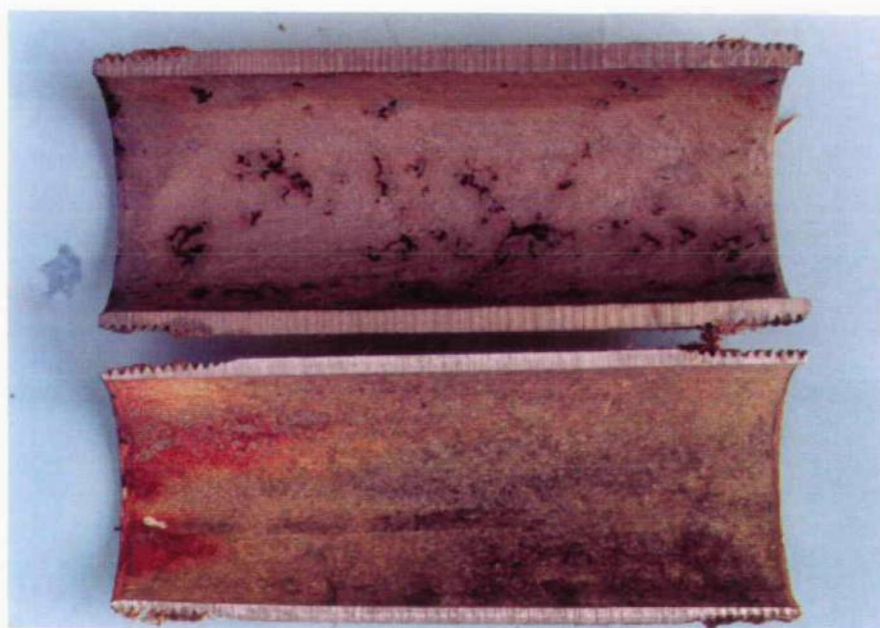
Visual examination of the galvanised steel pipe (welded) showed no tuberculation but the formation of a uniform scale which probably consisted of zinc carbonates. Superficial red rust staining, which did not affect the protective zinc layer, was observed after 42 months testing. The substrate was protected due to the galvanic protection offered by the zinc except at the end of the specimen (threaded region). Figures 12(a) and 12(b) show the surface of the galvanised sample before and after cleaning respectively.

The measured average corrosion rate for the galvanised steel pipe samples was determined as $90 \mu\text{m/yr}$ after 12 months as compared to $4 \mu\text{m/yr}$ after 18 months of testing. The specimens after 42 months of testing did not show any obvious signs of corrosion only slight white staining which was probably CaCO_3 or ZnCO_3 . These may be the cause of this significant decrease in the corrosion rate due to the formation of a protective film providing protection to the metal substrate.

Figure 12(a): Internal surface of galvanised pipe specimen before cleaning. (Note: White uniform scaling) (X0,64).

Figure 12(b): Internal surface of galvanised pipe after cleaning (X0,64).

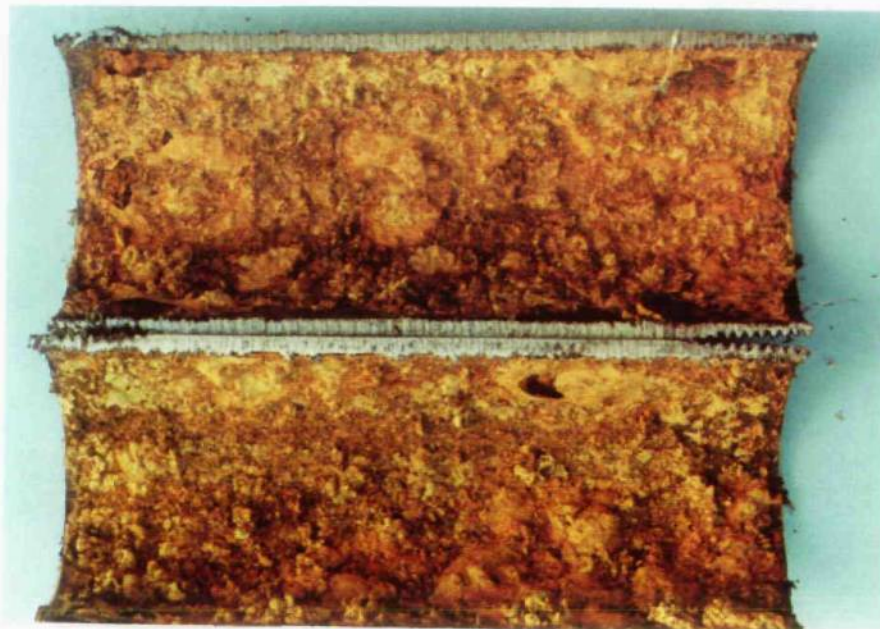
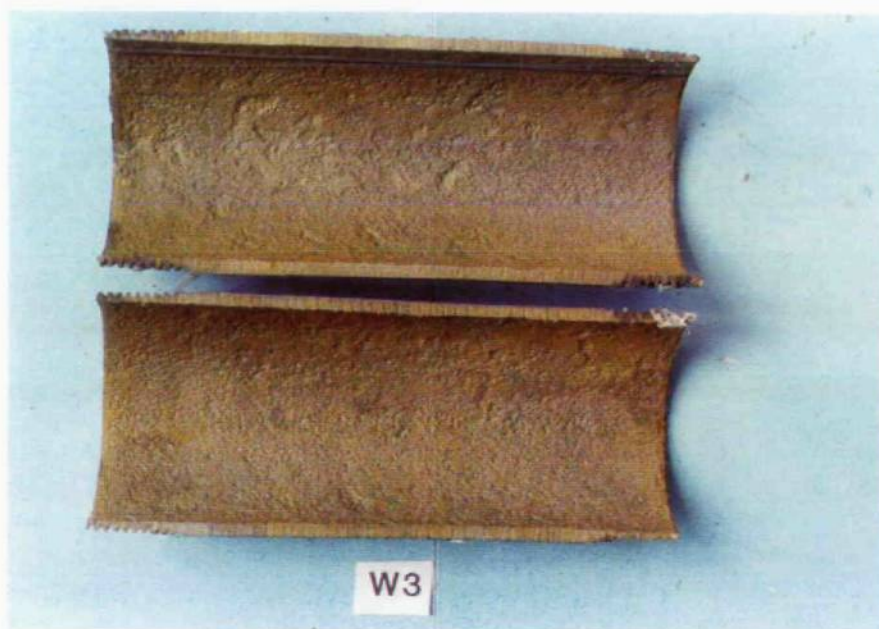
The welded and seamless carbon steel specimens showed extensive brown mounds of corrosion product (tubercles), due to sulphate reducing bacteria. Removal of the corrosion product indicated pitting corrosion of the metal substrate and weld corrosion attack on normalised carbon steel pipe. The appearance of the uncoated welded carbon steel pipe was similar to that of the seamless carbon steel pipe. Figures 13(a) and 13(b) show the internal surface of uncoated pipe specimens before and after cleaning respectively.

The uncoated carbon steel showed obvious signs of corrosion in the form of tuberculation of the surface and pitting of the substrate. This aspect once again stresses the fact that all steel pipelines used to convey potable water should be internally lined. Lining will not only mitigate internal corrosion but also maintain the water quality. In the case of corrosion rate, there was a decrease from $220 \mu\text{m/yr}$ after 12 months of testing to $90 \mu\text{m/yr}$ after 18 months of testing. The decrease in the corrosion rate may be due to the formation of protective corrosion products which form a diffusion barrier to the transport of oxygen to the carbon steel, and the corrosion rate was determined by mass loss which is a best case scenario. The corrosion rate of carbon steel pipe after 42 months testing was down to about $30 \mu\text{m/yr}$. The $90 \mu\text{m/yr}$ corrosion rate after 18 months is in fair agreement with previous recorded corrosion rates ($70 \mu\text{m/yr}$). The average pit depths measurements were $0,42 \text{ mm}$.

- 5.10 Although the corrosion rate of the unlined carbon steel specimens averaged 30 $\mu\text{m}/\text{yr}$, pits of 0,42 mm were present. This clearly illustrates the danger in basing corrosion rates on mass loss values, when localised corrosion such as pitting is the dominant corrosion process.

Figure 13(a): Internal surface of carbon steel pipe specimen cleaning (X0,64).
(Note: Tuberculation).

Figure 13(b): Internal surface of carbon steel pipe specimen after cleaning (X0,62).
(Note: Average pit depth (0,4mm)).

- 6.1 Unlined carbon steel should not be used to convey potable water.
- 6.2 Non-metallic piping such as HDPE, polypropylene and polycarbonate is suitable to convey potable water. Corrosion product originating from corrosion of steel piping does adhere to the non-metallic pipe surface.
- 6.3 HDPE-lined steel piping performed well under the test conditions.
- 6.4 The performance of the epoxy coatings was variable. The performance of the
