# **MICROBIAL CORROSION OF PIPE LININGS**

**J.S. Ramotlhola ● Dr C. Ringas**

**Advanced Engineering and Testing Services  
Division of Materials Science and Technology, CSIR**

**WRC Report No. 432/2/99  
ISBN 1 86845 478 9  
ISBN SET NO 1 86845 479 7**

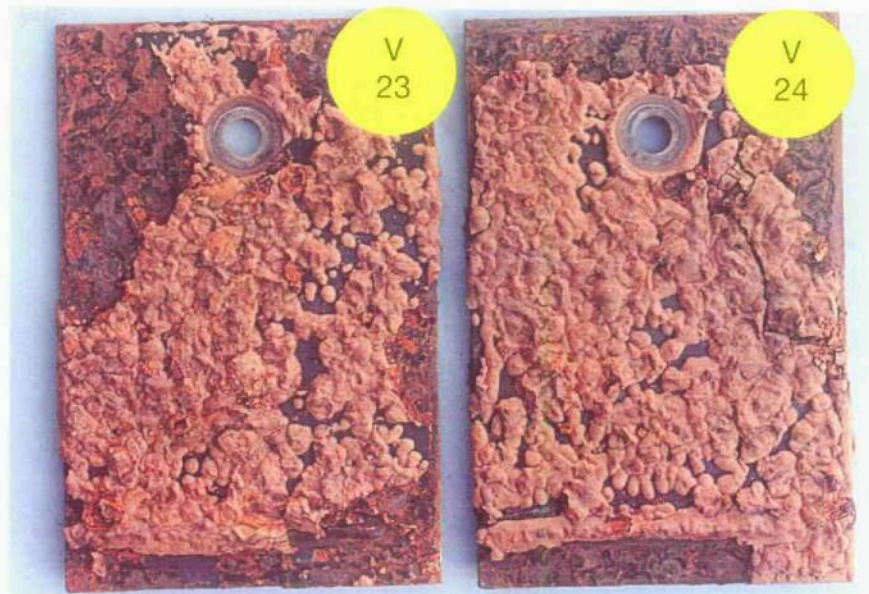
The mild steel panels and the zinc coated samples exposed in raw waters at the three dams showed signs of general corrosion (Figures 1(a) and 1(b)). The top right hand corner of most of the coated panels (which was not coated) also showed preferential corrosion attack. Massive corrosion product was evident and the presence of SRB was positively identified using standard microbiological techniques. The surfaces of these panels after cleaning showed deep pits which are common when microbiological attack has occurred. Visual examination of the galvanised and the zinc coated samples from the dams indicated general corrosion and isolated tubercles on the surface. The removal of the corrosion product showed the local depletion of the protective zinc layer (Figures 2(a) and 2(b)). The zinc coated samples from photos Roodeplaat Dam showed total depletion of the coating with red rust evident (Figure 1b - RZ20). Vinyl-

**Figure (1a):** Mild Steel samples from Vaal Dam.

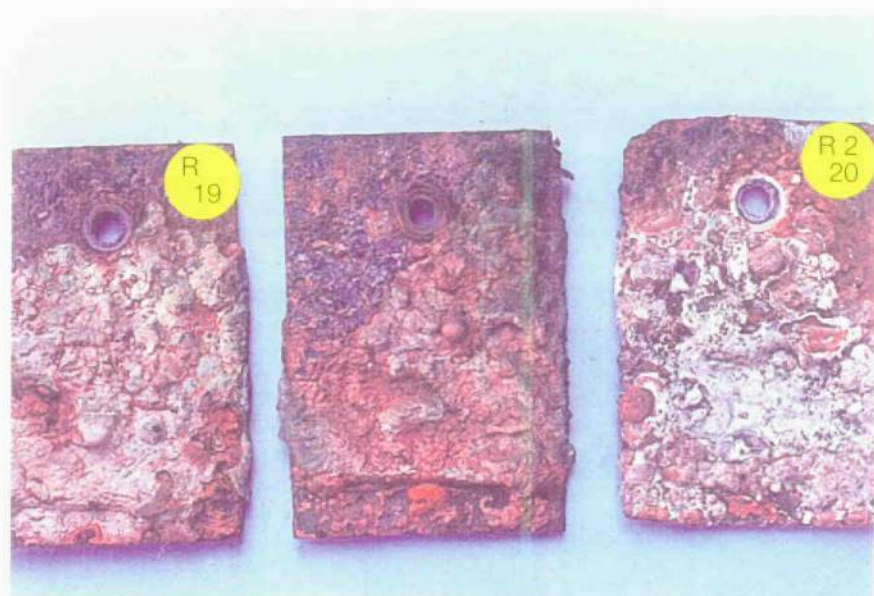
**Figure 1(b):** Zinc coated samples from Roodeplaat Dam.

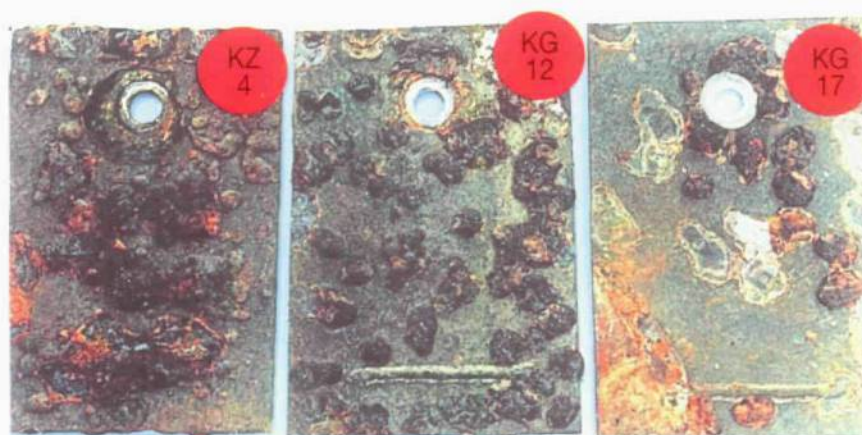
**Figure 2(a):** Galvanised and Zinc coated samples from Kleinplaas Dam.  
**Note:** Isolated tubercles.

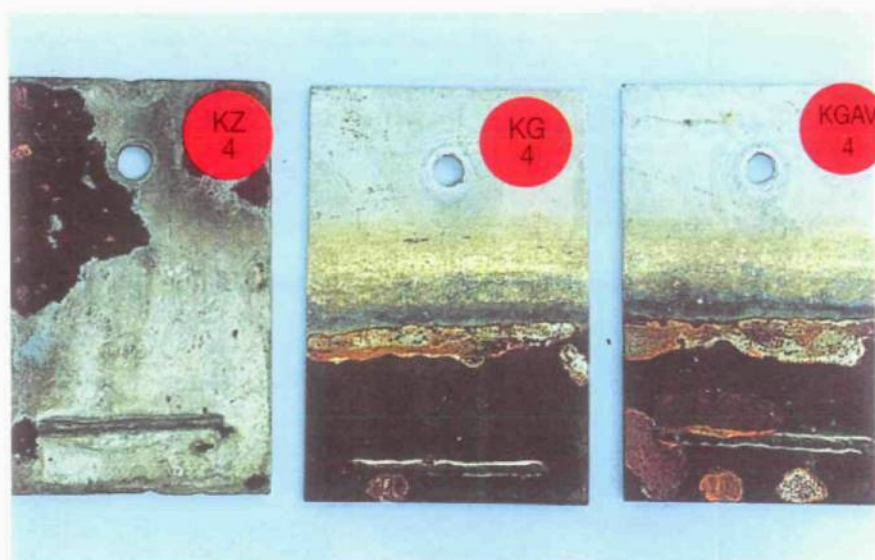
**Figure 2(b):** Galvanised and Zinc coated samples after cleaning.  
**Note:** Local depletion of zinc coating.

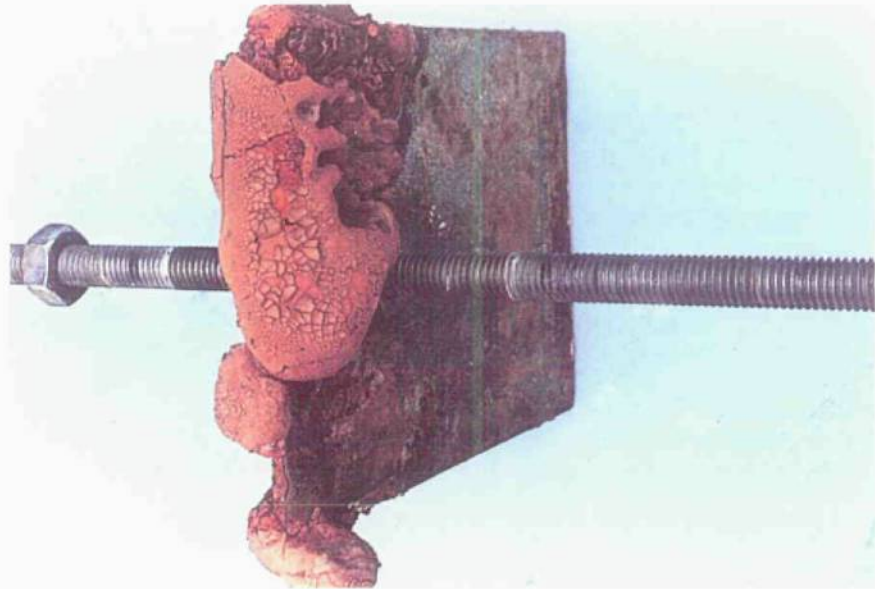
coated galvanised samples from the Vaal Dam showed isolated tubercles and massive tubercles on the edges which resulted in failure of the vinyl coating (Figures 3(a) and 3(b)).

**Figure 3(a):** Zinc-vinyl coated sample from Vaal Dam.  
**Note:** Massive tubercles along the edges.

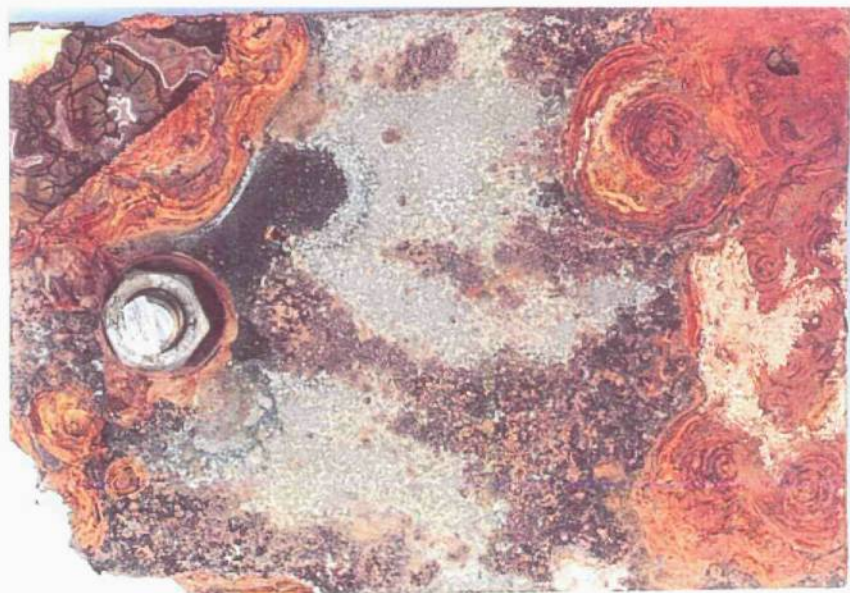
**Figure 3(b):** Coating defects and highly corroded Zinc-vinyl-coated sample from Vaal Dam.

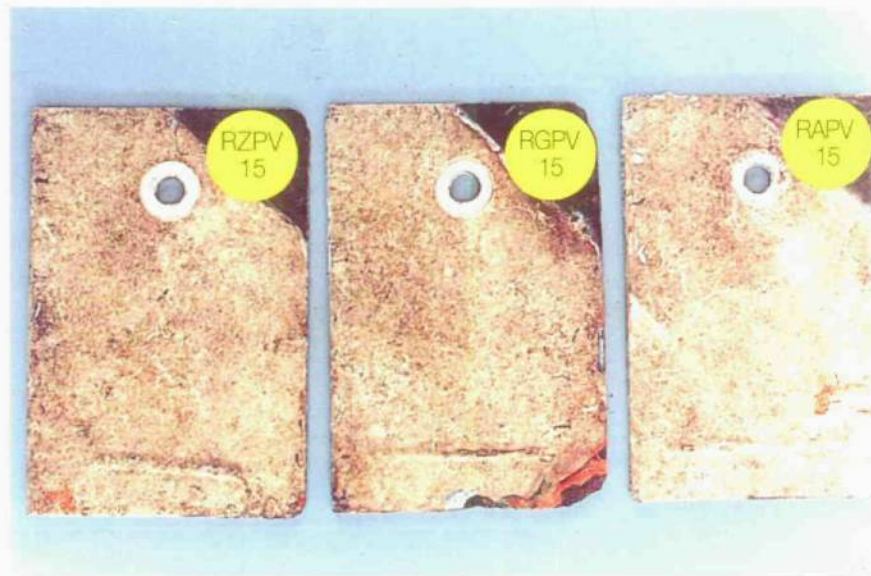
**Figure 4(a):** Coating defect at the bottom edge (arrowed) (RGPV 15).

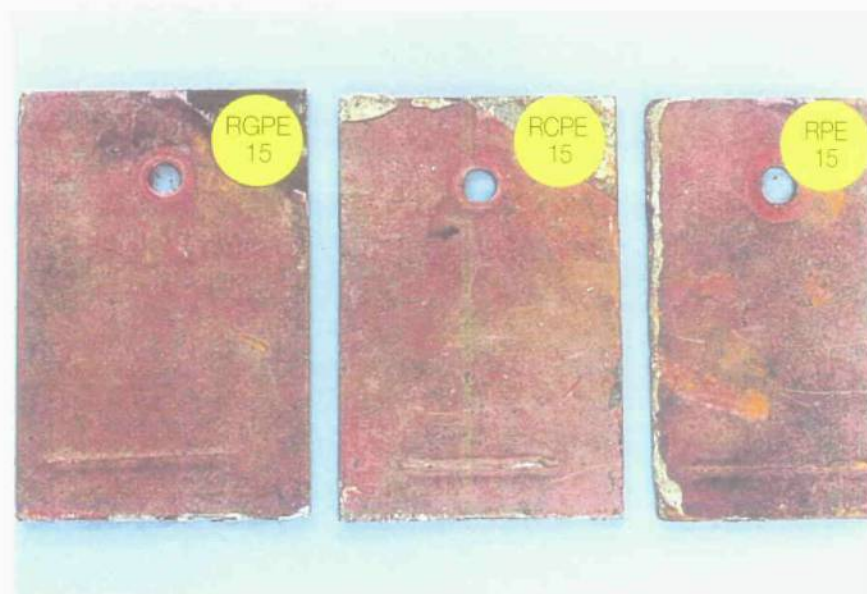
**Figure 4(b):** Failed coating at the edge (RPE 15).  
**Note:** Corroded edges (arrowed).

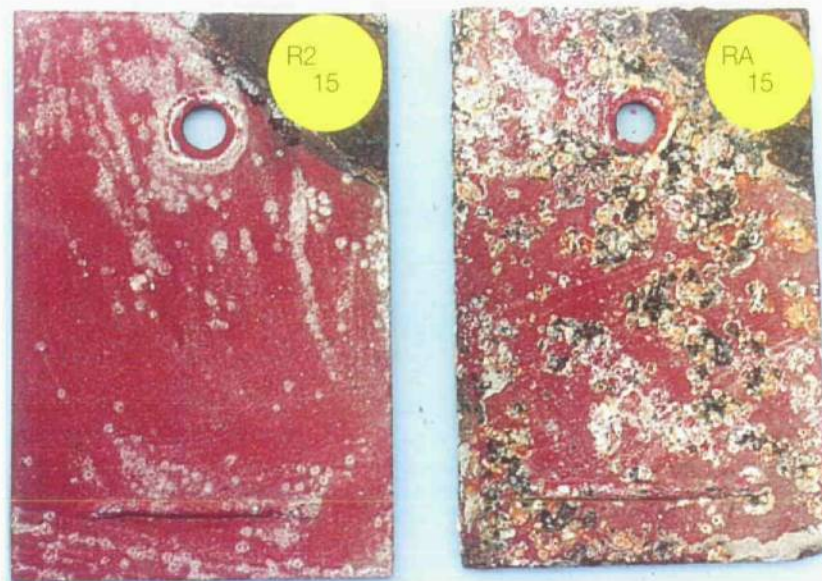
**Figure 5(a):** Non-metallic coated samples from Roodeplaat. **Note:** Isolated tubercles throughout the surface (RA 15), and corrosion product (black/brown).

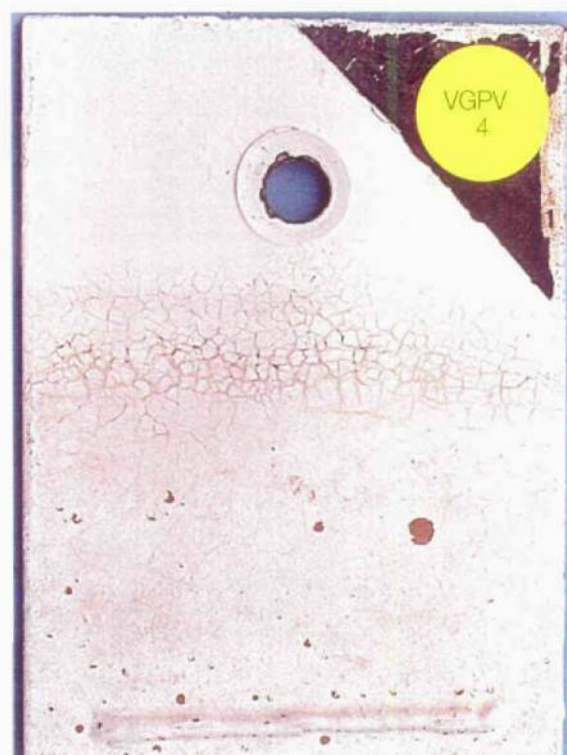
**Figure 5(b):** Non-metallic coated sample from Vaal Dam. **Note:** Cracked coating defect.

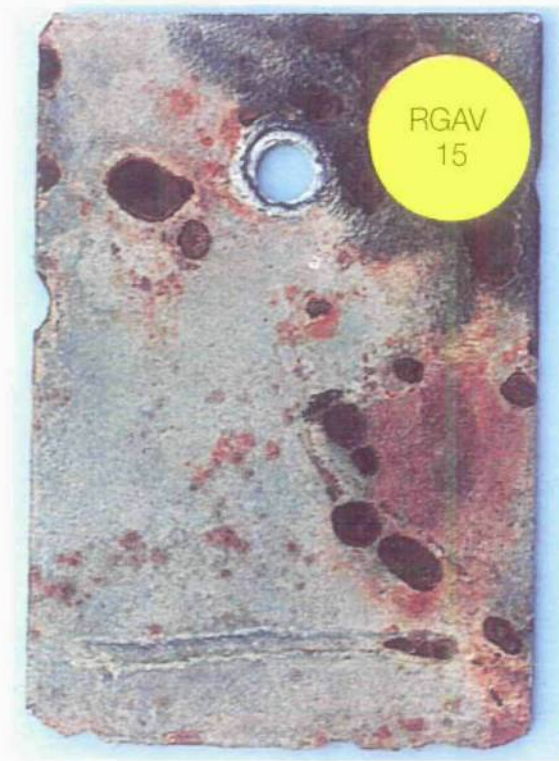
The samples with different non-metallic (i.e. organic) coatings showed no obvious signs of biodegradation in general. Different coatings showed no obvious coating defects or microbial attack except at different parts of the panels. The presence of edge attack as shown in Figures 4(a) and 4(b) (samples RGPV15 and RPE 15) showed the presence of SRB after culturing. In other samples, surface attack was evident and the substrate was exposed to microbial attack (Figure 5(a) - sample RA 15). SRB's were isolated at the superficial tubercles with corrosion product which were black brown in colour. Figure 5(b) shows a surface coating defect (cracking) and isolated blisters which have not penetrated the substrate. These defects seem not to have been favourable for the growth of SRB. Isolated pits were evident on samples RGAV 15, RZ 7 and RGAV 7 after cleaning showing typical morphology of MIC, see Figures 6(a) and 6(b).

**Figure 6(a):** Galvanised-vinyl-coated sample from Roodeplaat Dam.  
**Note:** Isolated pits and edge effect.

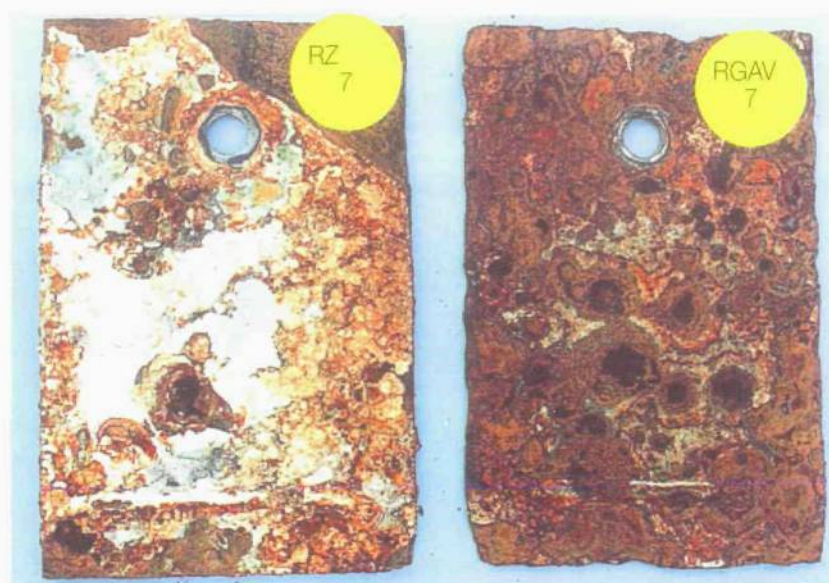
**Figure 6(b):** Zinc coated (RZ 7) and Galvanized-vinyl-coated samples from Roodeplaat Dam. **Note:** (RZ7) zinc coating removed and (RGAV7) with isolated pits.

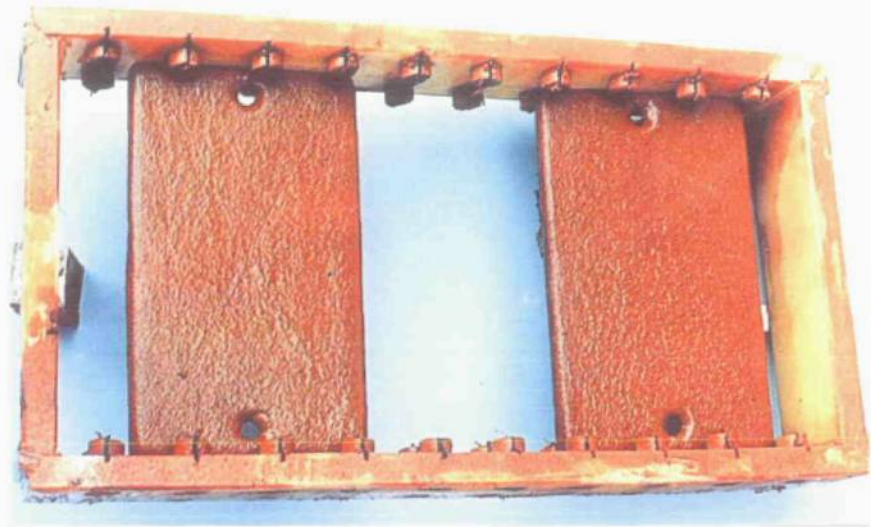
The "copon" coated samples exposed under stagnant conditions at Cottesloe showed the absence of SRB on the corrosion products whereas SRB were detected at the other sites. Generally, the coatings still looked good and no obvious biodegradation was evident (Figures 7(a) and 7(b)).

**Figure 7(a):** Coated samples exposed under stagnant conditions covered with brown surface deposits (Cottesloe).

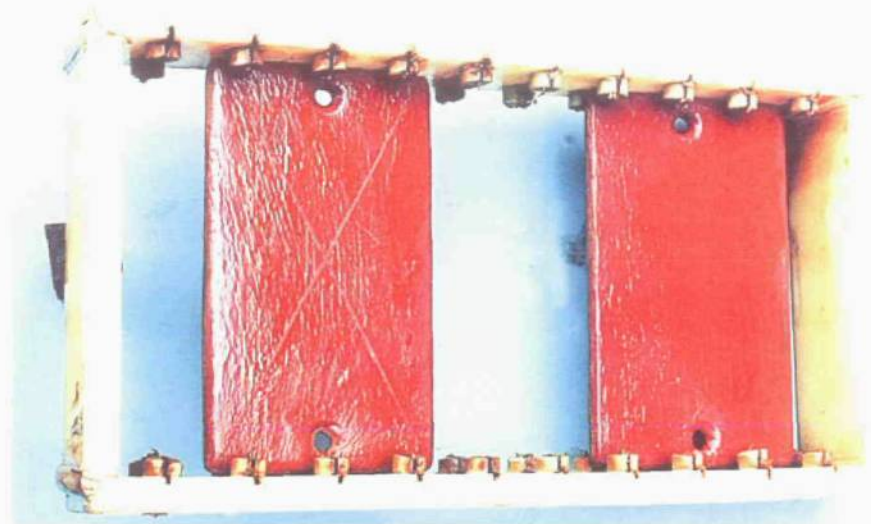
**Figure 7(b):** Cleaned coated samples exposed under stagnant conditions showing unaffected coating (Cottesloe).

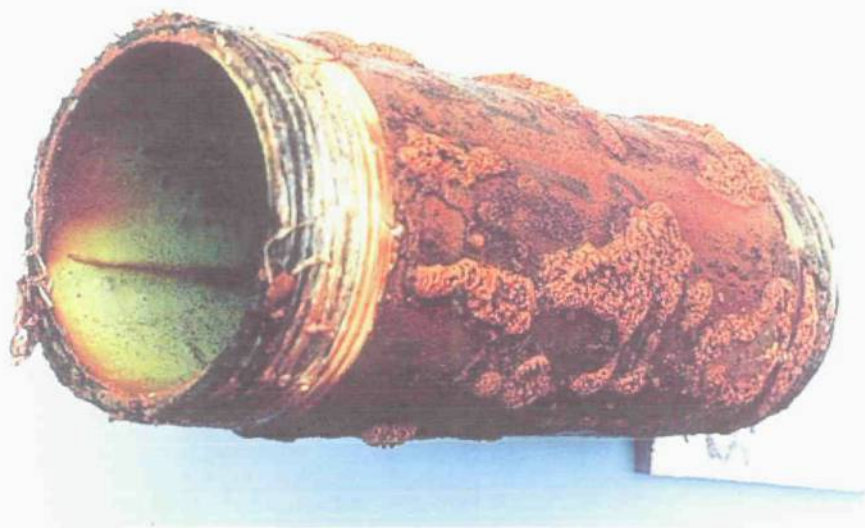
The internally lined piping materials showed blisters and cracking along the weld. The cracking on the coating showed some brown corrosion product (Figure 8(a)) which tested positive for SRB while Figure 8(b) shows the internally lined pipe sample after cleaning.

**Figure 8(a):** Internally lined pipe sample from stagnant condition (Cottesloe)  
**Note:** Cracking along weld.

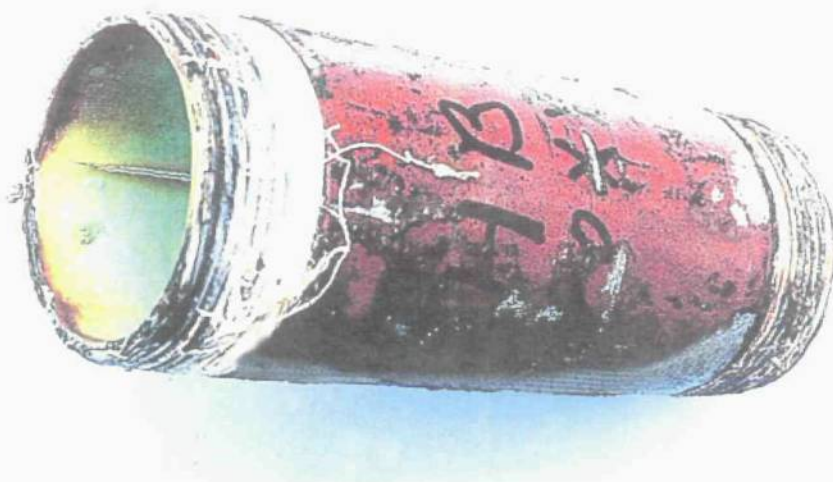
**Figure 8(b):** Internally lined pipe sample after cleaning from stagnant condition.

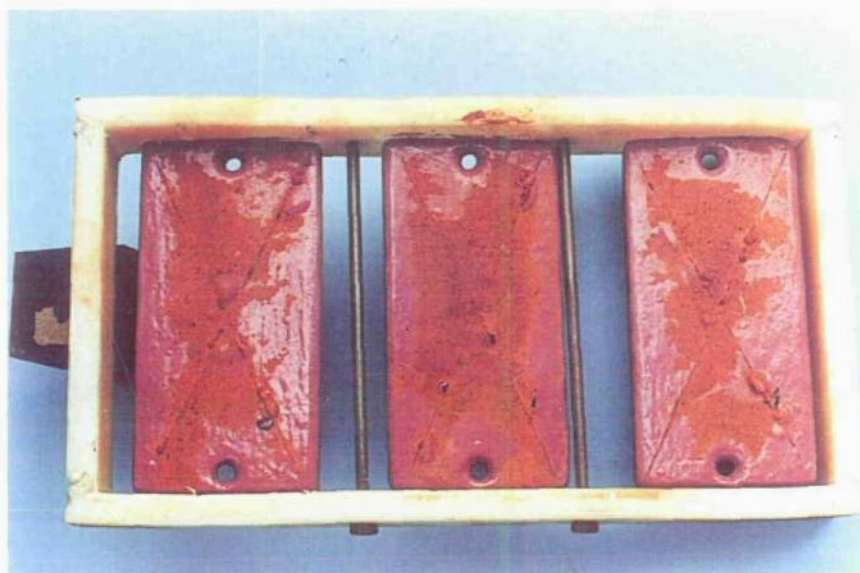
Copon coated samples exposed under stagnant conditions at Klerksdorp and the Vaal Dam (after 60 months) showed the presence of tubercles (brown corrosion product) along the scribed areas. These tested positive for the presence of SRB. The cleaned samples showed coating defects and blistering as shown in Figures 9(a), 9(b), 10(a) and 10(b).

**Figure 9(a):** Coated samples from the stagnant conditions covered with corrosion product at Western Transvaal Regional Water Company.

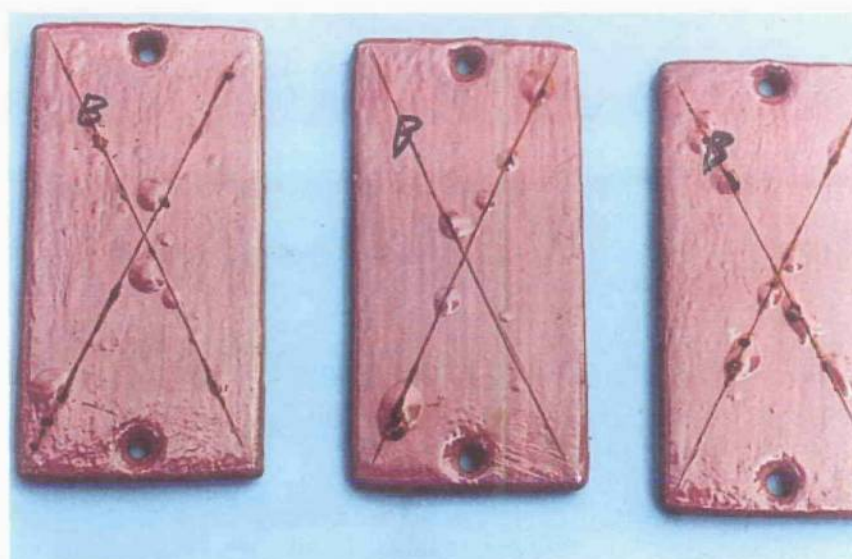
**Figure 9(b):** Coated samples exposed under stagnant conditions after cleaning at Western Transvaal Regional Water Company.  
**Note:** Blisters where coating failed.

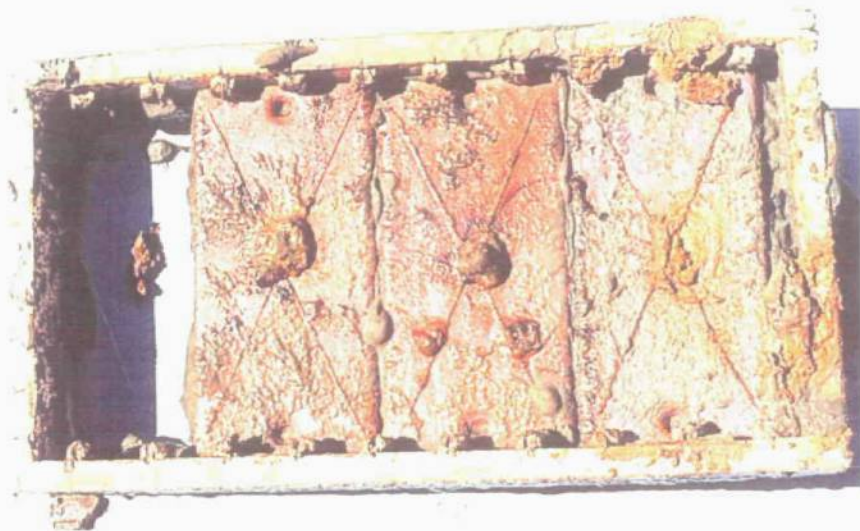
**Figure 10(a):** Coated samples exposed under stagnant conditions at vaal Dam.  
**Note:** Tubercles at scribed areas.

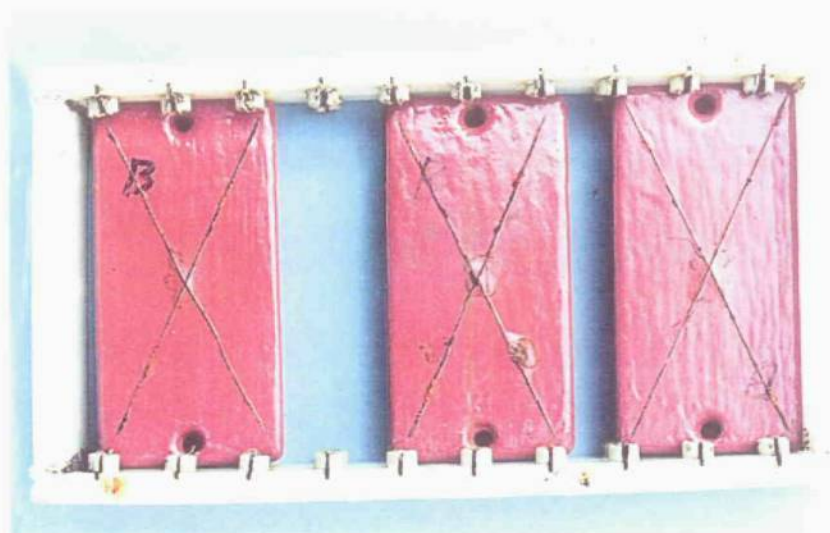
**Figure 10(b):** Coated samples exposed under stagnant conditions after cleaning at Vaal Dam.  
**Note:** Blistering at scribed areas.

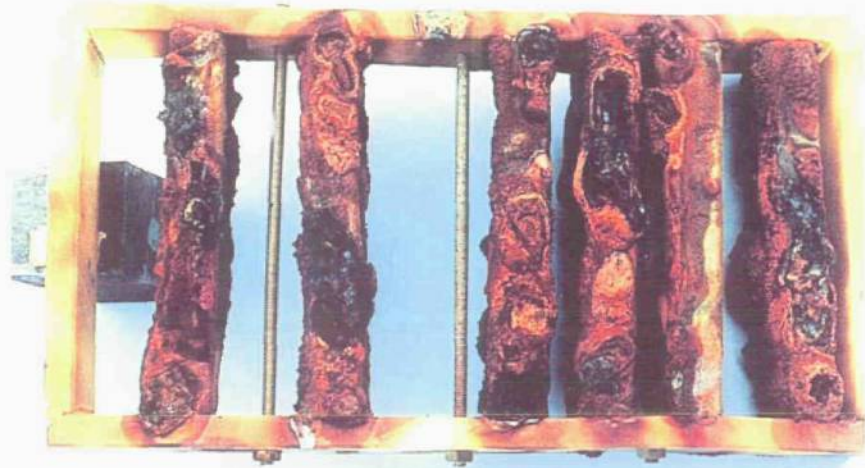
Figures 11(a) and 11(b) are coated cast-iron samples exposed under stagnant conditions at the Klerksdorp and Vaal Dam sites. These samples showed deteriorated coatings,

resulting in massive corrosion product. These proved favourable for SRB growth and corrosion attack.

**Figure 11(a):** Edge coated cast-iron samples exposed under stagnant conditions at Western Transvaal Regional Water Company. **Note:** Massive tubercles and brown/black corrosion product.

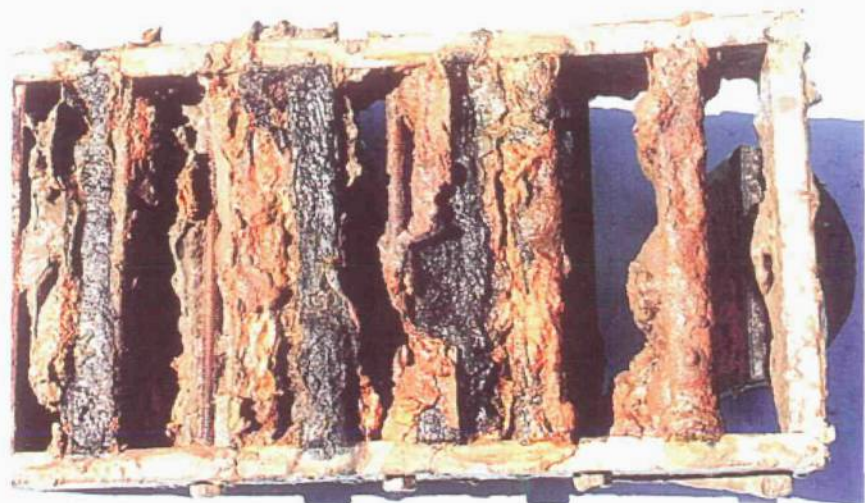
**Figure 11(b):** Edge coated cast-iron samples exposed under stagnant conditions at Vaal Dam. **Note:** Corrosion product (black/brown).

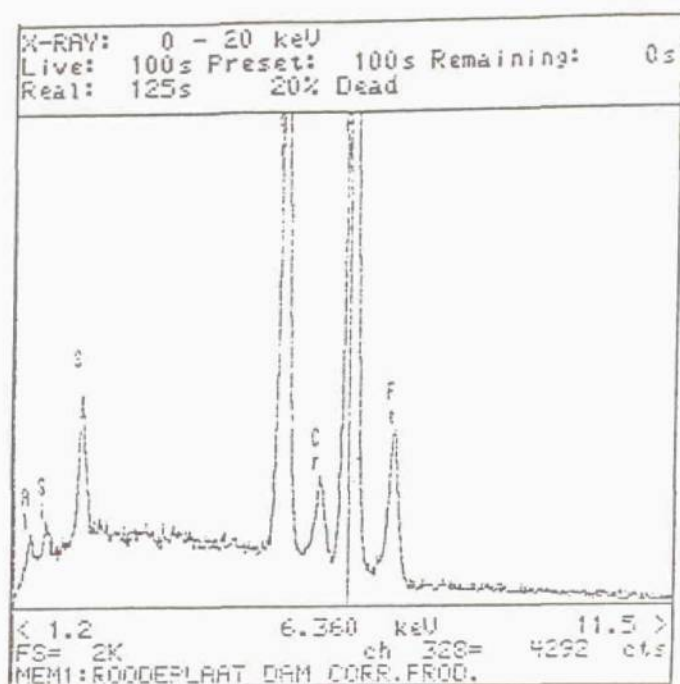
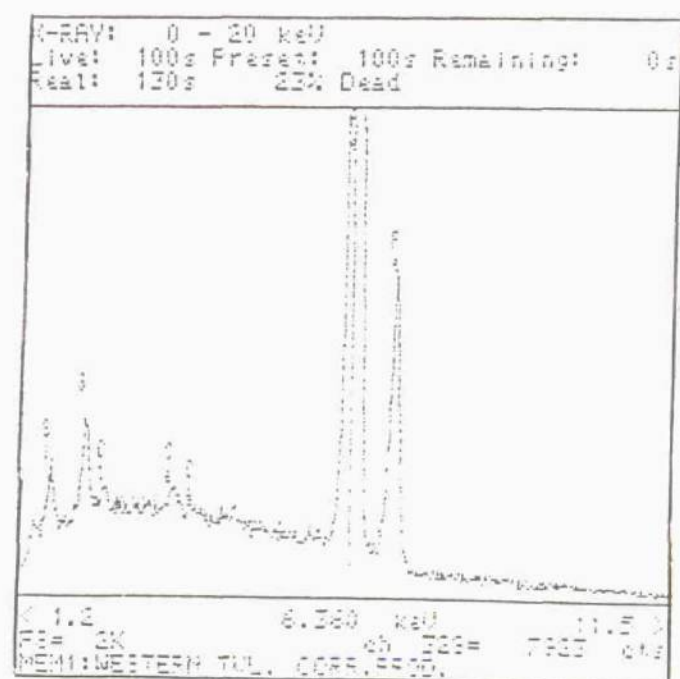
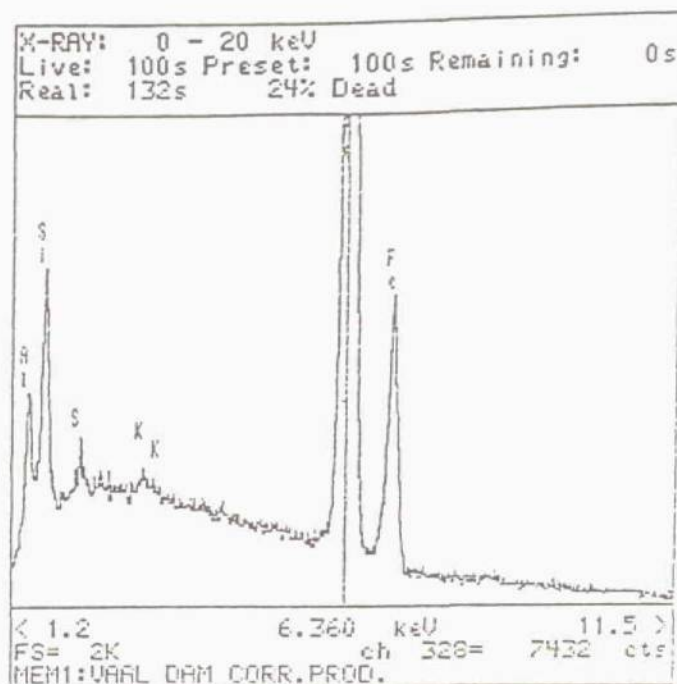
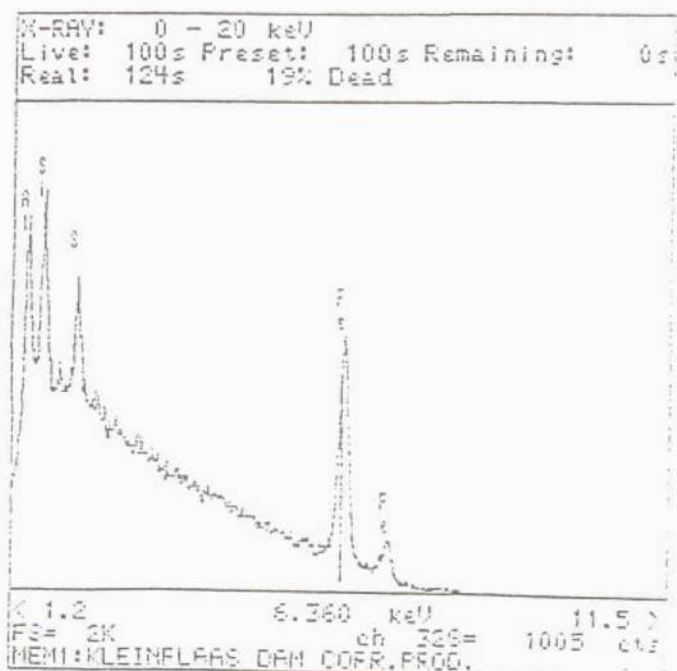
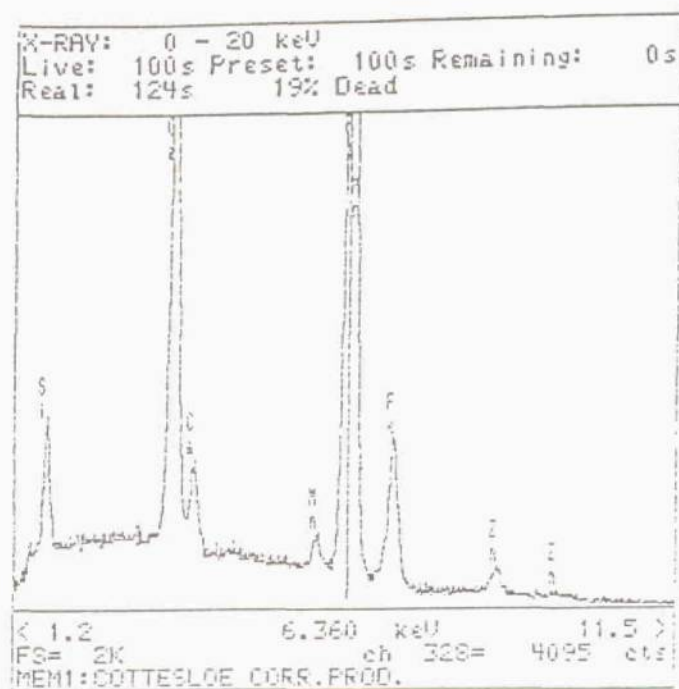
The EDS analyses of the corrosion products varied from site to site. The brown and black corrosion products from samples showed the presence of sulphur (S) and chloride (Cl) as dominant corrosive elements. Other elements detected were silicon (Si) and calcium (Ca). The results from the Western Transvaal Regional Water Company site showed the presence of more chloride than any other site. (Figures 12(a), 12(b), 12(c), 12(d) and 12(e)).
