A Manual on Mine Water Treatment and Management Practices in South Africa

APPENDIX Volume 3 Gold Mine Site Visit Reports

WRC Report No 527/3/96

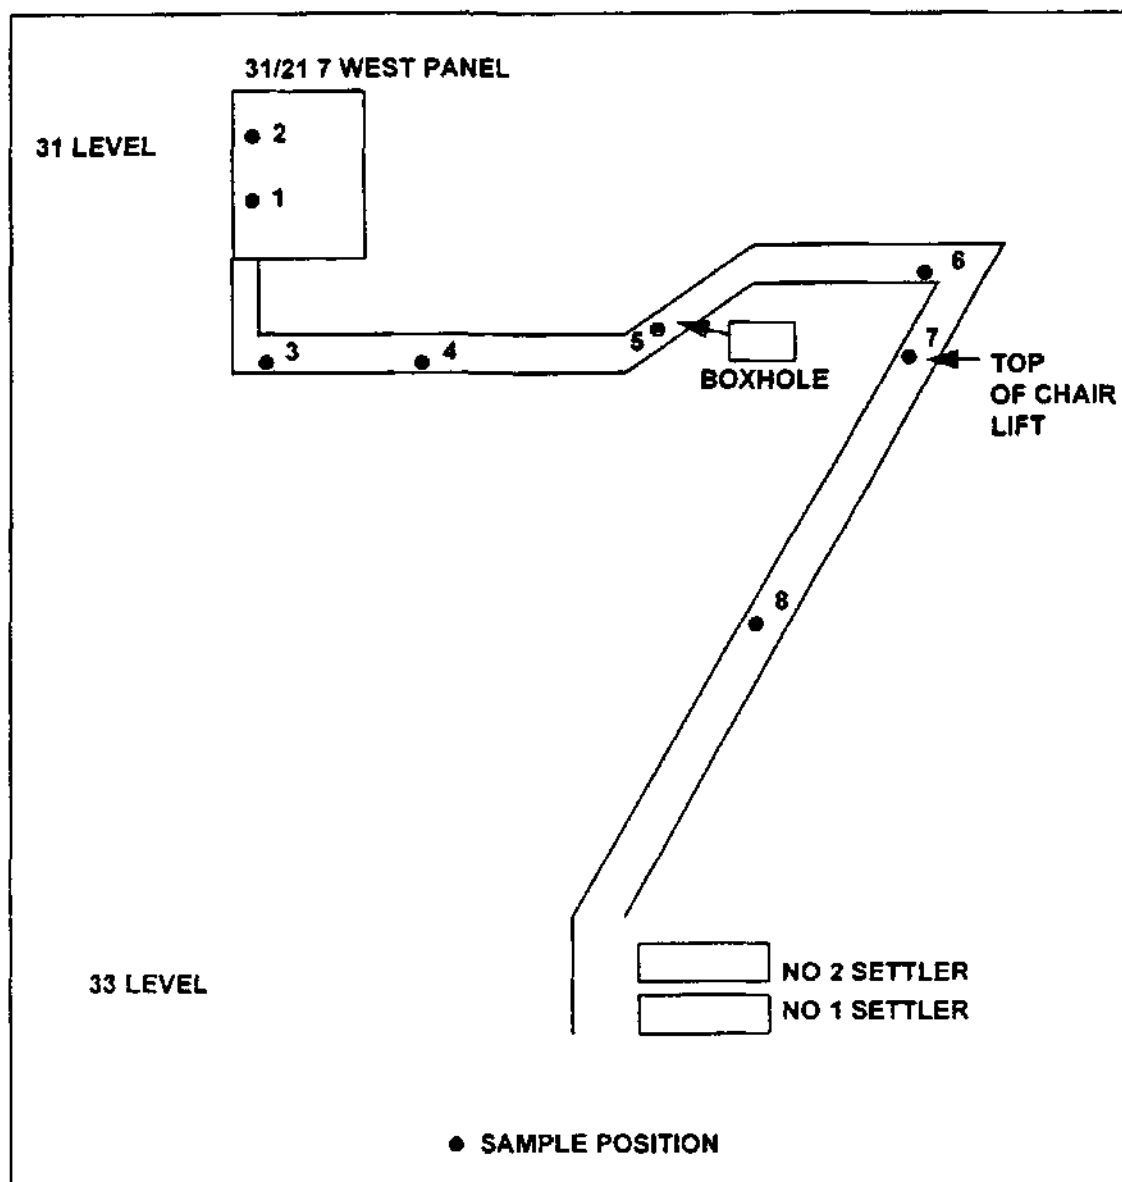
Figure 5 : Sampling points measured during the underground visit.

Sample Position	pH	Conductivity/(mS/m)	Temp/°C
1. Service water to stope	5.1	408	20
2. Water from drill hole	6.1	408	24
3. Footwall water in dip gully	2.9	546	29
4. Stagnant pond in dip gully	5.2	408	28
5. Water from borehole	5.1	478	28
6. Water into drain hole	3.5	489	29
7. Acid Mine Drainage at the top of chair lift	2.9	530	29
8. Water in drain of return air way on 33L	5.2	467	25

Acid mine drainage seeping from the sidewall at the top of the chair lift measured a pH of 2,9 and an electrical conductivity of 530 mS/m. This water, together with the runoff from the stopes causes an increase in dissolved salts in the service water to the settlers. The conductivity of the service water is 408 mS/m. The conductivity of the water increases by roughly 10% (from 408 to 450 mS/m) on a single pass through the underground mining operations.

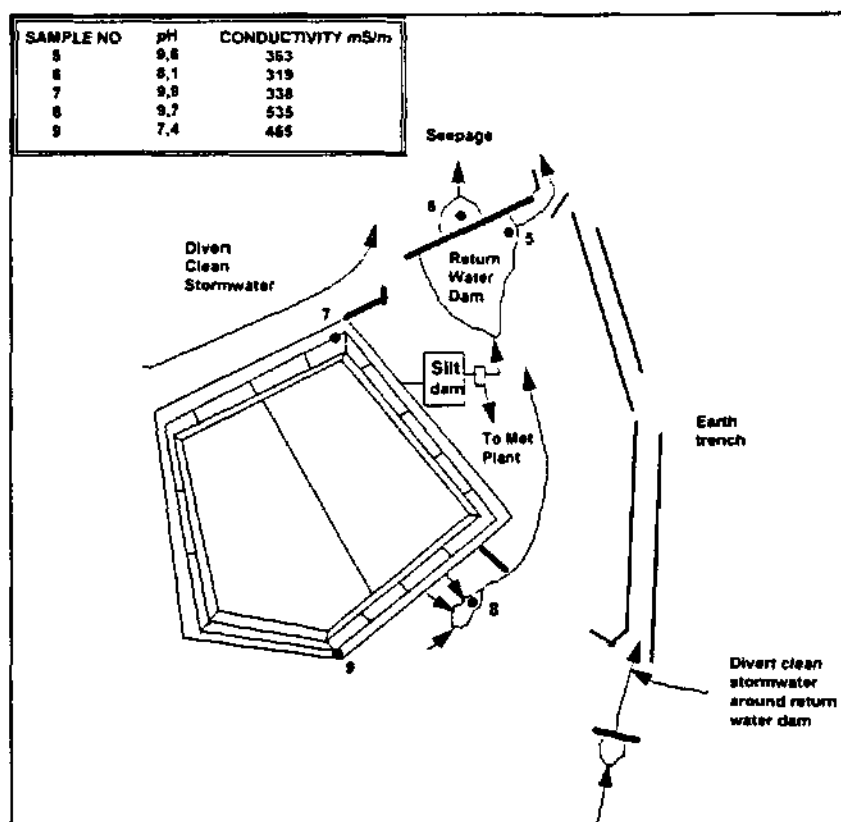
Figure 6 : Schematic outlay of the slimes dam and return water with the points sampled during the site visit.

Seepage is occurring through the return water dam wall and may cause contamination of downstream water systems.

Seepage to the lower vlei area on the eastern side of the slimes dam was measured with a pH of 9,7 and a conductivity at 535 mS/m. This high salt content could contaminate the groundwater or the precipitated salts could be mobilised with stormwater runoff.

The slimes dam is situated on an eye in the southeastern corner and during the site visit, seepage caused by flow from the eye was visible on the eastern side of the dam. At this point pH was measured at 7,4 with a conductivity of 465 mS/m. The eye could continue to be the driving force for pollution and acid mine drainage in the area long after closure of the mining operation.

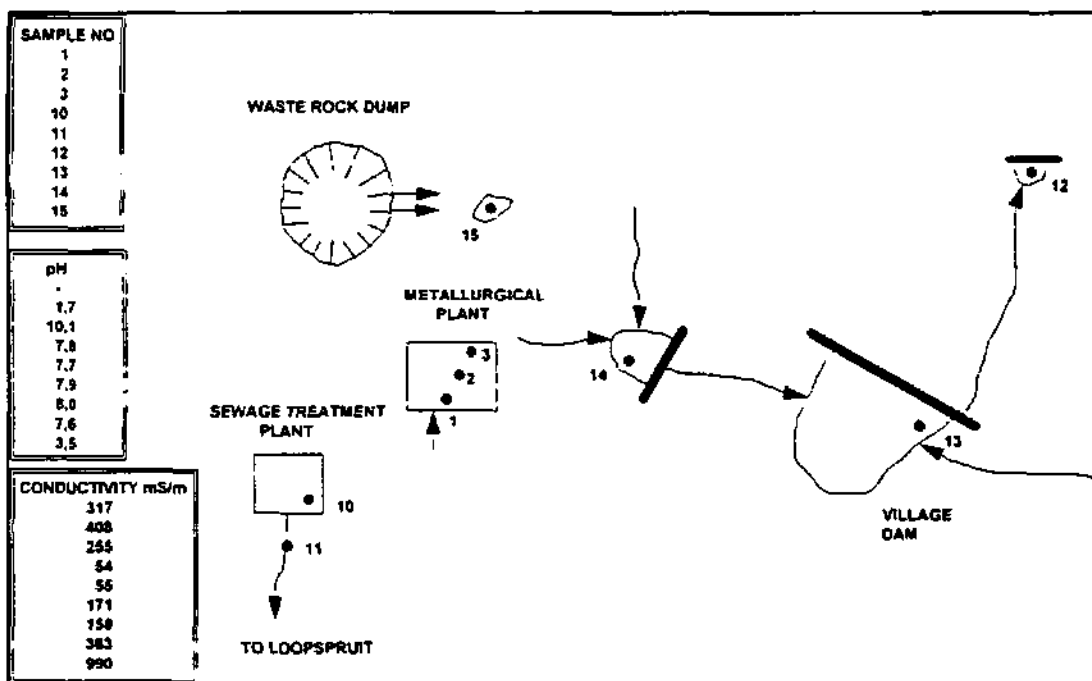
Figure 7 : The location of the sampling points measured around the waste rock dump, plant and Village dam.

During the site visit, the seepage to the eastern side of the waste rock dump was measured at a pH of 3.5 with a conductivity of 990 mS/m. Surface runoff and seepage from the area pollutes the water and surrounding land. After closure this acidic seepage may continue to cause a deterioration in the water quality if released into the environment.

The discharge of 1.7 *Me/day* of treated effluent into the Loopspruit is unnecessary wastage of a potentially valuable and useful water resource. Reuse of this water could significantly reduce the consumption of the Rand Water supply.

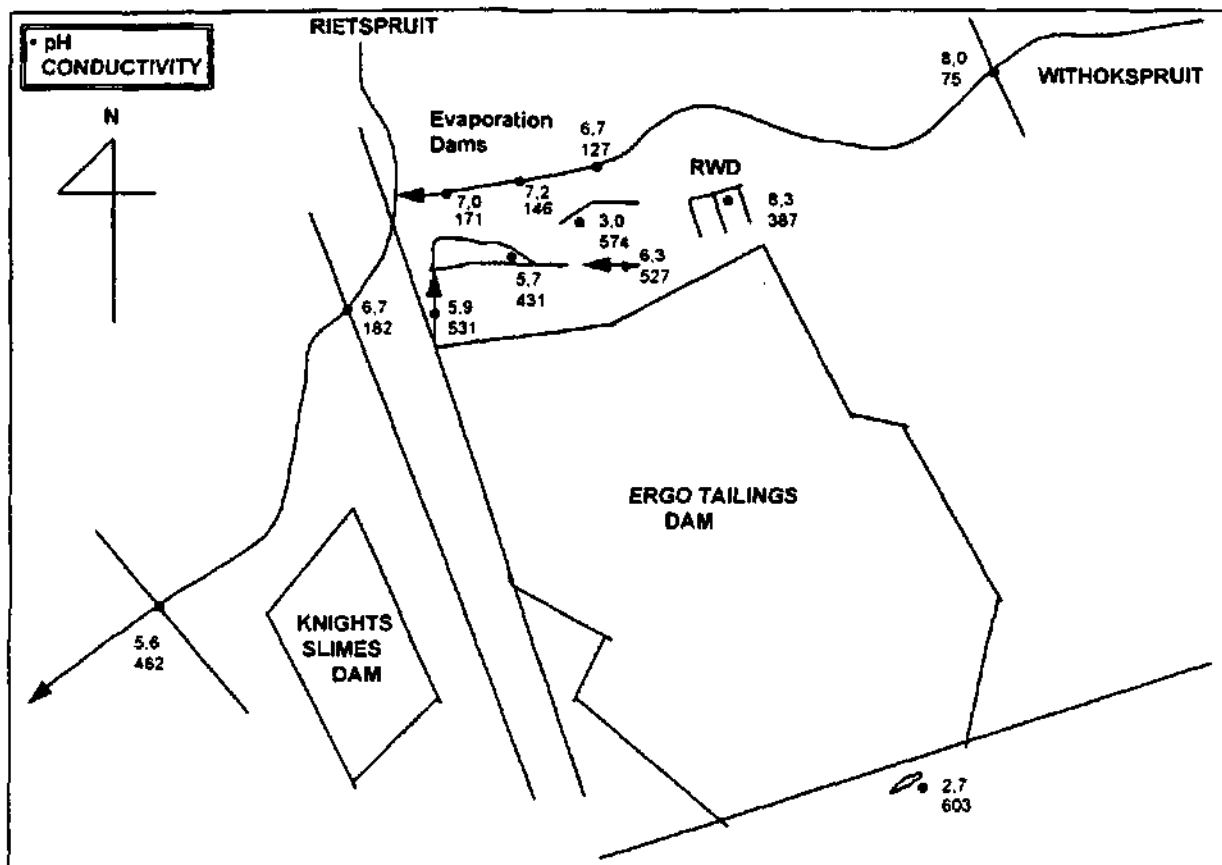
Figure 3 : pH and Conductivities measured

Figure 3 shows some of the pH and conductivities measured in these areas. Of significance is the changes in the water quality upstream and downstream of the tailings dam.

The Withokspruit flows from east to west past the ERGO tailings dam on the northern side. Upstream of the tailings dam, at the tar road, a pH of 8.0 and a conductivity of 75 mS/m was measured. The water quality, however, deteriorated and the pH changed to 7.0 and the conductivity increased to 171 mS/m closer to the confluence of the Withokspruit and Rietspruit. pH values as low as 3 and conductivities as high as 574 mS/m were measured in the area. The flow of underdrainage measured a pH of 5.9 and conductivity of 531. All seepage flow is collected in an evaporation pond and the wall of this dam showed signs of seepage. This evaporation facility is most likely causing a further deterioration in the Withokspruit water quality.

Due to the vlei nature of the area, it was only possible to measure the quality of the Rietspruit at selected points. Upstream of the Knights slimes dam a pH of 6.7 and a conductivity of 182 mS/m was recorded. Downstream of the Knights slimes dam, situated on the western side of the ERGO Tailings dam, the Rietspruit water quality deteriorated to a pH of 5.6 and conductivity of 462 mS/m. This represents a substantial deterioration in water quality and another contributing factor may be the large quarrying and crusher operation situated on the western side of the Rietspruit.

During the site visit the Blesbokspruit water quality upstream of the tailings dam was measured and a pH of 8,1 and conductivity of 151 mS/m was recorded. A pH of 6,3 and conductivity of 164 was measured downstream of the tailings dam in the Marievale bird sanctuary. There is an abundance of poor quality water in some of the paddocks on the western side of Blesbokspruit at the partially rehabilitated sites. In some of the paddocks the water quality was measured at a pH of 3,4 and a conductivity of 162. Severe salt precipitation was also observed in the area which would mobilise during a storm event and wash into the Blesbokspruit.

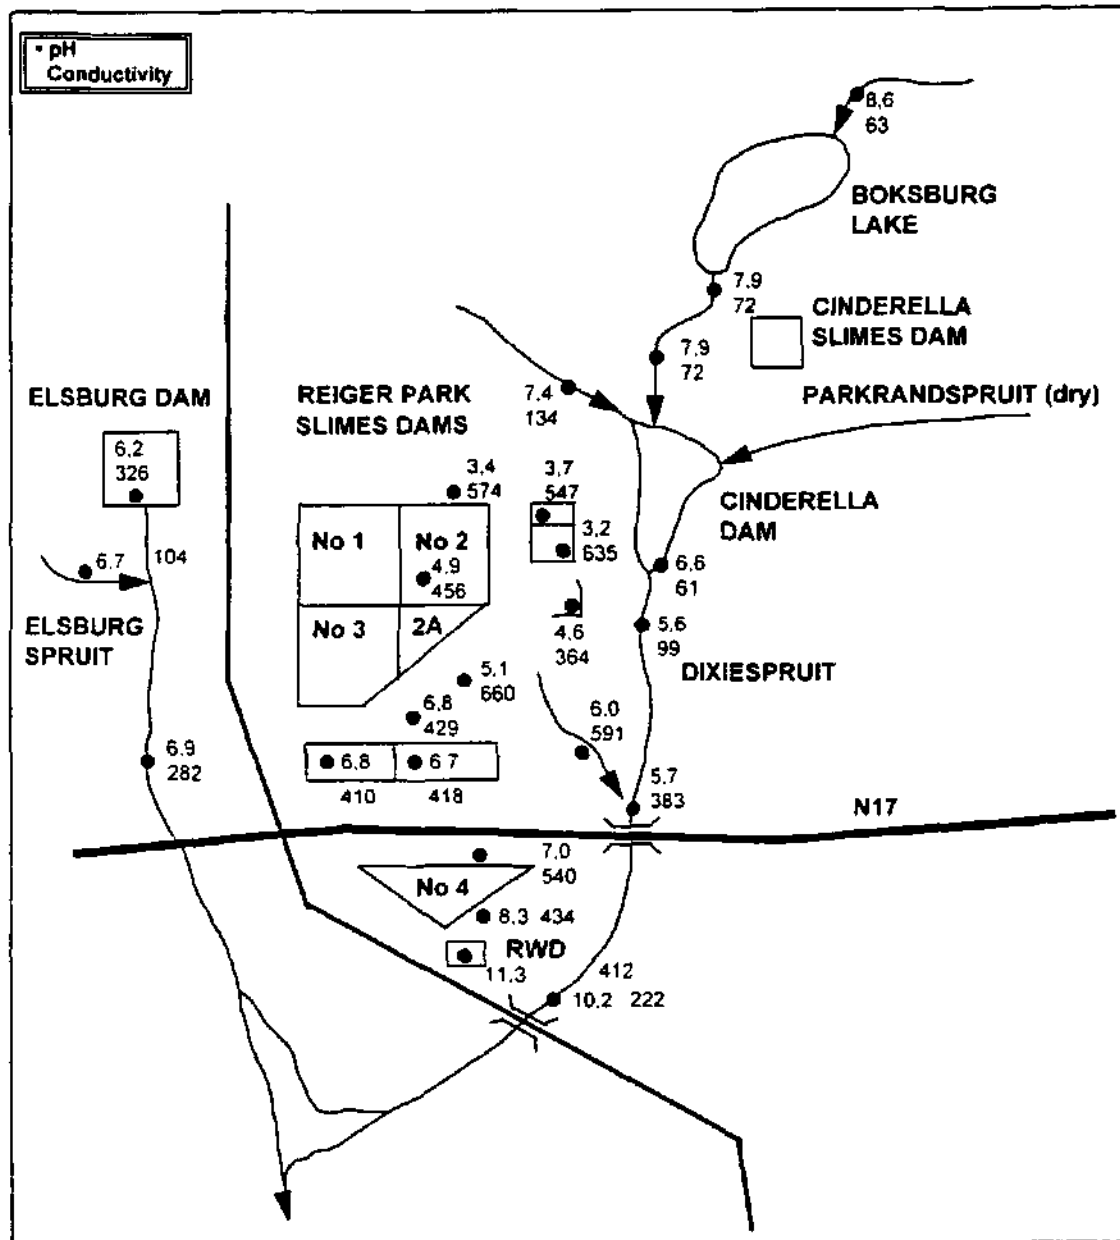
Figure 3 : Sampling points and readings obtained during the site visit around the slimes dam complex.

These results indicate a deterioration in water quality in the Dixiespruit, downstream of Cinderella Dam. This is possibly due to the effect of diffuse seepage from slimes dams No. 2 and 4. Various points were measured between No. 2 dam and Cinderella dam / Dixiespruit, and the pH readings ranged from 3,4 to 6,0 and the conductivity from 364 to 596 mS/m, indicating the possible presence of acid mine drainage.

of 6.7 and a conductivity of 104 mS/m. The stream has a diluting effect on the Elsburg Dam overflow and thus a conductivity of 282 mS/m was measured downstream.
