Evaluation of Metal Water Pipe Leaks in the Johannesburg Municipal Area

Report to the Water Research Commission by the Division of Materials Science and Technology CSIR

WRC Report No 587/1/99

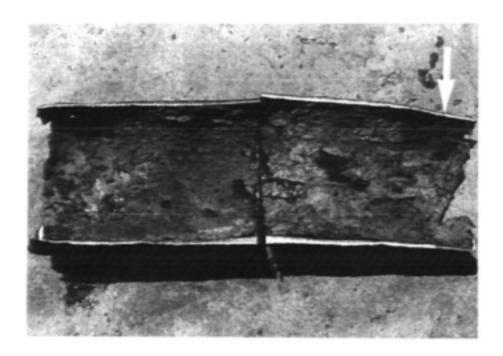
General corrosion amounted to 13% of the total. This figure does indicate that a significant portion of the corrosion of the pipelines occurs fairly slowly and is due to dissolved oxygen in the ground or aggressive soils or corrosive water on the inside of the pipeline. A typical example of general corrosion is shown in Figure 3.

General corrosion was very common as one would expect, because of the number of variables present underground. This type of corrosion could not be accounted for by any one particular effect. The most common feature of this corrosion was general thinning of the pipe both internally and externally.

Figure 3: General type corrosion (N.B. thinning wall arrowed). Magnification: X0.4.

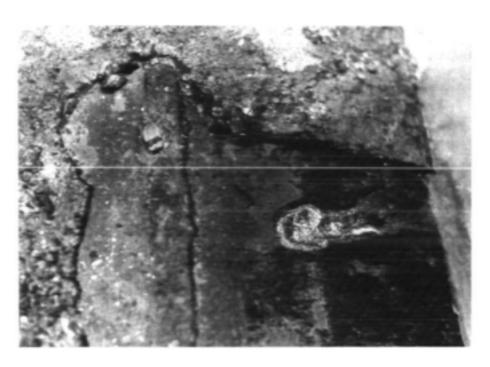
Figure 4 shows a failure attributed to stray currents. Failures attributed to stray currents amounted to 7% of the total and were certainly significant in terms of numbers.

The presence of electric railways, direct current generators and electric cables are common features of a highly developed city like Johannesburg. Of the total number of pipes, 7% failed by stray currents, which illustrates the importance of effective CP to minimise this type of corrosion.

Figure 4: Stray current on pipe samples after cleaning (note - melted parts).

One of the most commonly used criteria for cathodic protection is -0.850mV versus a Cu/CuSO₄ reference electrode. It would appear that since the bulk of the failures by corrosion were external that a greater emphasis on achieving adequate protection would reduce the external corrosion problem.

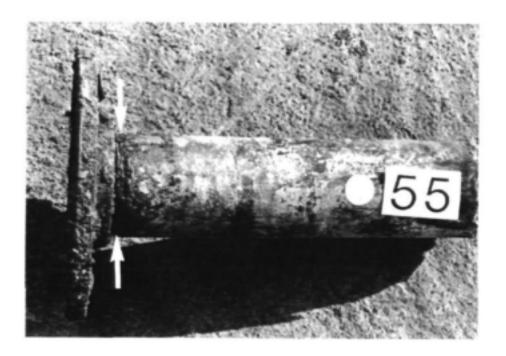
One example of galvanic corrosion was noted and is shown in Figure 5. A carbon steel flange was welded to a galvanised steel pipe, resulting in corrosion at the joint between the flange and the pipe.

The joining of a mild-steel flange to a galvanised pipe without protection may lead to adverse effects on the pipes as was found in this investigation.

Figure 5: Galvanic corrosion - (Mild steel flange and galvanised pipe (Note -corrosion attack arrowed). Magnification: X0,5.

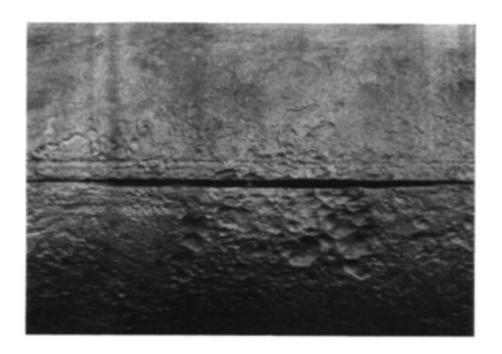
Figure 2(b) summarises the type of corrosion mechanism and the figures are expressed as a percentage. The single largest cause of failure was corrosion at the weld. It was found that this occurred in almost all the galvanised steel samples evaluated. The ages of the galvanised steel pipe samples varied, with the oldest dating from the 1920's and the youngest from the 1980's.

Preferential Weld Corrosion was found in both the galvanised steel pipes and the carbon steel pipes. This type of corrosion is mostly associated with aqueous environments. There is clearly a microstructural dependence and it has been shown that the presence of impurities and hardened structures can accelerate the corrosion around the weld.

Figure 6(a): Weld attack galvanised pipe (outside). Magnification: X0,6.

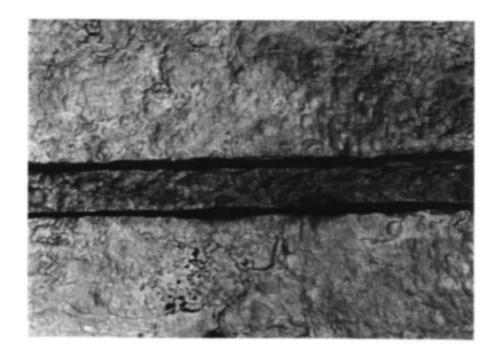
Figure 6(b): Weld attack (HAZ) mild steel pipe (inside). Magnification: X0,6.

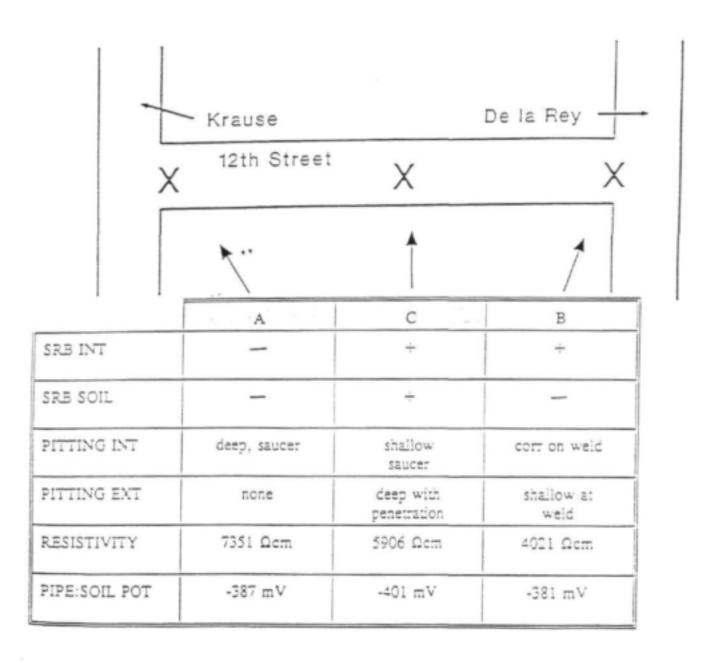
A detailed study of a pipeline in 12th Street, Pageview, between De la Rey and Krause Streets was undertaken in 1993. The whole pipeline was being replaced with PVC piping. A detailed study of three sections from the entire pipeline length was carried out by a visit to the site. Figure 7 shows the area of pipeline sampled and the results obtained. The pipe to soil potential readings showed that the pipe was actively corroding at all three sites tested. The resistivity, which changes from one end of the pipe to the other, indicated that the soil was fairly aggressive. It did, however, highlight the variations in soil type that can occur even over a short length of pipe (±300m). Although SRB were not isolated from the interior of section A, they were present in other samples tested. It is possible that the bacteria were killed by heat during the cutting process as the section removed was not long enough to prevent

heating effects at the centre. The nature of attack does seem to be due to SRB, and these organisms were most likely present along the whole length of the pipe. Severe external corrosion only occurred at the site where SRB were isolated from the soil, which strongly suggests that they were responsible for the external corrosion as well.

Figure 7: Results from study of Pageview pipeline. (Diagram not to scale)
