# **EVALUATION OF METAL WATER PIPE LEAKS IN THE JOHANNESBURG MUNICIPAL AREA**

**J.S. Ramotlhola ● Dr C. Ringas**

**Advanced Engineering and Testing Services  
Division of Materials Science and Technology, CSIR**

**WRC Report No. 587/1/99  
ISBN 1 86845 480 0**

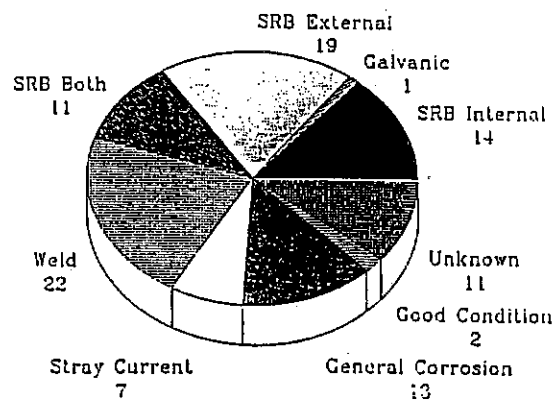
**Figure 2(a):** 3-D pie-chart showing percentage location of corrosion

Figure 2(a) shows a graphic representation of the location of corrosion. External corrosion at 34 % accounted for the highest number of failures. However, the failures caused by stray currents were also external so in fact the failures which were clearly due to external corrosion amount to 41 % of the total.

The category external and internal amounting to 33 % was due to the fact that some pipe samples showed signs of both internal and external corrosion and it was not clear which had caused the failure. However, if one were to take half of this category (say 16 %) and add it to the external category then the number of failures due to external factors would rise to 57 % of the total. This is a clear indication that the bulk of the corrosion problem experienced by Johannesburg Municipality Area is predominantly due to external factors as 41 % of the failures were due predominantly to external factors.

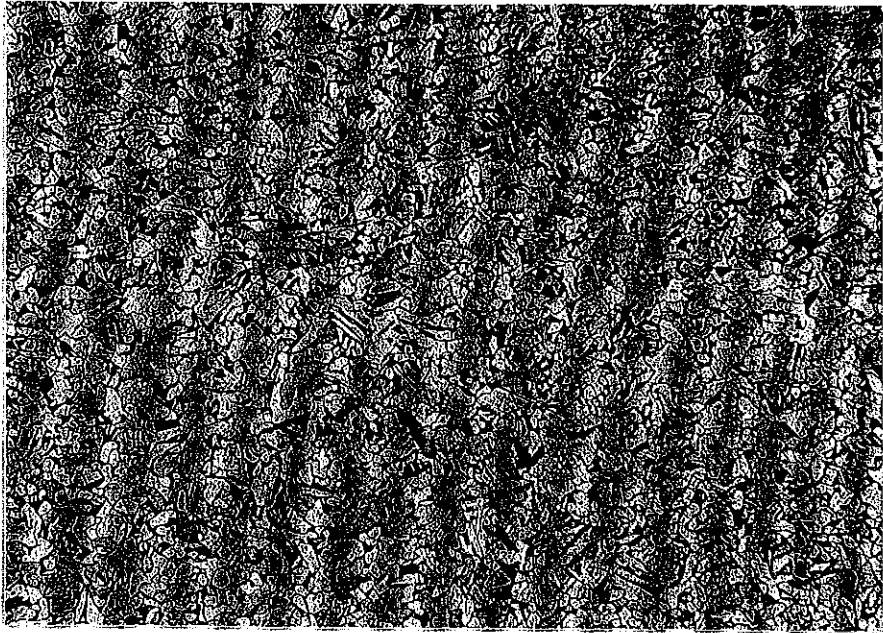
PIPE NUMBER: 23  
SECTION: WELD (ATTACK FROM INSIDE) MICROGRAPH  
MAGNIFICATION: X57  
YEAR: 1920

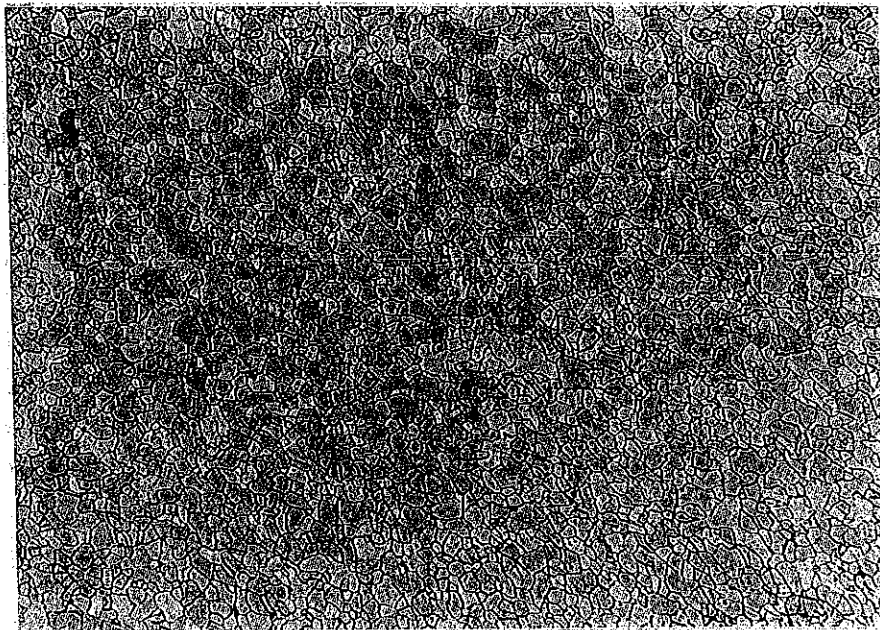
PIPE NUMBER: 89  
SECTION: WELD ATTACK  
MAGNIFICATION: X57  
YEAR: 1930

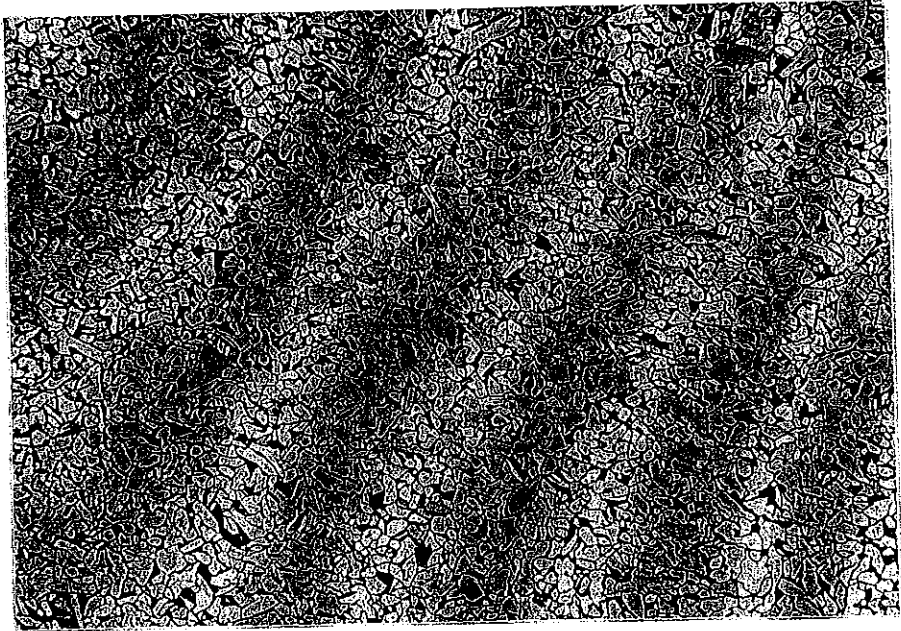
PIPE NUMBER: 76  
SECTION: WELD (ATTACK FROM OUTSIDE)  
MAGNIFICATION: X57  
YEAR: 1940

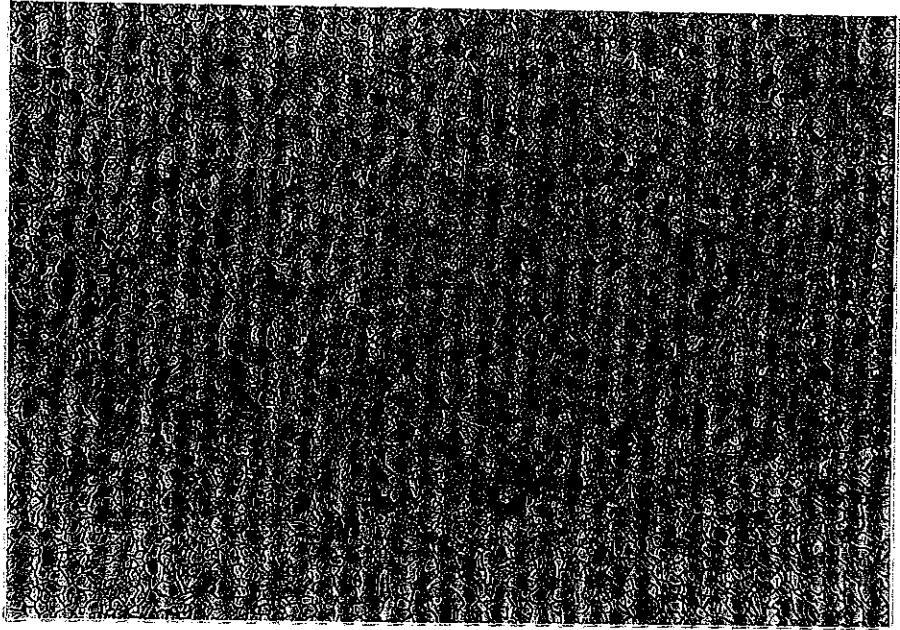
PIPE NUMBER: 99  
SECTION: WELD (ATTACK FROM BOTH INSIDE AND OUTSIDE)  
MAGNIFICATION: X57  
YEAR: 1950

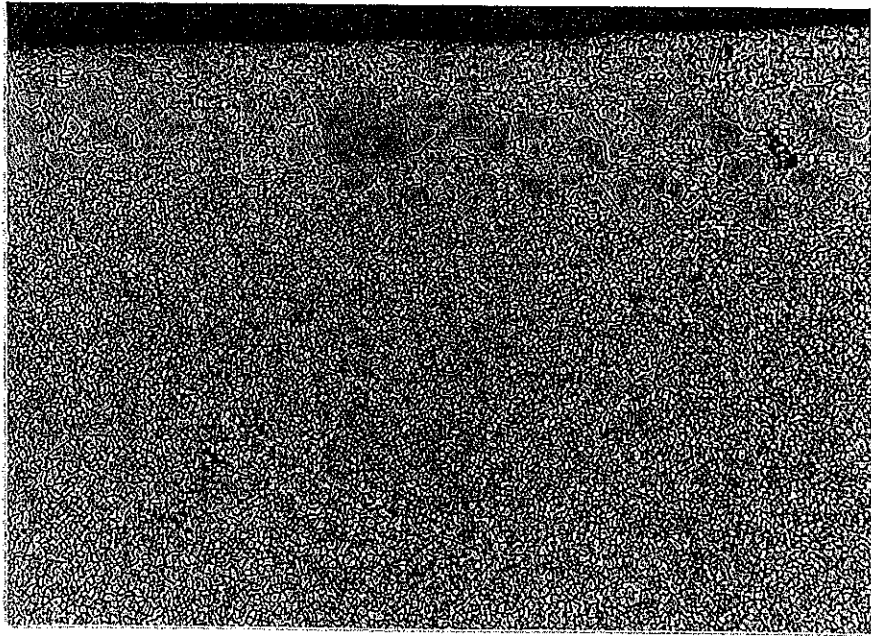
PIPE NUMBER: 68  
SECTION: WELD ATTACK  
MAGNIFICATION: X57  
YEAR: 1960

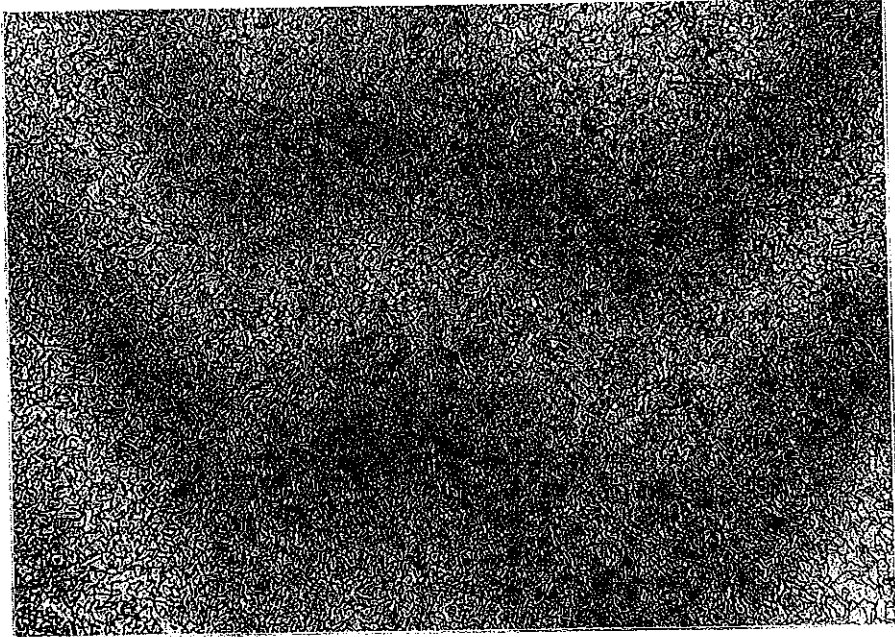
PIPE NUMBER: 91  
SECTION: WELD (POROSITY) ATTACK MICROGRAPH  
MAGNIFICATION: X57  
YEAR: 1970

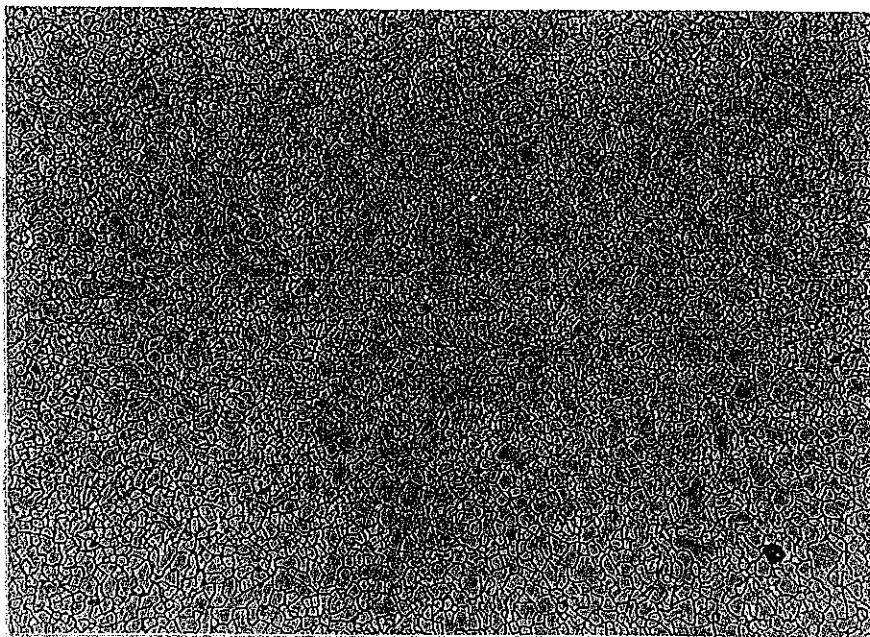
PIPE NUMBER: 101  
SECTION: WELD (ATTACK) INSIDE  
MAGNIFICATION: X57  
YEAR: 1970

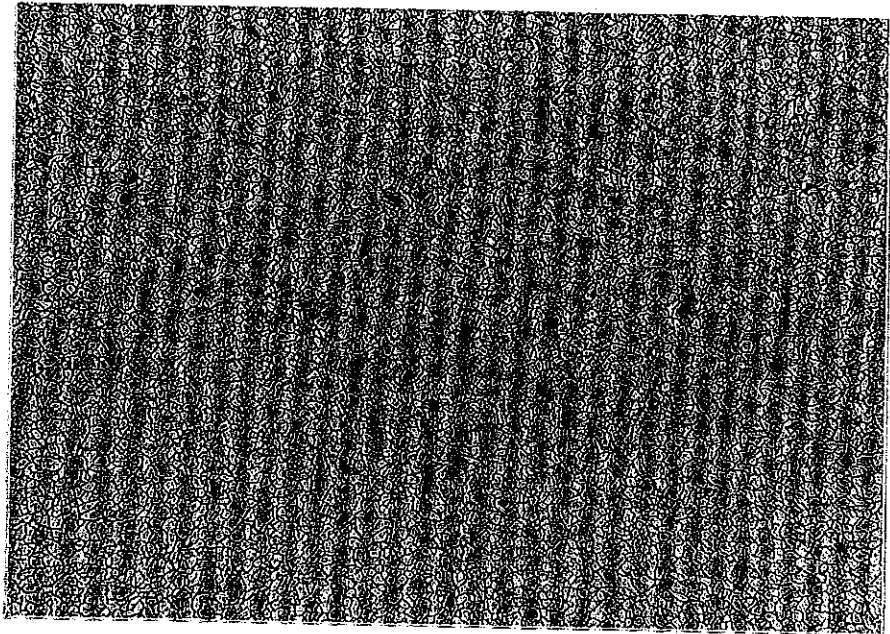
PIPE NUMBER: 77  
SECTION: WELD (POROSITY AND FILLER METAL ATTACK)  
MAGNIFICATION: X57  
YEAR: 1980

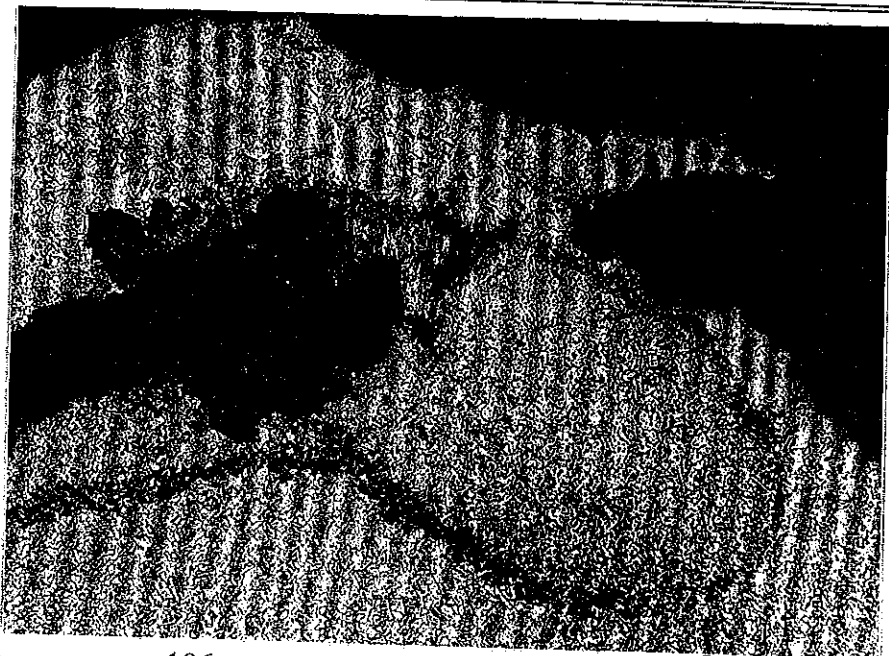
PIPE NUMBER: 106  
SECTION: WELD (ATTACK) MICROGRAPH  
MAGNIFICATION: X57  
YEAR: 1990
