LET'S FIX OUR RIVERS!

RIVER REHABILITATION CASE STUDIES

HANDBOOK

09

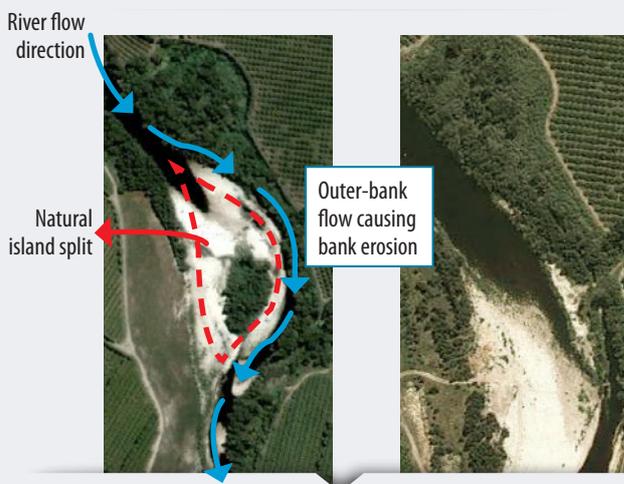
FIGURE 1: Historical Google Earth images of the site showing the progression of erosion on the outer bank in 2004 (*left image*) and 2011 (*right image*).

The concentration of flows in the river channel, partly due to alien invasion and the loss of deep-rooted, in-channel indigenous vegetation such as palmiet, had led to the deepening of the river channel. As the channel deepened, flood flows became confined within it, preventing them from spreading into the adjacent floodplain. This intensified flood velocities, causing severe erosion. The presence of invasive species such as black wattle and beefwood exacerbated erosion, by forcing the river to shift unpredictably, threatening farmland and infrastructure. In 2008, a major flood swept away a natural island at Frankenhof, accelerating bank erosion and increasing sediment build-up.

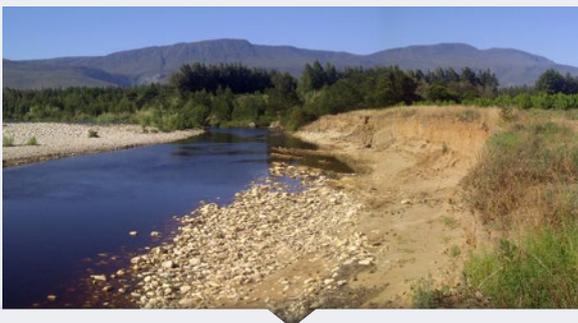
FIGURE 2: Close up view of the outer riverbank erosion in 2011 before rehabilitation.

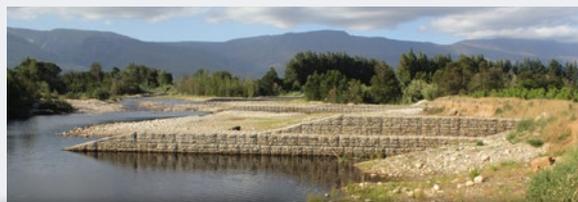
FIGURE 3: Post construction of groyne structures in 2012.

In 2012, four rock-filled groynes were built to deflect water flow safely around the outer bend, preventing bank erosion. The structures were designed to be low-cost, visually unobtrusive, and adaptable to unstable foundations. Their construction method also supported local job creation.

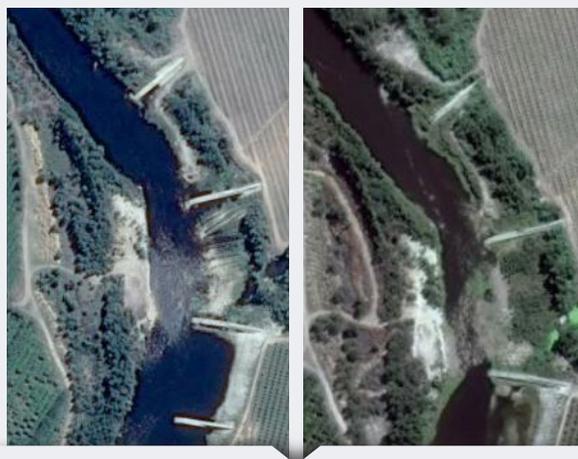
FIGURE 4: Historic Google Earth images of the site, showing the early impact of the groyne structures in 2014 (*left image*) and 2015 (*right image*). The structures substantially reduced the impact to the river channel, stabilizing the outer bank.

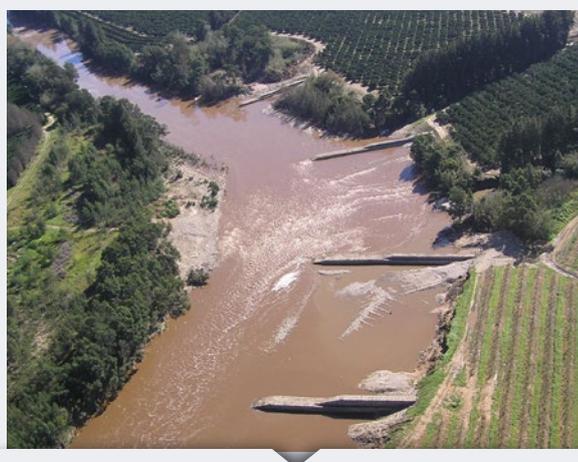
FIGURE 5: Aerial view of the completed first phase of the project. Vegetation has still to establish between the structures.

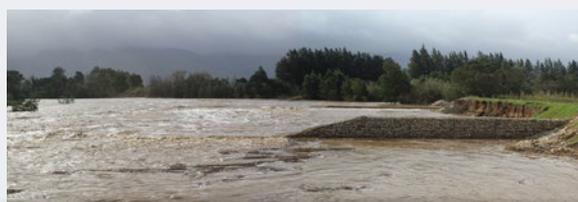
Since construction, several floods (including events up to a 1:20-year flood magnitude) have occurred, and the groyne structures have successfully redirected flows without causing damage to the banks. The success of this project lay in keeping the structures low but effective. However, a key challenge with phased projects has been that re-vegetation was sometimes neglected once erosion control structures were built, despite its essential role in ensuring long-term river stability and improving biodiversity.

FIGURE 6: Groyne structures pictured during the first flood in 2012.

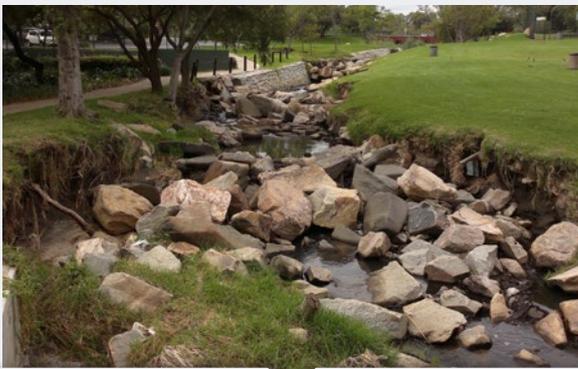
FIGURE 1: Shown (above) is a photo taken in 2012 by C.Brooker illustrating the stream flowing through Fourways garden showing erosion and channel cutting along the bank.

Changes in river flows in the Fourways Gardens area resulted in severe channel incision and the creation of deep, steep-sided gullies. The valley bottom wetlands gave way to a deep, eroding channel and ornamental ponds along the channel filled with unsightly sediment, while access roads eroded.

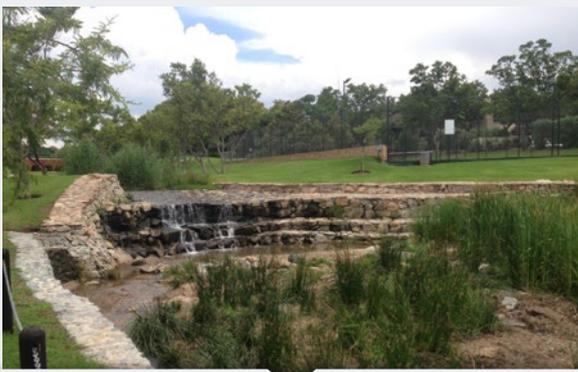
FIGURE 2: A series of low rock weirs (above) were built to prevent vertical erosion (incision) and stabilize the river channel.

- **Rock weirs** (small, professionally sized rock barriers) were installed along the river to slow water flow and prevent further erosion.
- **Large boulders and cobbles** were placed along the riverbanks and downstream of the gabion weirs to absorb water energy and reduce erosion.
- **Grading and Planting:** In between the weirs, the river banks were graded (generally to gradients of 1:4 or less), lined with loose rock riprap to stabilise the banks and prevent erosion and planted with indigenous vegetation to improve habitat.
- **Concrete and rock walls** were utilised in areas where space was too limited to allow for more natural slopes (1:4 or less steep). These were however confined to one side of the river only, leaving the opposite bank shaped more naturally.

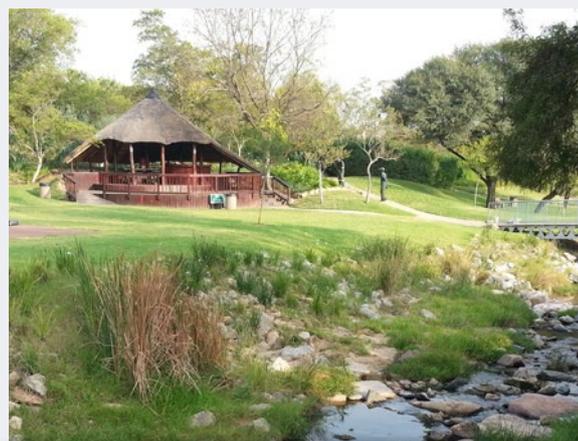
FIGURE 3: In-channel boulders, especially downstream of weirs, and plantings help to dissipate water energy and prevent erosion in the river channel.

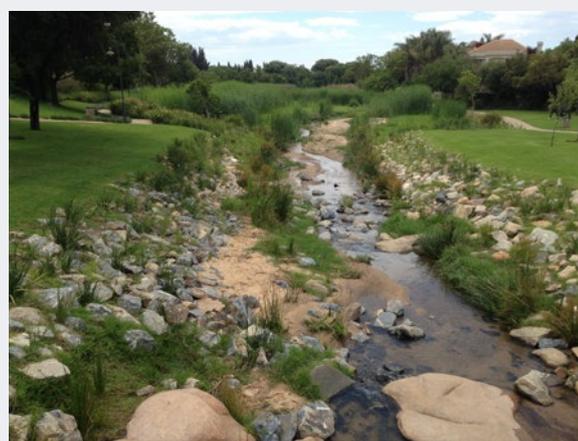
FIGURE 4: Formerly steep, eroded banks were reshaped and reinforced with riprap and riparian vegetation to enhance stability.

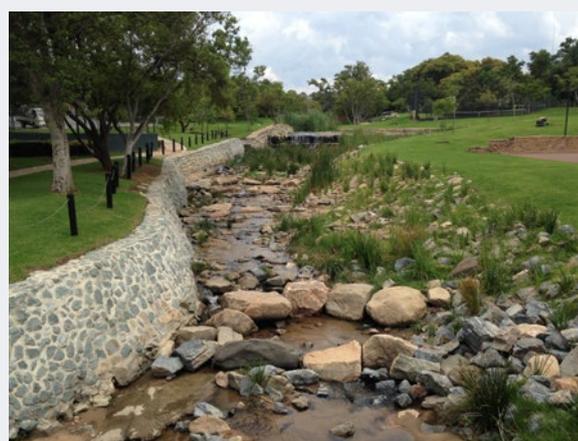
FIGURE 5: In areas where there was not adequate space for wide, shallow banks, vertical rock and concrete walls were built for protection.

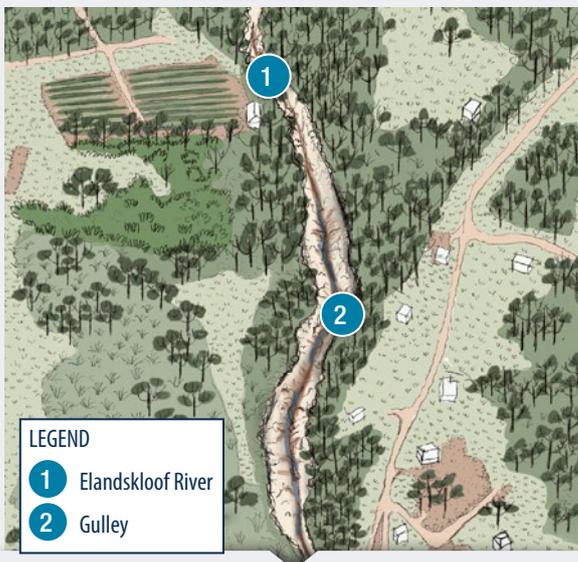
FIGURE 1: Landscape sketch plan of the site depicting the widened floodplain (gully) along the Elands Kloof River as it was in 2014.

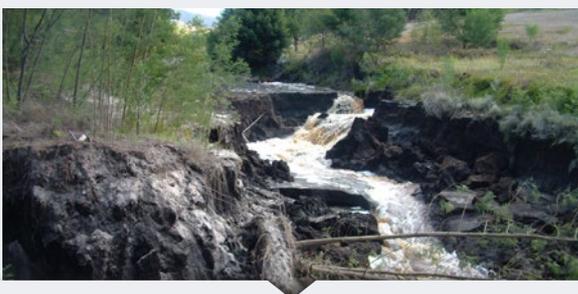
In 2003, a small dam built for watering horses was washed away during a flood. This triggered headcut erosion, carving a deep gully that progressed upstream. The Western Cape Department of Agriculture was called in to help stabilise the erosion, but the landowner refused to remove the invasive black wattle that was preventing native wetland vegetation from recovering. With limited funds, the Department opted to assist more cooperative landowners elsewhere.

FIGURE 2: The gully as it appeared in 2003.

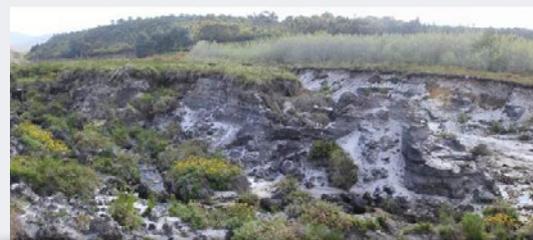
Subsequent floods worsened the problem. By 2015, the gully had extended nearly a kilometre upstream and had reached depths of up to 13 metres. Over 600 metres of pristine wetland, once 100 metres wide, had been destroyed. The damage was not confined to the gully – floodwaters had carried sediment downstream, smothering another wetland area; clogging a bridge crossing; and redirecting river flow into its banks. This triggered new erosion, further destabilising the river. What started as a small dam failure ultimately led to severe degradation over several kilometres of the wetland.

FIGURE 3: The gully, located 1 km upstream in the catchment, as seen in 2015.

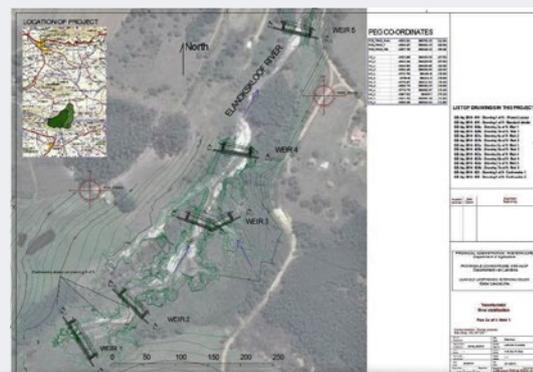
FIGURE 4: Shown above is the plan of the site indicating where the gabion weirs were constructed.

The solution involved constructing five major gabion weirs, each about 4 metres high, to manage water flow through the gully. These weirs together controlled a 23-metre drop over 600 metres and were designed to withstand extreme floods. The project also reshaped steep gully walls into gentler slopes to support revegetation.

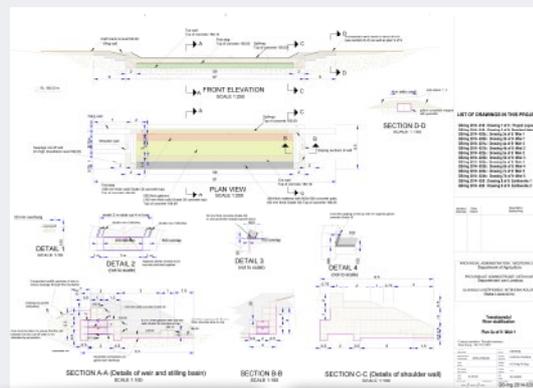
FIGURE 5: Technical construction detail drawings of the weir structure showing the front view (top) and the top view (bottom).

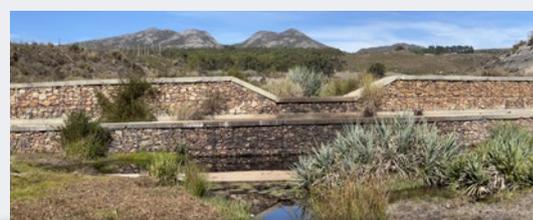
Vegetation establishment around weir structures is providing increasingly diverse habitat types and reducing the initial sterility of the structures (see Figure 6). The weirs trap sediment, which will build up in time and support an expanding wetland system. Plant establishment, including natural colonisation, has been most successful in the wettest parts of the system.

FIGURE 6: Post construction photo of the weir structures with vegetation growth taking place.

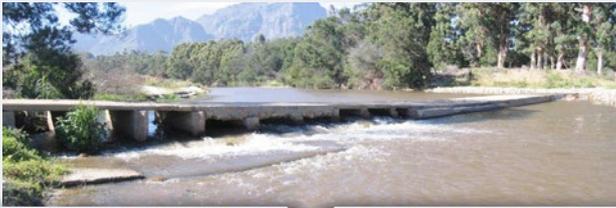
FIGURE 1: Original causeway crossing over the Berg River. View looking upstream, with the left-hand bank visible on the right side of the image.

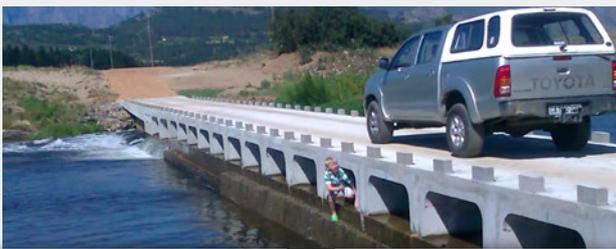
FIGURE 2: New culverts installed on original causeway, ca 2011. Raised approach road and gabion baskets visible on far left bank.

An unauthorised road crossing was built over a previously damaged low-level causeway on the Berg River, near Franschhoek, Western Cape. This raised the height of the structure, using multiple culverts. The alteration caused debris to build up on the upstream side during high flows, obstructing the river. Additionally, the approach road was extended into the lowflow channel using gabion baskets. Within two years, floods outflanked the gabions, cutting a secondary channel through the approach road and the floodplain wetland. Logs and branches from upstream alien clearing exacerbated the situation by forming debris dams above the culverts, further redirecting river flow into the eroded secondary channel. In response, the causeway was re-extended in 2012 with larger culverts, but by 2013, another flood scoured the left riverbank, creating a 2–3 m high vertical bank. This ongoing erosion not only caused ecological damage but also threatened nearby Eskom infrastructure and valuable agricultural land. Future floods were expected to exacerbate these effects.

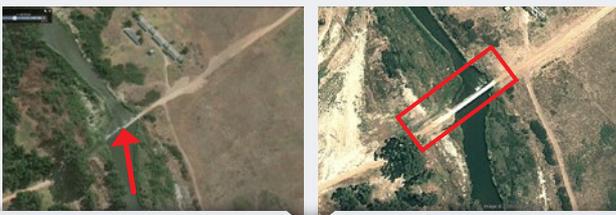
FIGURE 3: Changes to the Berg River causeway imagery from Google (2011–2012). *Left image (2011):* The original low-level causeway with the river's flow direction indicated by the arrow. *Right image (2012):* The causeway (highlighted in red) raised with culverts and the road extended into the channel on the left bank using gabion stabilisation. Note the removal of alien vegetation.

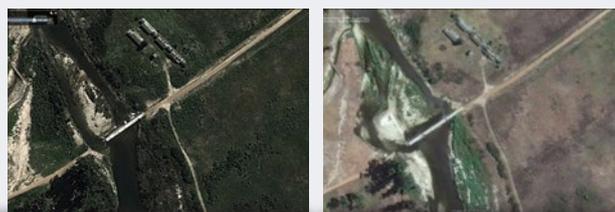
FIGURE 4: Progressive erosion of the left bank. Imagery from Google (2012–2014). **Left image** (October 2012): The causeway was outflanked on the left bank, leading to the formation of a new channel. With no structure in this area, the channel became the lowest point of the crossing and the preferred flow pathway. **Right image** (January 2014): Flooding in August 2013 caused severe erosion of the left bank, endangering infrastructure (Eskom line) and creating an unstable channel prone to further erosion and bank collapse.

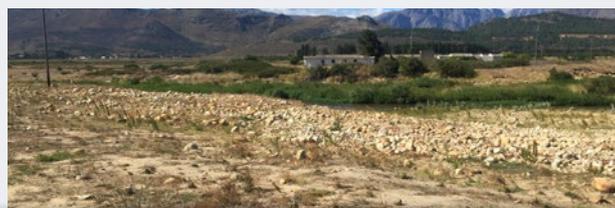
FIGURE 7: Rehabilitated Channel (January 2015). The floodplain was regraded, stabilising previously eroded areas, though the lefthand (secondary) channel remained relatively straight. The secondary channel on the left bank was retained following road repairs.

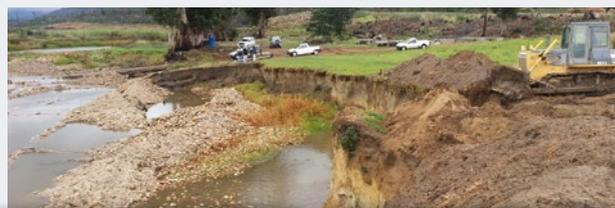
FIGURE 8: Rehabilitation focus: vertical, unstable river banks were targeted for reshaping, riprap lining, and vegetation establishment. The view is downstream, with the newly eroded channel visible on the right side of the photograph.

The project aimed to stabilise the Berg River's eroded banks while maintaining the newly formed secondary channel and promoting the growth of stabilising marginal vegetation. The intervention combined bank reshaping, riprap placement, and vegetation establishment, covering 140 m of riverbank and an area of approximately 1,540 m². Initially, 555 m³ of protective material was spread at an average depth of 360 mm, sloped at a 1:4 grade. However, during implementation, the bank was further reshaped to a gentler 1:6 slope, requiring additional material and higher construction costs.

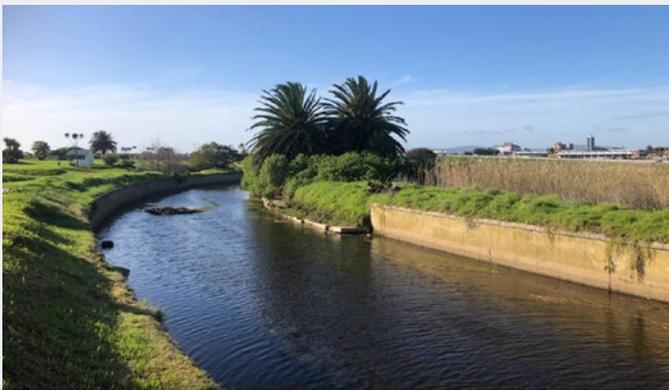
FIGURE 1: Liesbeek Canal before rehabilitation.

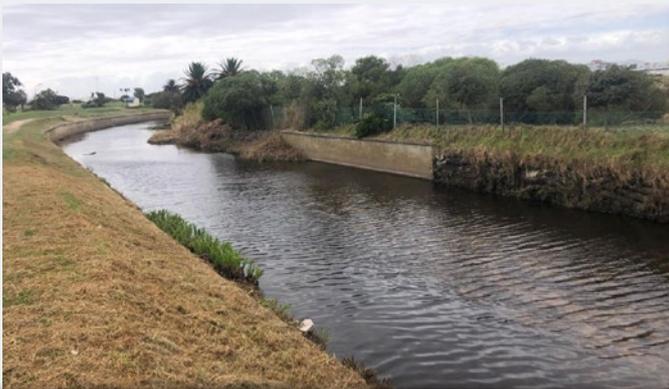
FIGURE 2: Another view of the Liesbeek Canal prior to rehabilitation.

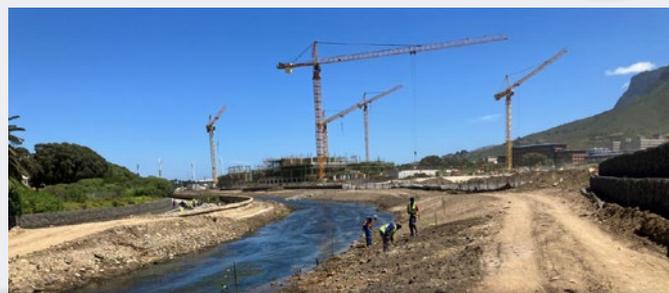
FIGURE 3: Shaping of diversion channel (foreground) allowing concrete removal in canal (background).

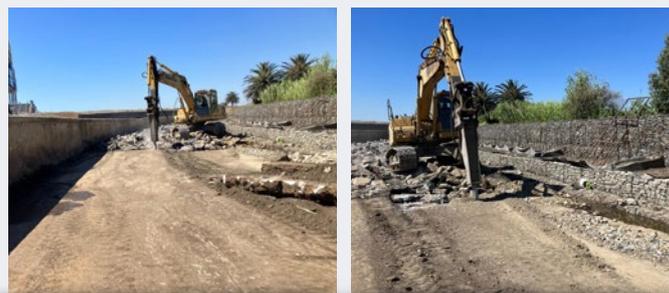
FIGURE 4: Removing the concrete canal, with gabion lining and planters already installed along the right-hand side of the channel.

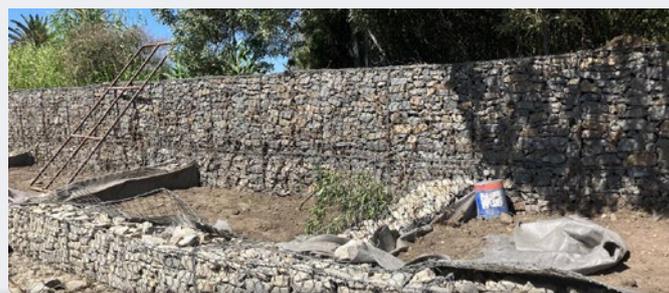
FIGURE 5: Gabion planters in early construction phase. See also Handbook 3, page 23.

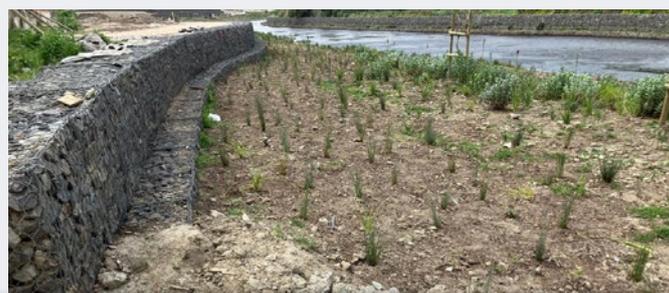
FIGURE 6: Early planting along the rehabilitated Liesbeek River.

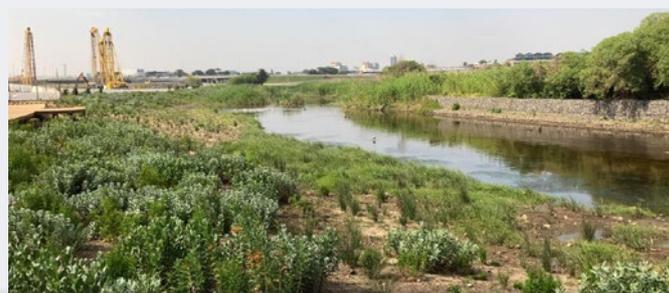
FIGURE 7: Rehabilitated channel approximately eight months after planting.
