# Small Farm Dams: A TICKING TIME BOMB?

*Many of South Africa's small farm dams have become mere sediment traps threatening the country's larger storage reservoirs, as research in the Karoo indicates, writes John Boardman, Ian Foster, Kate Rowntree, Tim Mighall and Tony Parsons.*

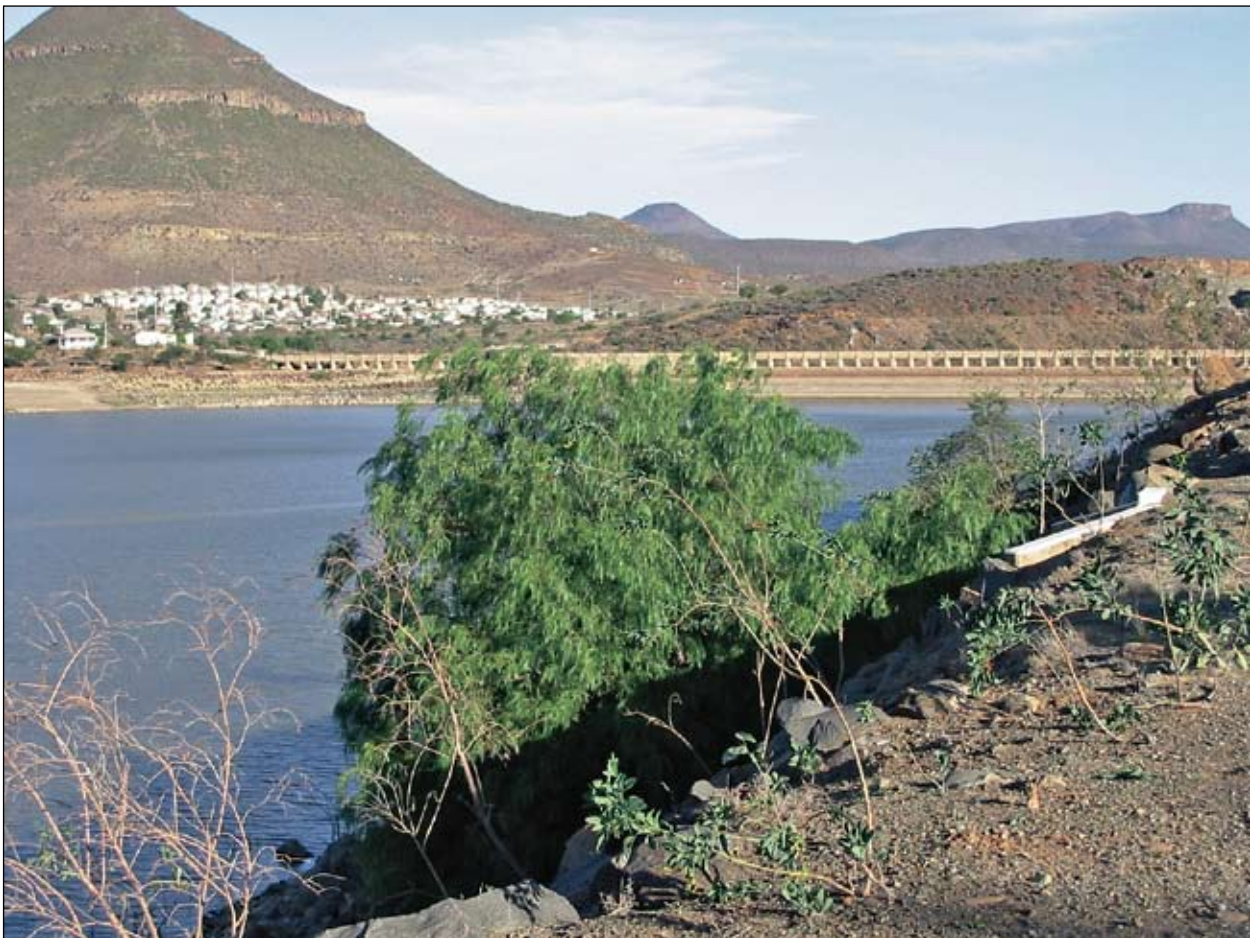
South Africa's Van Ryneveldspas Dam on the Sunday's River at Graaff Reinet has a catchment area of 12,382 km<sup>2</sup>. By 2009 it is estimated that there will be around 49,1 million m<sup>3</sup> of sediment in the reservoir, with a remaining storage capacity of only 29 million m<sup>3</sup>.

The nearest big dam to the study area in the Sneeuberg is the Van Ryneveldspas at Graaff Reinet. This dam on the Sundays River, has a catchment area of 13 382 km<sup>2</sup> and surveys show that about 47 million m<sup>3</sup> of storage capacity remained in 1978 with about

31 million m<sup>3</sup> sediment partly filling the reservoir. This suggests an average deposition rate of 584,906 m<sup>3</sup>/y and that by this year there will be around 49,1 million m<sup>3</sup> of sediment in the reservoir with a remaining storage capacity of about 29 million m<sup>3</sup>. At present rates of sediment transport this suggests a dam life of about 50 years.

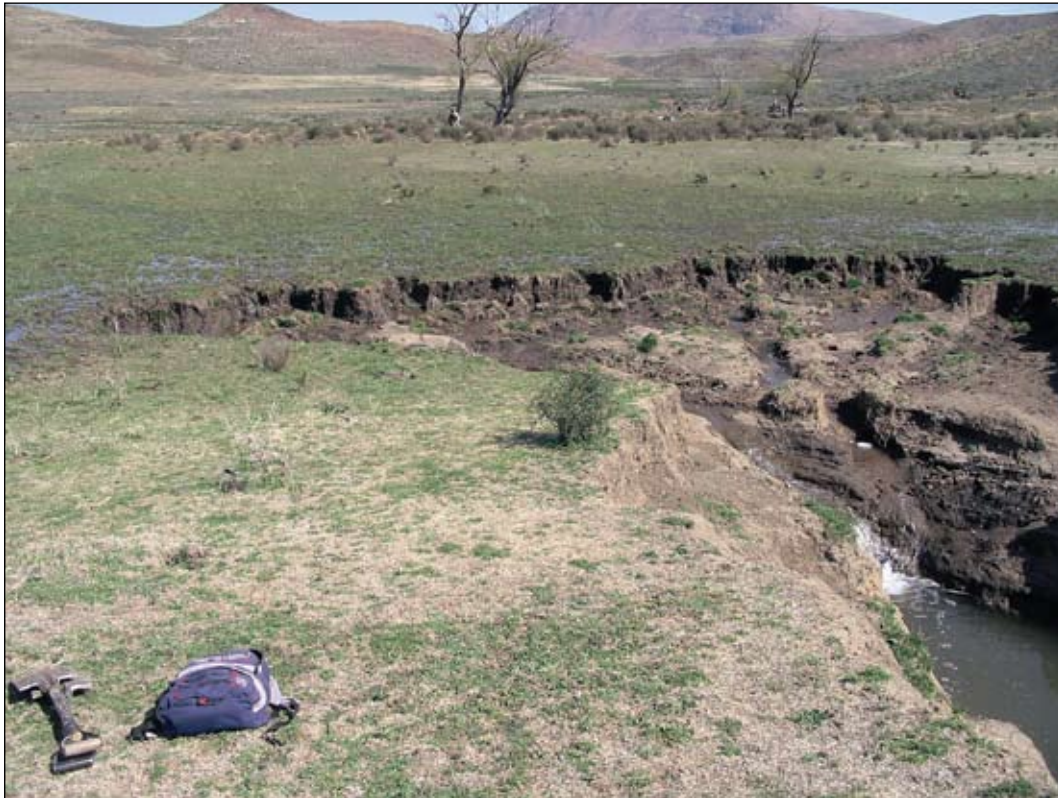
**Above:** Compassberg Dam breach. Initial breaching occurred in 2000 and this photo, taken in December 2003, shows the establishment of a new gully that is eroding previously stored sediment.

For example, the Compassberg Dam wall was breached as a result of 118 mm of rain on 24 March 2000; the dam was already full of sediment. Since 2000, a gully has begun to eat back into the sediments in the reservoir above the breach. Breaching is also occurring as a result of animal burrowing activity in dam walls. Many dams are therefore providing a ready source of sediment to downstream sections of rivers and reservoirs. If the authors' conservative estimates of 27 000 t/km<sup>2</sup> are correct, there is a large volume of sediment waiting to be mobilised in a relatively short time.

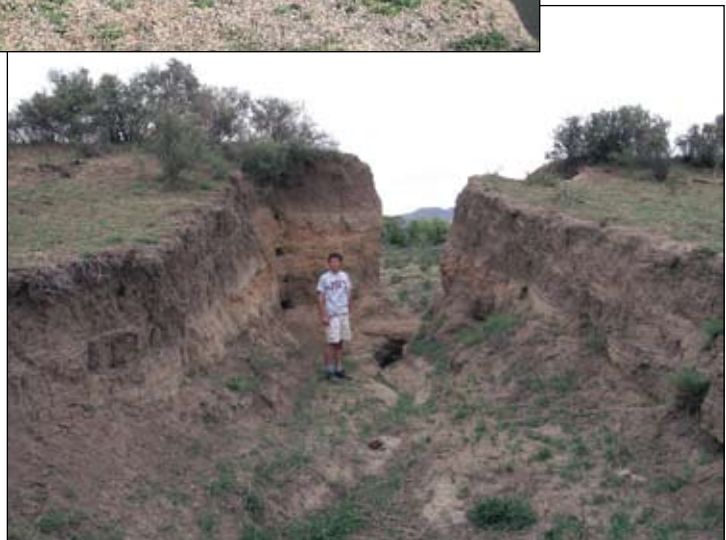
**Right:** By July 2006, a well established gully was cutting back into the stored reservoir sediments. The gully head has extended around 25 m since 2003.

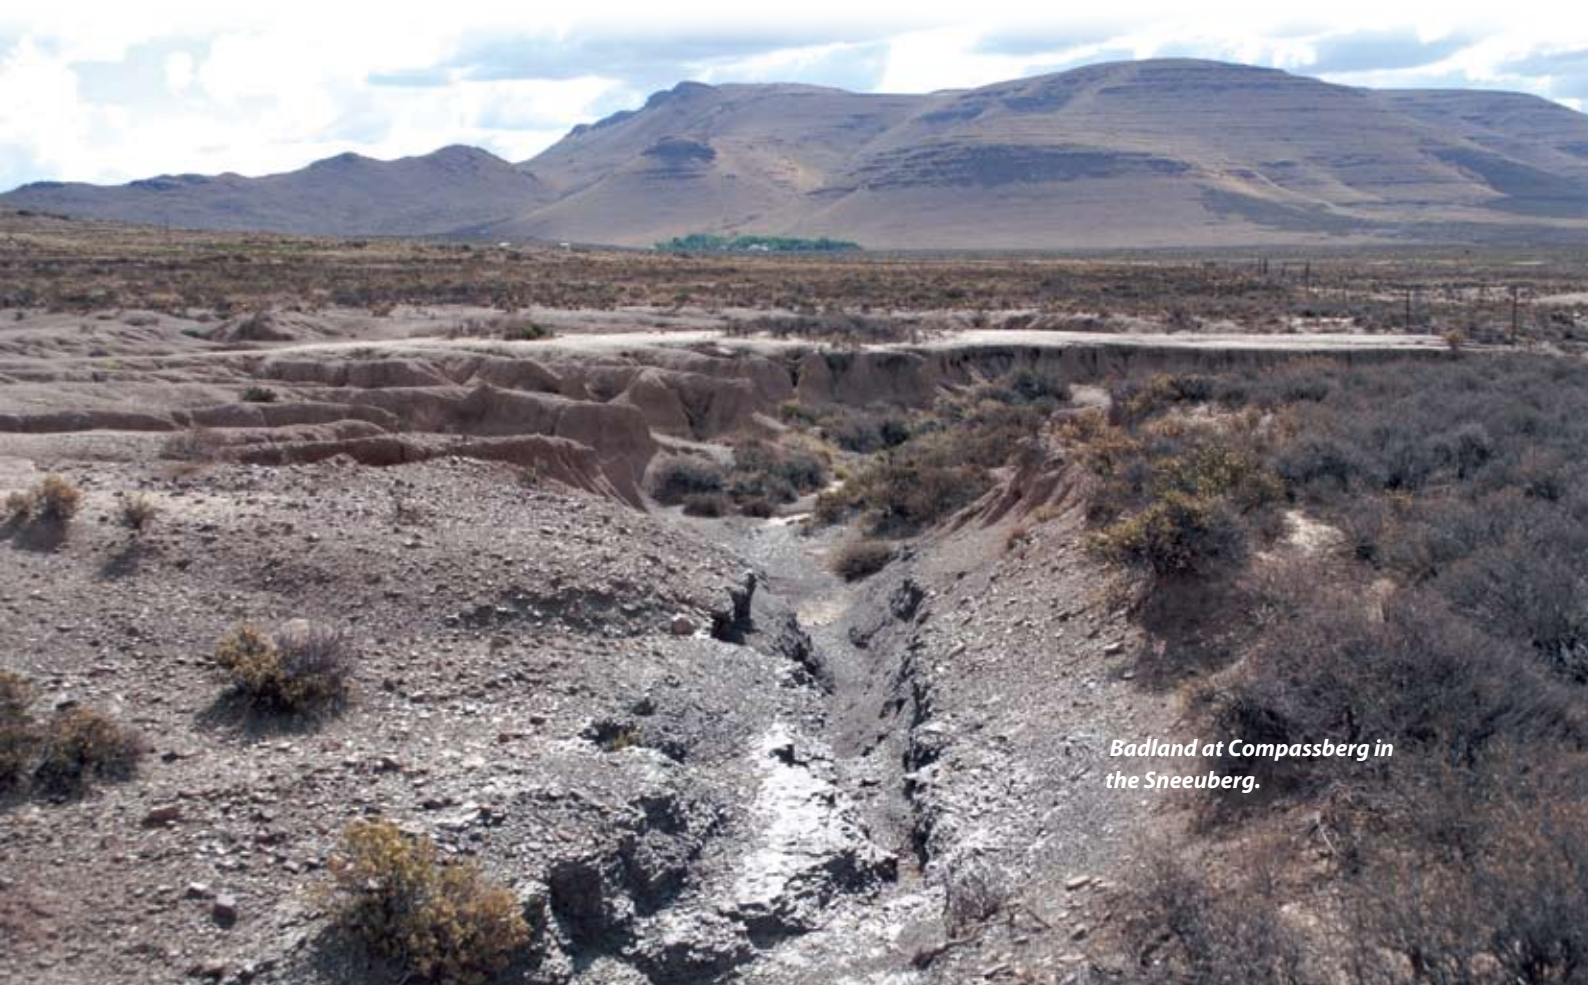
*Badland at Compassberg in the Sneeuberg.*
