RIVER REHALIBITATION: LITERATURE REVIEW, CASE STUDIES AND EMERGING PRINCIPLES

Report to the Water Research Commission

**WRC No.: 1161/1/03
ISBN No.: 1-77005-098-1**

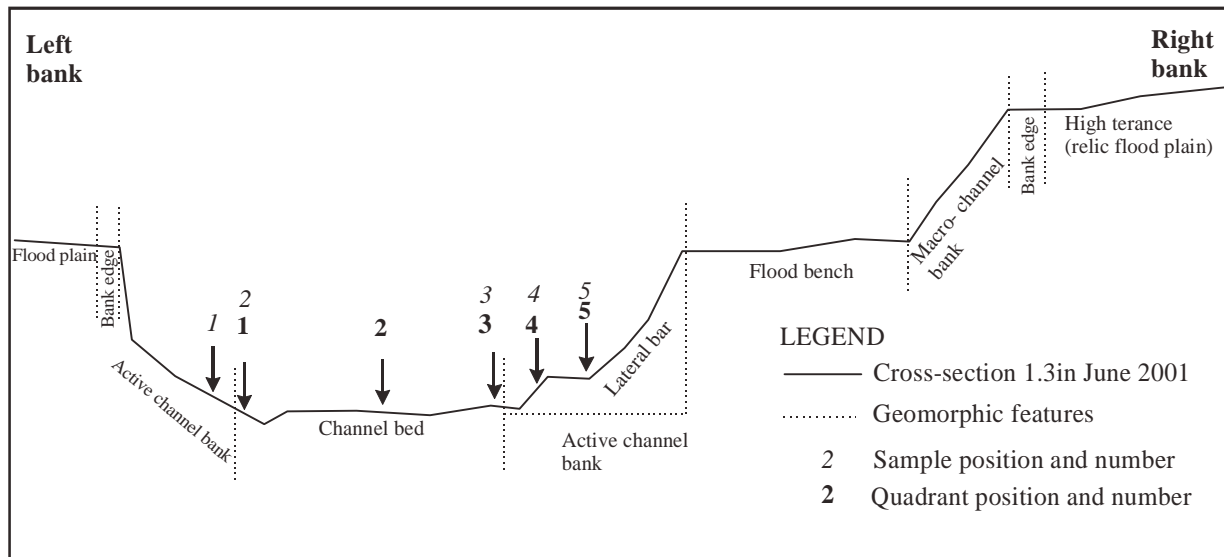
Figure 12.8 Substratum quadrant and sample positions at Site 1, cross-section 1.3, in 2001.

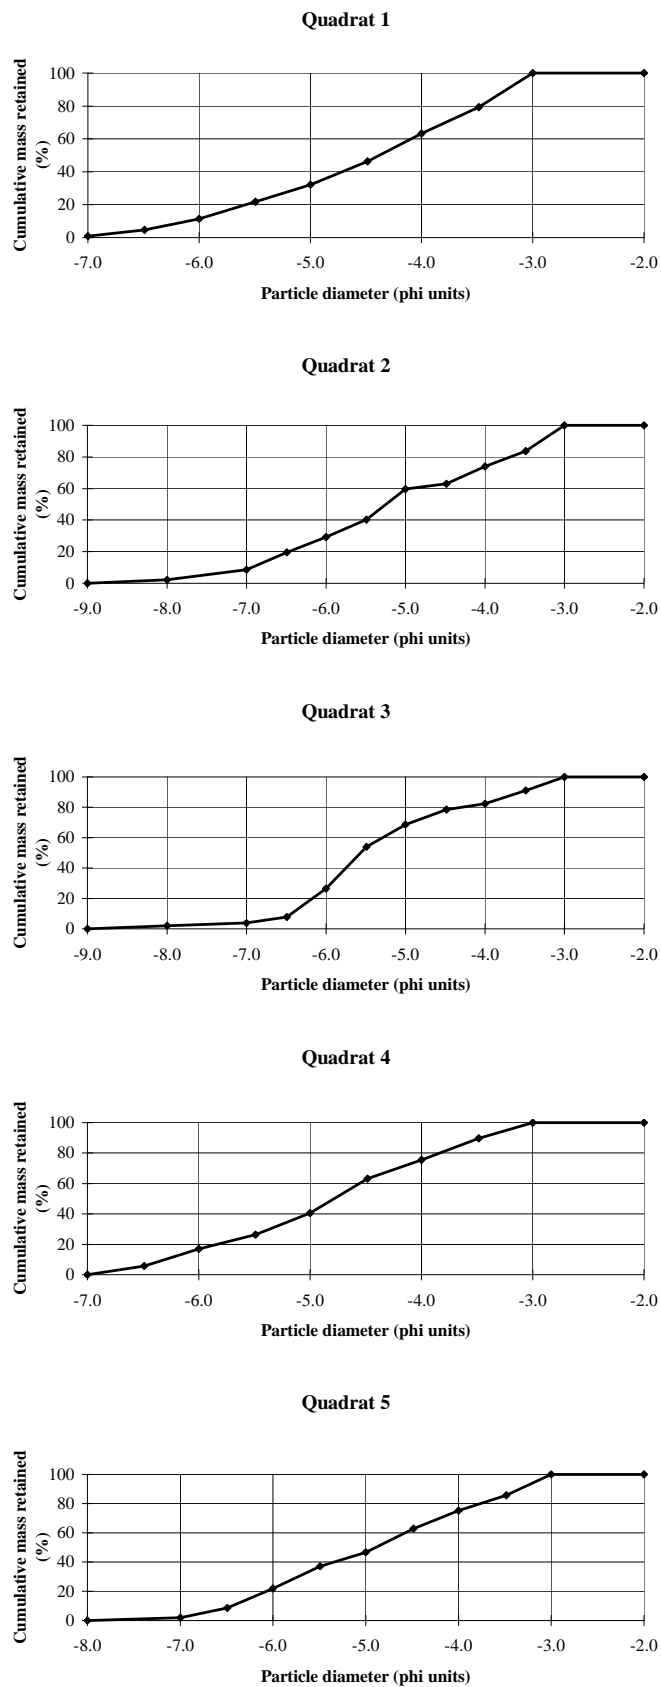
Figure 12.9a Grain size cumulative curves for quadrats 1-5 at cross-section 1.3, Site 1.

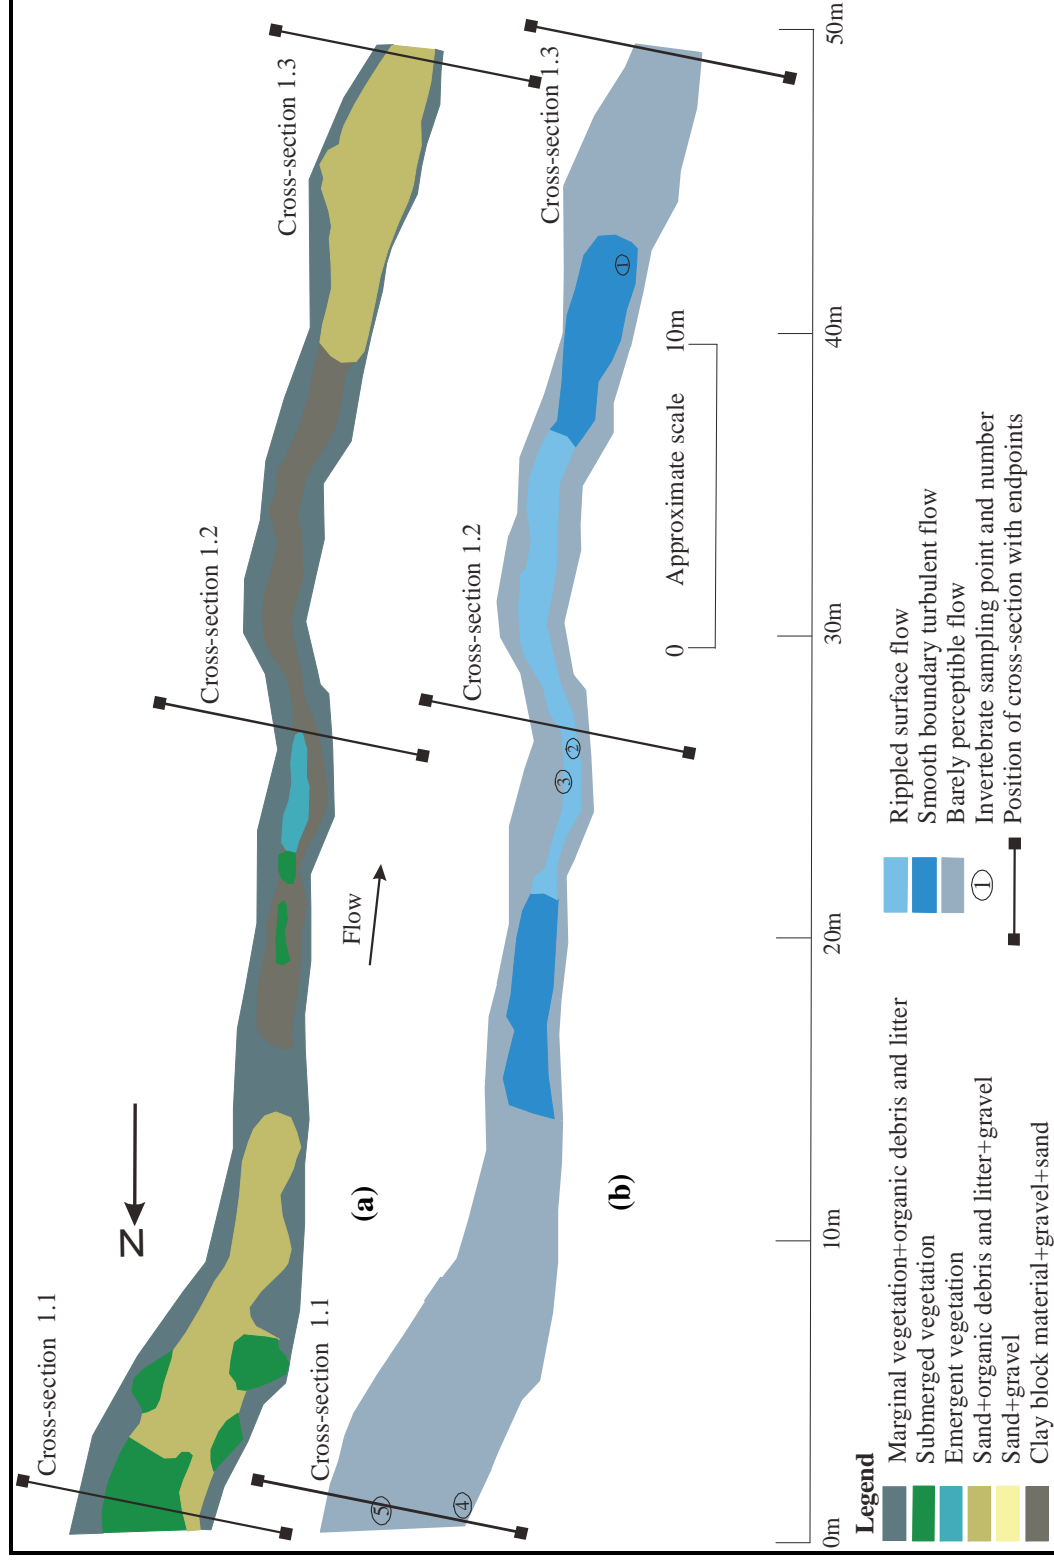
Figure 13.6: Substratum (a) and flow type (b) maps of Site 1 - February 2001.
