Demonstration and Scaled up Implementation of Pour Flush Sanitation in South Africa

Report to the
WATER RESEARCH COMMISSION

PARTNERS IN DEVELOPMENT

WRC Report No. 2203/1/18
ISBN 978-1-4312-0011-8

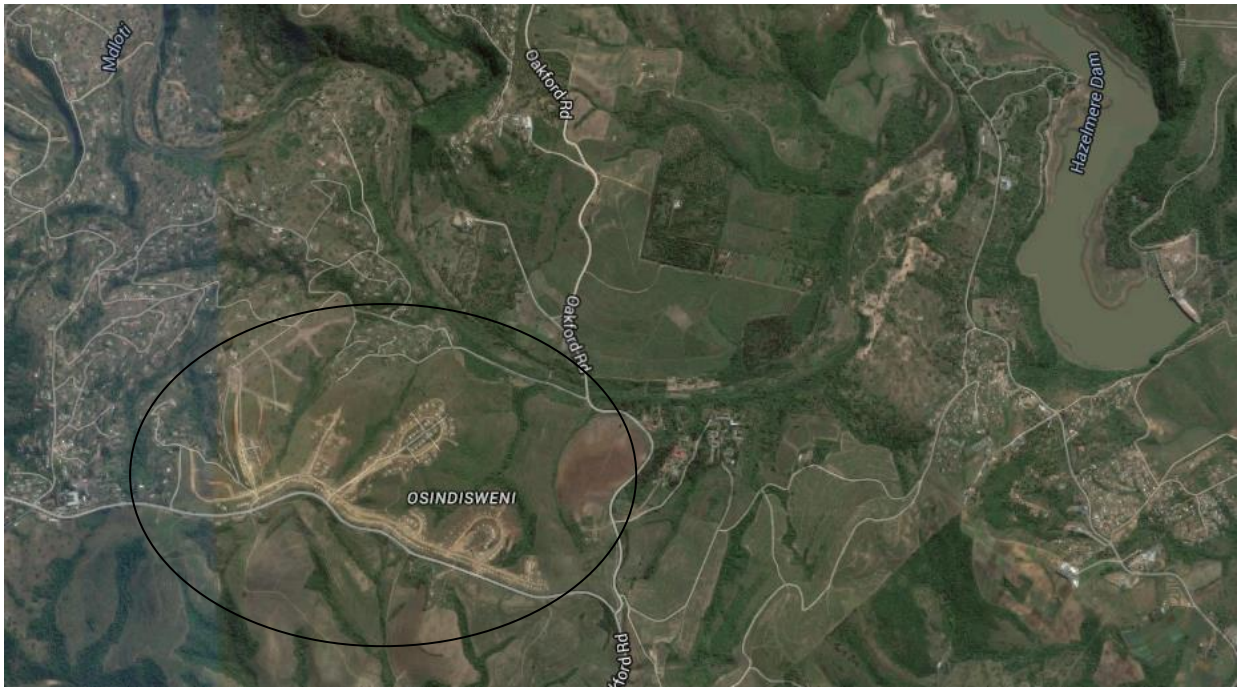
Figure 2: The Oakford Priors Housing Project (circled) is approximately 3 km south west of the Hazelmere Dam. To the west lies the community of Osindisweni. Some of the families who will move to this new development will be relocated from the area immediately around the Hazelmere Dam, which is currently being raised.

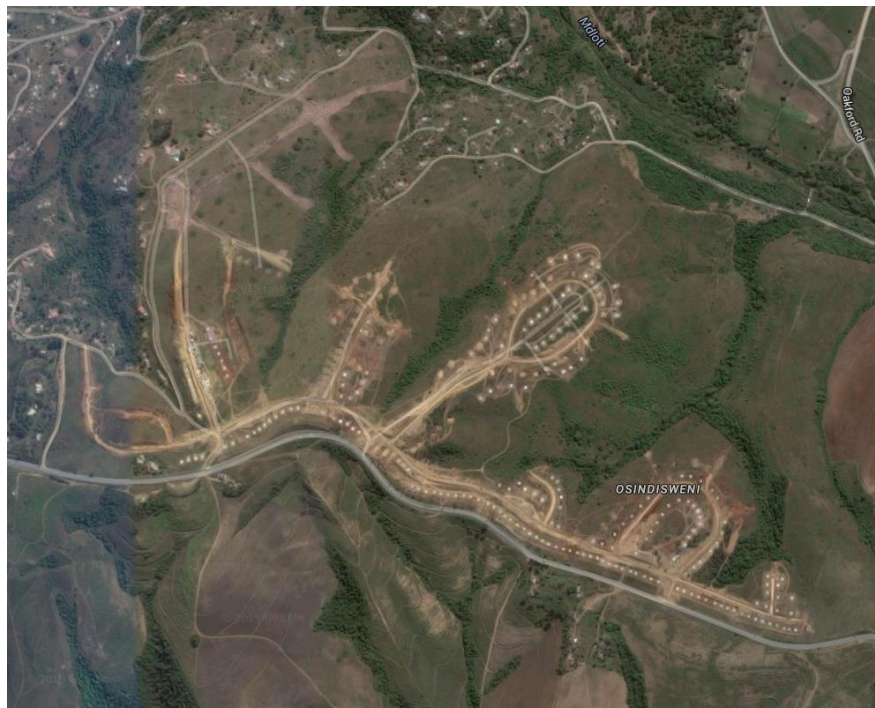
Figure 3: The Oakford Project comprises some 690 sites with an average size of 500 m² each.

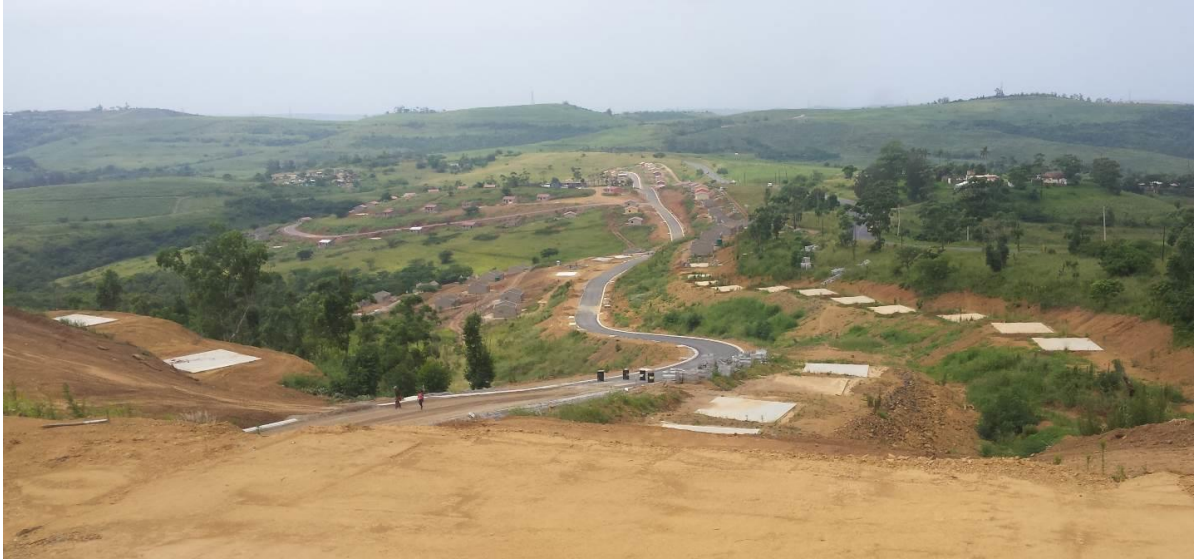
Figure 4: Housing under construction at Oakford.

On 3 November 2015, the construction of houses finally commenced (**Figure 4** and **Figure 5**). In February 2016 work was held up again when inspectors of the *National Home Builders Registration Council* (NHBRC) became involved in the project. They were unfamiliar with the Pour Flush system and several meetings were required to satisfy them that the system was acceptable.

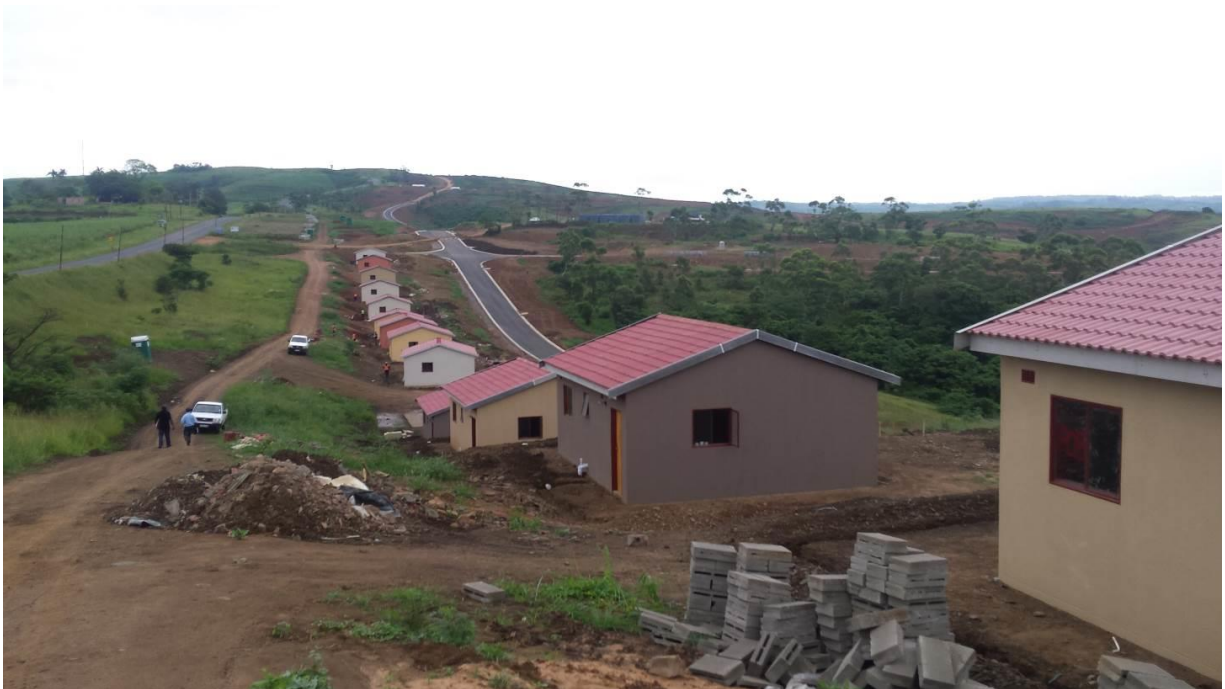
Figure 5: A view of the first set of houses nearing completion.

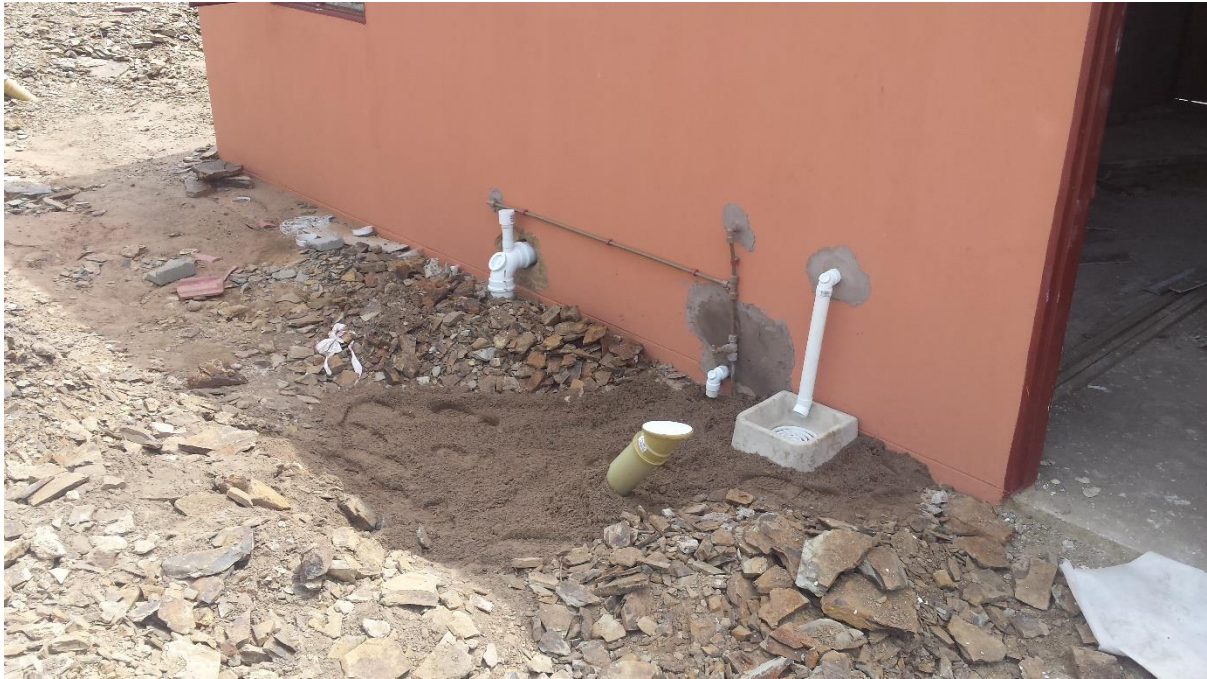
Figure 6: Ground conditions at some sites have been particularly difficult.

- The stipulated minimum wage for the site is relatively high at R200 per day. Labour must be recruited from the local community and a number of work stoppages were experienced in the early stages until task rates had been agreed.
- The ground conditions are for many of the sites particularly hard (see **Figure 6** and **Figure 7**, for example). Progress excavating this material by hand has been very slow and rock breaking equipment has had to be hired at times.
- The site is inaccessible whenever there is rain and this has regularly caused delays with the deliveries of materials.

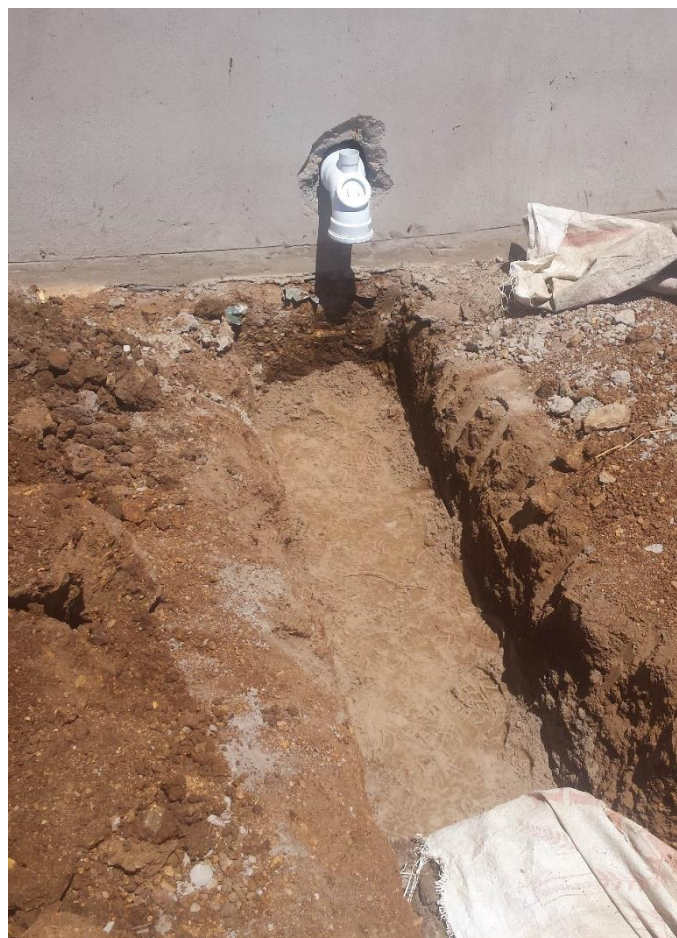
Figure 7: Bedding and blanketing material has had to be imported from commercial sources to protect the pipes.

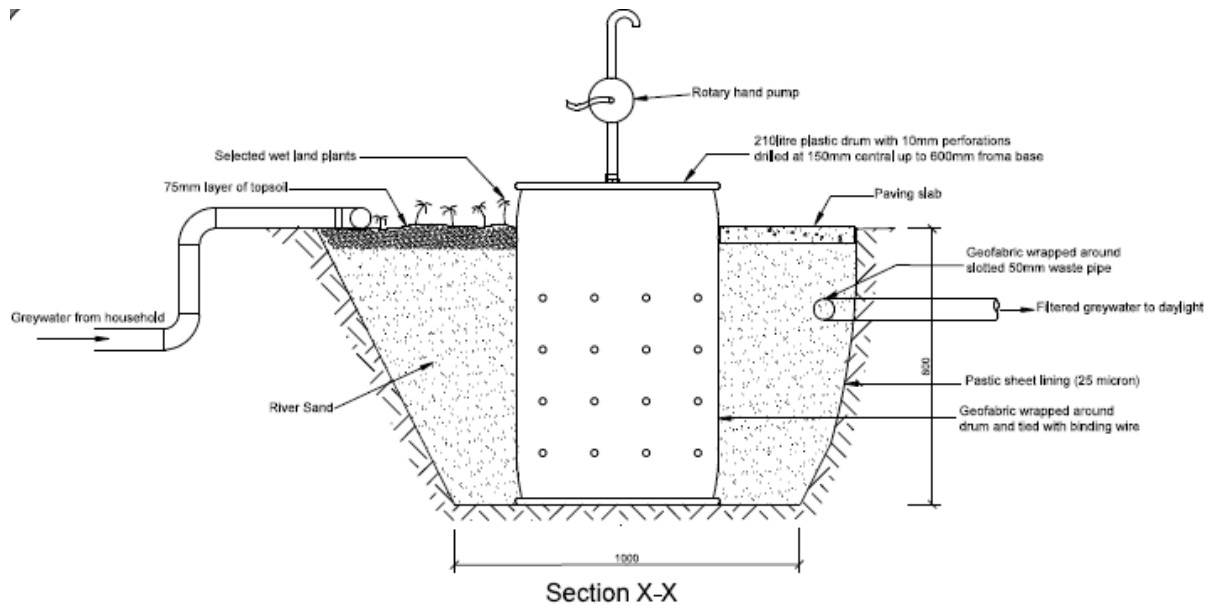
Figure 9: The greywater collection and recycling system developed for Oakford.

eThekweni have further specified that they want the greywater collected separately and that it must be possible for users to collect and recycle their greywater. PID therefore had to develop a design for a greywater collection and recycling system, which is shown in **Figure 9** (the full design is included in **Appendix 1**).

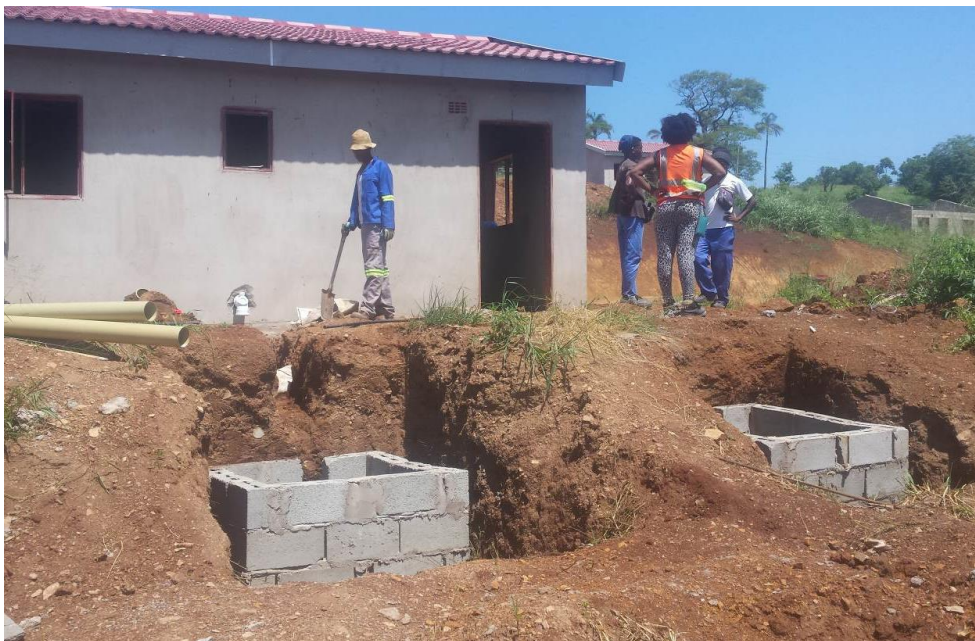
Figure 10: A view of leach pits under construction at one of the Oakford houses.

Photographs of the installed system can be viewed in **Figures 10-13**.

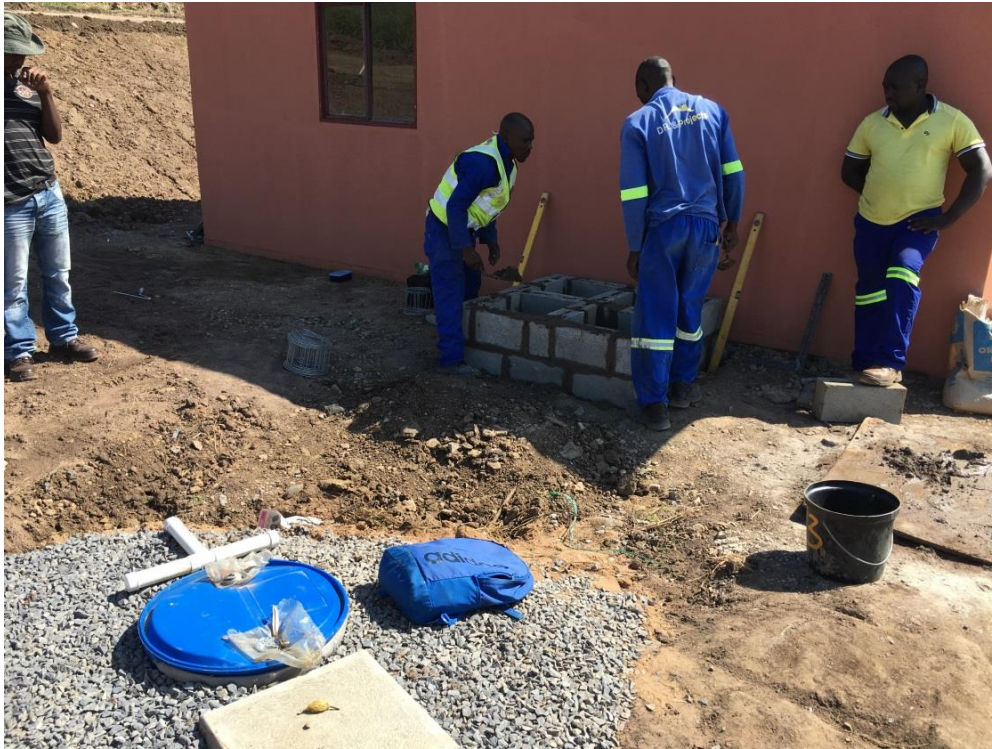
Figure 11: A greywater recycling system under construction in the foreground. In the background a stand is being constructed for a rainwater harvesting tank.

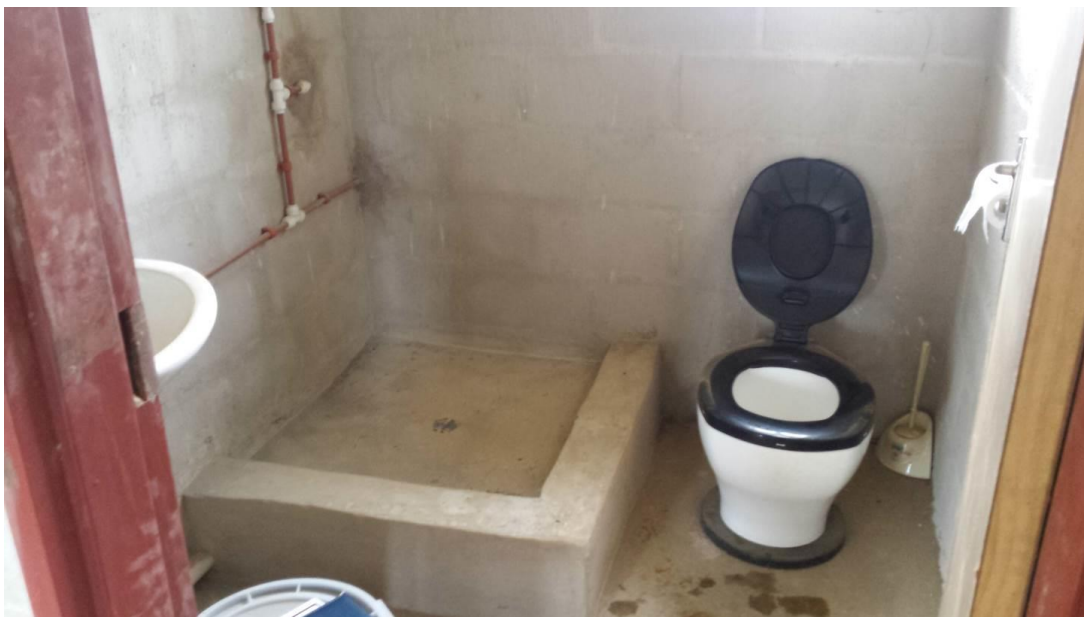
Figure 12: A view of a Pour Flush toilet in a bath room in one of the Oakford houses.

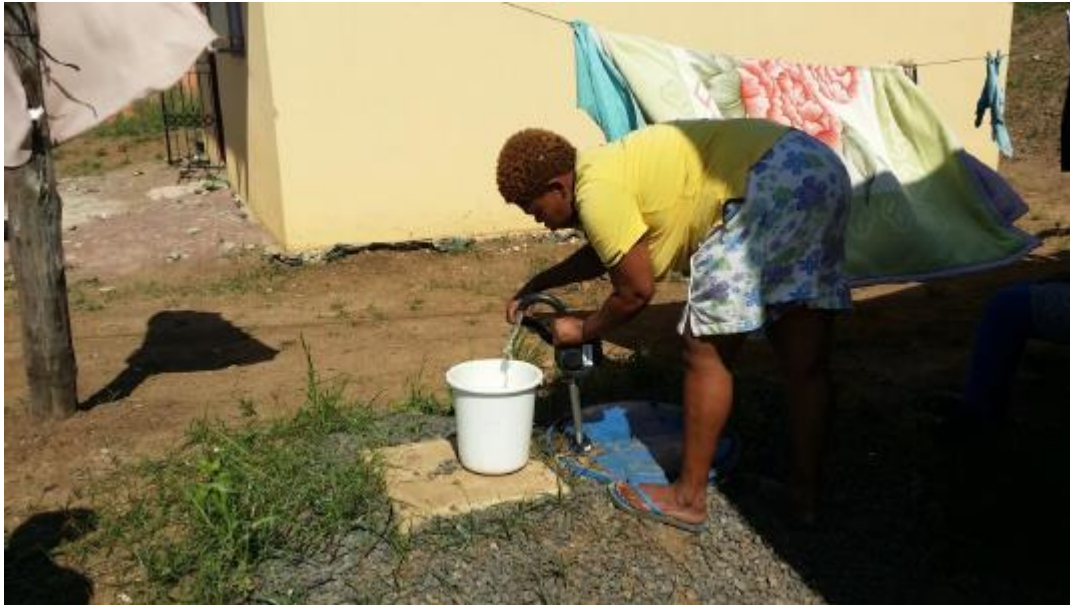
Figure 13. The greywater collection tank with handpump fitted for extraction of flushing water. The water is filtered through sand and geofabric before it enters the collection drum.

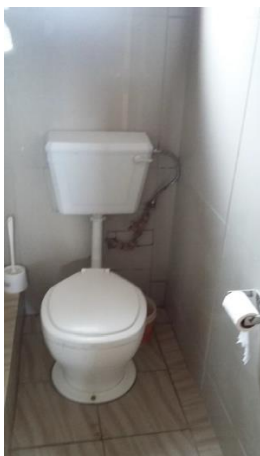
Figure 14: Pour Flush system retrofitted with cistern by the eThekweni Housing Department. The cistern installation was in response to pressure brought to bear on them by community representatives who did not fully understand the cistern-less Pour Flush system (to reduce water leaks). The homeowner tiled the bathroom which shows a sense of ownership.

The first homes were only occupied in December 2016 so it has not been possible until recently to gauge user response. Between the completion of PID's work and the occupation of the houses, eThekweni's Housing section took it upon themselves to add cisterns to every toilet, so this became a low flush toilet rather than a Pour Flush toilet (Figure 14).

The response to the toilets is positive, with all toilets in use. There have been some problems with small leaks around the cistern installations as these were not done very professionally.
