## Projects Restoring Land and Water

*In a sleepy hollow in the foothills of the Drakensberg, in KwaZulu-Natal, local communities are not only learning to take care of their own land and water resources, but are also contributing to the protection of one of Gauteng's economic lifelines – the Tugela-Vaal water transfer scheme.*

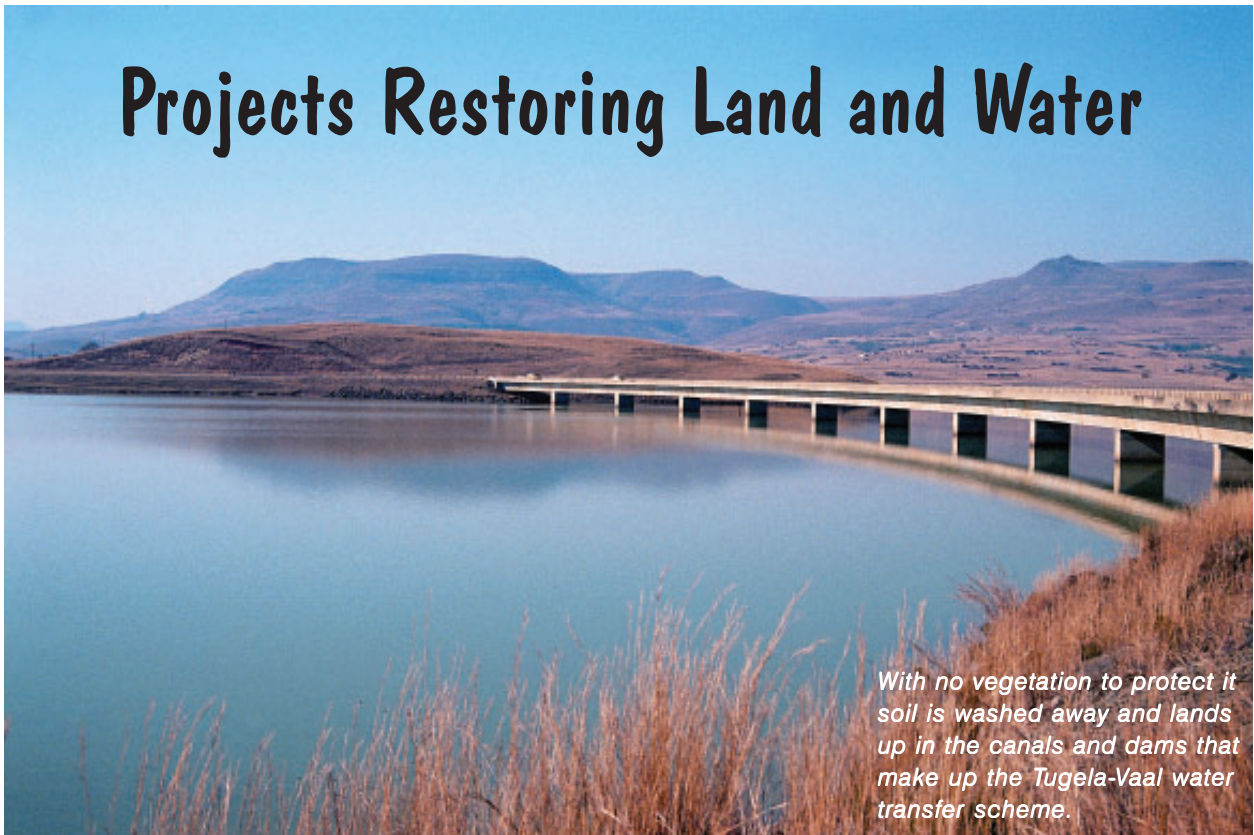
*With no vegetation to protect it soil is washed away and lands up in the canals and dams that make up the Tugela-Vaal water transfer scheme.*

The communities do not only lose land that could be used for food production. Huge loads of silt also lands up in the rivers of the catchment and get washed into the dams that make up the Tugela-Vaal water transfer scheme, such as Woodstock Dam and Sterkfontein Dam. This silt not only reduces the capacity of the storage reservoirs, but is expensive to remove.

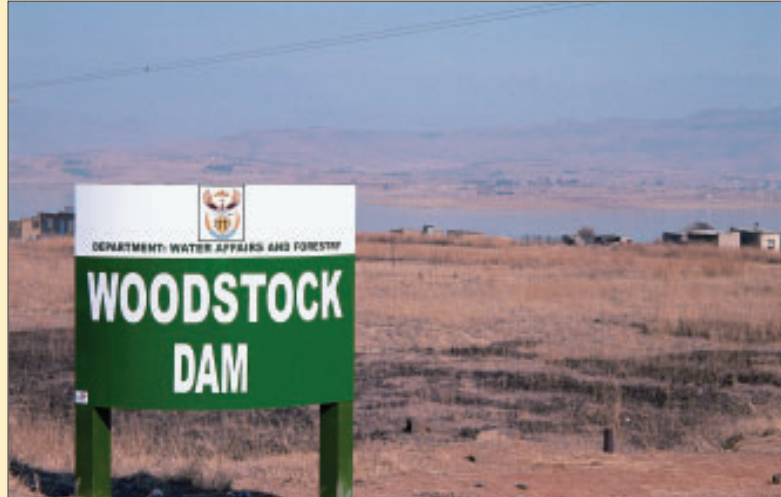
## MORE ABOUT THE TUGELA-VAAL WATER TRANSFER SCHEME

In the early 1960s it was determined that the capacity of the Vaal Dam would not be sufficient to cater for the water needs of Gauteng. This resulted in the development of the Tugela-Vaal scheme, which was completed in 1974.

With the construction of the transfer scheme, a certain amount of water from the Tugela River, which starts at Mont Aux Sources, in the Drakensberg, is transferred via canals, pipelines and dams into the Vaal River system.

The Tugela River flows into the Woodstock Dam and then into the Driel Barrage further downstream. A certain amount of water is pumped from the Driel Barrage into canals which then flow via gravity into the Kilburn Dam. Water from the Kilburn Dam is then pumped underground, over the Drakensberg and into the Driekloof Dam.

This section of the scheme is used to generate electricity. Eskom built a hydroelectric power station in the Drakensberg mountain called the Drakensberg Pumped Storage Scheme. When electricity is needed water is dropped from the Driekloof Dam, through hydroelectric turbines, and into the Kilburn Dam. Then in quiet periods the water is pumped back from the Kilburn Dam and into the Driekloof Dam.

When the Driekloof Dam is full water flows over a weir and into the Sterkfontein Dam where it is stored. Incidentally, when the Sterkfontein Dam was completed in 1986, it was the world’s second-largest earth wall and the largest without a spillway. The dam has a surface area of 67 km<sup>2</sup>, an average depth of 93 m and a total storage capacity of 2,62 billion cubic metres.

When water is needed in the Vaal River system, water is released from the Sterkfontein Dam and into the Nuwejaarspruit, which then flows into the Wilge River and then into the Vaal Dam.

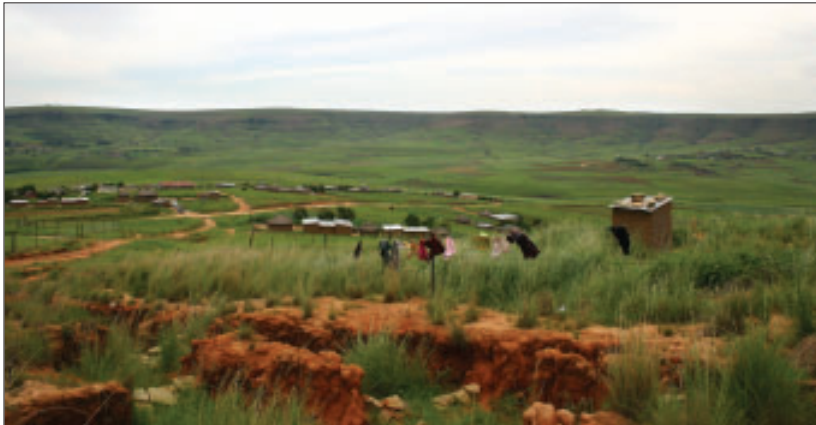
*Overgrazing and inappropriate agricultural practices have led to increased runoff and loss of soil, resulting in huge dongas in some areas of the catchment.*

allowed to eat too much of the vegetation in an area the water does not infiltrate properly into the ground when it rains. This leads to increased water runoff and soil erosion. Huge dongas have already formed in the area.

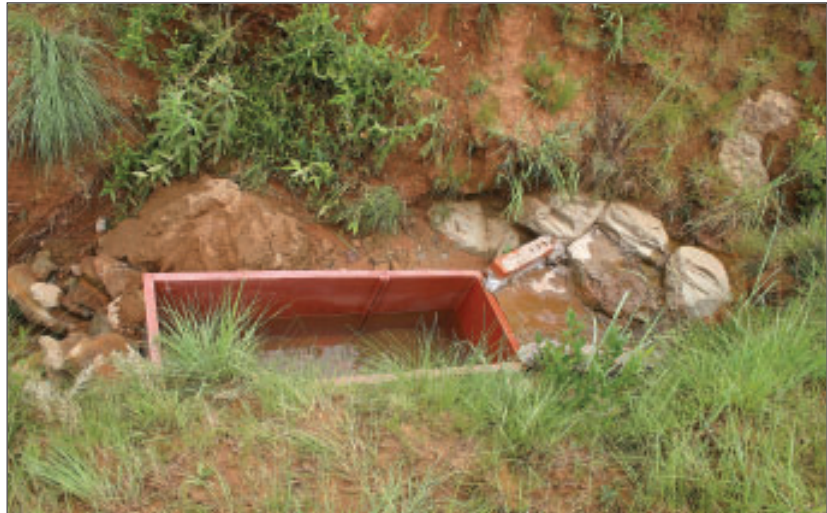
*Weirs are one of the monitoring techniques used by the Okhombe Monitoring Group.*

One of the aims of the project is to implement participatory monitoring whereby the rural participants record and analyse differences and change. A total of 17 community members, who now form the Okhombe Monitoring Group (OMG), have been trained in assessing the rehabilitation techniques. Simple techniques are used to monitor soil erosion. Each technique is used on an eroded and rehabilitated site so that the two can be compared. For example, basal cover is determined using a square metre quadrant subdivided into 25 squares. A Morgan splash cup measures up- and down-slope erosion, while splash boards are used to measure the height of 'splash' when it rains.

In each sub-ward rainfall is measured with rain gauges. Donga profiles are measured to determine sediment deposited in the dongas. In addition, square metre run-off plots have been installed and water quality and quantity is measured from the runoff collected in two-litre bottles. All the monitoring sites have been fenced off to keep livestock out.
