ECOLOGICAL INFRASTRUCTURE

Water resources in the semi-arid Baviaanskloof: A fascinating area with contrasting water-related ecological infrastructure

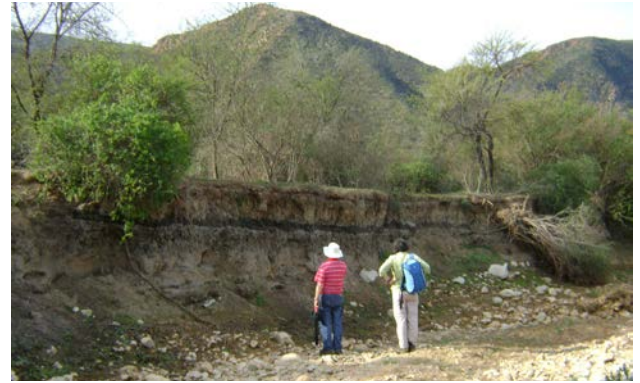
Figure 5. Incised river channel bank located just downstream of the confluence of the Tchandokloof tributary and Baviaanskloof River, showing gleyed (gray) soil layers. This is clear evidence of the former existence of a peat deposit and permanent wetland which had been dried by erosion and lowering of the water table. Peat fires had destroyed much of the former peat as indicated by ash layers above the peat deposit.

The valley floor soils consist largely of loamy sand with gravel. Furthermore, alluvial layering in the soils is associated with the Dundee soil form, which dominates in the Baviaanskloof. Soils influence or facilitate infiltration, groundwater recharge, habitat provision, vegetation structure and surface runoff management. The latter also mitigates flood risk and enhances water availability. The valley floor in the foothills consists of alternating unconfined (wider) and confined (narrower) sections of between 7 and 16 km in length. Unconfined sections are approximately 900 m in width, whereas confined sections are 30 to 100 m in width. The alternating valley confinement settings are thought to be the product of past faulting and varied rock formations, which force erosion-resistant rocks together (narrow sections) and the lateral erosion of weaker rocks during flooding (wide sections, Figure 5).
