# **CONSOLIDATION AND TRANSFER OF LIMESTONE MEDIATED STABILISATION TECHNOLOGY FOR SMALL TO MEDIUM SCALE USERS**

REPORT TO THE WATER RESEARCH COMMISSION

*CSIR Division of Water, Environment and Forestry Technology  
PO Box 320, Stellenbosch 7599*

*WRC REPORT NO. K5/1026*

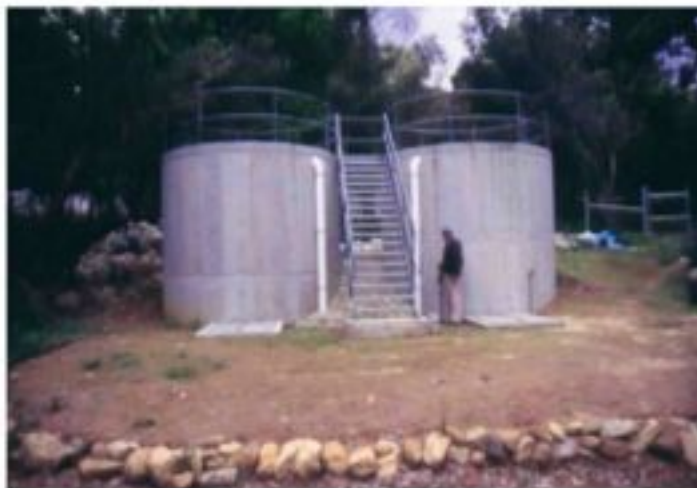
*Figure 3.2: CSIR-type cylindrical design and alternative rectangular design limestone contact units*

On-site investigations indicated that most of the stabilisation units visited were of the CSIR-type design i.e. cylindrical, whilst three installations of the rectangular configuration exist (see Figure 3.2).

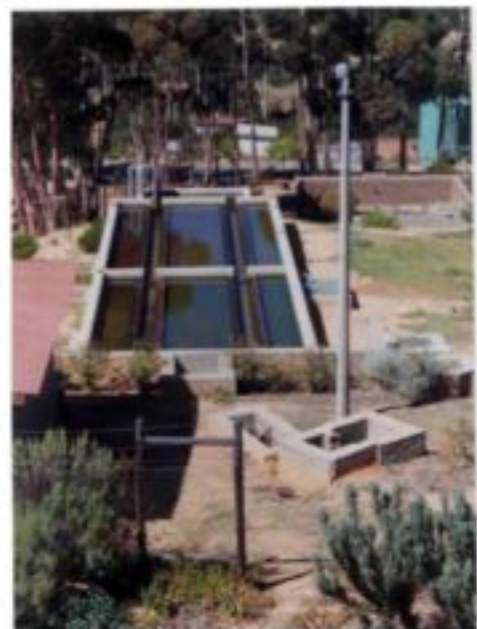
All of the limestone contactors visited operate in an "upflow" manner, i.e. with water entering via the bottom of the unit and flowing upwards through a fixed bed of limestone pebbles. In the CSIR-type units, take-off is by a single bell mouth type pipe; whilst for the rectangular units take-off is by a notched weir.

In most cases water distribution systems were of a false-bottom nature, with some older CSIR-type units having a slotted pipe configuration. In addition, all units are constructed from reinforced cement concrete (apart from the unit at Porterville, which is a CSIR-type system constructed from glass-reinforced fibre and the pressurised steel limestone contactor at Franschhoek).

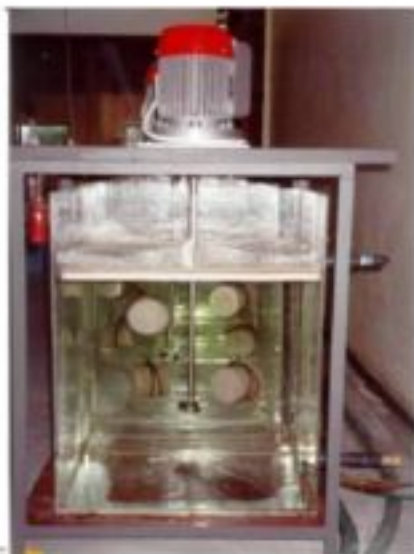
A metal H-frame resting on the upper edges of each tank supports an electric paddle stirrer, which runs continuously. Four cement concrete samples, suspended from the H-frame by nylon fishing line, hang at different levels (approximately 220 mm, 280 mm, 350 mm and 430 mm from the base) in a tank, shown in Figure 5.1. A square expanded polystyrene board with a 3 mm marine plywood backing floats on the water surface to minimize atmospheric carbon dioxide dissolution in the water in the tank.

**Figure 5.1: Aggression test apparatus.**

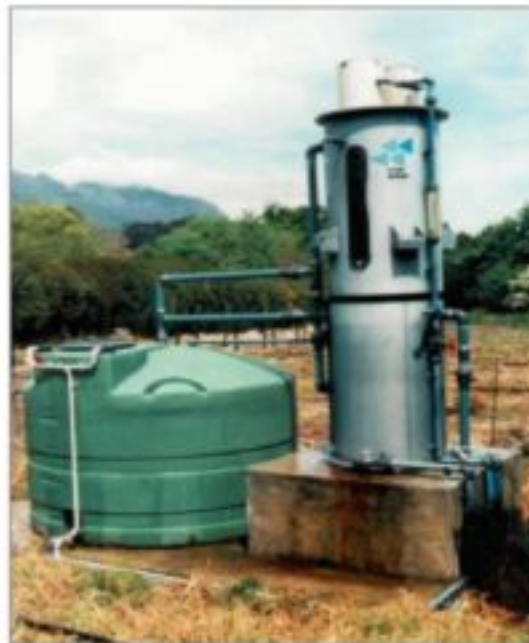
**Figure 7.2: Installed production Spraystab unit.**

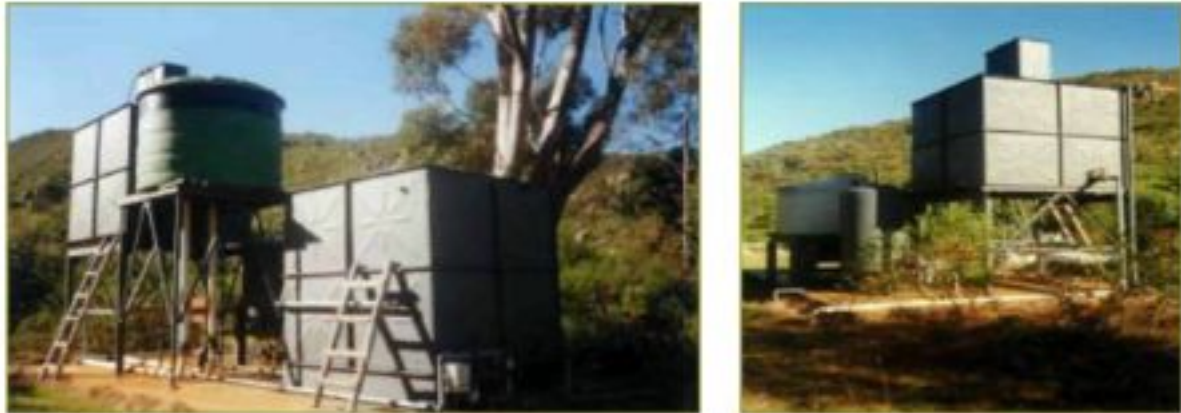
The plant uses the same process chain as the original Spraystab system, but has separate unit processes for spray aeration/settling, clarification, filtration and stabilisation. The system has proven to be very robust, producing an acceptable product and requiring very little maintenance.

**Figure 7.4: Plant "A" stabilisation/iron removal system**

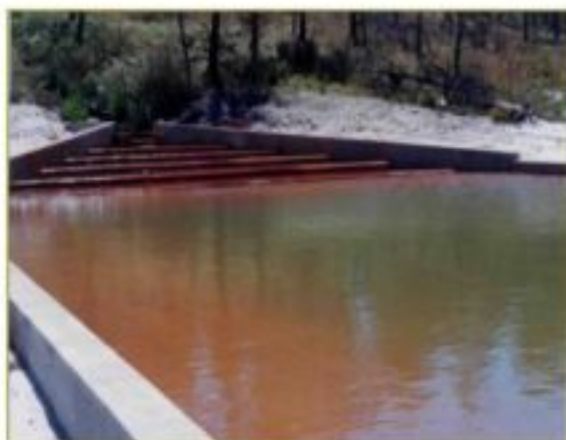
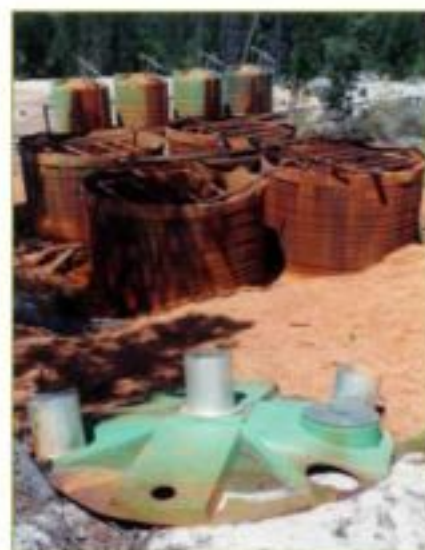
The plant consists of a large open horizontal settling basin with a sloping bottom and overflow weir at the deep end. At the inlet end the water cascades over about five shallow "step", affording some aeration. This unit was retro-installed when the original plant proved troublesome. From the settling basin the water gravitates to four limestone tanks, with the water dribbling from a number of slotted filter nozzles (as is normally used on the bottom of a sand filter) onto the limestone bed. From the limestone units, the water passes to self -backwashing sand filters and to a storage reservoir.

Figure 7.3: Plant "B" stabilisation/iron removal system.
