**STORMWATER INGRESS  
IN SOUTH AFRICAN SEWER SYSTEMS:  
UNDERSTANDING THE PROBLEM  
AND DEALING WITH IT**

with particular reference to the Msunduzi Municipality, KwaZulu-Natal

Report to the  
**Water Research Commission**

**WRC Report No. 1731/1/11  
ISBN 978-1-4312-0119-8**

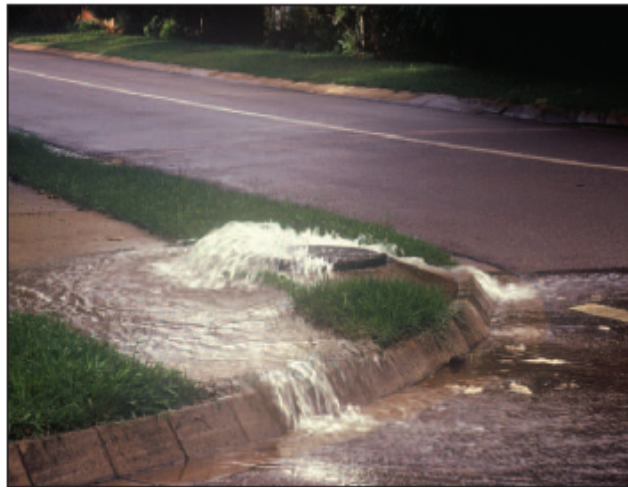
**Figure 1: Wastewater overflowing (not held under pressure)**

During a moderate to heavy rainfall event, it is not unusual for the sewer infrastructure in cities to become completely overloaded. The excessive flow within the sewer pipes results in surcharging sewer manholes which subsequently overflow (Figure 1), pump stations that cannot manage the extra flow and ultimately the overburdening of the Waste Water Treatment Works (WWTW) (Figure 2). When this occurs, untreated sewage finds its way onto streets, into stormwater drains and into streams and rivers.

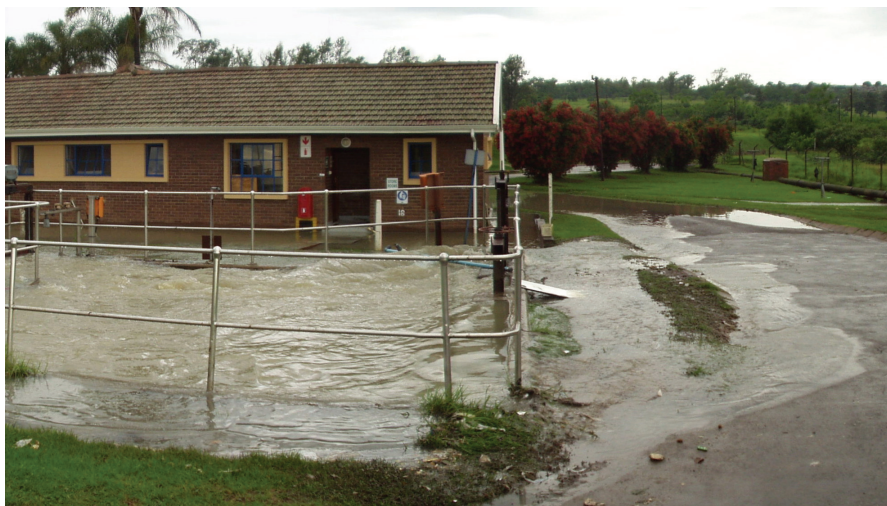
**Figure 2: Darvill Waste Water Treatment Works overflowing during a storm in Pietermaritzburg**  
(Steve Terry, 2007)

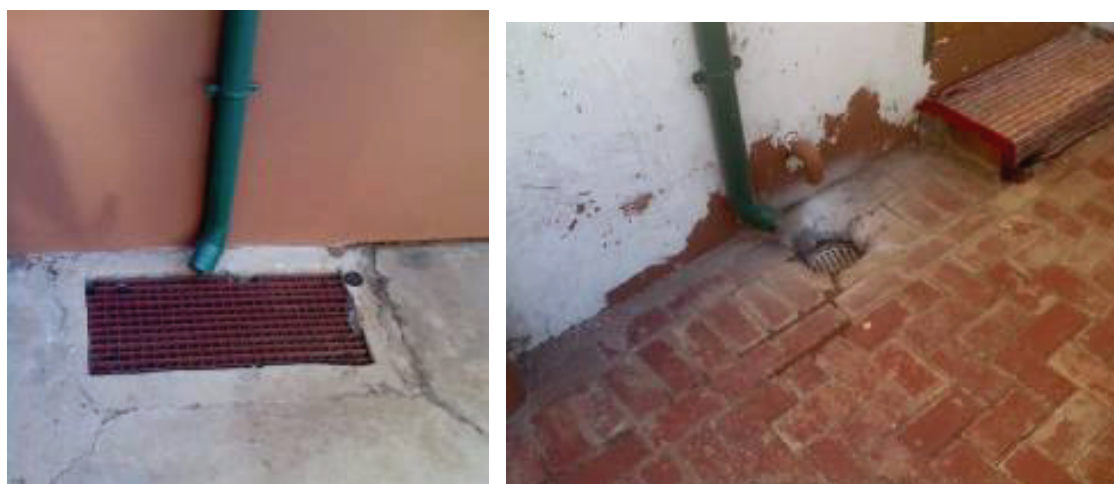
**Figure 5: Roof gutters directed into sewer lines (Source: Pienaar, 2007)**

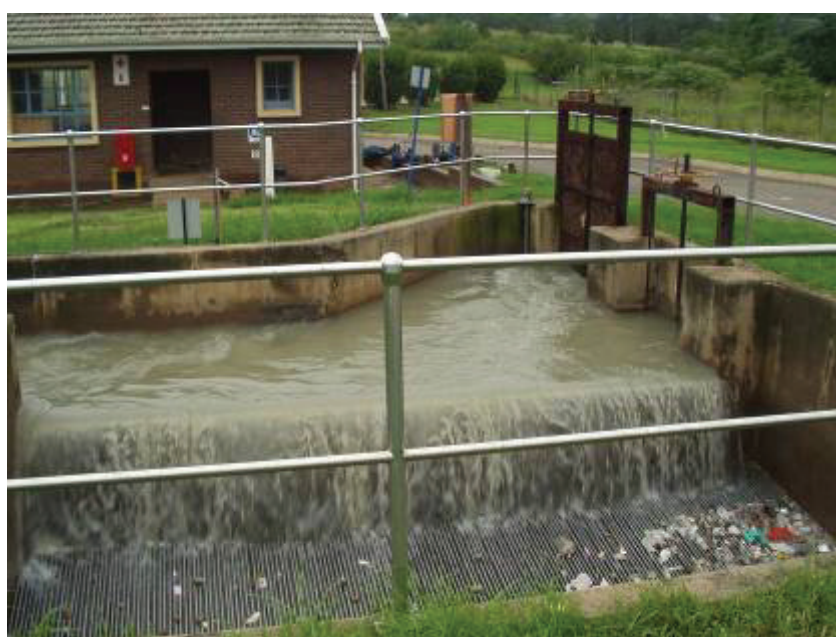
**Figure 7: Darvill WWTW overflowing to the storm dam during a routine wet weather event**

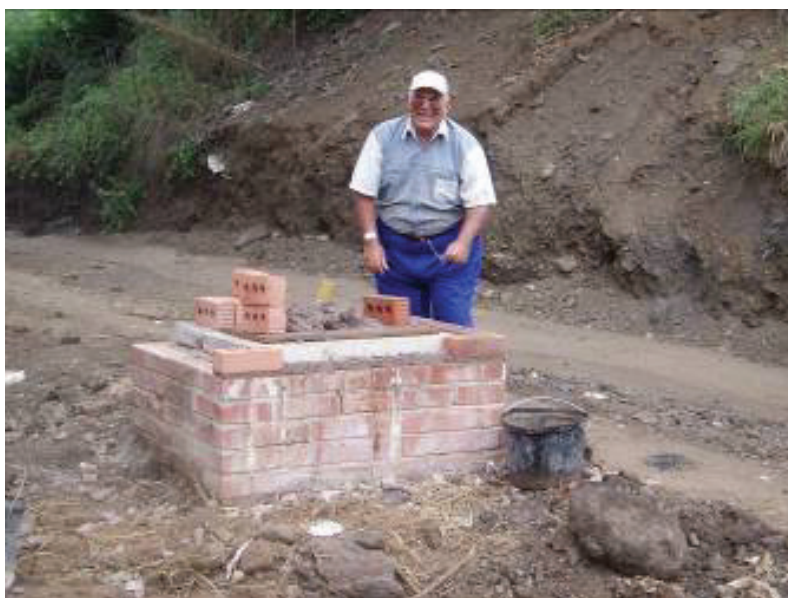
**Figure 14: “Vandal proof” manhole covers**

Following a major sewer spill in Pietermaritzburg which turned out to have been caused by a log which had become lodged in a bulk sewer, the Msunduzi Municipality made the decision to replace the manhole covers in the problem area and brick them in. These concrete covers cannot (easily) be stolen. However should the sanitation department require access to those particular manholes, the supporting structure would have to be partially broken (Figure 14).

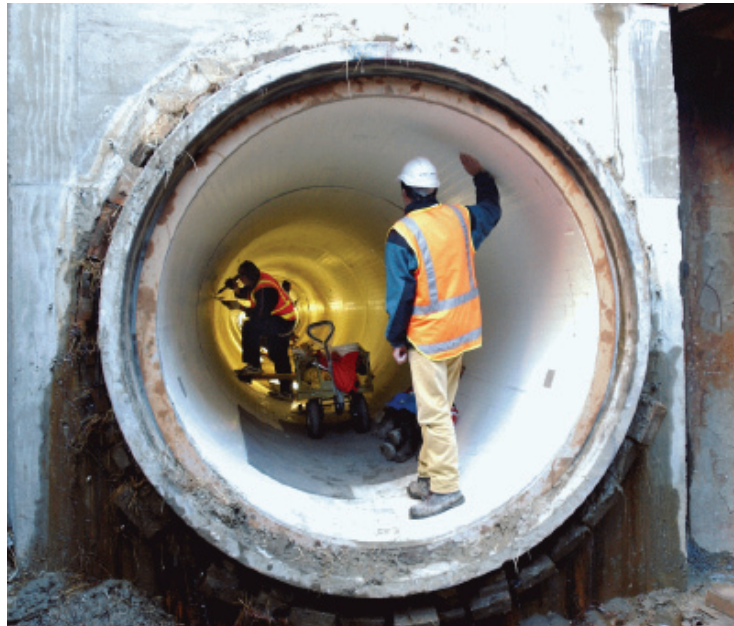
**Figure 15: Construction of the Browns Bay on line storage tunnel**  
(Source: Wisumperuma and Vercruyssen, 2006)

Some sewer systems can be modified to cope with stormwater ingress through increasing the storage capacity within the system (Wisumperuma and Vercruyssen, 2006). Peak storm overflow facilities (often referred to as stormwater retention dams) can be constructed alongside the WWTW. Excessive flows can be temporarily stored for treatment at a later stage. While this might reduce the frequency of spillage into receiving waters, it does not address the additional costs associated with processing excessive amounts of wastewater. Flow control devices can also be used to solve flooding problems. These devices would typically be installed at the on-line or off-line detention tanks. The detention tanks are constructed at various places along the sewer line and in combination with flow control devices are used to control the onward and downstream flow of wastewater throughout the system (Stephenson and Barta, 2005).

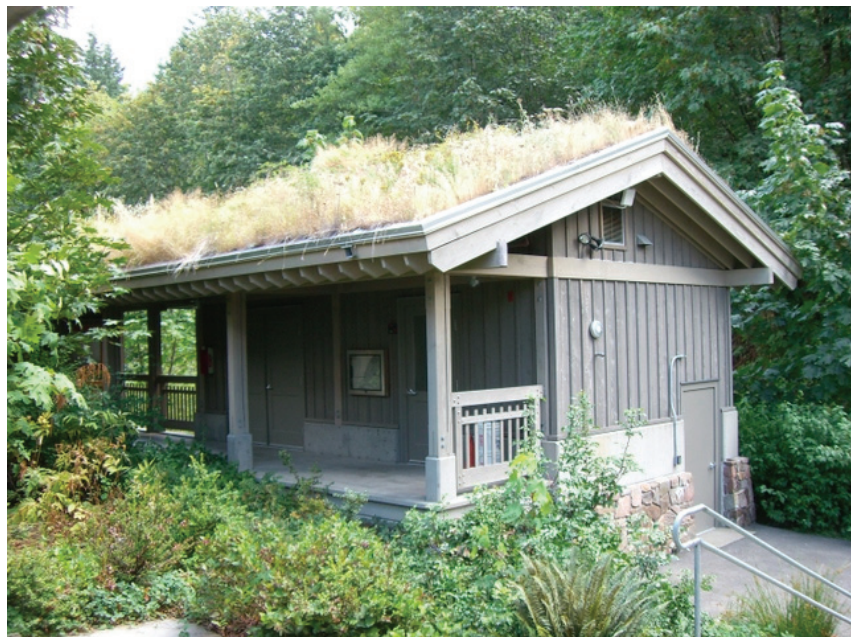
**Figure 20: An example of a green roof, which reduces stormwater runoff by absorption and evapotranspiration**

Less common alternatives include green roofs (pictured right) and the construction of on-site wetlands or water features into which stormwater is channelled.

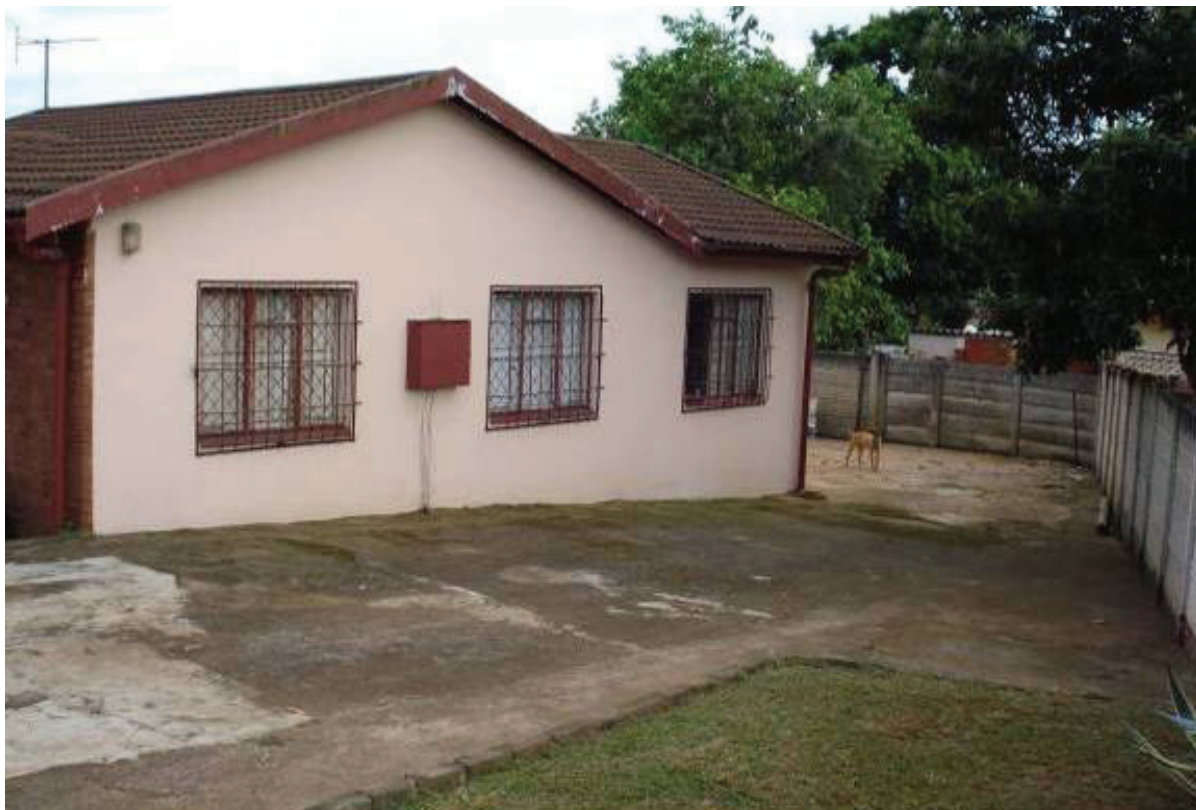
**Figure 21:** A typical yard in the Northdale area, with a large percentage paved and the downpipes disappearing into gullies which may be connected to the sewer network.

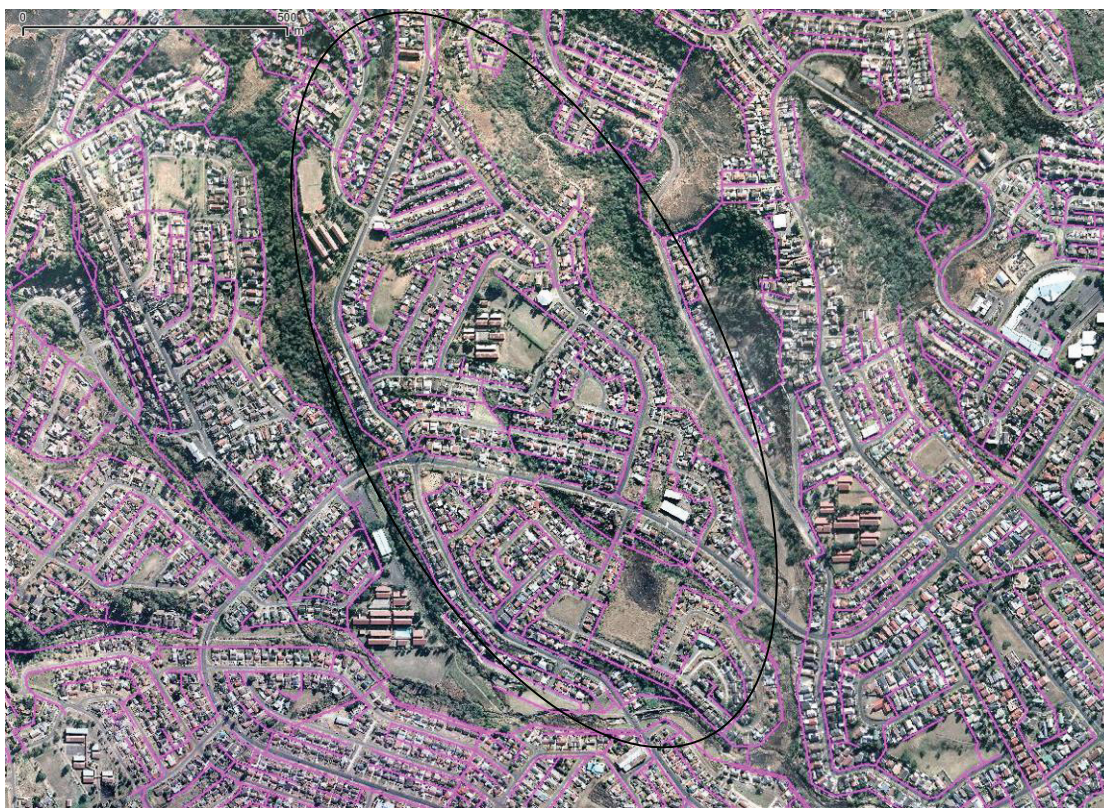
**Figure 22:** Suncrest (in the middle between the river lines) and its associated sewer network

- the suburb of Suncrest, on steeper ground with somewhat newer housing and larger plot sizes, which is located in the council's Ward 28 (Figure 22) and
- Lotusville/Woodlands, on flatter ground with older housing and smaller plot sizes, which is located in the council's Ward 31 (Figure 23)

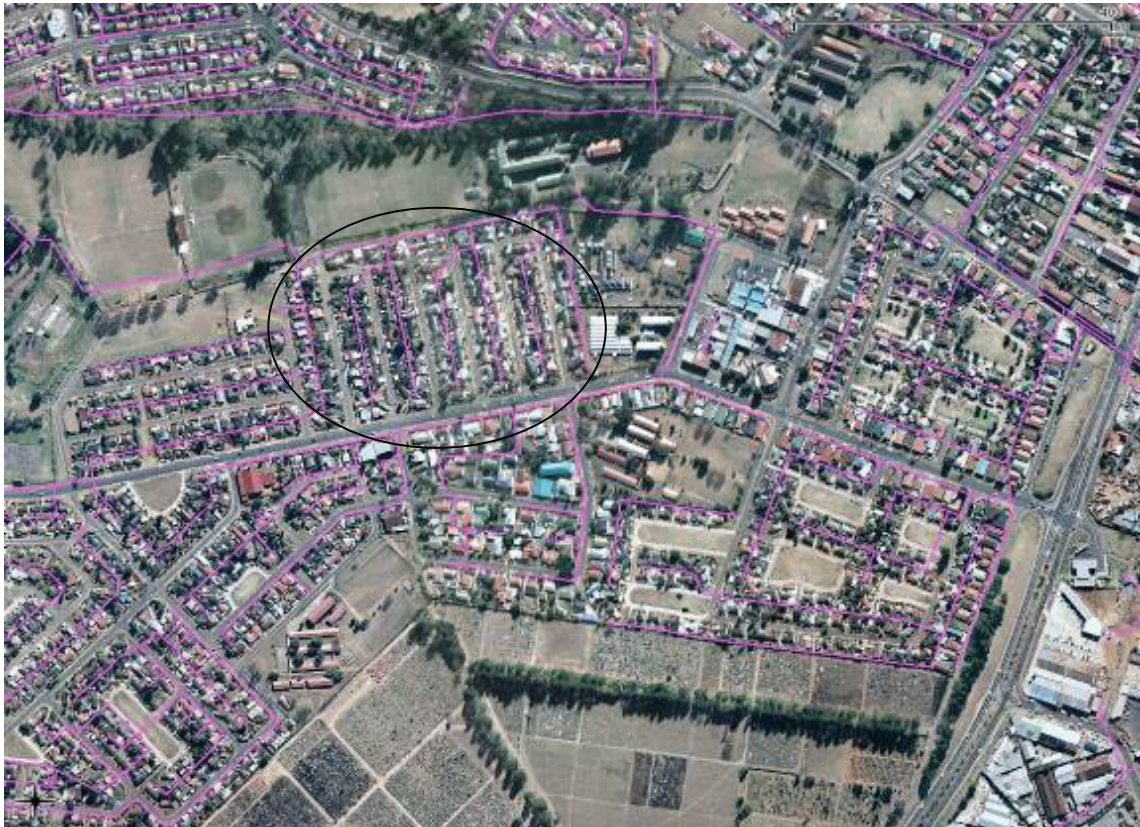
**Figure 23: Lotusville and associated sewer network**

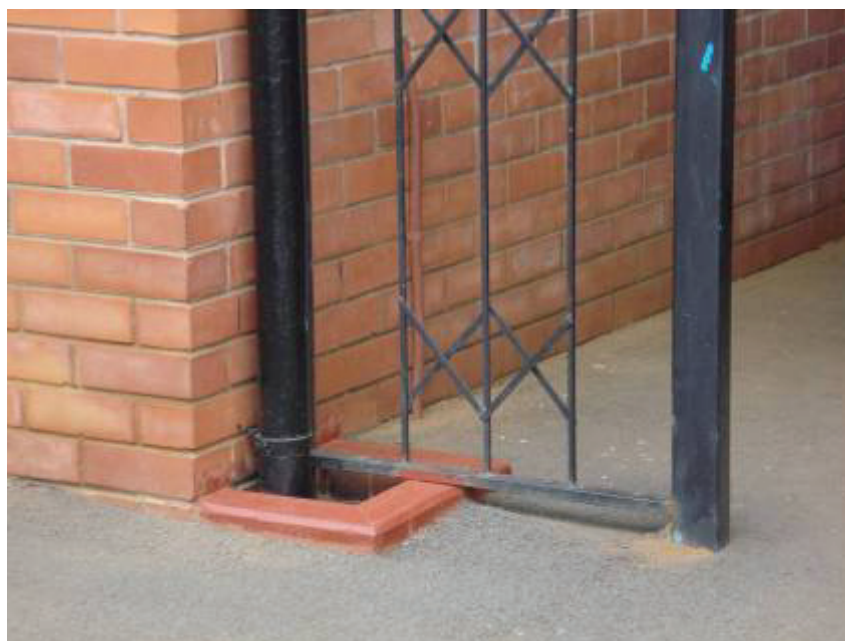
**Figure 24: A downpipe from a home in Lotusville disappearing into a gully – where does the water go?**

During a site visit one home was found where the gutters from the roof disappeared into the ground in neatly constructed drains. The owner of the property did not know where the rainwater went and there was no evidence of stormwater drains to which they could have been linked (Figure 24). The yard of the property was extensively surfaced with a stormwater manhole in the centre of the driveway.

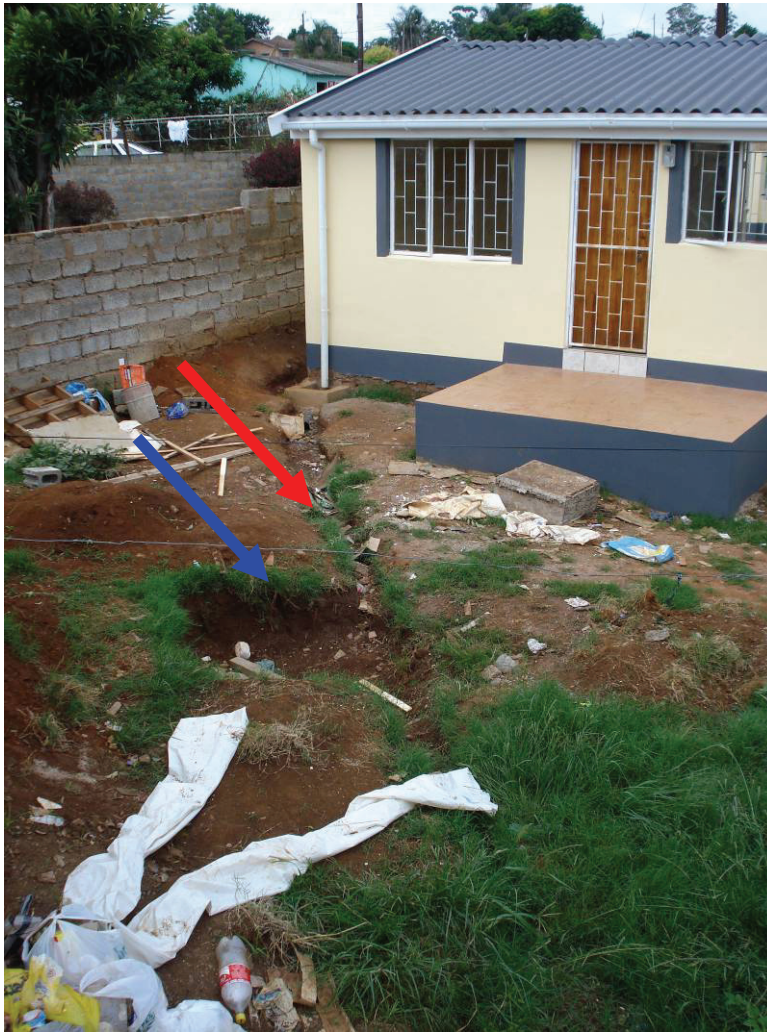
**Figure 25:** The red arrow shows a trench designed to route stormwater to the sewer (off camera), while the blue arrow shows what appears to be intended as an inline soakpit.

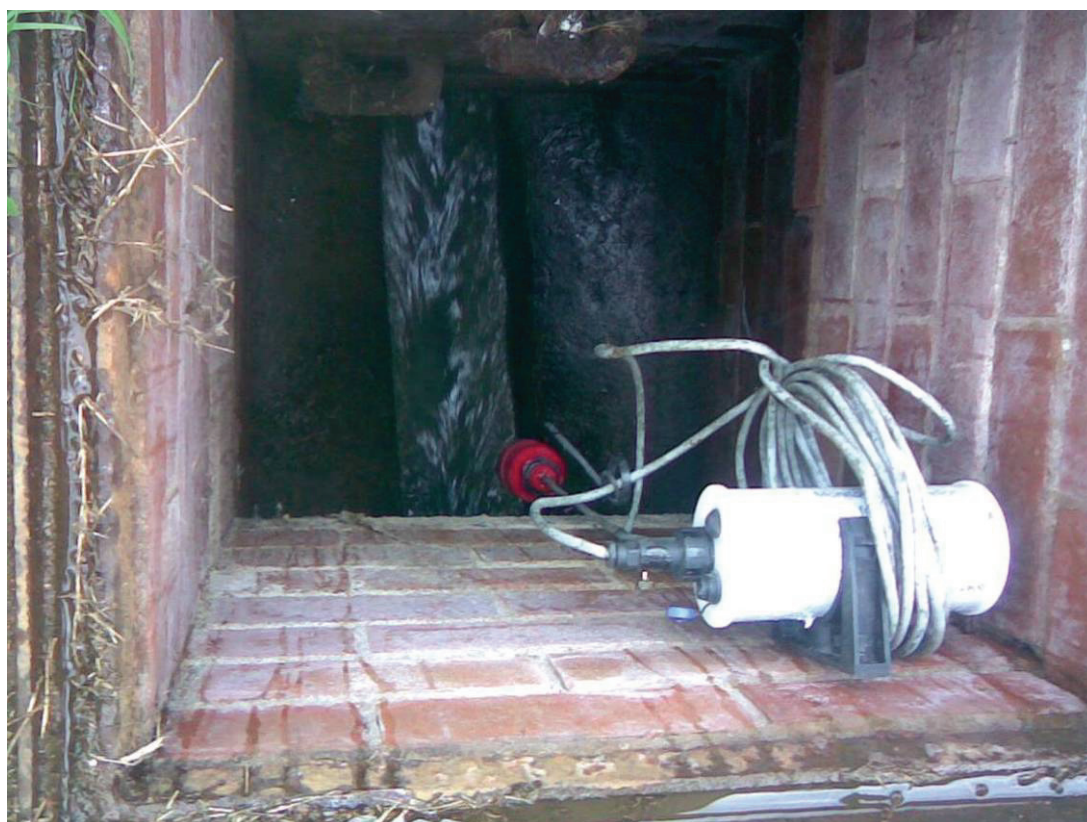
**Figure 32: Installation of sewer flow logging equipment at Ward 31 site**

The survey discussed in sections 5.4 and 5.5 above was carried out in September 2008. The Msunduzi Municipality then agreed to assist with this research by contracting a specialist company (Flowmetrix) to log the sewer flows in the survey area for a period during the rain season. Two loggers were installed at the Ward 31 site on 10 December 2008 and these were removed on 26 January 2009. The upper measuring station was located in a manhole immediately above the 283 homes included in the survey, while the lower measuring station was located in a manhole below these homes (Figure 32). The exact falls of the sewers above these two manholes were established using a dumpy level, in order that depth measurements in the sewer channels could be converted into flow measurements. A local resident (one of the people used to conduct the original survey) was contracted to record the rainfall during the monitoring period and a rain gauge was set up on his property for the purpose.

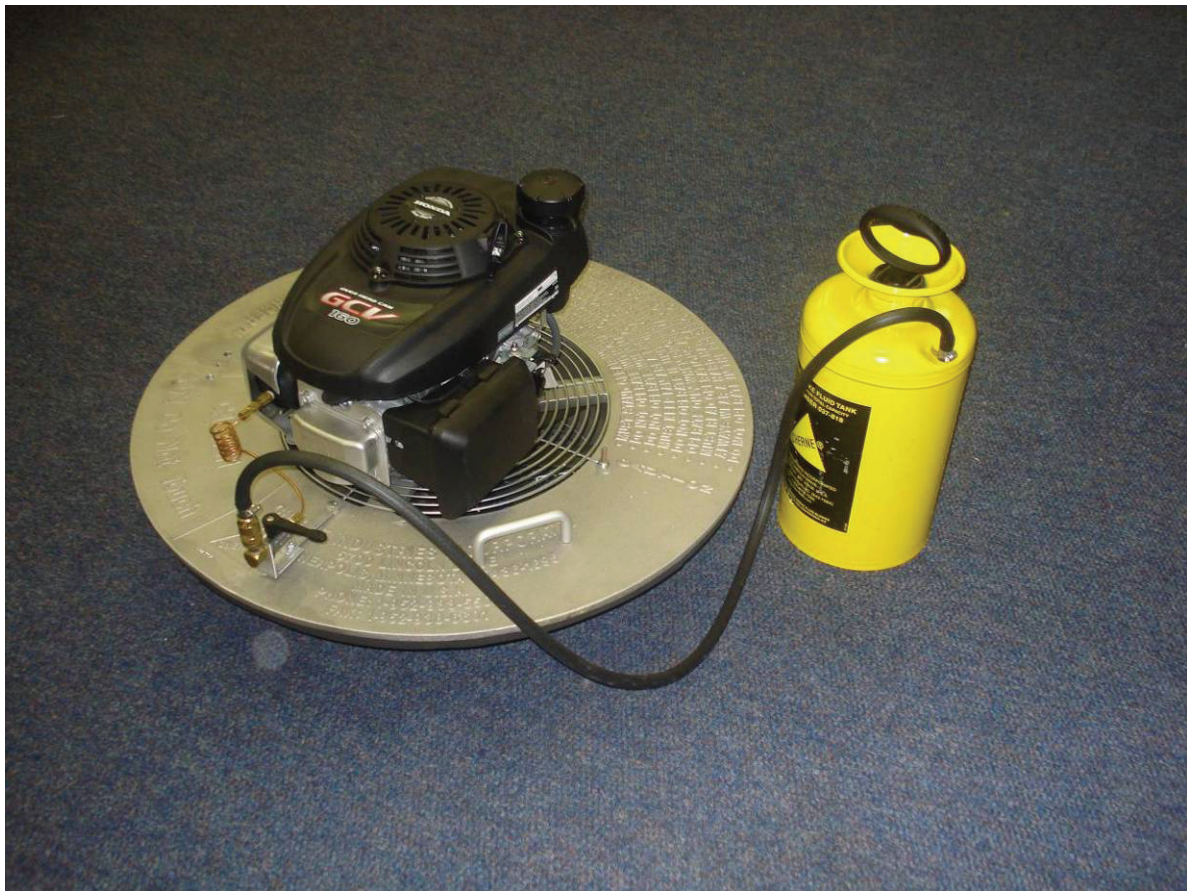
**Figure A1: The smoke generator machine acquired by eThekweni Water Services to assist with the detection of direct stormwater to sewer connections**

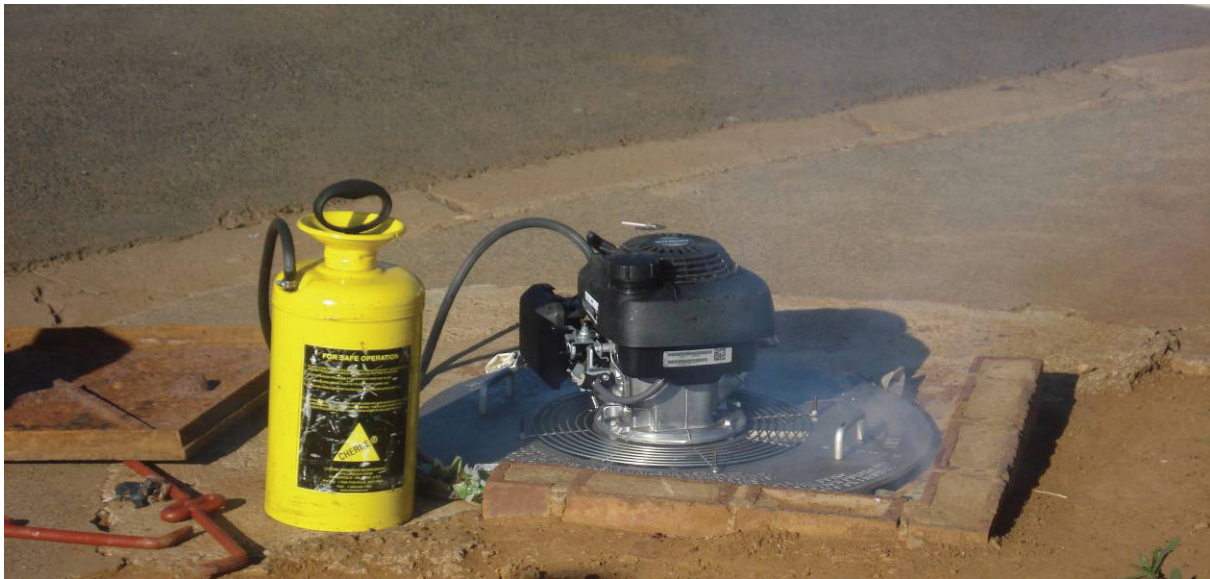
**Figure A2: The smoke machine in place over a manhole and in operation. A base plate adaptor is needed to enable the machine to work more effectively over manhole openings (such as this one) which are not an exact match for the machine's base plate.**

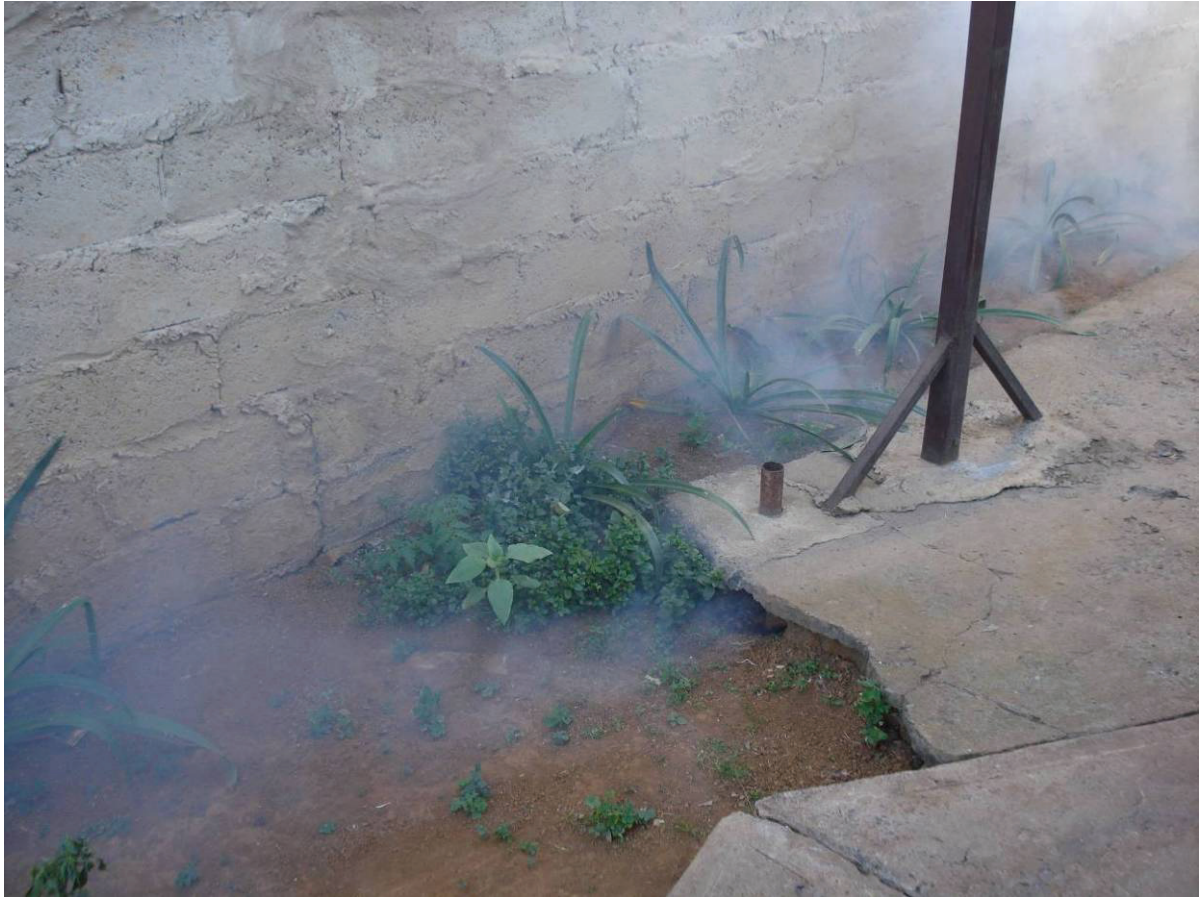
**Figure A3: Smoke pours out of the ground revealing the location of a broken section of domestic sewer. In this case the home owner may not be aware of the problem with the sewer pipe, but such a section of pipe will function as a subsoil drain, carrying away stormwater when it rains. This kind of sewer break would be hard to find using a routine visual inspection of the yard.**

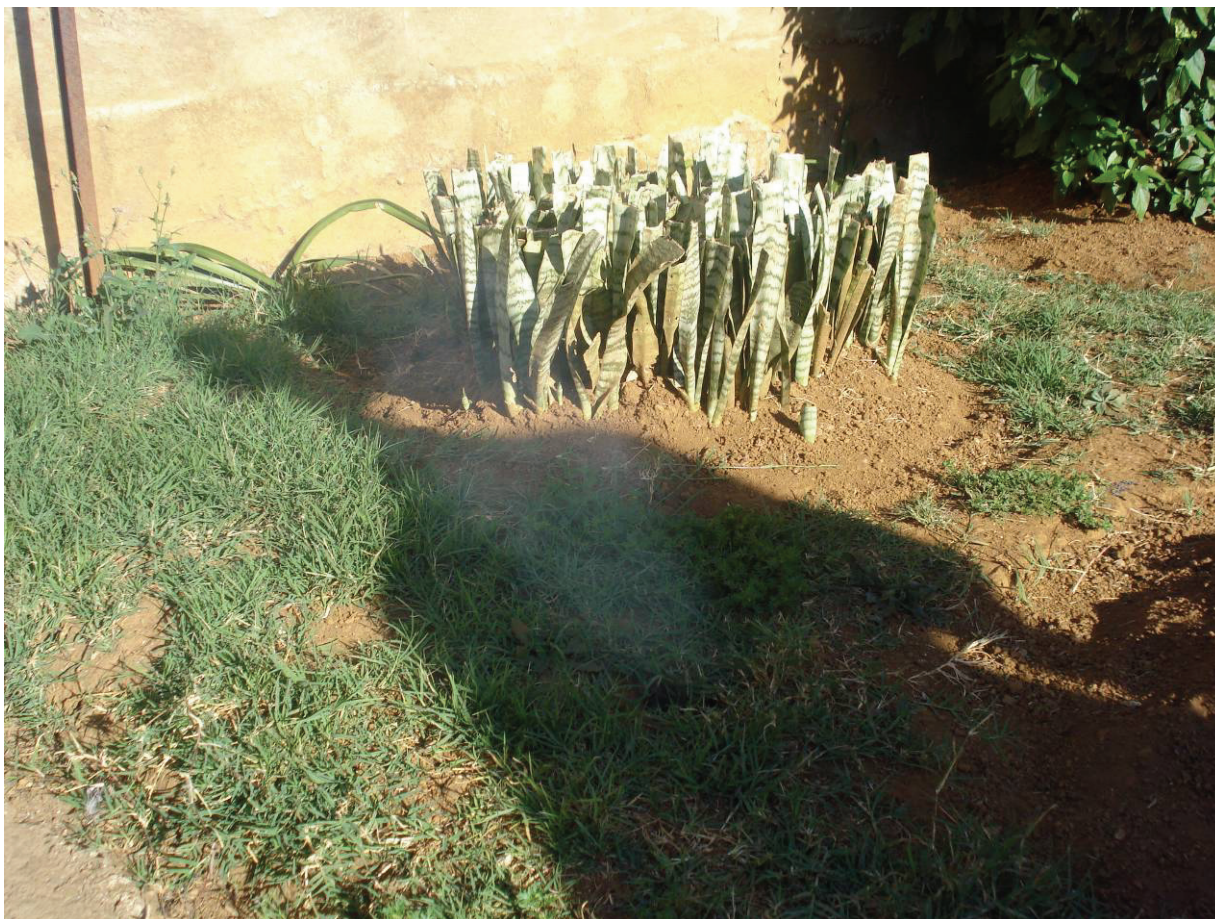
**Figure A4:** Smoke rises from the ground in a patch of lawn, revealing a broken sewer pipe below the surface. As with the break shown in Figure A3, a problem like this would be hard to find using a routine visual inspection.
