**DESCRIPTION OF CATCHMENTS AND  
METHODOLOGY**

**By JJ Lambourne & TJ Coleman**

**Report to the Water Research Commission on the Project  
"Effects on Urbanization on Catchment Water Balance"**

**WRC REPORT NO. 183/2/93**

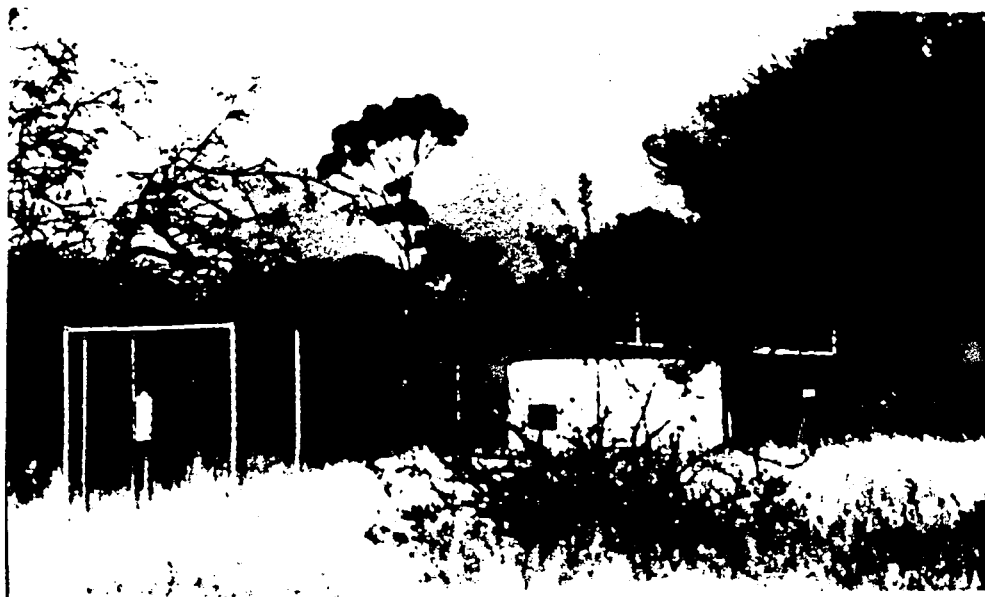
Figure 2.8 - Waterval - Typical Veld and tree conditions

An example of typical veld and tree conditions is presented in Figure 2.8.
