# **LEAKAGE CHARACTERISATION OF BULK WATER PIPELINES**

Report

to the Water Research Commission

WRC Report No. 2572/1/19

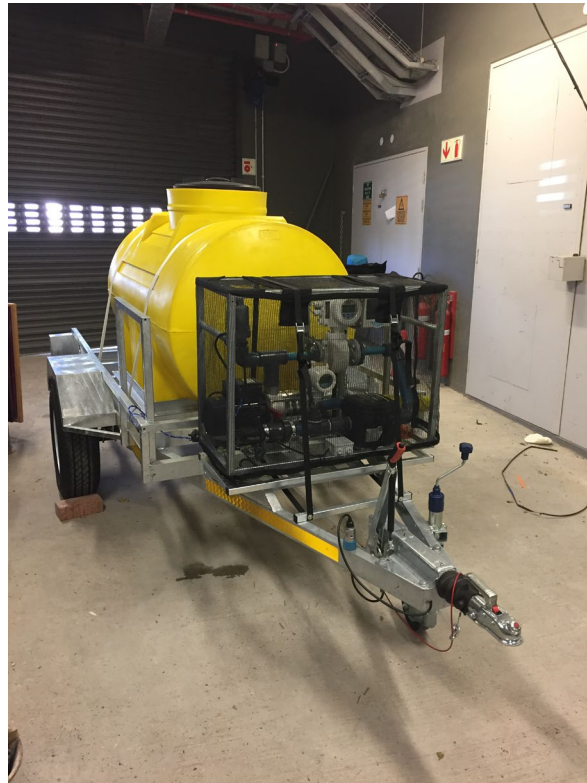
Several components were incorporated into the PCAE to satisfy the aforementioned considerations. Figure 0.1 shows the PCAE, which contains a water tank on a trailer, valves, a magnetic flow meter, an inverter, a pump, unplasticised polyvinyl chloride (uPVC) pipes and a plastic reinforced hose adaptor.

**Figure 0.1: The pipe condition assessment equipment**

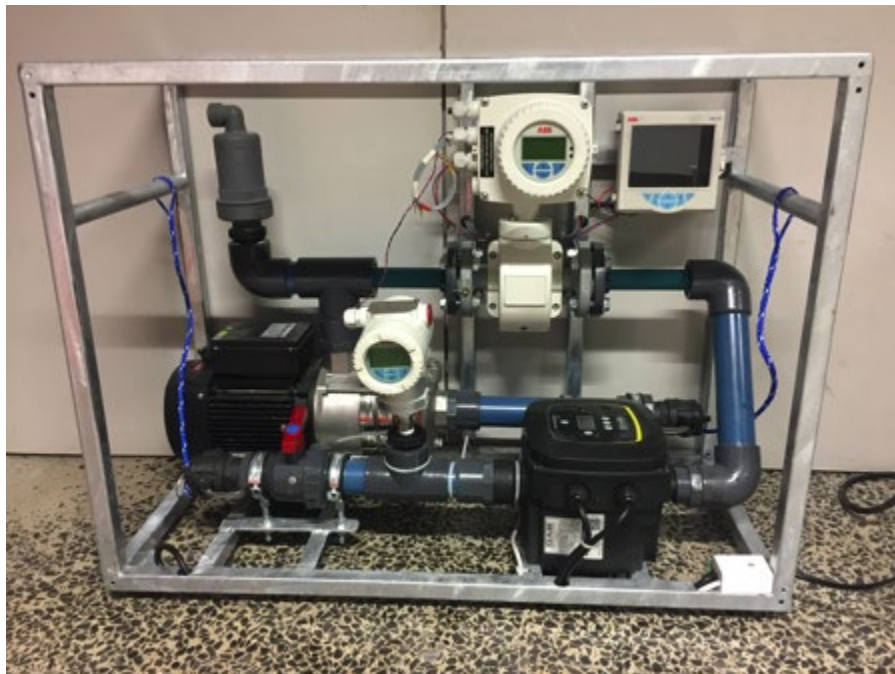
**Figure 3.13: Constructed pipe condition assessment equipment**

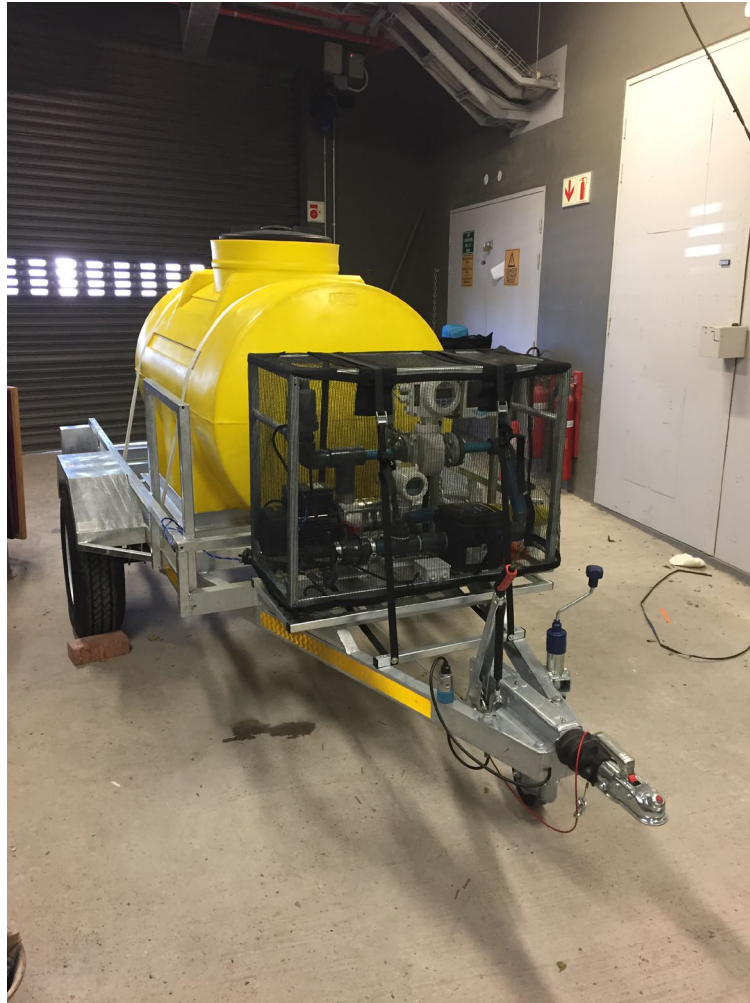
**Figure 3.14: PCAE installed on a 1 000 ℓ water trailer**

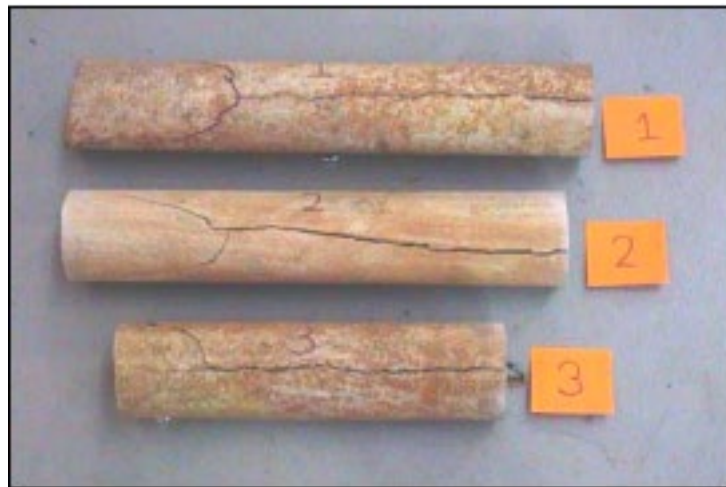
**Figure 4.31: Typical failure mechanisms in asbestos cement pipes (Greyvenstein, 2004)**

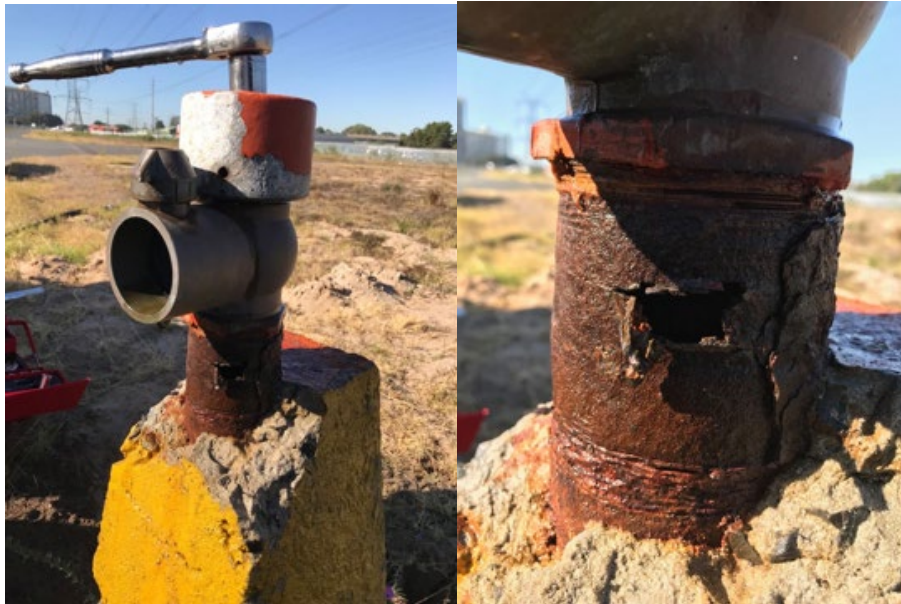
**Figure 4.34: Failed fire hydrant pipe**

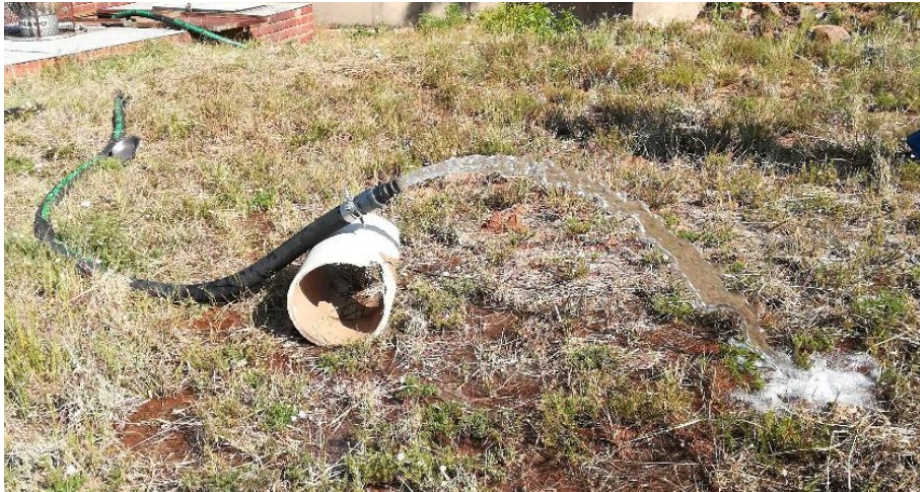
**Figure 4.45: Constant flow observed after valve V1 was closed**
