AN INDEPENDENT INVESTIGATION AND ADVISORY ON THE ROLE OF WATER, SANITATION AND HYGIENE IN THE 2023 CHOLERA OUTBREAK IN HAMMANSKRAAL, SOUTH AFRICA

WORK PACKAGE 4: WATER AND SANITATION SAFETY ASSESSMENT AND ENVIRONMENTAL MONITORING

Part 4: Assessment and Monitoring of Solid Waste and Sewer Overflows

Final Report to the
Water Research Commission

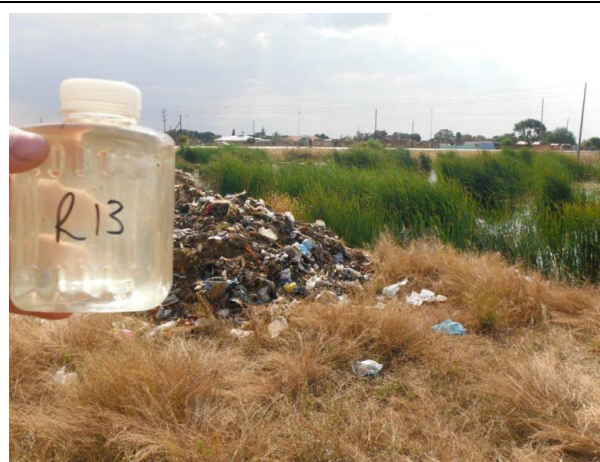
Figure 4: Site 13 – Receptor

MICROBIOLOGY TEST RESULTS			CHEMISTRY TEST RESULTS		
DETERMINANT	UoM	R13	DETERMINANT	UoM	R13
Total coliforms	MPN.100ml ⁻¹	488000	Chemical oxygen demand (COD)	mg.L ⁻¹	40.0
<i>Escherichia coli</i>	MPN.100ml ⁻¹	17000	Electrical conductivity	mS.m ⁻¹	113.0
Heterotrophic plate count	CFU.1ml ⁻¹	68000	Ammonia-nitrogen (NH ₃)	mg.L ⁻¹	0.4
<i>Salmonella enterica</i>	Positive/Negative	Negative	pH		7.9
<i>Shigella</i> species and/or EIEC	Positive/Negative	Negative	Comment: Results acceptable No cholera		
Toxigenic <i>Vibrio cholerae</i> (ctxAB+)	Positive/Negative	Negative

Site	Conclusion
Site 13	No evidence of microbial contamination or the presence of <i>V. cholerae</i> .
Site 16 and Site for Investigation	Both microbiology (Salmonella and Shigella – Site 16 and INV) and chemistry results (NH ₃ – INV) are indicative of sewerage contamination. <i>V. cholerae</i> was not detected.
Site 85 & 86	Chemistry results of R86 relating to NH ₃ is indicative of potential sewerage contamination. <i>V. cholerae</i> was not detected.
Linked sites	No evidence of microbial contamination or the presence of <i>V. cholerae</i> .

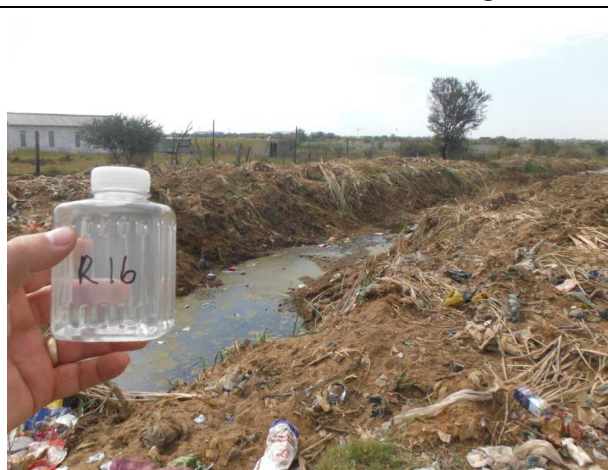
Figure 6: Site 16

MICROBIOLOGY TEST RESULTS				CHEMISTRY TEST RESULTS			
DETERMINANT	UoM	R16	INV1	DETERMINANT	UoM	R16	INV1
Total coliforms	MPN.100ml ⁻¹	>24 200	>2 420 000	Chemical oxygen demand (COD)	mg.L ⁻⁰	26.0	44.0
<i>Escherichia coli</i>	MPN.100ml ⁻¹	24200	276000	Electrical conductivity	mS.m ⁻⁰	118.0	86.0
Heterotrophic plate count	CFU.1ml ⁻¹	184000	2 350 000	Ammonia-nitrogen (NH ₃)	mg.L ⁻⁰	0.5	10.9
<i>Salmonella enterica</i>	Positive/Negative	Positive	Negative	pH		8.4	7.3
<i>Shigella</i> species and/or EIEC	Positive/Negative	Negative	Positive	Comment: Both microbiology (<i>Salmonella</i> and <i>Shigella</i>) and Chemistry results (INV NH ₃) are indicative of sewerage contamination. <i>V. cholerae</i> negative.			
Toxigenic <i>Vibrio cholerae</i> (ctxAB+)	Positive/Negative	Negative	Negative

There is however evidence of chronic sewerage contamination caused by leaking sewerage lines or manholes. These could potentially serve as a pathway for cholera. Other pathogens that cause gastro-intestinal disease, including salmonella and shigella were in fact detected.

A concerted effort should be made to maintain sewerage infrastructure to avoid a potential pathway for the spreading of diseases. A proper waste collection system should also be implemented to avoid illegal dumping of municipal solid waste.

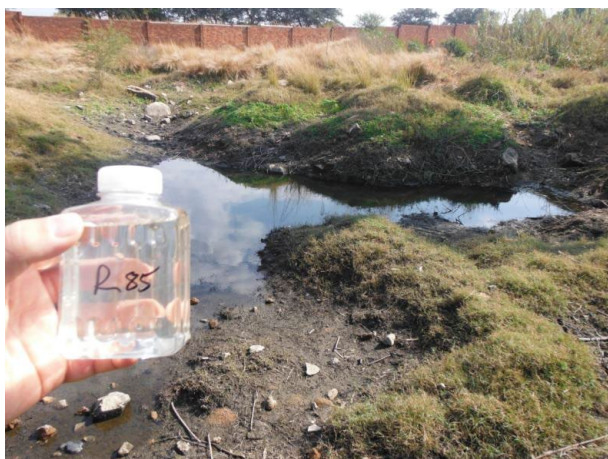
Figure 9: Site 85

MICROBIOLOGY TEST RESULTS				CHEMISTRY TEST RESULTS			
DETERMINANT	UoM	R85	R86	DETERMINANT	UoM	R85	R86
Total coliforms	MPN.100ml ⁻¹	>2 420	10460	Chemical oxygen demand (COD)	mg.L ⁻⁰	38.0	35.0
<i>Escherichia coli</i>	MPN.100ml ⁻¹	18	400	Electrical conductivity	mS.m ⁻⁰	181.0	134.0
Heterotrophic plate count	CFU.1ml ⁻¹	40000	58000	Ammonia-nitrogen (NH ₃)	mg.L ⁻⁰	0.5	4.1
<i>Salmonella enterica</i>	Positive/Negative	Negative	Negative	pH		8.2	8.3
<i>Shigella</i> species and/or EIEC	Positive/Negative	Negative	Negative	Comment: Chemistry results of R86 (NH ₃) indicative of potential sewerage contamination. <i>V. cholerae</i> negative.			
Toxigenic <i>Vibrio cholerae</i> (ctxAB+)	Positive/Negative	Negative	Negative

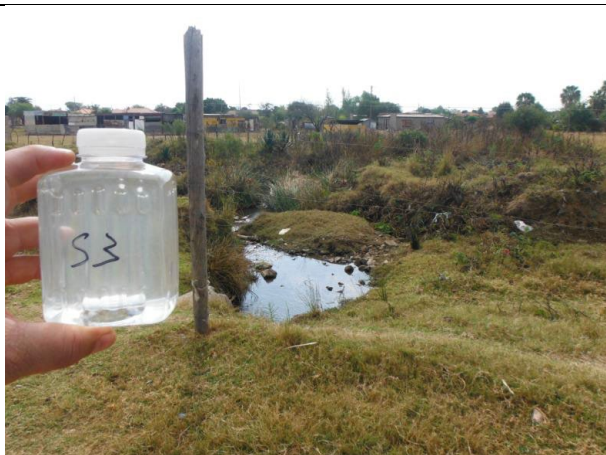
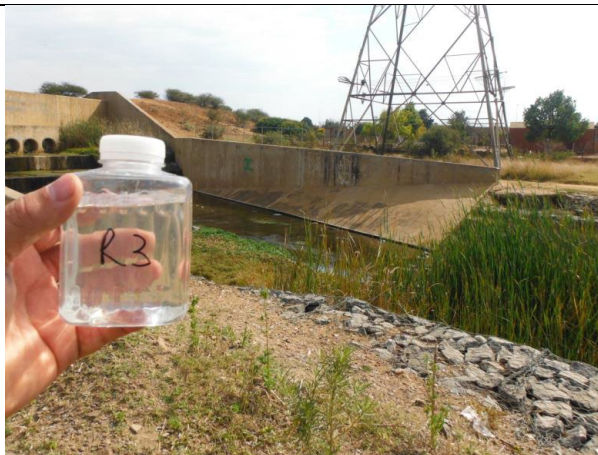
Figure 12: Site 3

Comment: Illegal dump site S39 at the source of a natural stormwater stream links a number of other identified sites downstream to S3. Samples along this linkage was composited and analysed as for the other sites.

MICROBIOLOGY TEST RESULTS			CHEMISTRY TEST RESULTS		
DETERMINANT	UoM	R7, S3 & R39	DETERMINANT	UoM	R7, S3 & R39
Total coliforms	MPN.100ml ⁻¹	21400	Chemical oxygen demand (COD)	mg.L ⁻¹	<10.0
<i>Escherichia coli</i>	MPN.100ml ⁻¹	5900	Electrical conductivity	mS.m ⁻¹	82.0
Heterotrophic plate count	CFU.1ml ⁻¹	105000	Ammonia-nitrogen (NH ₃)	mg.L ⁻¹	0.2
<i>Salmonella enterica</i>	Positive/Negative	Negative	pH		8.2
<i>Shigella</i> species and/or EIEC	Positive/Negative	Negative	Comment: Results acceptable <i>V. cholerae</i> negative.		
Toxigenic <i>Vibrio cholerae</i> (ctxAB+)	Positive/Negative	Negative
