# Comparison of the chemical quality of rainwater harvested from roof and surface run-off systems

Despite numerous studies, little is known about the quality of rainwater harvested (RWH) from roofs or overland flow by smallholder farmers of Africa. Thus, the main objective of this study was to compare the physical and chemical quality of the rainwater harvested from both dwelling roofs and yards situated in a smallholder community in KwaZulu-Natal (South Africa). Rainwater samples were collected at 51 households during a dry period for assessment of the concentration of specific chemical elements. The water harvested from metallic roofs and yards did not meet the World Health Organization (WHO, 2011) guidelines for drinking water, as it exceeded recommended levels of Se, Al, B and Cd in at least 75% of the roof water samples, and of Al in the case of yard RWH. Compared to yard water, RWH from metallic roofs exhibited higher B, Se, Ni, Pb, Cu, As, Cd, and Cr but lower dissolved organic carbon (DOC), NO<sub>3</sub><sup>-</sup>, Fe, SO<sub>4</sub><sup>2-</sup>, Na, Mg, Ca, K, Fe concentrations. The content of nutrients and DOC in the water harvested from the surface correlated with t

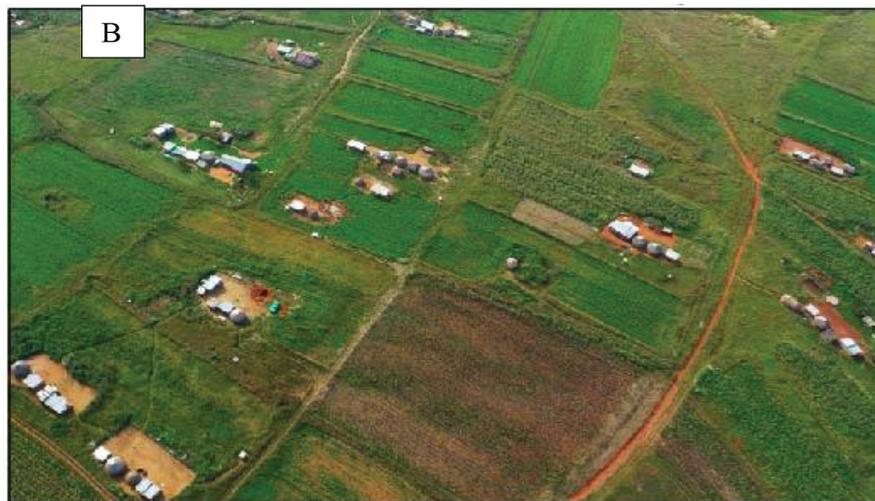
**Figure 1**

(A) Location of the study area in the uplands of the Thukela basin in KwaZulu-Natal, South Africa (B) view of the typical homestead layout.

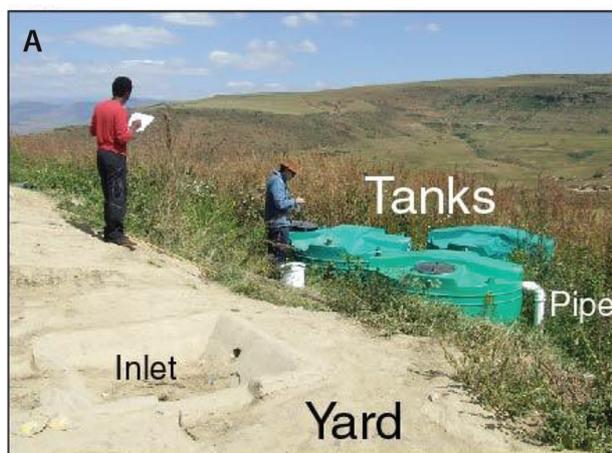
**Figure 2**

The water-harvesting techniques found at the study area (A) harvesting from yard; B) harvested from roof.

installed at 51 households to harvest water from either roofs or yards and to store it, with subsidies provided by the South African Government, through the erstwhile Department of Water Affairs. The 51 households harvest water from yards and roofs. The vast majority (47) of the roofs were constructed from metal sheets. However, three roofing systems made of tiles and one constructed from thatch were also considered for the purpose of comparison, despite data being very limited. Typically, the metal roof sheets used are galvanised with zinc and range widely from new ( $n = 5$ ) to highly oxidised ( $n = 3$ ) sheets. The harvested water was, in all cases, stored in 5 000 L cylindrical plastic tanks (Fig. 2A). Tanks receiving water from yards were buried underground, while those that received water from roofs were placed above ground. In this resource-poor area, harvesting systems are simple, consisting only of gutters and downpipes leading directly to the storage tank (Fig. 2B). First-flush filters are not used and the government subsidy covered the tanks only, not any of the related infrastructure. The majority of the households had two tanks for collecting the roof water and two tanks for collecting the yard water.

Water harvested from roof tops is mostly used for domestic purposes, whilst that harvested from yards is intended for food gardening later in the year. However, several households have reported that in the dry winter months water harvested from the yard is used for domestic purposes. Consequently, concerns have been raised regarding the quality of water, relative to its intended use.
