**REPORT TO THE WATER RESEARCH COMMISSION**

**EVALUATING THE LONG TERM USE  
OF POLYPROPYLENE FOR HOT  
AND COLD WATER PIPING**

**WRC REPORT NO. 434/1/94  
ISBN NO. 1 86845 090 2**

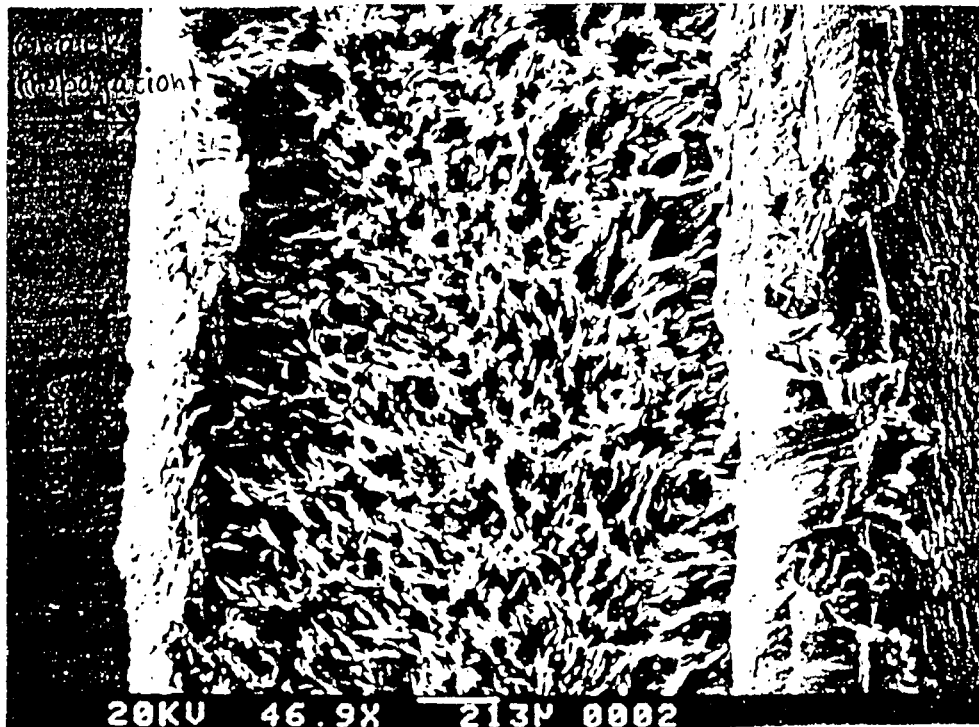
**Plate 5.5:** Fracture surface of Pipe B specimen fatigue loaded at 120°C between two constant stresses:  $\sigma_{\min} = 0.18$  MPa,  $\sigma_{\max} = 1.8$  MPa. Frequency 0,5 Hz. Brittle crack propagation occurred by void formation and fibrillation.

It should be noted that the region of brittle crack propagation is larger in the fatigued than in the constantly loaded specimen, and one would therefore expect the former to have a longer time to failure. However, the fatigued specimen failed after only 40 hours whereas the constantly loaded specimen failed after 100 hours. This evidence therefore suggests that the lifetime of pipes is significantly reduced, if they are subjected to dynamic fatigue cycling instead of simply being subjected to static pressurization.
