LET'S FIX OUR RIVERS!

HANDBOOK

DEALING WITH RIVER EROSION IN SOUTH AFRICA

Hans King • Liz Day • Mandy Uys

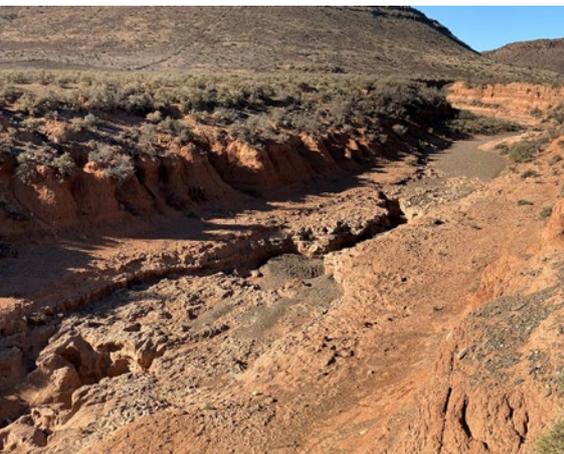
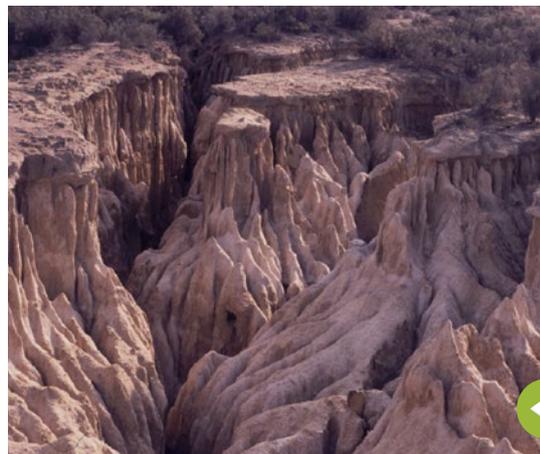
Carbonate collecting in the soil creates the hardpan layer (seen in the bottom of the gully in the image to the far left), while electrostatic charges due to salts in the soil cause the soil particles to repel each other when wet, i.e., the soil displays the tendency to be dispersive (seen in the image left).

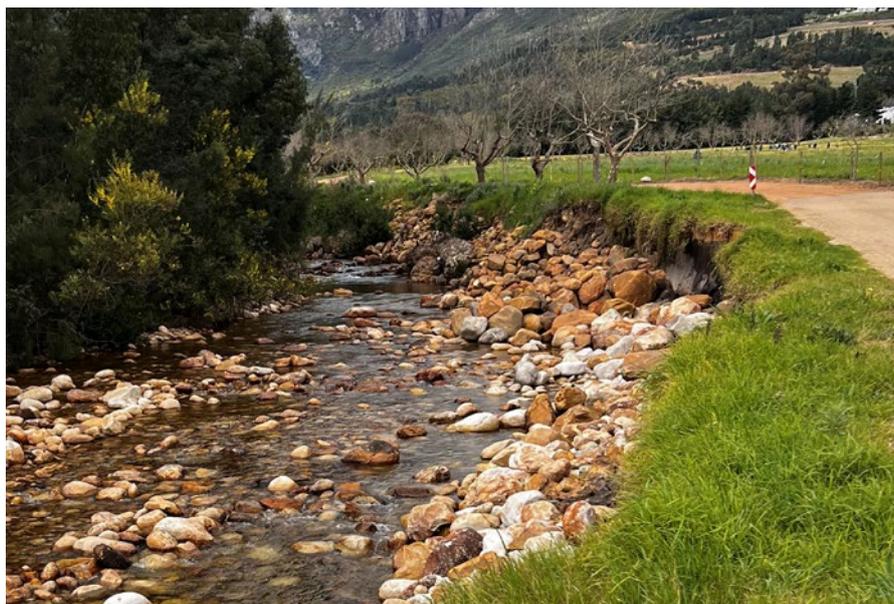
The large rocks packed along the river bank in this image are only moved by extremely fast flowing water.

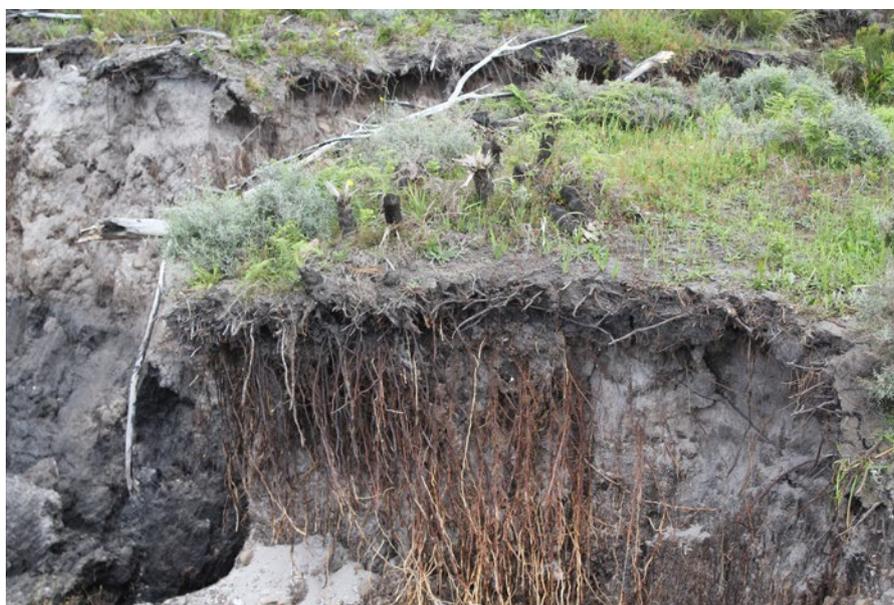
The woody alien vegetation, when upright, traps all sorts of debris during floods. This creates an obstruction in the watercourse that can result in erosion. Indigenous wetland vegetation tends to be flexible and to lie flat during floods, protecting the soil from erosion, and not creating a blockage.

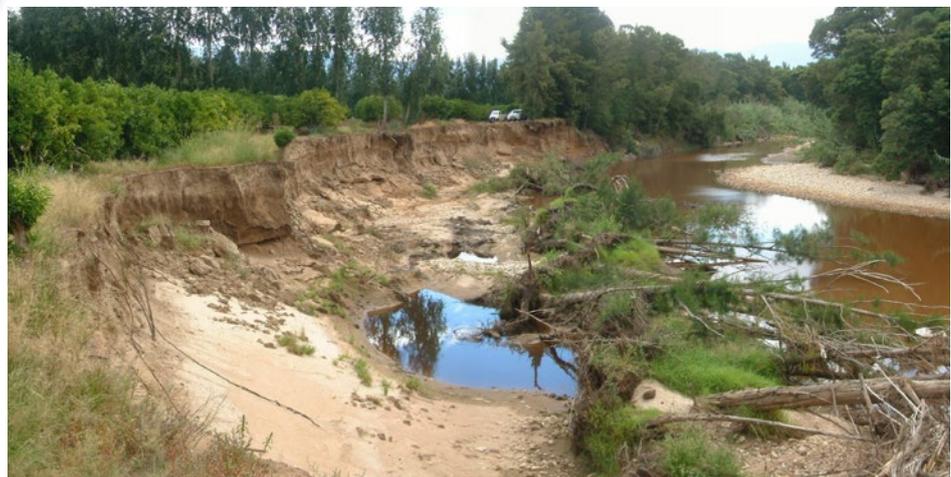
The undermining of the riverbank (to the left) has been driven by the stand of alien trees colonising the sediment on the opposite bank (to the right), deflecting the flow of the river. This has led to the collapse of the riverbank.

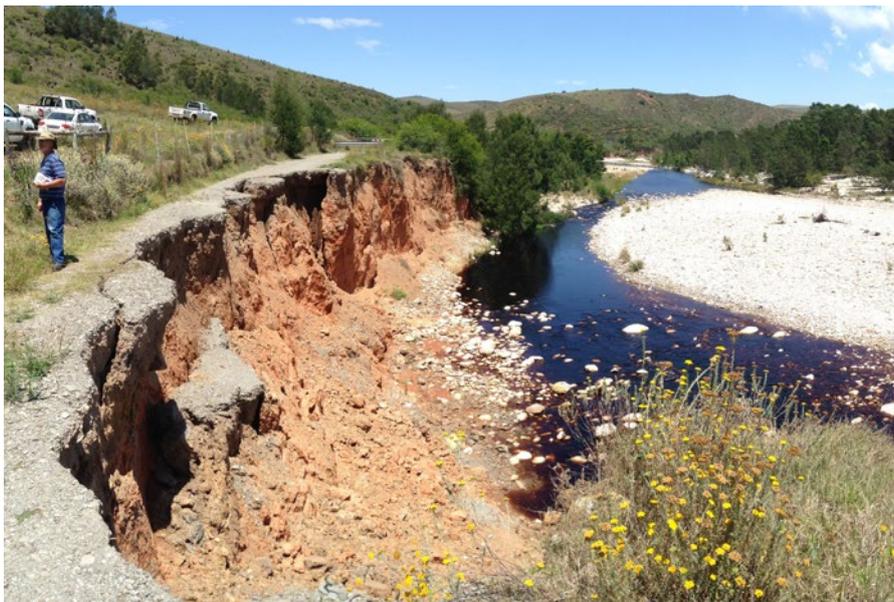
The high and steep riverbank is unstable and slips into the river below.

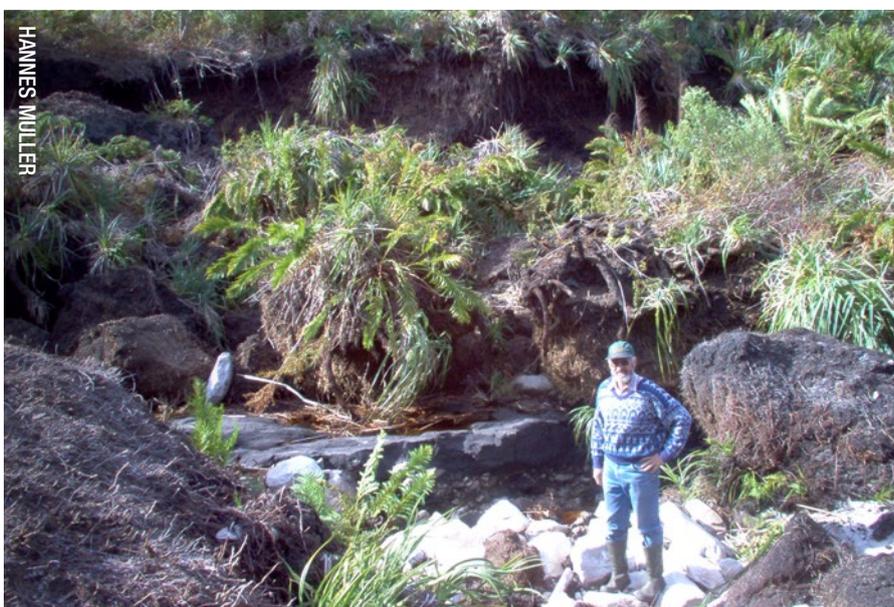
Peat soils commonly have highly permeable layers of river gravel and stone beneath them, or sometimes transecting them. Once an edge of the peat is exposed by erosion, subterranean water pressure releases via the gravel layer and washes it out at the exposed face. Once this happens the block of peat above breaks off and the face of the erosion advances uphill.

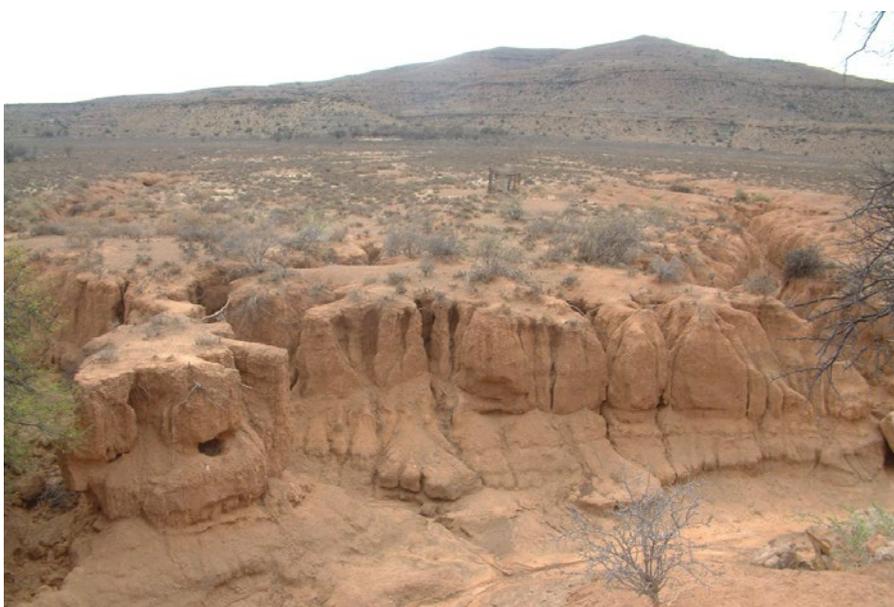
In arid areas like the Karoo, an unusual form of erosion occurs. Once small gulleys form in the landscape, they prevent the ponding of water on the soil when it rains. As the soil is hydrophobic, with no ponding of water, no water penetrates the soil, and the plants die back. Once the plants have gone, the rate of erosion increases and the gulleys become larger. This leads to the formation of 'bare patches' and associated river bank erosion.

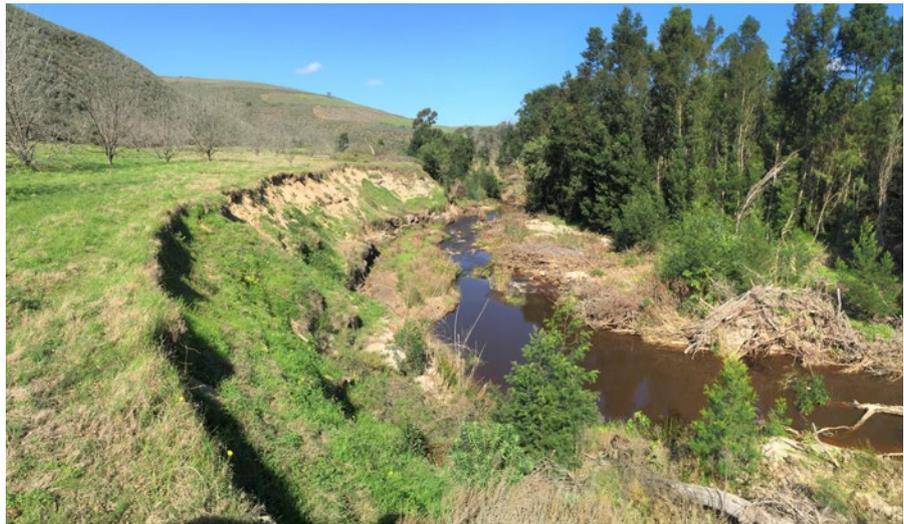
INDIRECT APPROACH

The alien vegetation (to the right) is deflecting the flow of water into the riverbank on the left, undermining the toe and making the riverbank unstable. A practical solution would be to clear the alien vegetation, and perhaps fill the eroded riverbank with surplus soil that has accumulated around the alien trees, and then to establish indigenous wetland vegetation along the toe area.

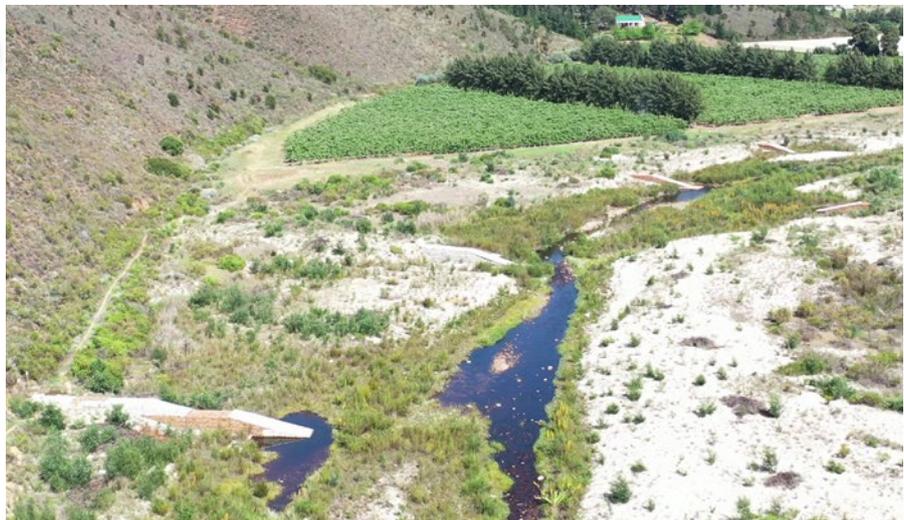
INDIRECT APPROACH

Groyne structures have been installed here to guide water around a bend in a river and protect the river bank from erosion (see page 18).

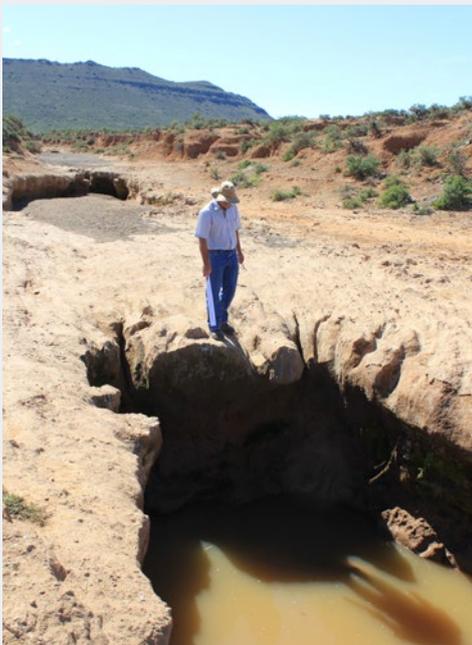
Karoo gully incision frequently gets slowed down temporarily when harder soil layers are experienced.

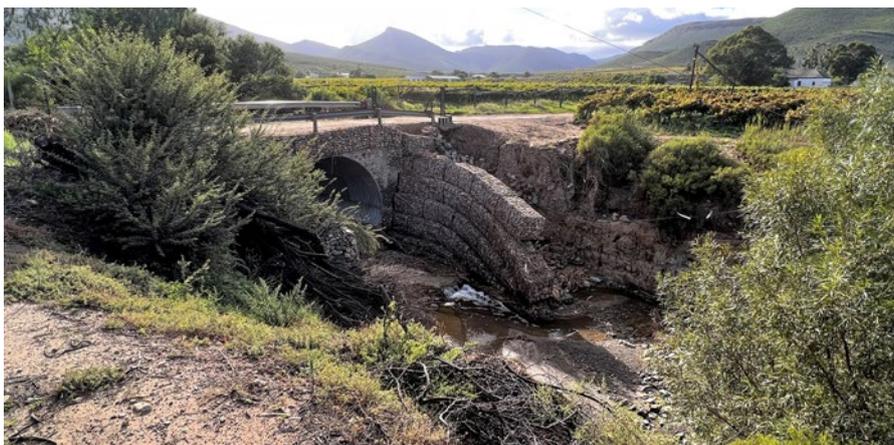
CONDENSED RIVER

A long-since condensed river (probably condensed by farmers expanding their vineyards into the river channel) can scarcely accommodate the 1 in 10-year flood. The shape of the river channel (deep and narrow) results in abnormally high flow velocities and regular erosion of the river bed.

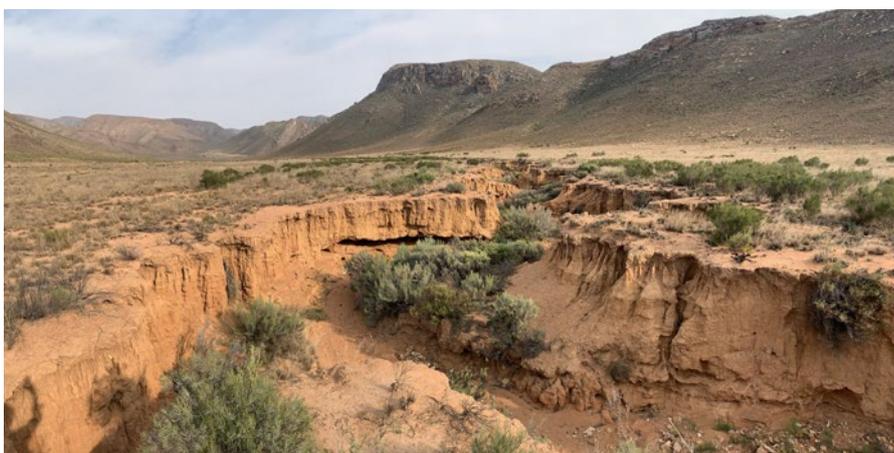
Little Karoo gully incision, probably because of the ground having been ploughed some time ago. In this arid ecoregion, erosion is difficult to address. Plant growth is very slow, and incision and loss of soil is permanent.

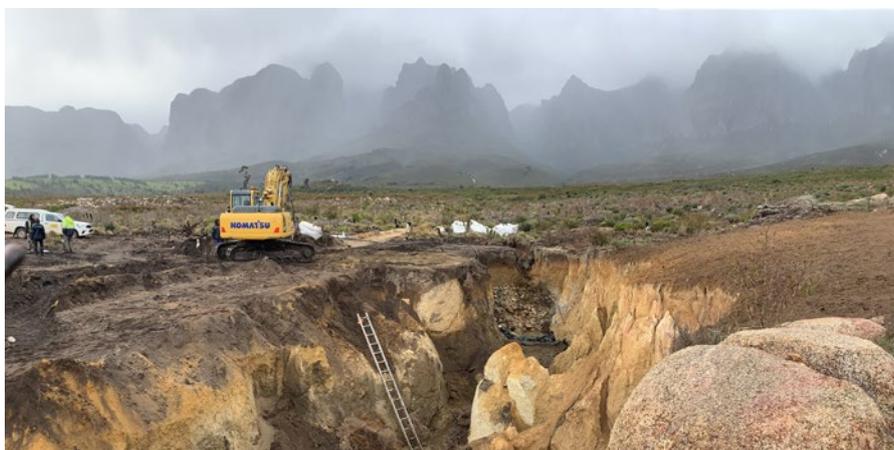
Erosion in dispersive soil – this deep, wide gully formed in 3 years once the original gully penetrated through the top 500 mm of stable transported soil. This highlights the need to act fast to address erosion before it progresses.

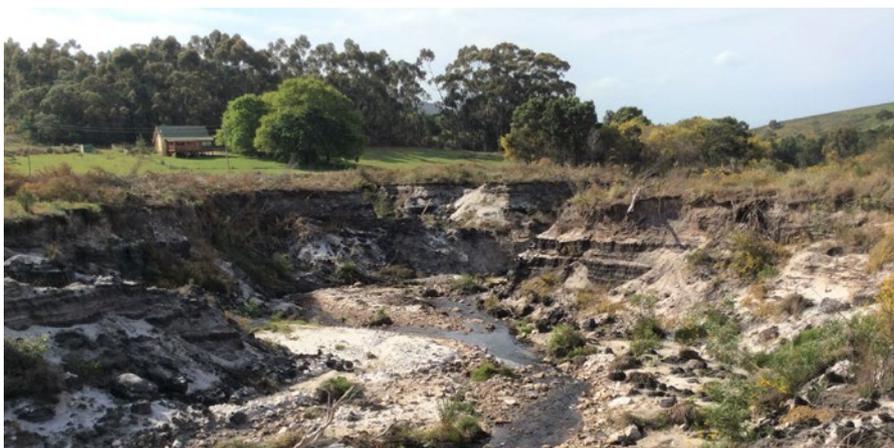
In peat valley-bottom wetlands, once the gravel layer beneath the peat is exposed by channel incision, erosion can progress quickly. This gully, caused by failure of a small dam and encroachment of alien vegetation, resulted in head-cut formation and took just 9 years to form.

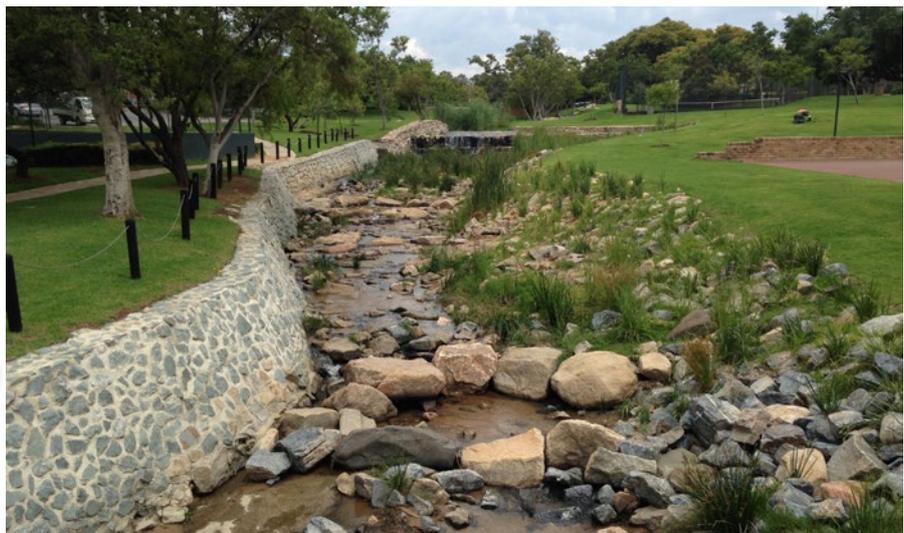
River incision can be controlled with the placing of large rocks to create flow resistance and slow down the flow velocity of the river (see **Handbook 9, Case Study 2**).

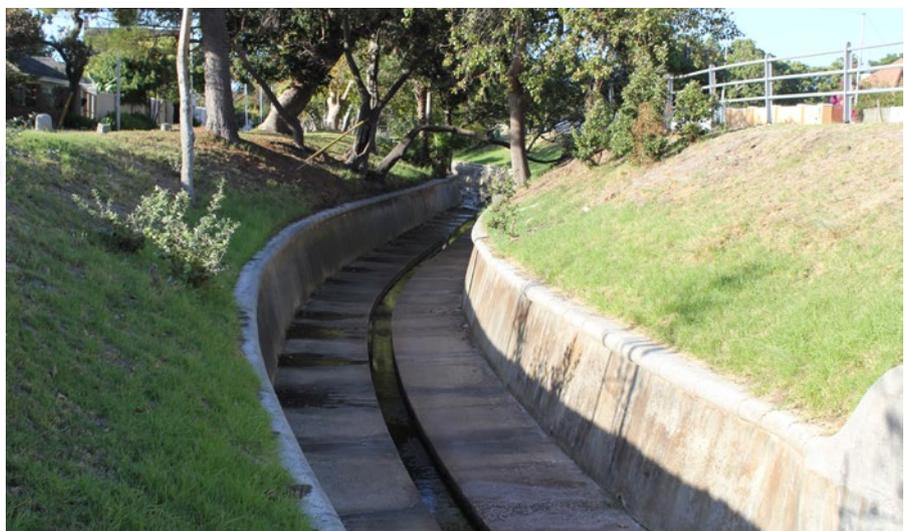
River incision can also be controlled with a concrete lined canal. These are very expensive to construct, separate river flows from groundwater and do not support ecological processes or biodiversity. Today the tendency is for these structures to be replaced with more environmentally acceptable solutions, where space permits.

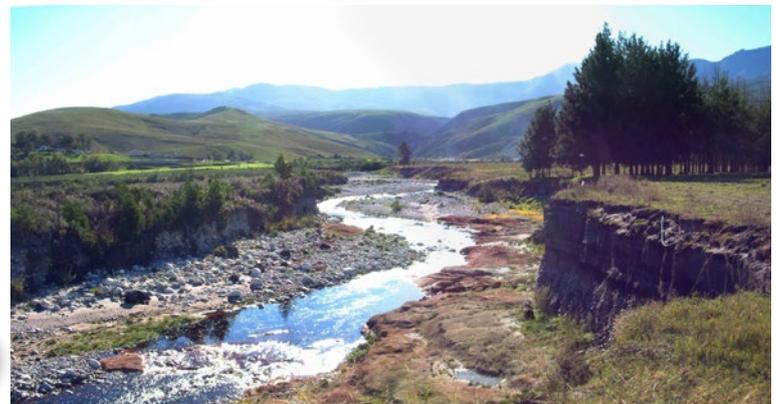
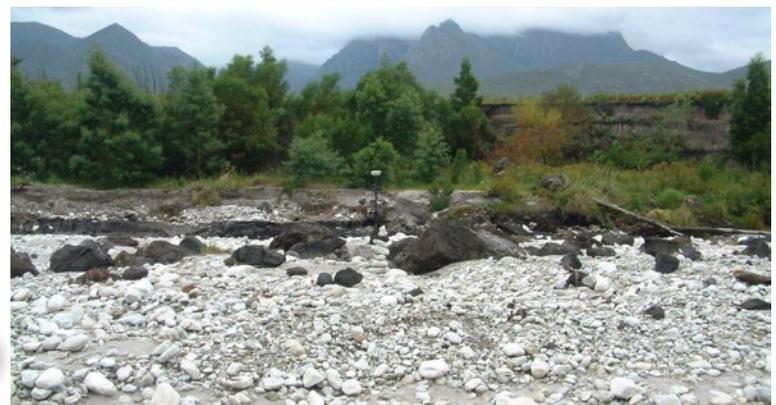
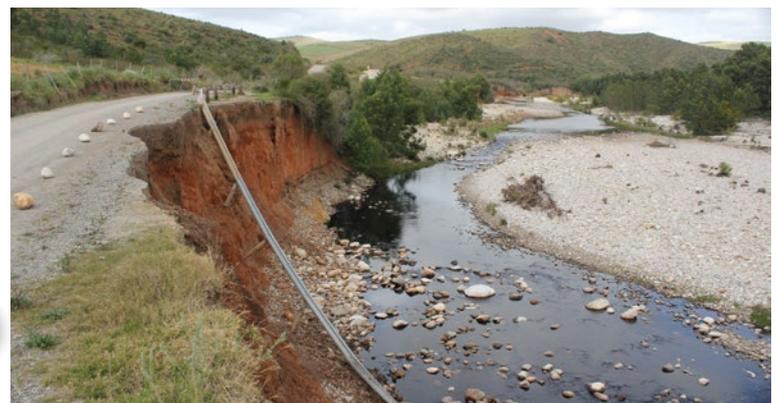
1 On site damage – a gully 600 m long, 50–100 m wide, and 6 m deep in what was a natural wetland, resulting from a drainage ditch dug between the wetland and a new citrus orchard. This damage happened in 3 major floods over 20 years. The ditch created a path along which the whole wetland drained. The concentration of all the water along this line resulted in abnormally high flow velocities and consequent soil erosion.

3 Off-site damage – one such blockage caused by the deposition of river boulders and other sediment in the river channel 1 km downstream from the erosion in image 1, deflected the flow into the riverbank where a road had been for many years. This erosion took 4 years to completely undermine the road.

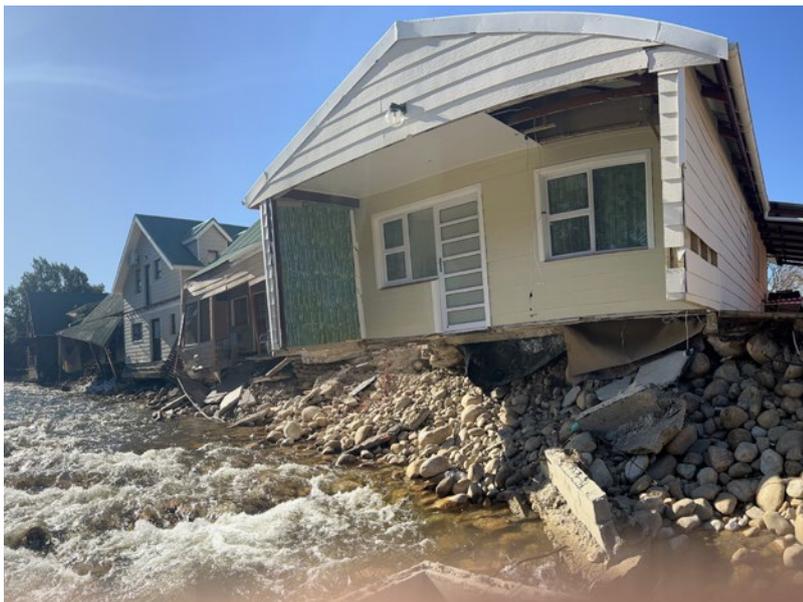
Direct (on-site) damage to infrastructure can be sudden, and devastating. The photo above also shows why developments and infrastructure need to be set well back from river floodplains, to allow space for flood processes.

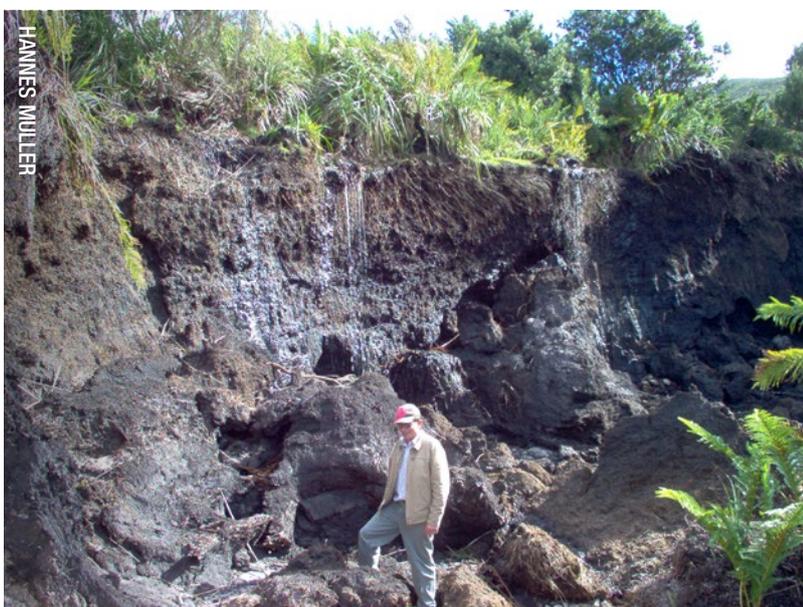
The on-site damage to the environment can also be sudden. The erosion of the wetland shown on the left was initiated by a poorly constructed road crossing, further downstream. The road changed the gradient of the channel, making it steeper and initiating a headcut. The headcut worked its way upstream. Today very little of the peat soil remains as it has all been washed away. The gully drains water from the surrounding wetland, drying it out and making the peat vulnerable to fires that can burn underground for years.

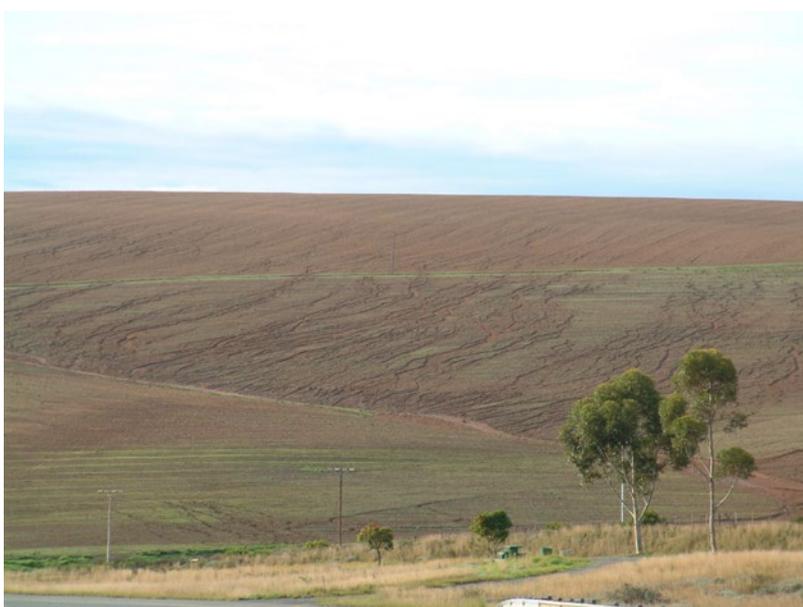
Surface erosion of cultivated lands – this soil eventually ends up in rivers, causing blockages and secondary erosion, and may silt up dams. Many rivers draining water from communal lands (where overgrazing is often problematic) are known to have abnormally high sediment loads for the same reason.

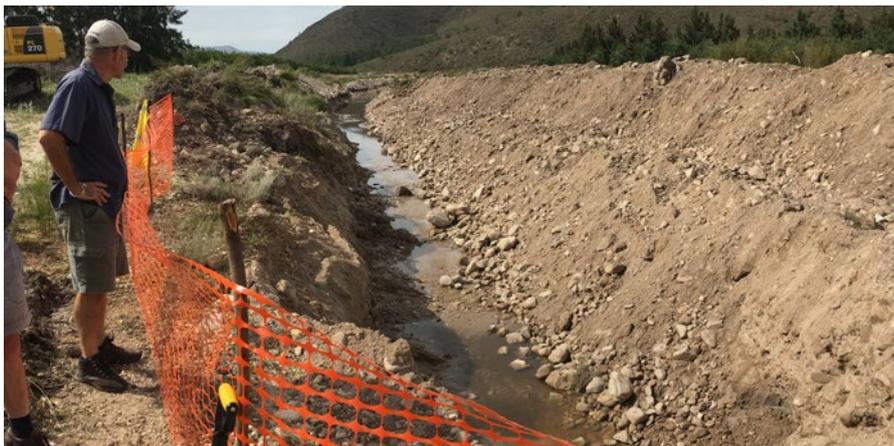
Safety barriers around deep excavations are essential.

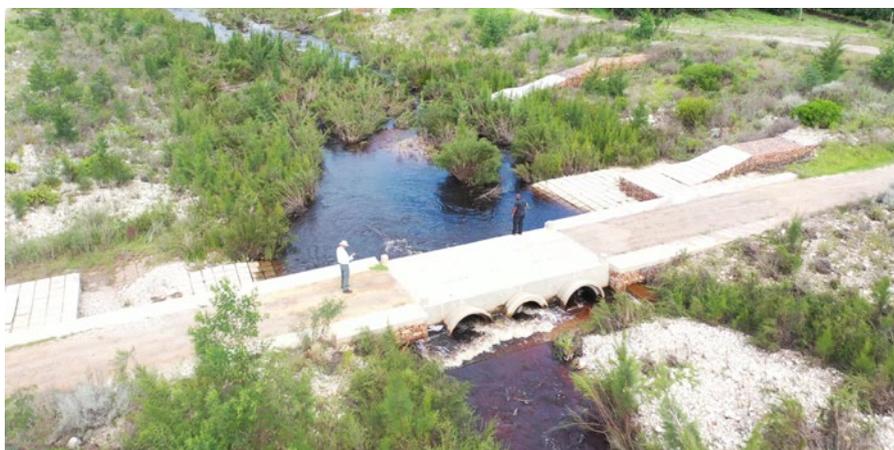
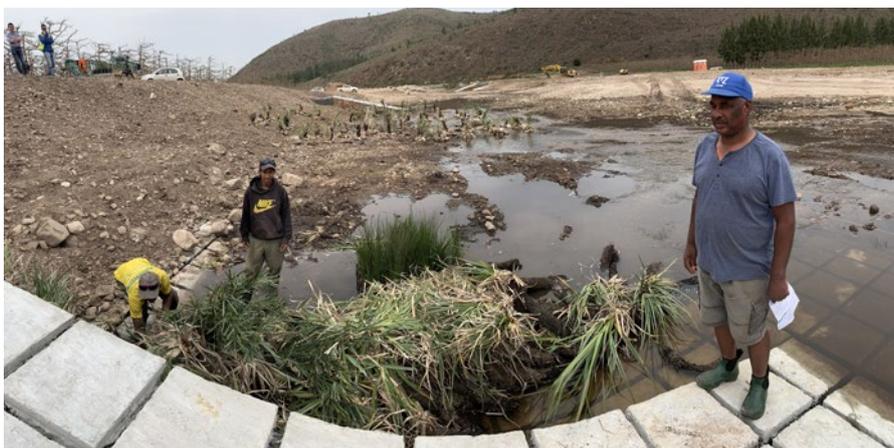
Establishing vegetation in wetland and river rehabilitation projects can be an ideal employment creation and training opportunity.

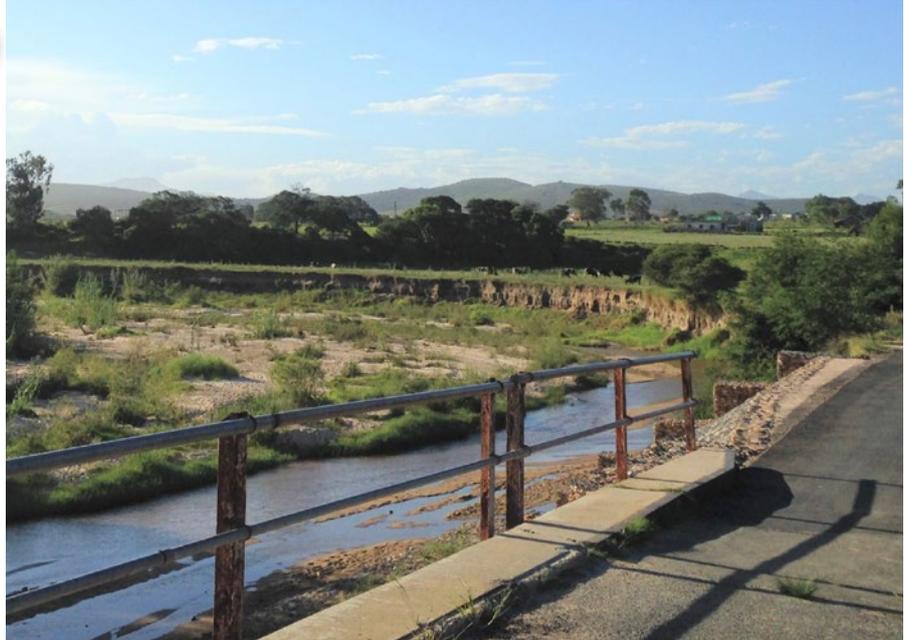
1 This 2016 image shows how alien vegetation (on the left bank in the image of the Brandwacht River near Mossel Bay) was largely responsible for driving the river into the opposite bank (to the right in the image). The public road (which may also have contributed to changes in flow) was in serious danger of being washed away by the next flood. The use of groynes was decided on to address this erosion.

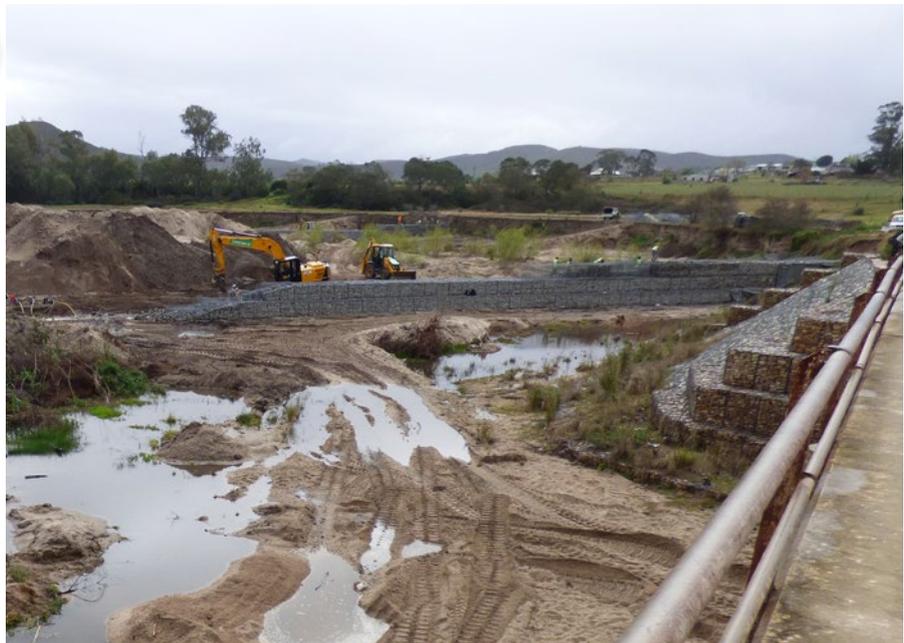
2 The rehabilitation solution being implemented: The extent of construction damage while implementing these projects can be disturbing, and calls for careful planning and strict environmental controls.

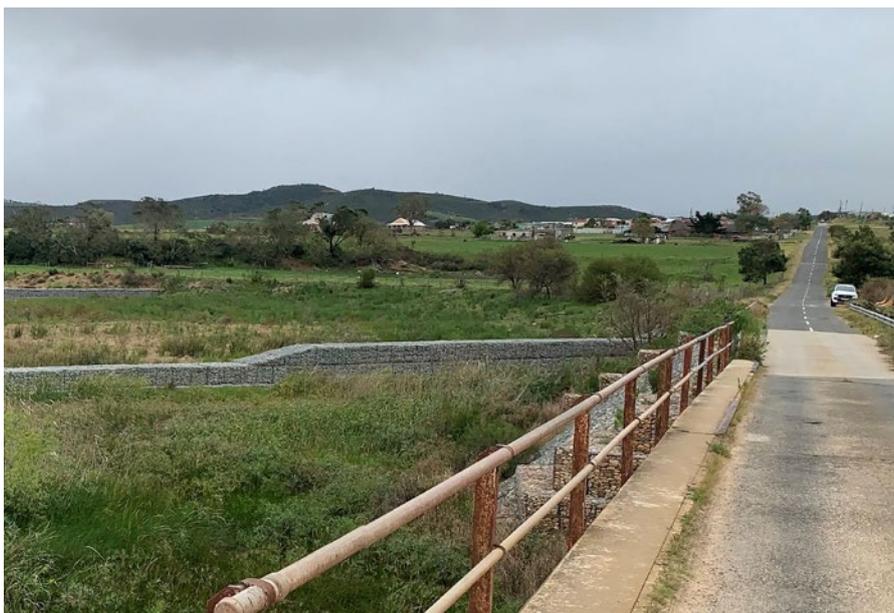
3 Post rehabilitation, the groyne structures guide the fast flowing water in the channel towards the bridge (which crosses the river), while still allowing floods to occupy the full floodplain.

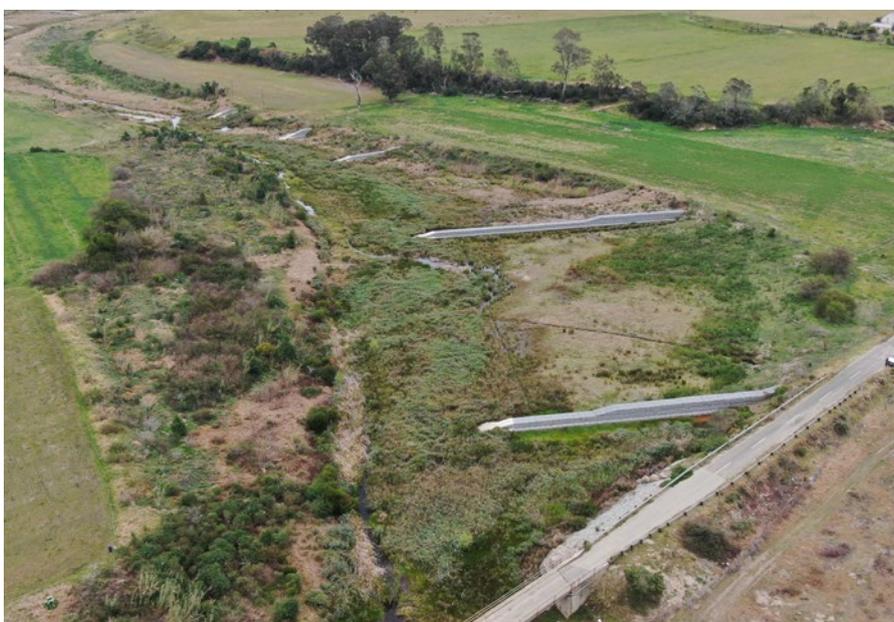
4 A field of groyne structures successfully guiding the river to the bridge and preventing migration of the channel and further erosion.

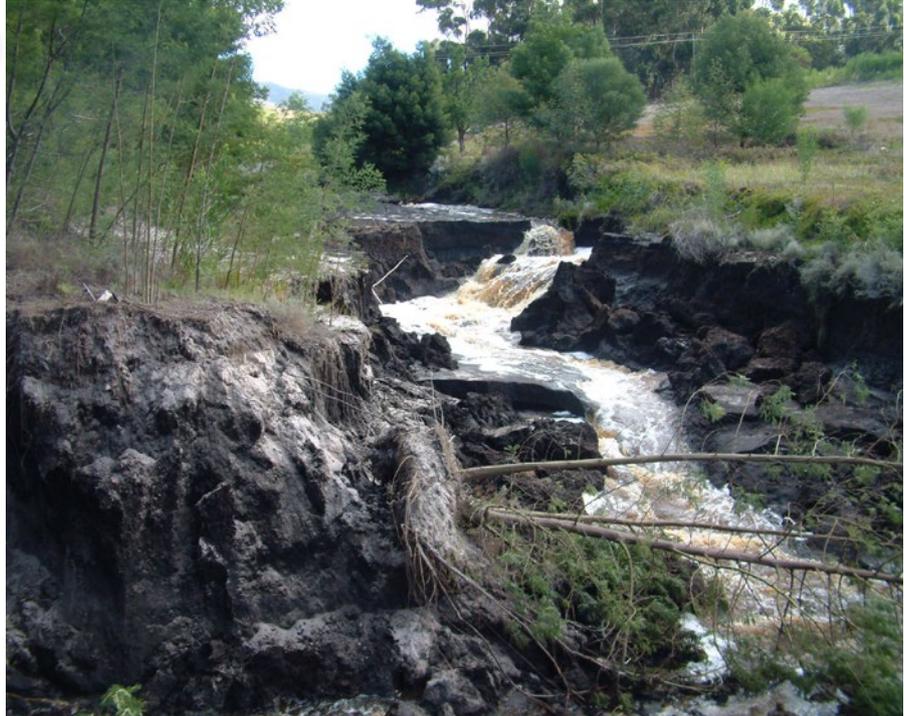
1

The erosion started in 2003 when a small dam downstream of the wetland collapsed. No funding was available at that time to repair the damage, and it was not foreseen that the gully would spread so quickly (600 m in 9 years).

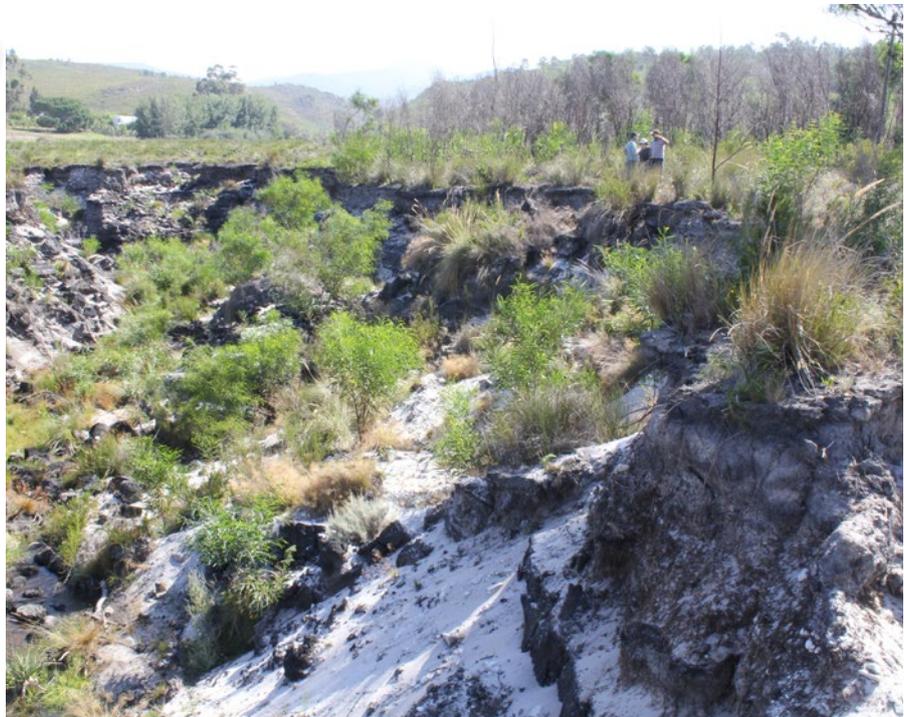
2

The top of the gully in 2011 – it was still to extend by 100 m before construction could begin. Just before construction began, the gully was 600 m long and 13 m deep at the deepest point. Water passing down the gully fell 21 m in total.

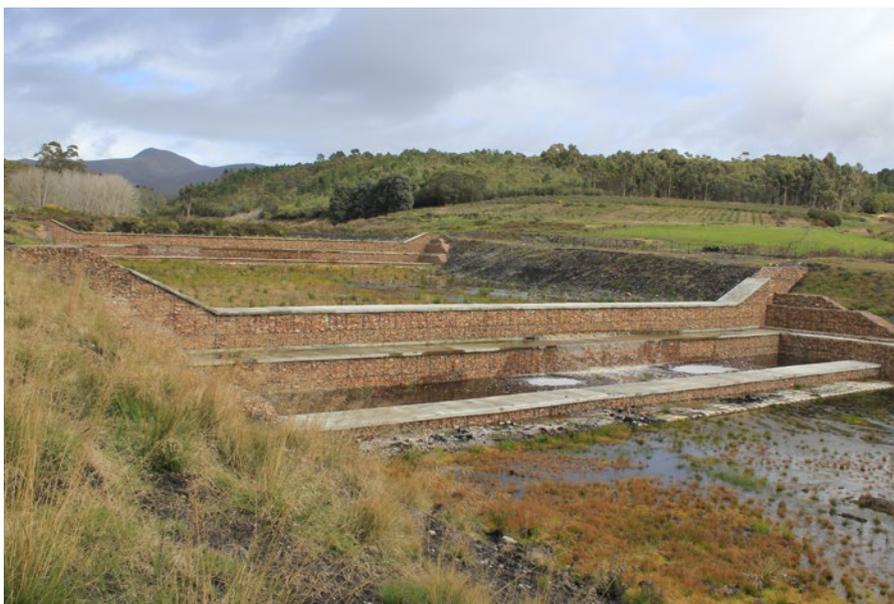
3

The same area in 2017, one year after construction. The channel width and slope was designed to be non-eroding during the 1:50 year flood. The sides of the gully had to be collapsed to create a side slope suitable for revegetation.

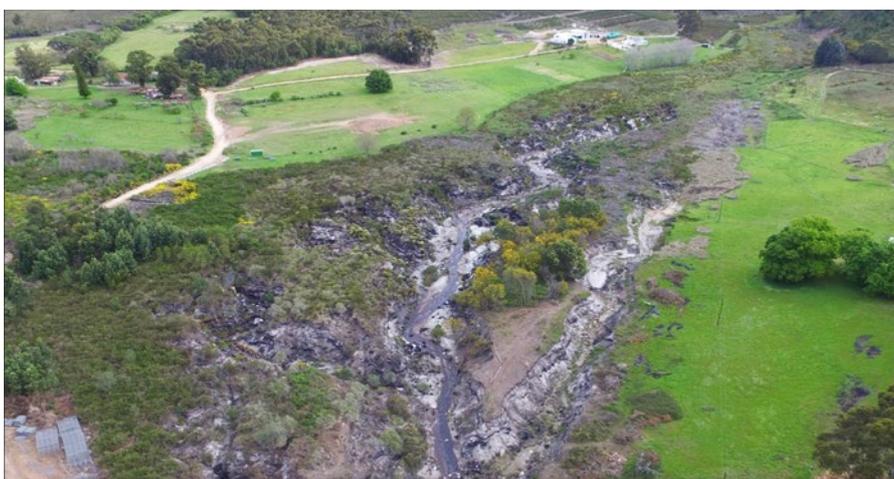
2015

BEFORE INTERVENTION

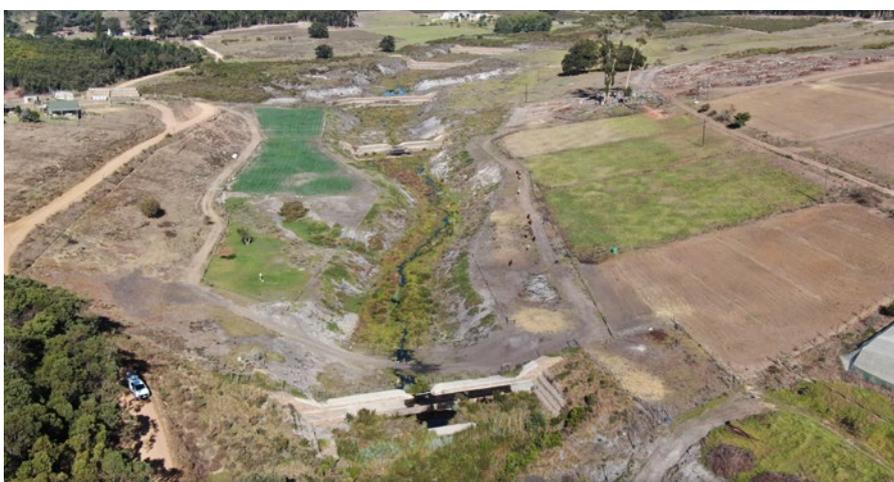
2017

AFTER INTERVENTION – The ecosystem is permanently altered but stabilised

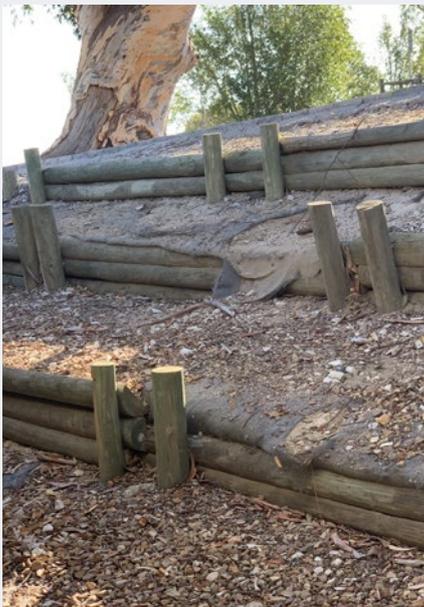
The logging of unstable slopes can be a means of flattening the slope so that vegetation may be established.

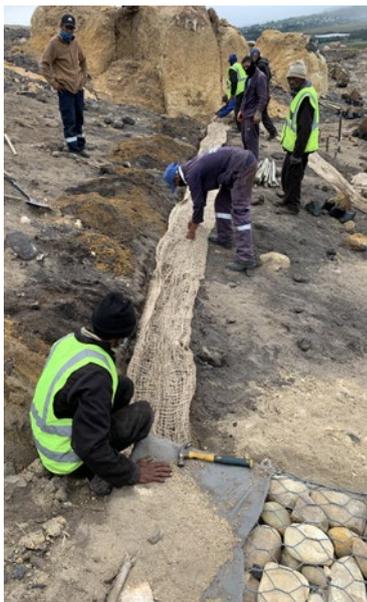
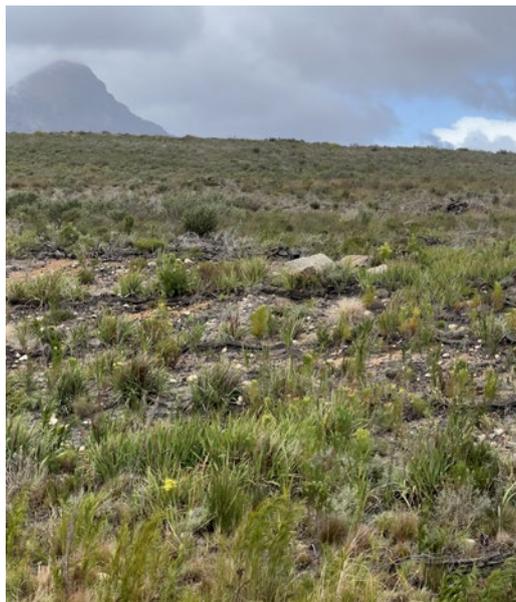
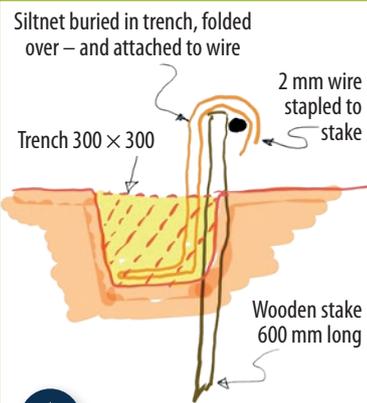
Placing silt nets on the contour can prevent the formation of rills while vegetation gets a chance to get established. The left image shows the silt net being installed 'on the contour' (with a good portion of the net buried to prevent failure by tunnelling – see image above), the image to the right shows the same slope 2 years later.

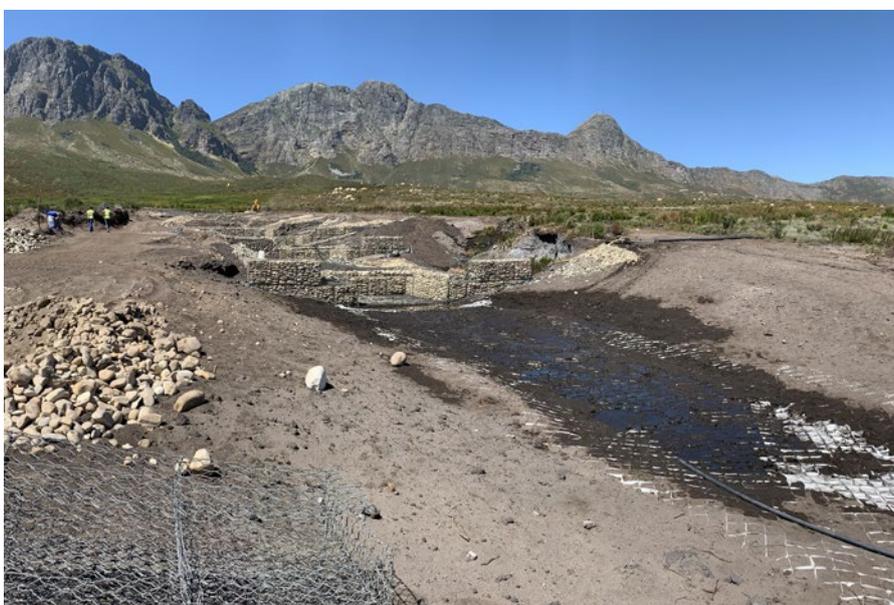
A landscaped channel in soft and disturbed peat soil lined with a geo-web during construction, filled with gravel (upper left image). This was planted with indigenous wetland plants and two years later, despite several severe storms, was looking very stable. The cost of this operation was about a tenth of the cost of an additional weir, which would have been an alternative engineered structural solution to the problem.

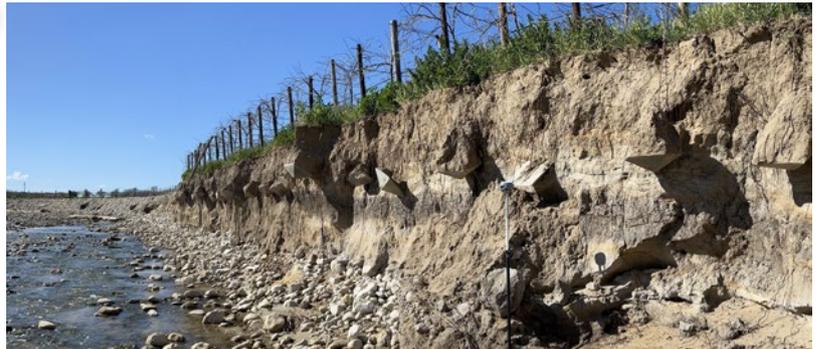
Alien vegetation grows tall quickly and out-competes indigenous wetland vegetation for sunlight – so displacing the indigenous vegetation. Changing the indigenous vegetation in favour of alien plant growth may result in river blockages, erosion and high costs to repair the damage.

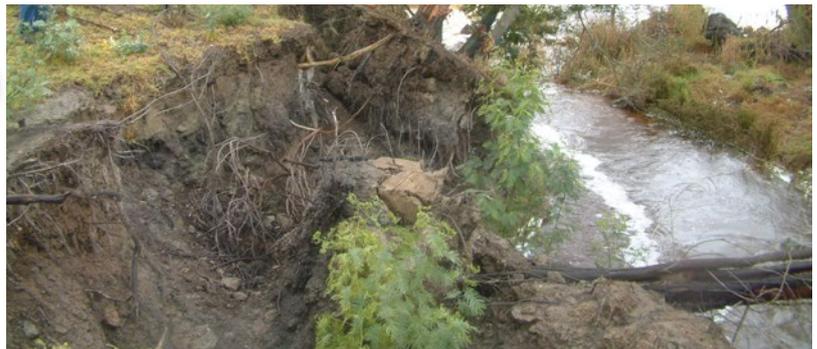
Do not remove indigenous wetland and riparian vegetation – apart from legal consequences, you will find that without the vegetation the river becomes unstable and will cost you money to fix.

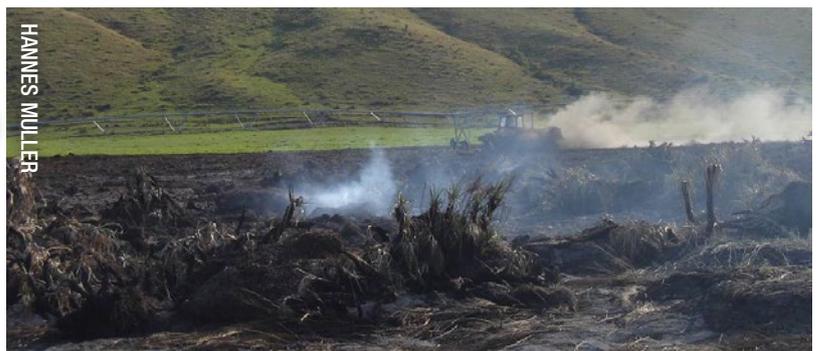
Bulldozing a river 'open' may give you short term relief from flooding, but the loosened sediment will be washed downstream where it will cause the erosion of your neighbour's river banks when it forms plugs in the river. Bulldozing the river also creates an ideal habitat for woody alien vegetation to get established – and this may cause river erosion problems.

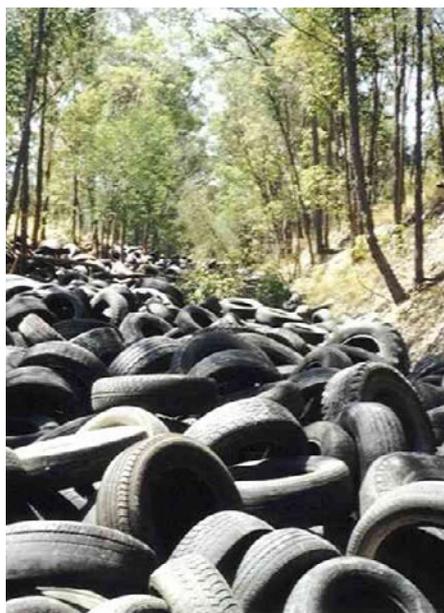
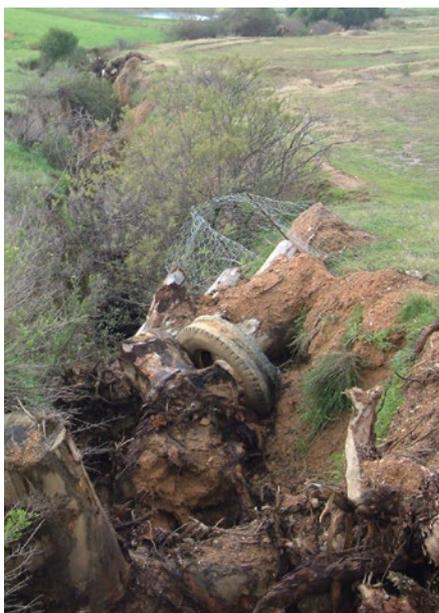
Filling a gully with old car tyres or old tree stumps may make you feel that you have addressed the problem of erosion. You have not! Water flows around the tyres and will widen the gully. Also, the tyres and stumps may well wash downstream in a large flood, and cause further damage, as well as degrade into undesirable by-products that remain in the environment for a long time.

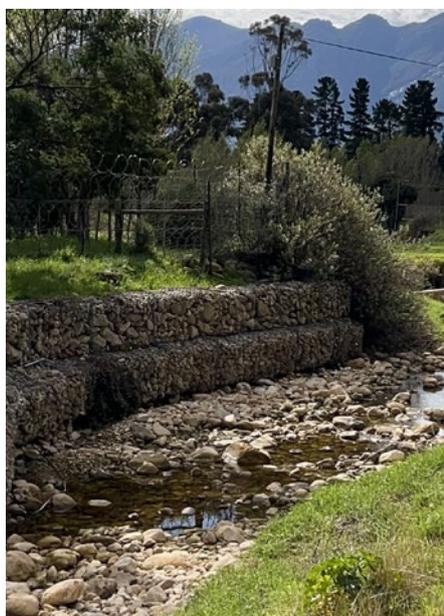
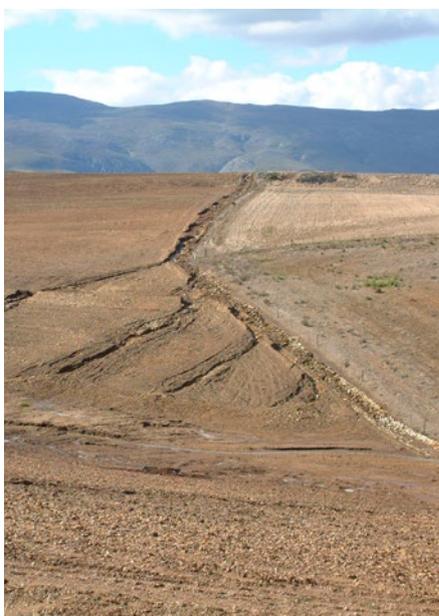
When you need to manage erosion, whether with a structure such as a gabion retaining wall or a groyne, or just by clearing the channel of debris and landscaping in terms of a Management and Maintenance Program (MMP), you are well advised to get the opinion of someone with appropriate experience. The gabion wall (on the far left) has been undermined and will result in further erosion. The stormwater channel (to the left) has been poorly located and is causing erosion. Both of these need further expensive rehabilitation.

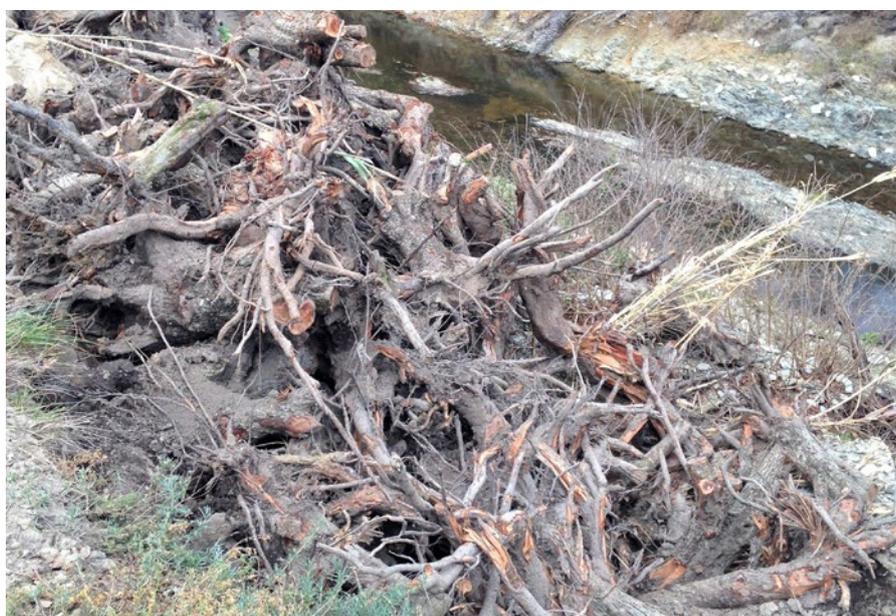
Dumping orchard cuttings on a river bank will not solve erosion problems, because during a big flood they will wash away. When that happens, they will become someone else's problem, causing a blockage in the river, and more erosion. Rather consider planting the bank with indigenous vegetation that will slow down flows, bind soils and trap sediment. You can also secure commercially available 'coir-logs' to a terraced bank and plant between these.
