Water Research Commission Rainwater Harvesting Workshop

21 November 2013

Rainwater harvesting at Kharkams in the Northern Cape

Kharkams High School wanted to optimise their rainwater harvesting and storage:

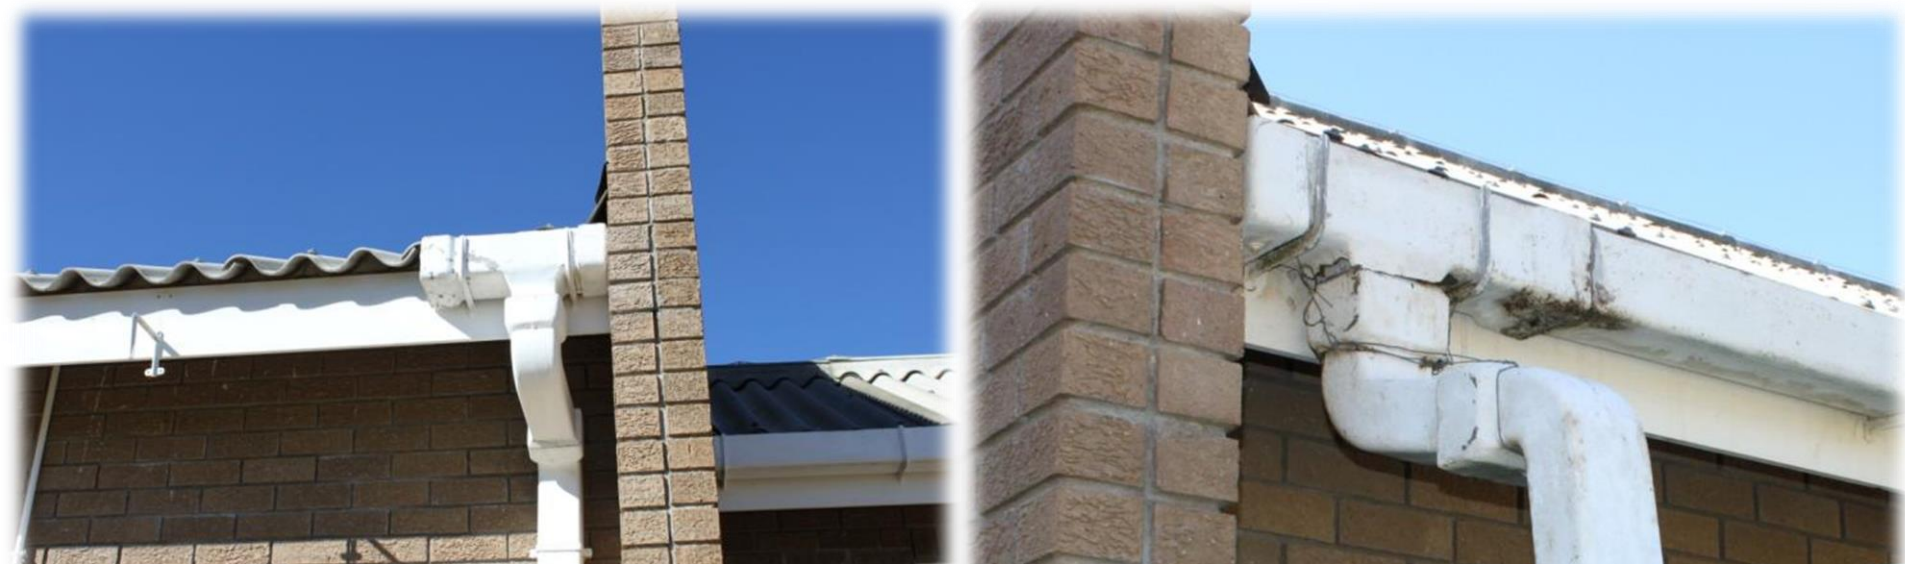
Gutters and downspouts

- Asbestos
 - Some in bad condition
 - Need to be replaced over time
- Urgent repairs, replacement and maintenance needed

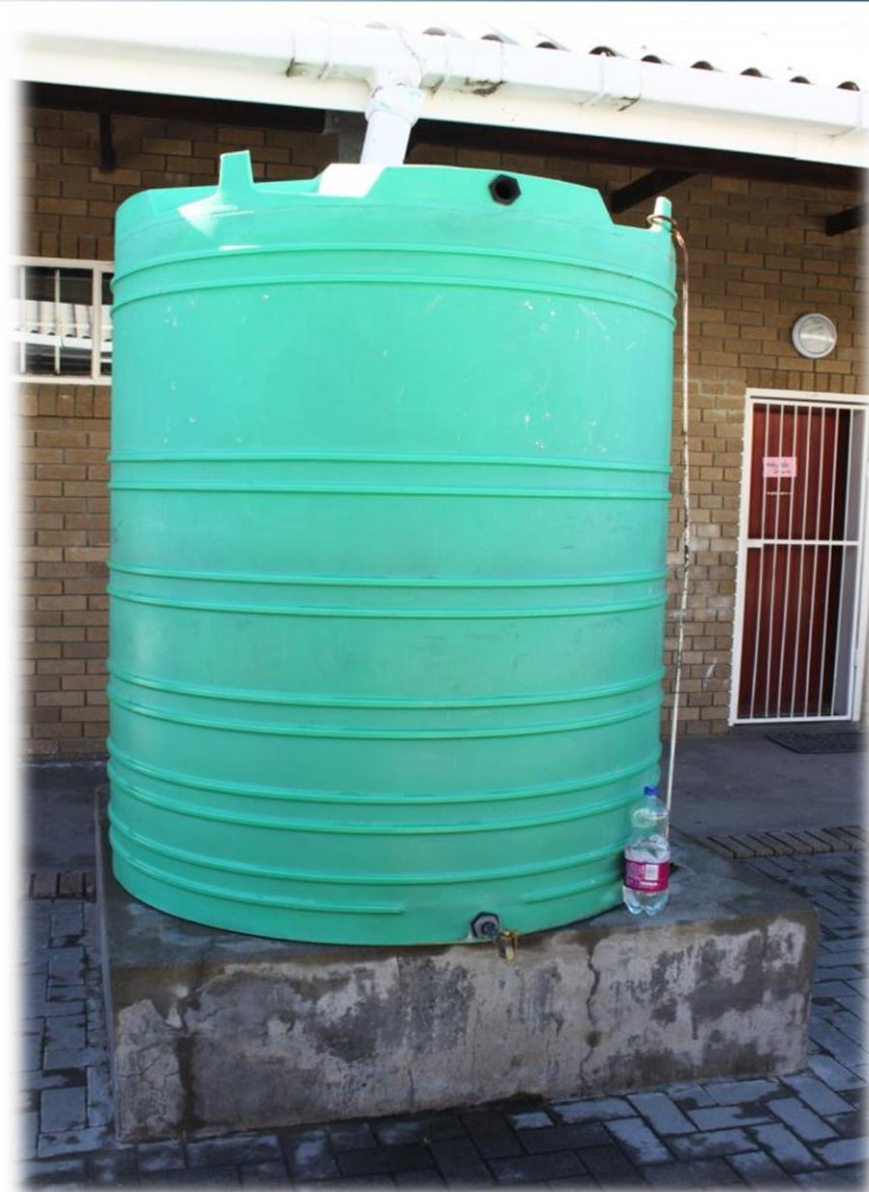
Storage tanks

- 8 storage tanks
 - 4 x 5 000 litres
 - 4 x 2 500 litres
- Average condition
- Tap connections leaking
- Some repairs needed

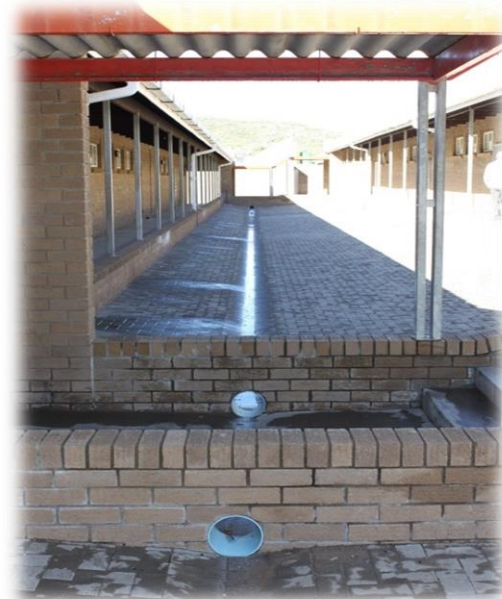
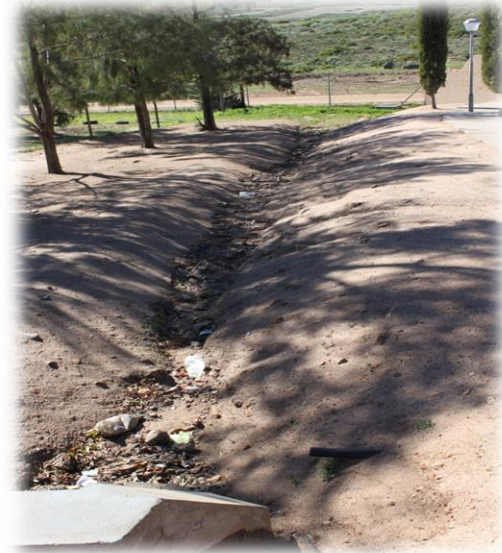
Storm water drainage

- Cement gulleys, gutters and pipes
 - Good condition
 - No urgent repairs needed on drainage system
- Spillways
 - Urgent attention needed to prevent further erosion

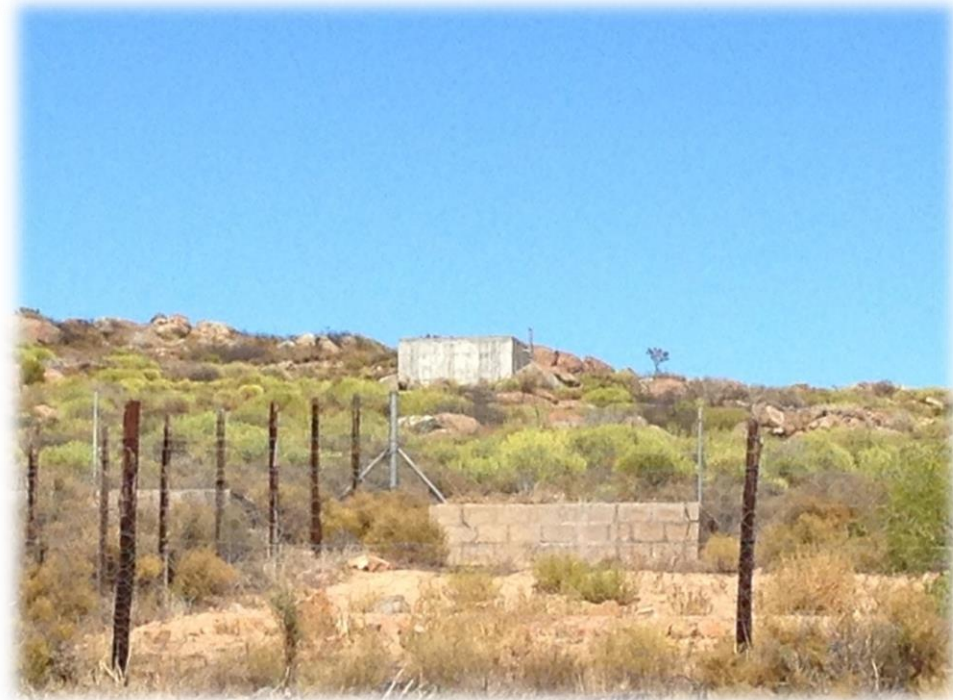
Header tank/reservoir and irrigation

- Cement reservoir/header tank
 - Bad condition
 - Serious repairs necessary

- Irrigation system
 - Seemed in good condition

No water to test

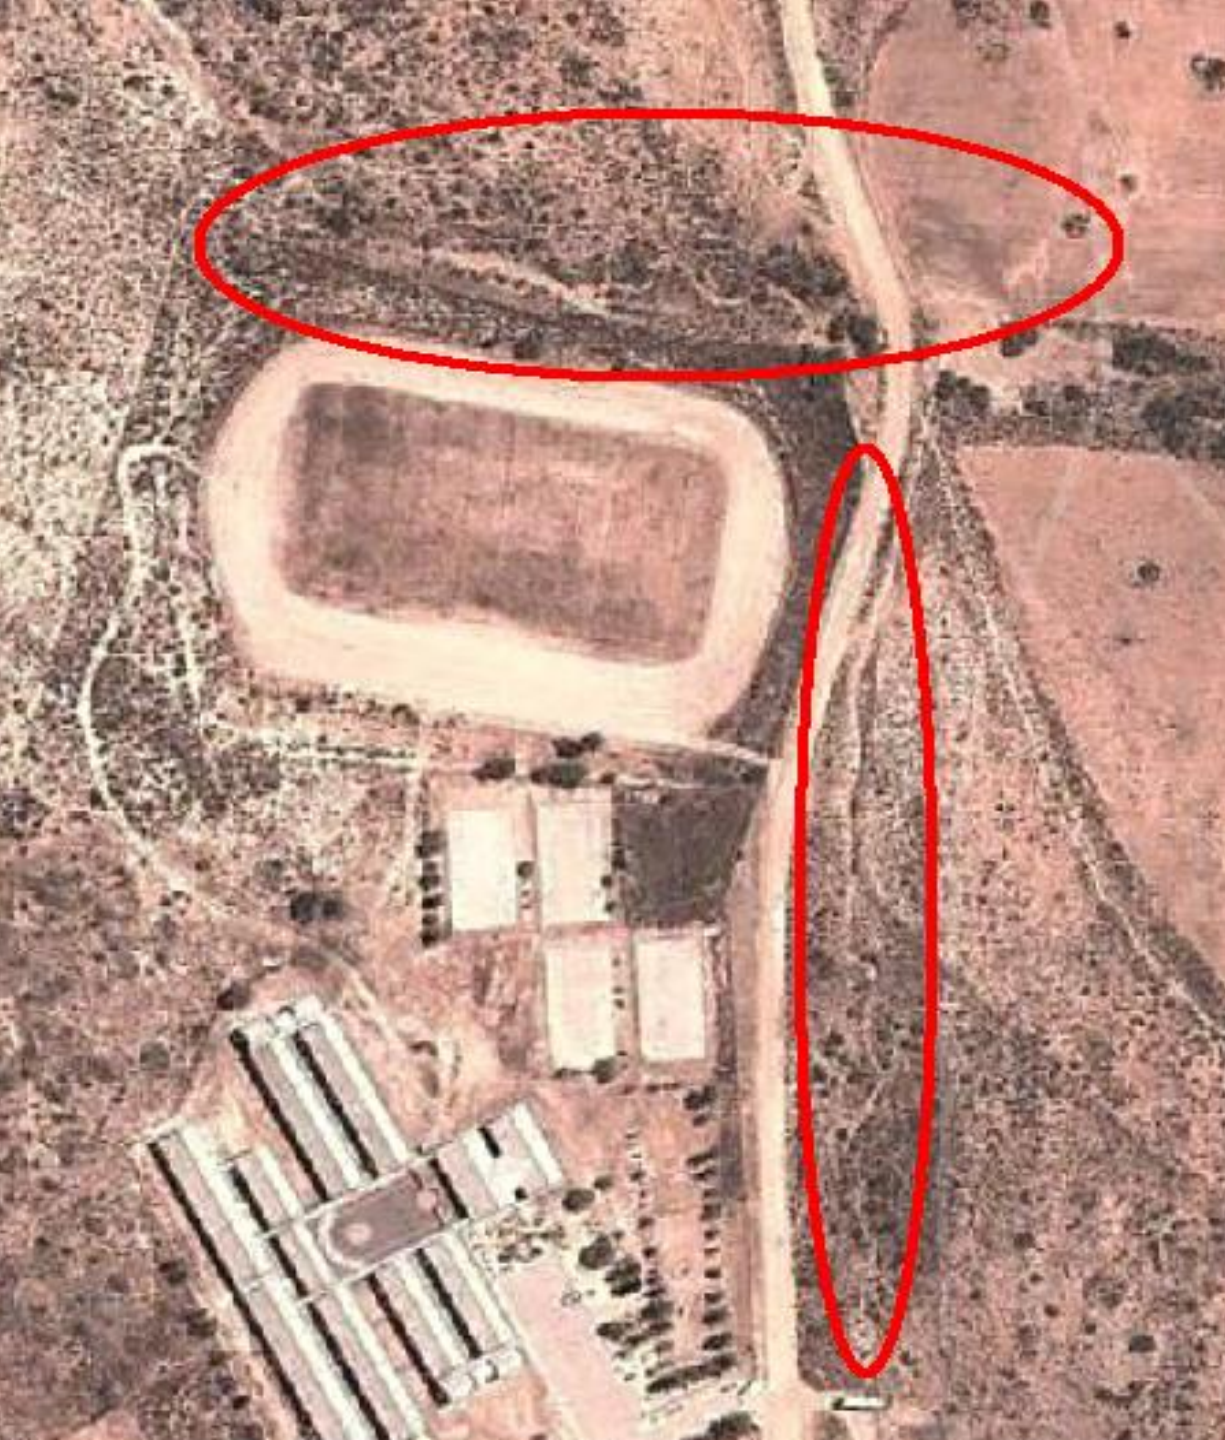
Two possible
locations for a
constructed
wetland,
depending on
EIA

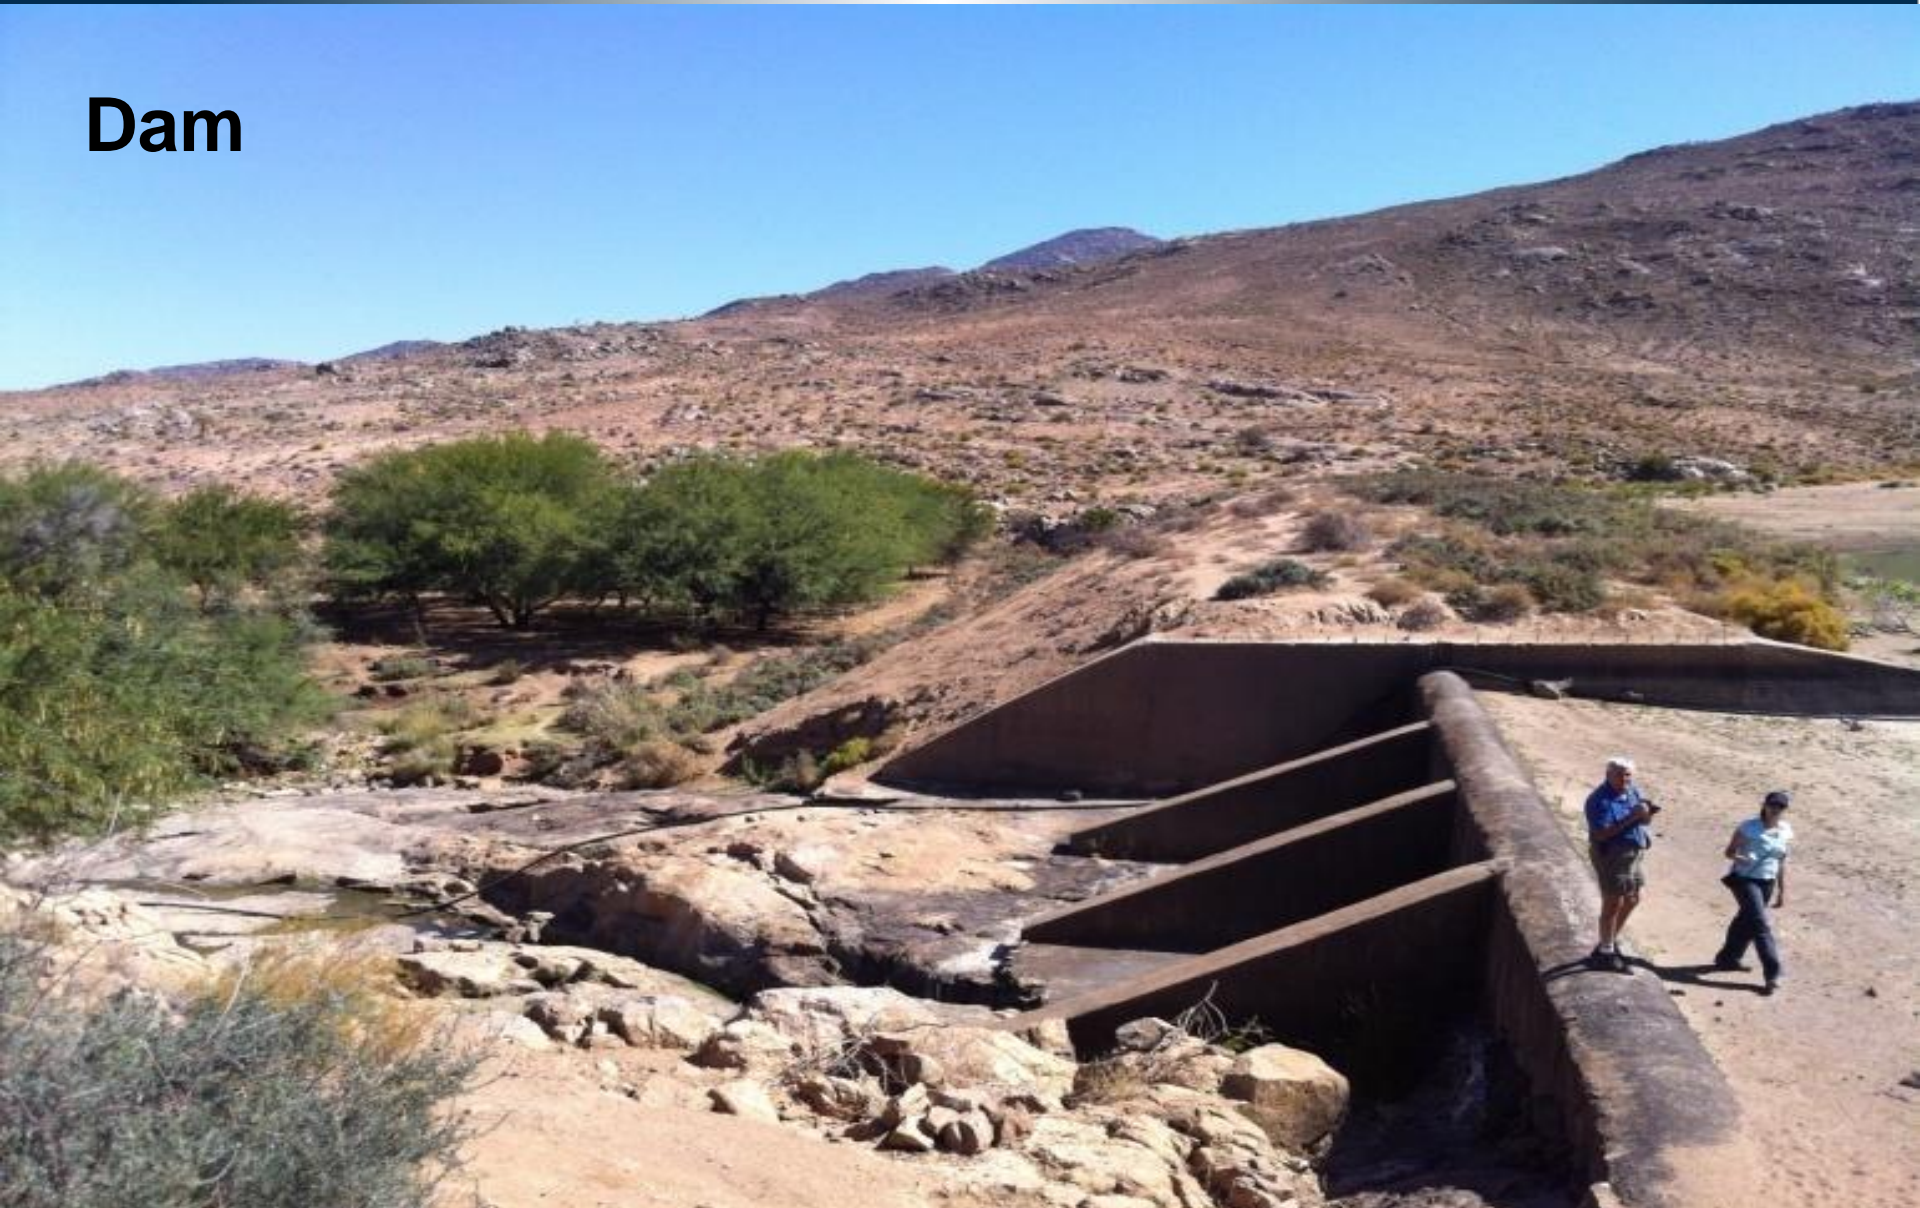
Dam

- Evaporation rates very high
- Mineral concentrations
- Flash flood damages
- Extreme silting
- High capital costs
- Operation and maintenance costly
