ST LUCIA

2001 to 2012: A decade of drought

**Management interventions and what
we have learnt about the ecosystem**

WRC Report No. TT 576/13

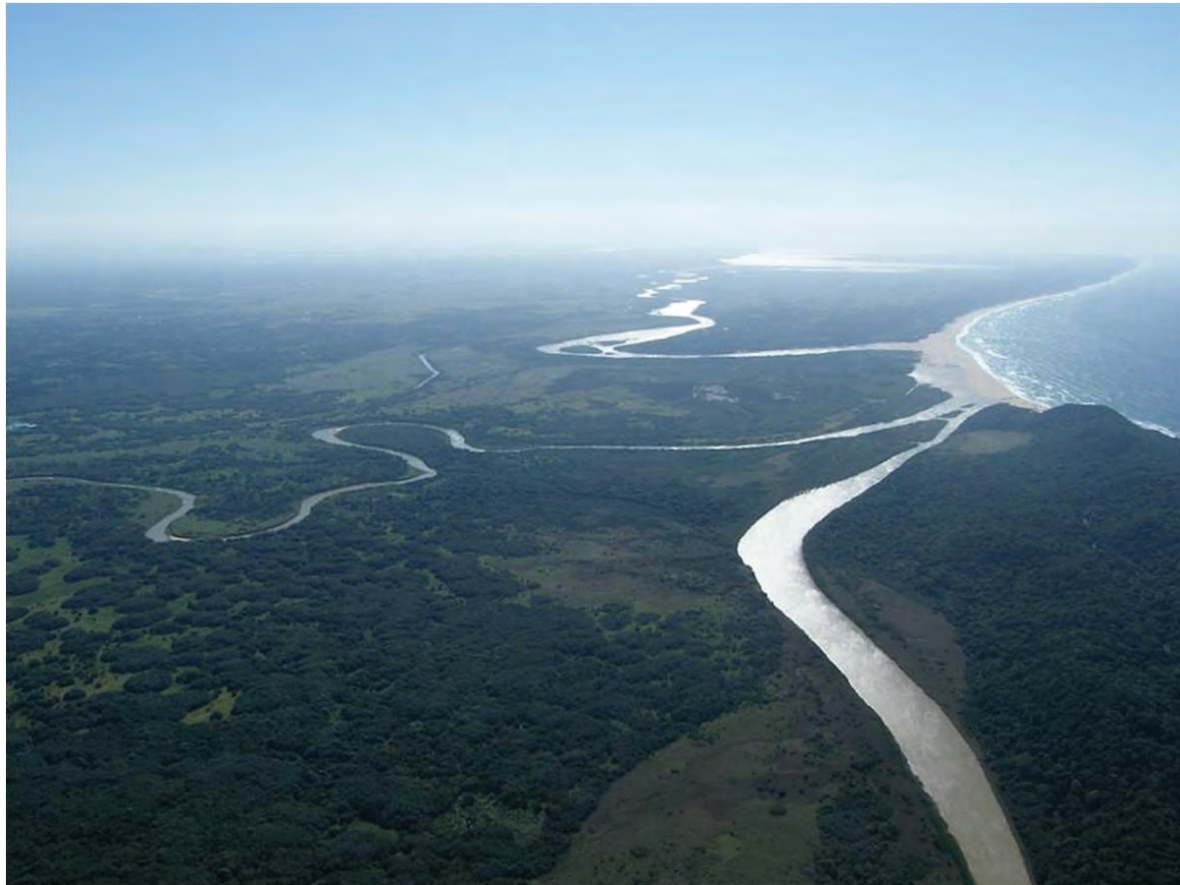
Figure 1. The Mfolozi and St Lucia mouths – a focus area for management. This photograph shows the confluence of the Msunduzi (bottom right) and the Mfolozi Rivers (centre) which then enter the sea as the Mfolozi Mouth. To the north (top of photograph) is the St Lucia system. Prior to 1950 the Mfolozi flowed into St Lucia at times of drought.

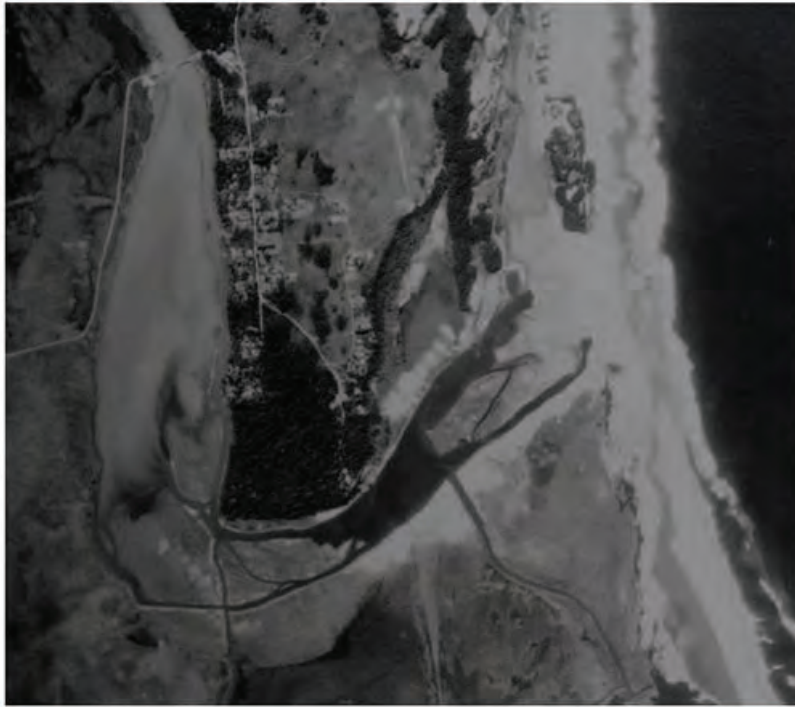
June 1960

13 years of
dredging
needed to
clear
sediments
from the 1951
closure

Figure 2. Aerial photograph of the St Lucia mouth taken in 1960 showing the extent of the dredge operations that had started in the mid-1950s. It also shows the extent of the remaining sediments.

The concern about sediments dates back to the huge sediment deposits that occurred in the lower portions of the Narrows and the combined St Lucia-Mfolozi bay in the drought of the 1940s to the early 1950s. The dredging of St Lucia was initiated to remove these sediment deposits (Figure 2). Knowledge of sediments is still sparse, and little is still known about how much sediment transported by the Mfolozi will enter St Lucia with the linking of the two systems.

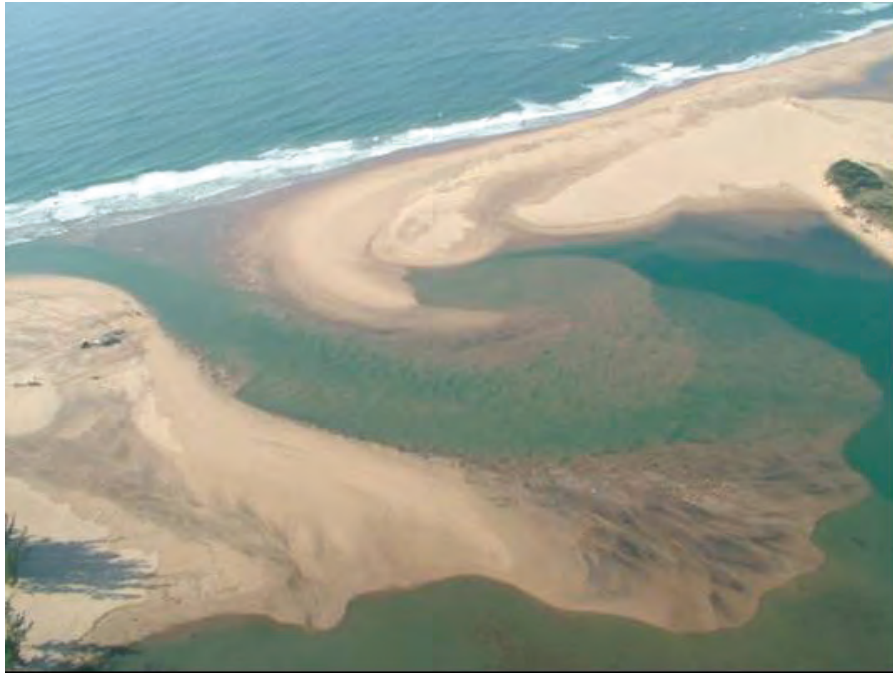
Figure 3. A flood-tidal delta formed by sand brought into the St Lucia system by marine tidal inflows. If the movements of water through the mouth are dominated by river flows in addition to the out-flowing of tides, then this delta does not develop much and the mouth stays open. The sediment trap concept is to trap this sand so that it does not penetrate beyond the inner edge of this delta. (2 August 2007, R Taylor).

Instead of having hard structures to stabilise the mouth, the advice of Van Heerden and Swart (1986) was to dredge a sediment trap at the inland edge of the flood-tidal delta. Its purpose would be to catch marine sediments as they entered the system, and pump these sediments into the sea north of the mouth. By doing so the mouth would be more stable and less likely to drift northwards. This action would also delay the closure of the mouth at the onset of a drought. This removal of sediment in some ways mimics the losses that would have occurred with the natural river flushing processes had the Mfolozi been joined to St Lucia in a combined mouth. This strategy proved to be an effective way to manage the mouth. It did not entirely stop mouth closures and it was accepted that the mouth would still close in droughts. After closure it was accepted that the mouth could remain closed for up to 18 months at a time.

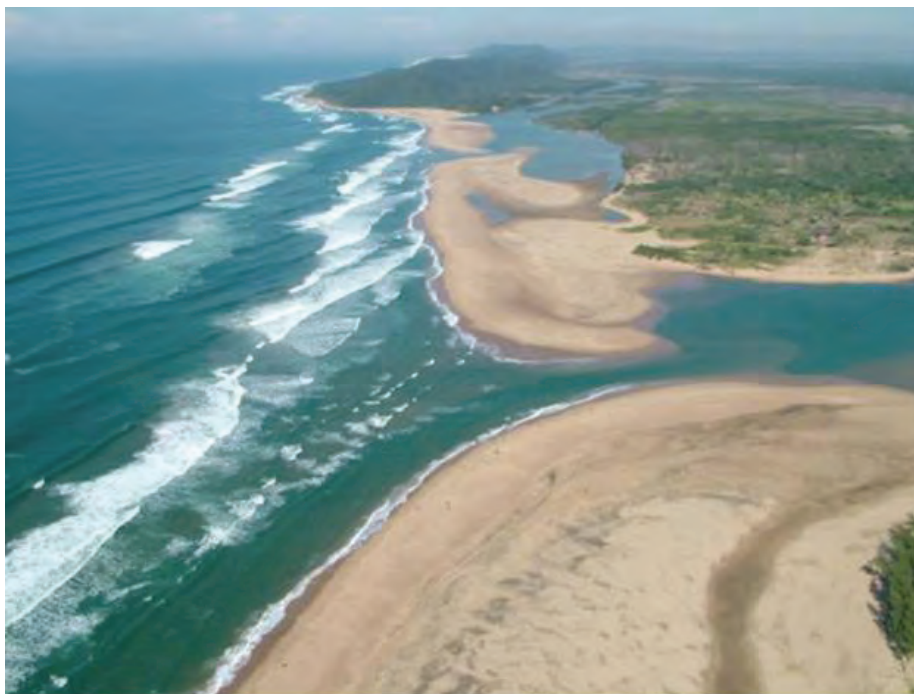
Figure 4. The ebb-tidal delta which forms a fan of sediment in the marine wave zone. The slowing of the waves in the shallow water over this delta is evident here as the curved wave pattern in front of the mouth. Note also the spits coming into the estuary on both the north and south banks of the estuary (2 August 2007, R Taylor).

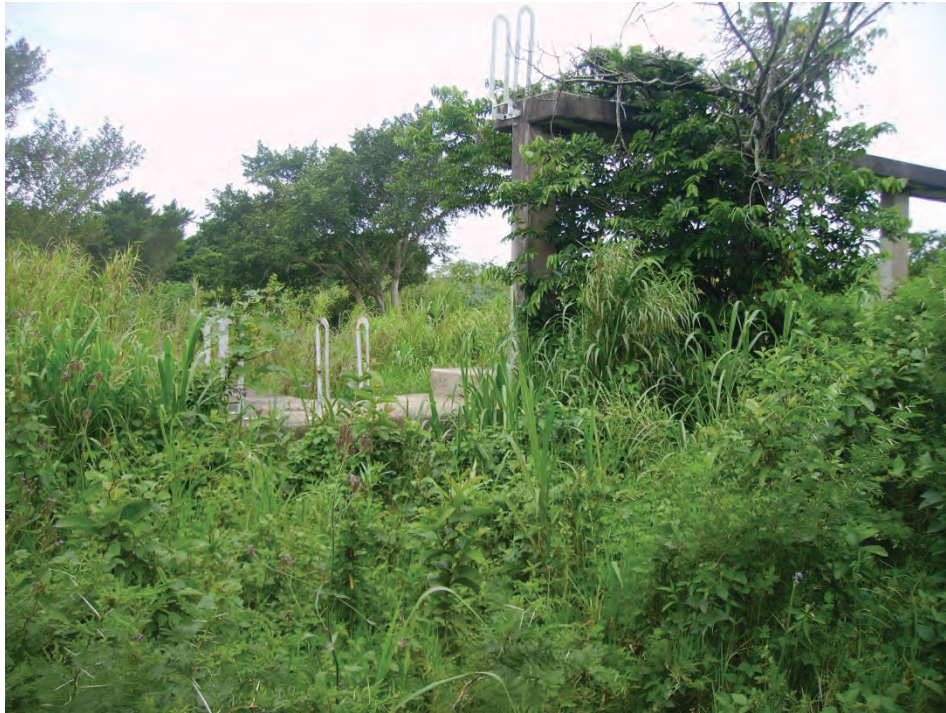
Figure 5. The superstructure for the flood protection gates at the Intake Works at the start of the Link Canal (November 2006, R. Taylor).

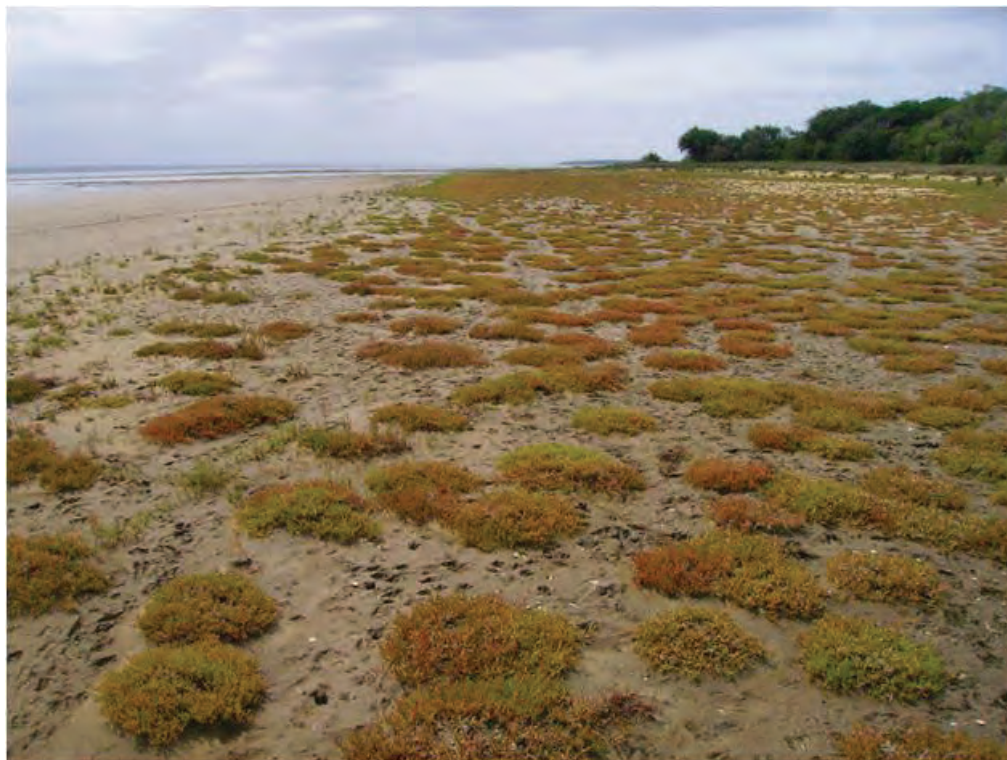
Figure 6. Succulent salt-marsh at Charters Creek. The abundant growth is a rapid response of the plants to colonise the vacant habitat which is available as the lake level recedes.

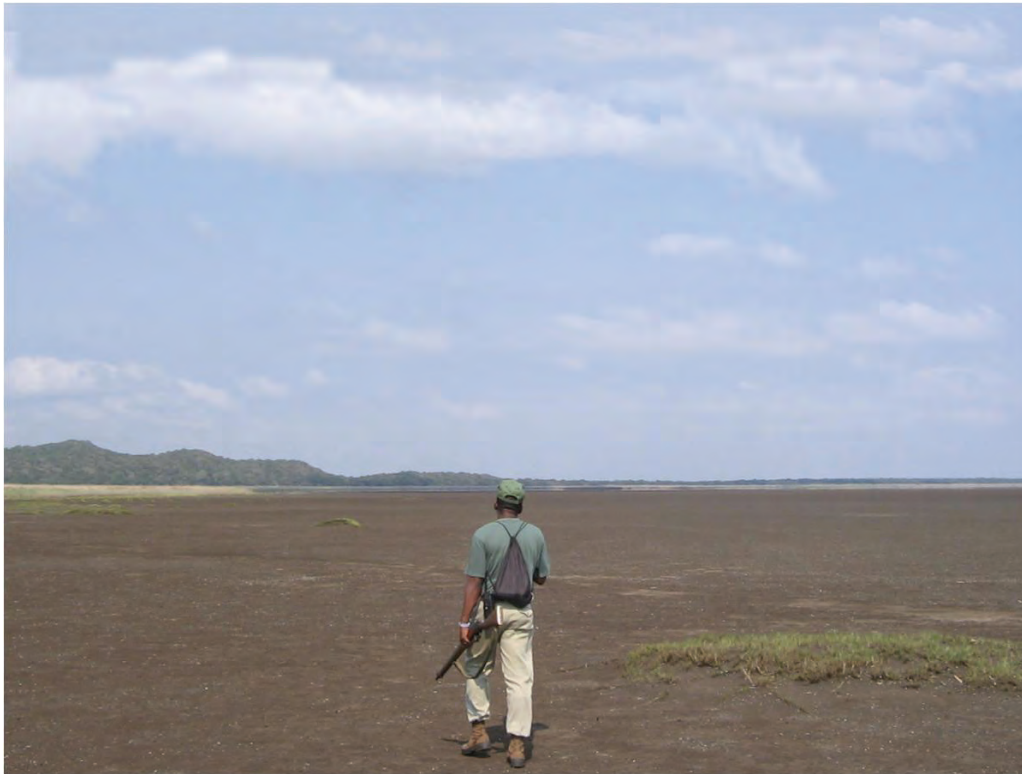
Figure 7. At the peak of the drought the whole of the North Lake dried up. A field ranger walks across the dry lake bed in the Selley's Lakes area. (Photo C Dickson).

One of the most spectacular features of the 2002 to 2012 drought was the drying up of large portions of the lake basin. At its most extreme about 80% of the system was dry. From the start it was appreciated that by leaving the mouth closed the water level would drop and result in a reduction in the lake surface area. But, without the addition of freshwater to replace water lost to evaporation there is a loss in water volume. If the mouth is closed then the water level drops or if the mouth is open, the water lost is replaced with sea water. If it is replaced with sea water then the quantity of salt that enters the system will build up and may take years to flush out at the end of the drought. Both scenarios lead to extreme ecological conditions. For this drought the management option was to keep the mouth closed.

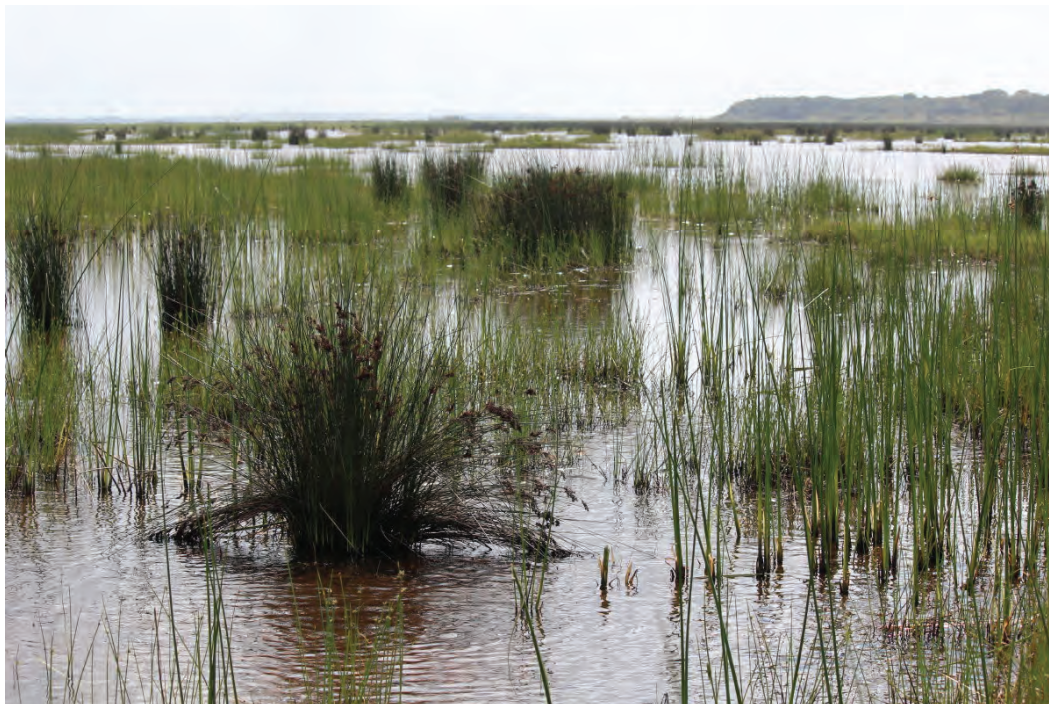
Figure 10. Emergent vegetation in the Brodies Shallows area.

colonise. Where it has colonised it now is growing as an emergent species along the flooded lake margins where it can withstand flooding by low salinity water (Figure 10).

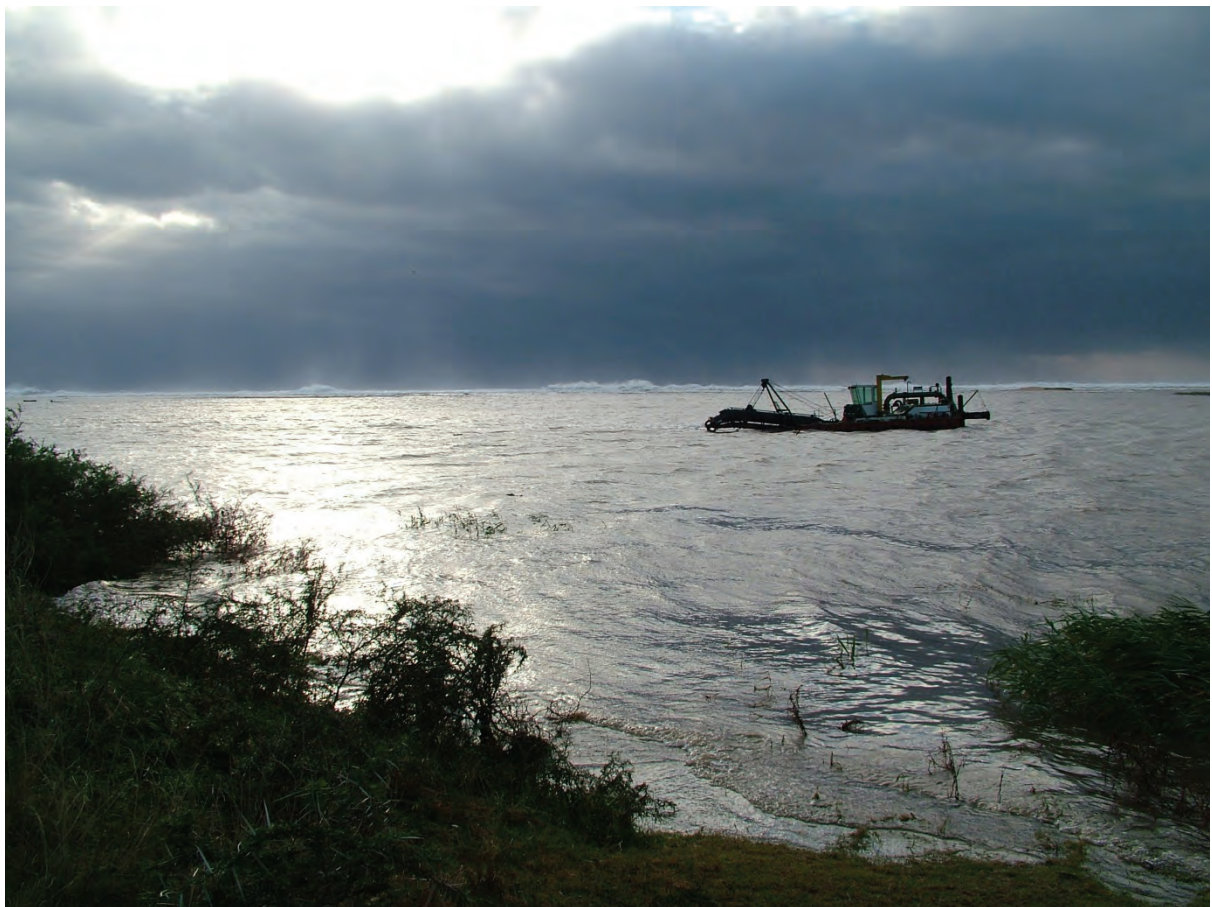
Figure 16. Rough seas coming into the newly-breached St Lucia Mouth on a particularly high tide.(19 March 2007, R. Taylor).

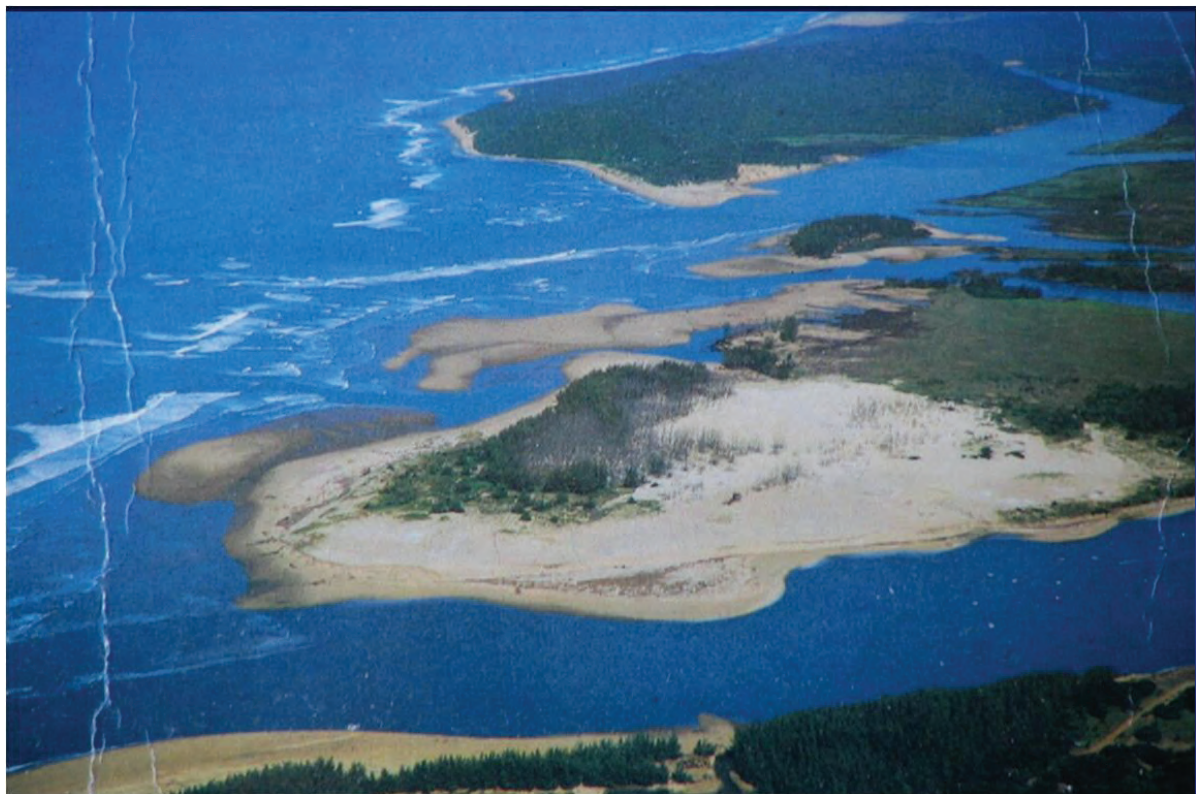
Figure 1. The mouth configuration changed dramatically during the floods of 1984 and 1987. This undated photograph (probably taken shortly after 1987) shows that much of the beach had been washed away. What is very evident is the pile of dredge spoil in the centre of the photograph – a legacy of the intensive dredging of sediments that occurred after the closure of the mouth in the 1950s. Photograph source unknown.

The drought of 1968 to 1972 left a deep impression on those who had experienced it. But it was the floods of 1984 and 1987 that made everybody realize that there is only a limited amount that managers can do to intervene to counter the extreme events that affect St Lucia. These floods scoured away the man-made structures and sediments from the mouth area (Figure 1).

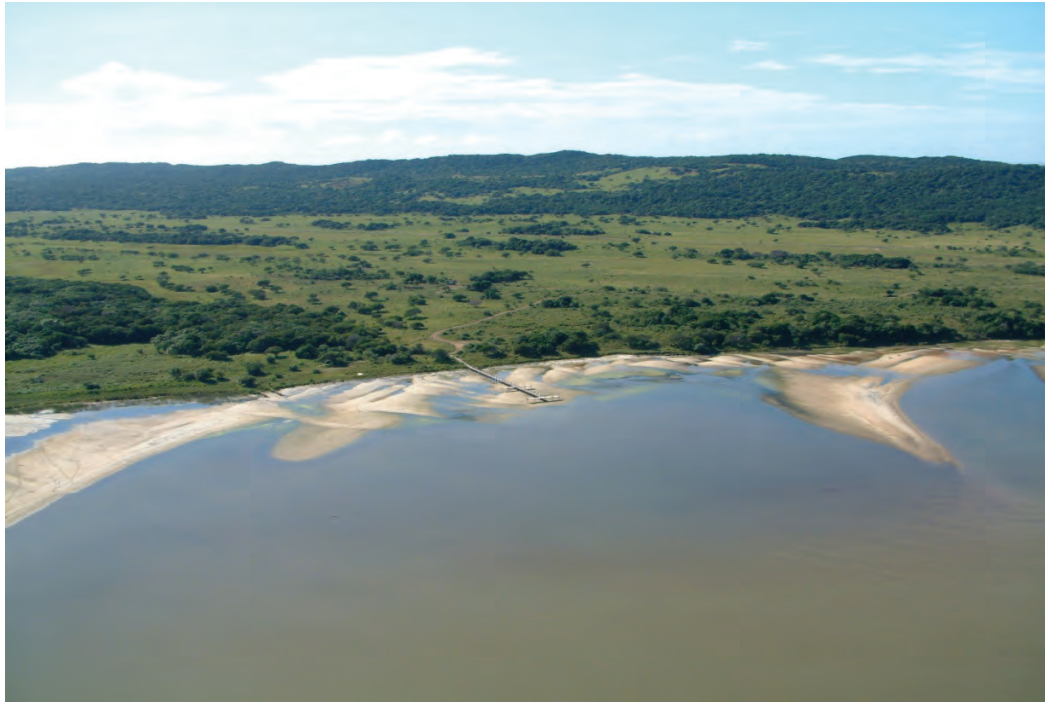
Figure 10. Photograph of Catalina jetty showing exposed sand bars (23 May 2003, R Taylor).

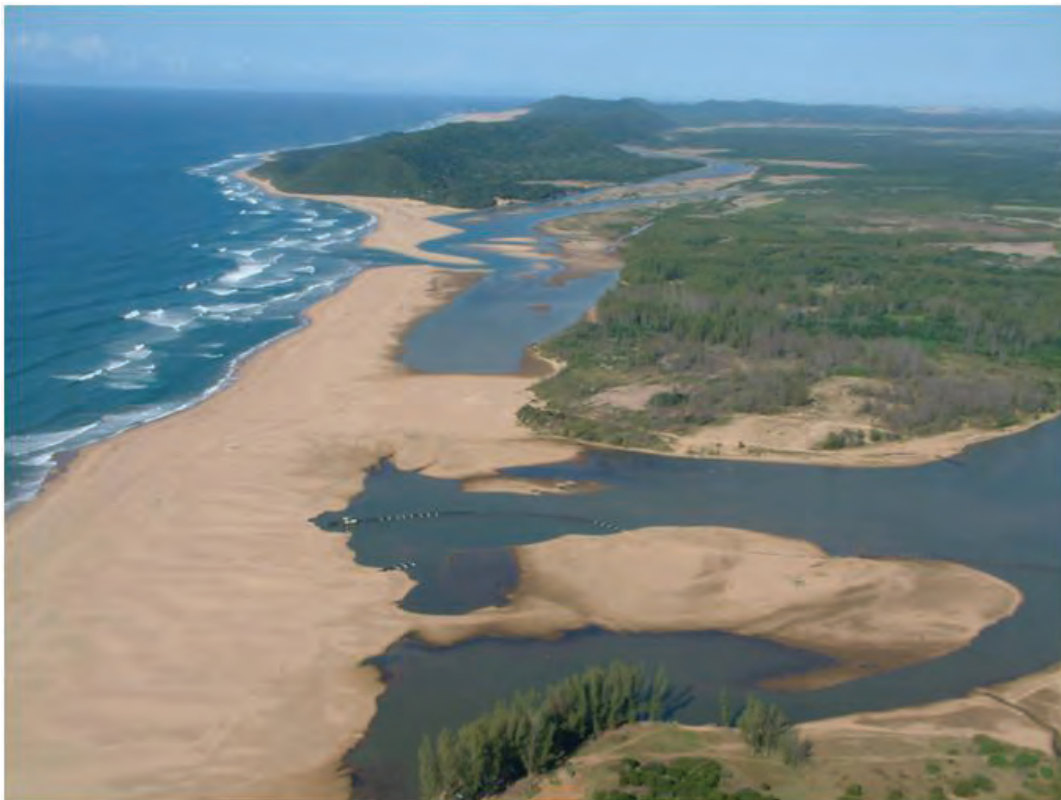
Figure 11. Configuration of the mouths in May 2003 showing the closed St Lucia Mouth in the foreground. The dredge was excavating the sediment basin at the time, pumping the spoil northwards.

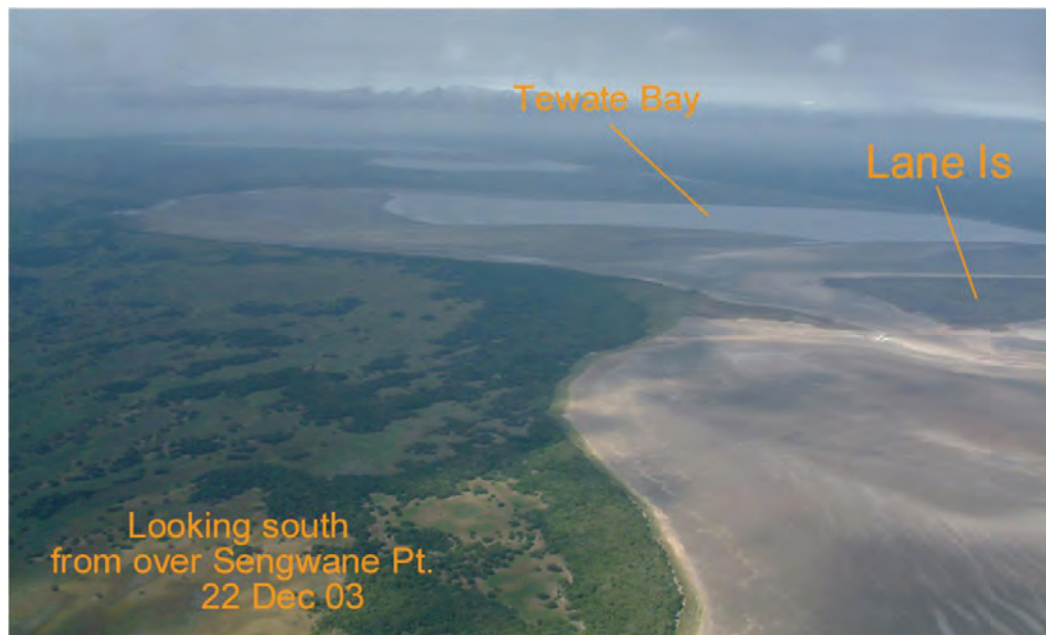
Figure 14. By December 2003 the water level had lowered to expose large areas of the lake bed. (Photo R Taylor).

Lake level had dropped to about 90 cm below sea level and large areas of the lake-bed were now exposed. The lake water surface had been reduced considerably (See Figures 14 to 17). About 75% of the lake bed was dry and exposed.

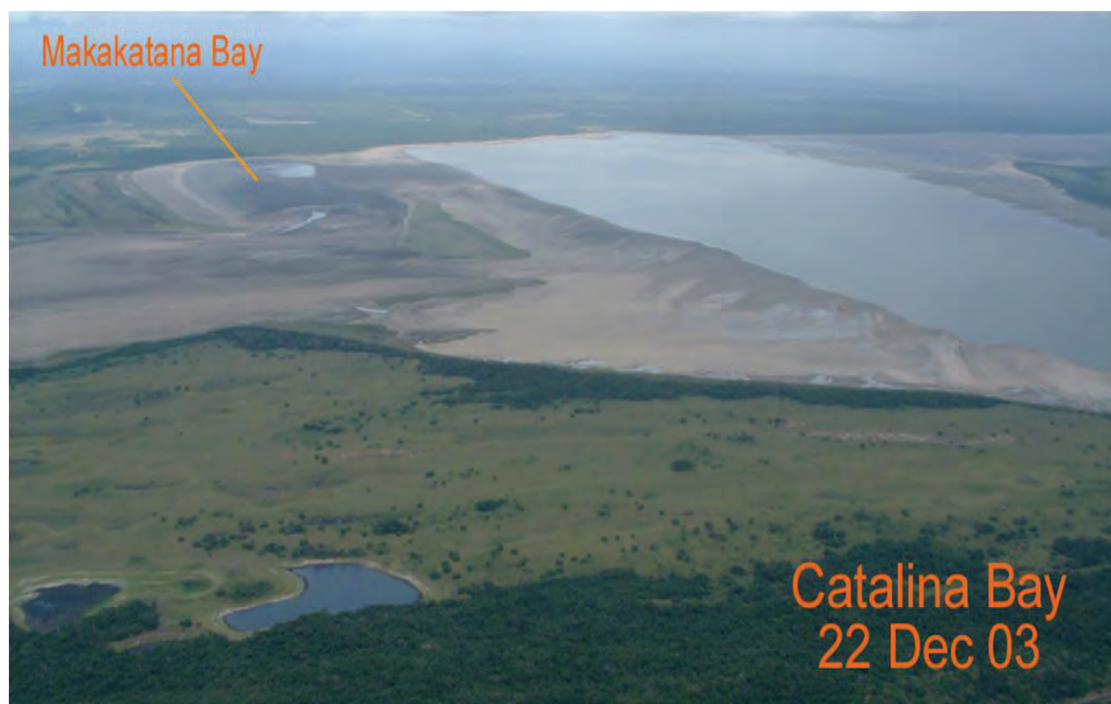
Figure 15. The small bay at Makakatana was virtually dry. (Photo R Taylor).

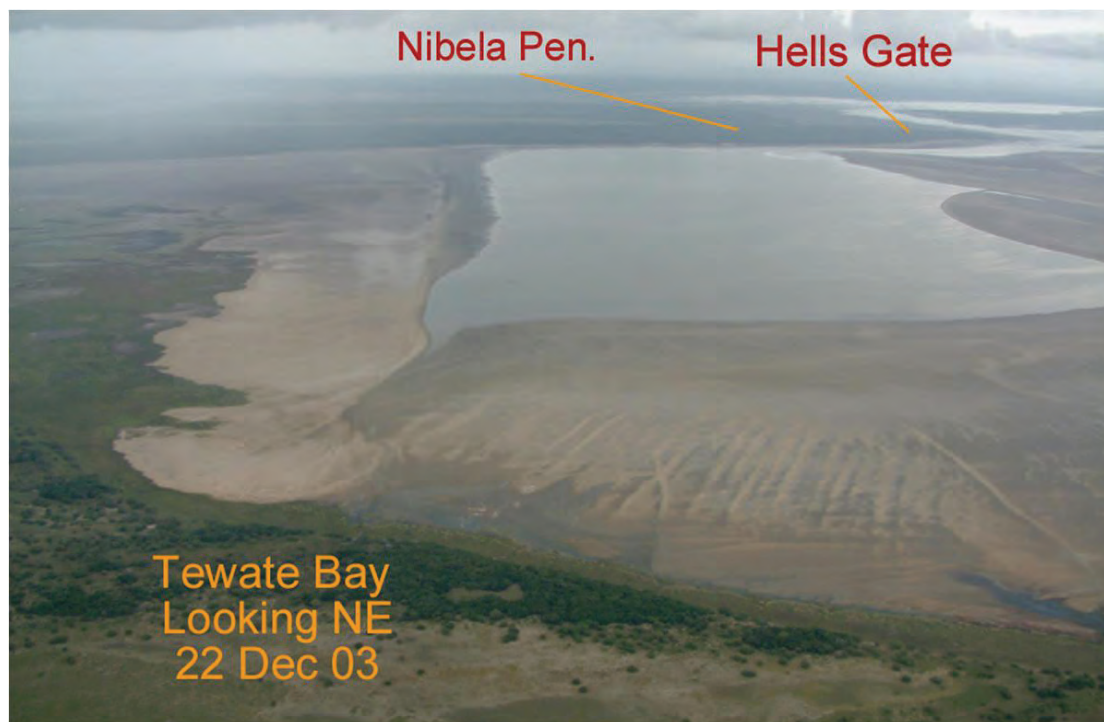
Figure 16. Water remained only in the deeper parts of Tewate Bay. (Photo R Taylor).

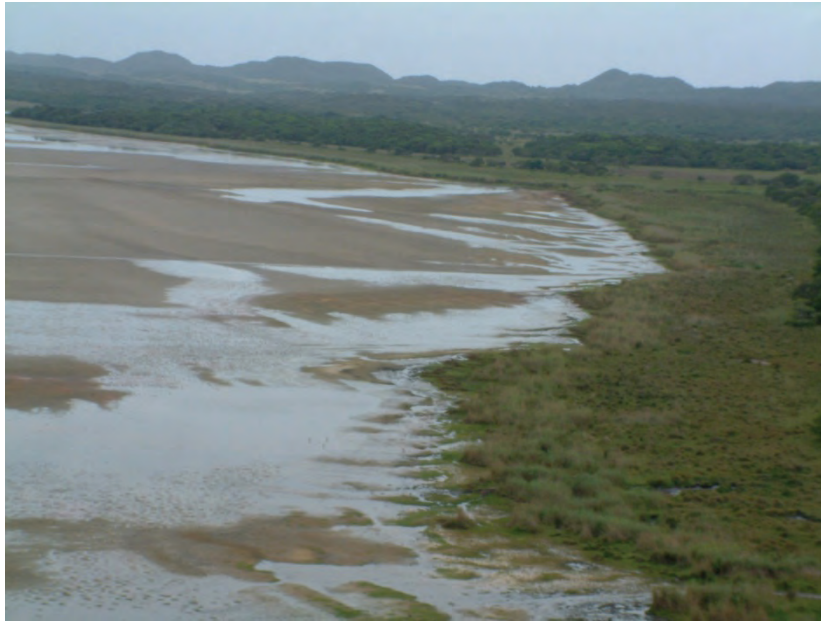
Figure 19. Seepage from shoreline groundwater south of Tewate Bay (27 October 2003, R Taylor).

There was a lot of shoreline seepage on the eastern shoreline south of Fanies Island to southern Brodies Shallows (see Figures 18, 19 and 20). The Nkazana Stream was flowing. North of Fanies Island freshwater was seeping into shoreline at Tewate basin and along the shoreline southwards to Fanies Island. There was very little freshwater north of this.

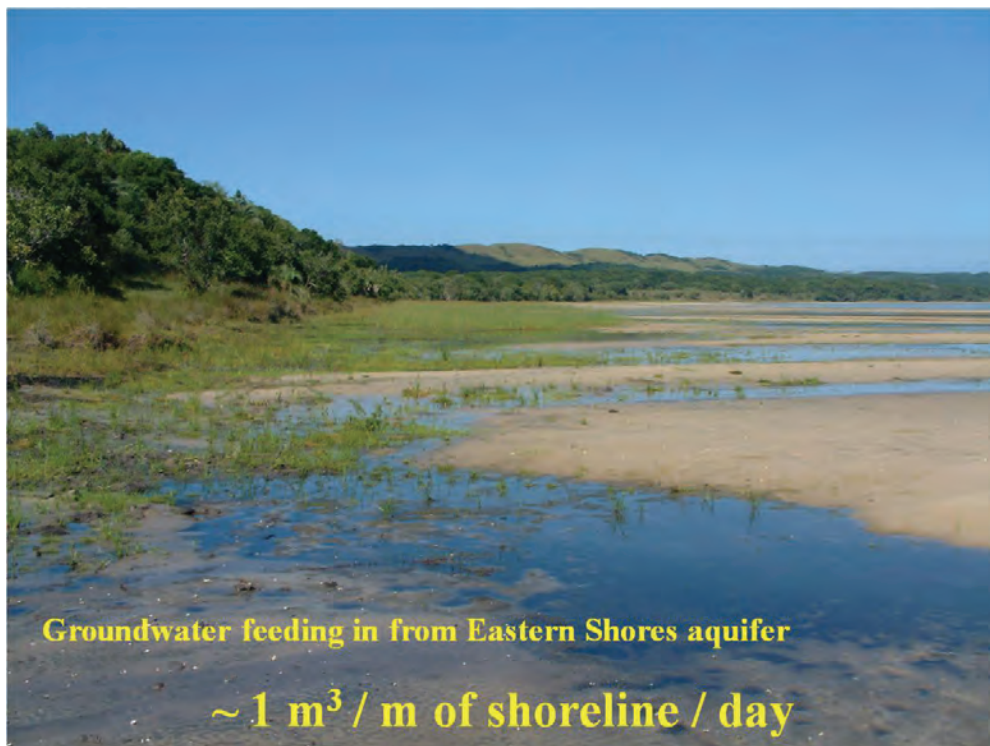
Figure 20. Groundwater seepage on the exposed shoreline south of Old Jetty. The groundwater model indicated that such seepage would persist for the duration of an extreme drought (Photo R Taylor).

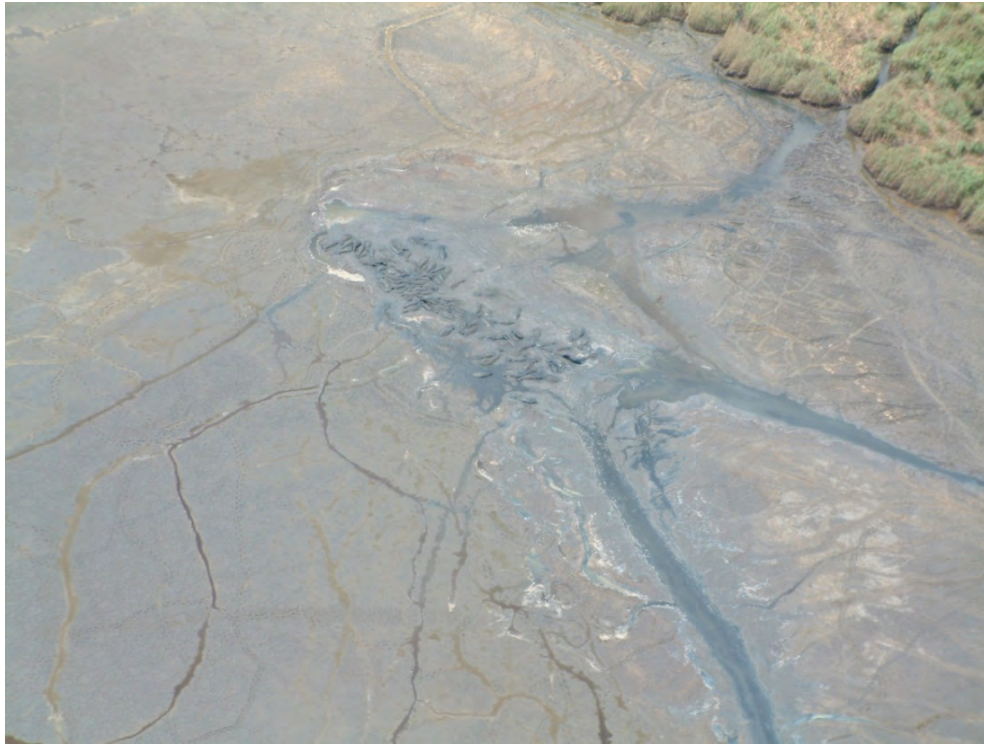
Figure 22. Aerial view of hippos in a mud wallow north-east of Sengwane on 27 October 2003. At this time the last remaining source of freshwater in the north-eastern reaches of the lake.

In the North Lake area there were still a lot of hippos. Almost all of these were in two pods. One in Tewate Bay where there were 180-200 hippos, and one at the north-eastern margin of Sengwane – containing more than 100 hippo (Figure 22 and 23). In both cases the hippos were concentrated in mud wallows associated with freshwater seepage sites.

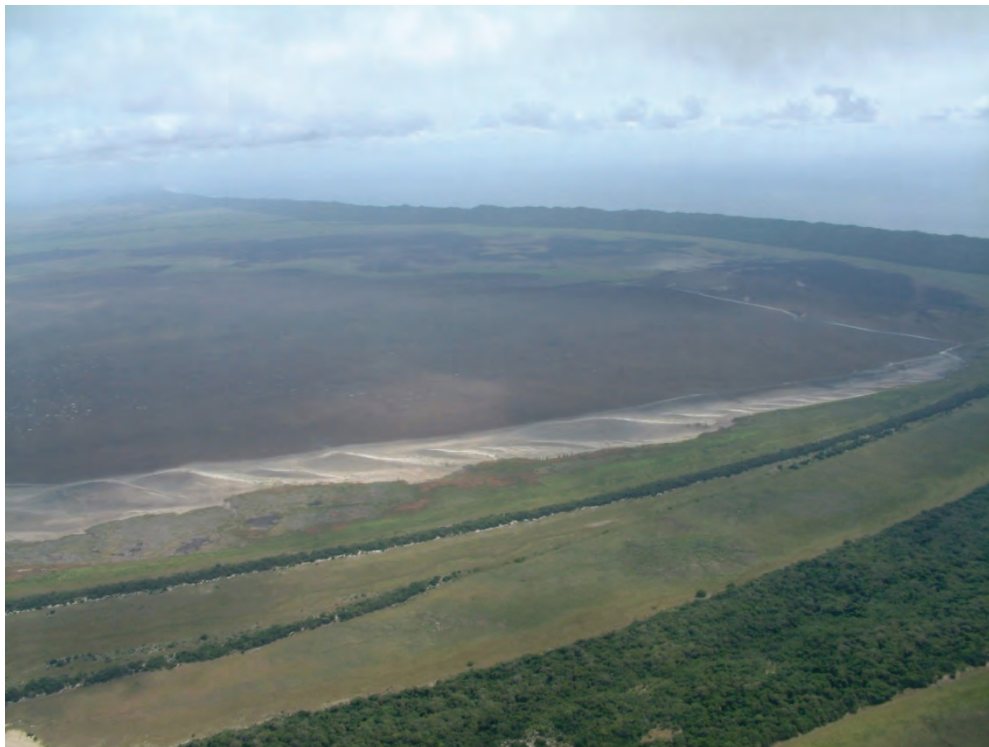
Figure 23. The Sengwana Peninsula and the dry lake bed beyond it. The wallow with the hippos shown in Figure 22 was to the far right of the photo. (22 December 2003, R Taylor).

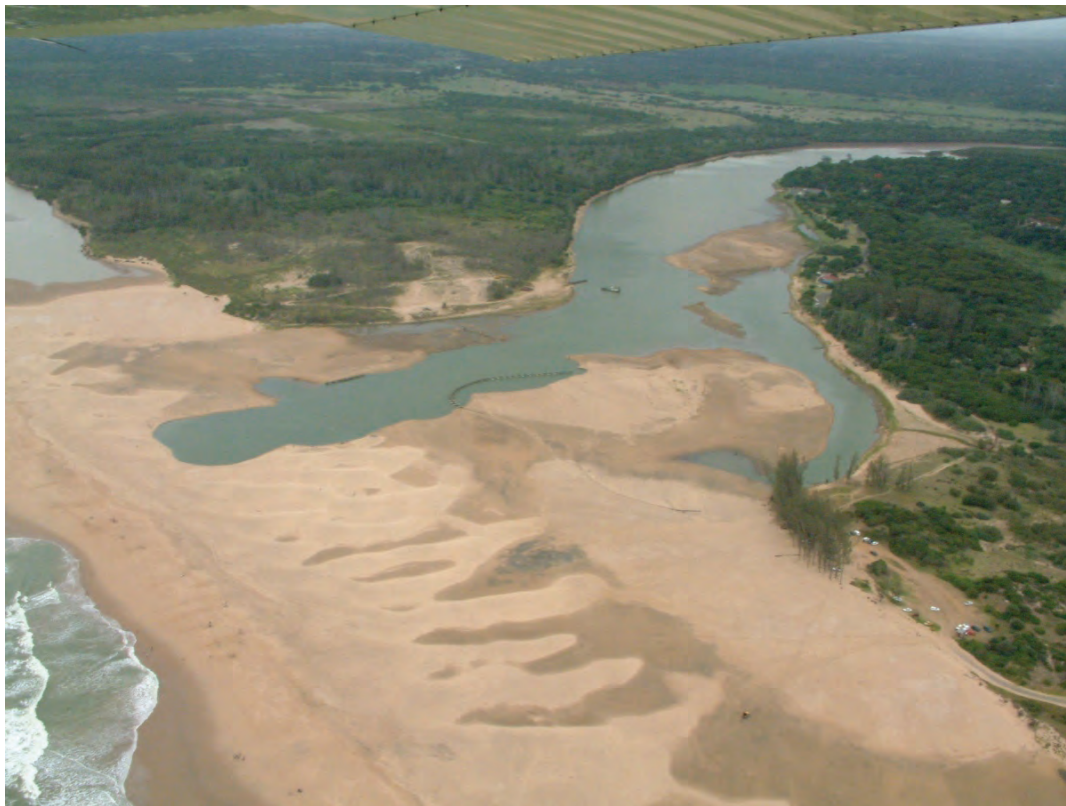
Figure 24. Dredging of the sediment trap. Note how the dredge was eating into the beach berm. Spoil was deposited on the beach in front of the car park (22 December 2003, R Taylor).

This sediment trap was in place in March 2007, with a channel from it into the beach berm. The combination of extreme tides and high seas and effect of Cyclone Gamede caused the mouth to breach on 2 March 2007. The overtopping sea water was able to erode gulleys into the inland side of the beach berm. It was where these gulleys eroded into the sediment trap that they resulted in the breaching of the St Lucia Mouth. Had the dredged channel and sediment trap not been there it is considered unlikely that the mouth would have breached.

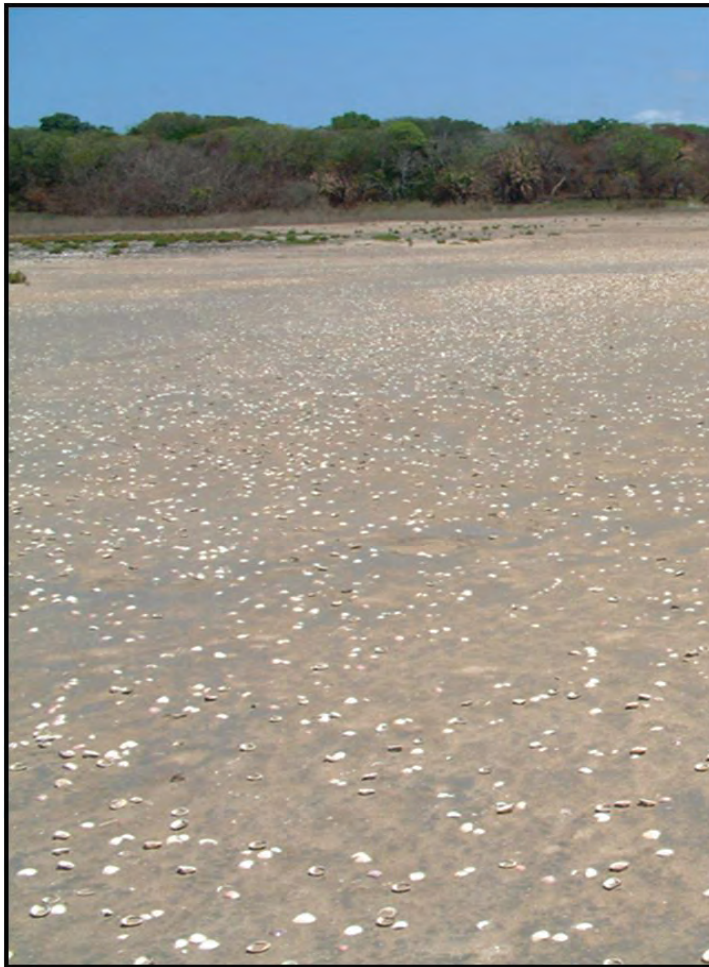
Figure 26. Shells of the bivalve *Meretrix morphina* killed by exposure (Photo R Taylor).

Lake level was very low – with large areas of the lake bed exposed. There were many shells of stranded bivalves (Figure 26).

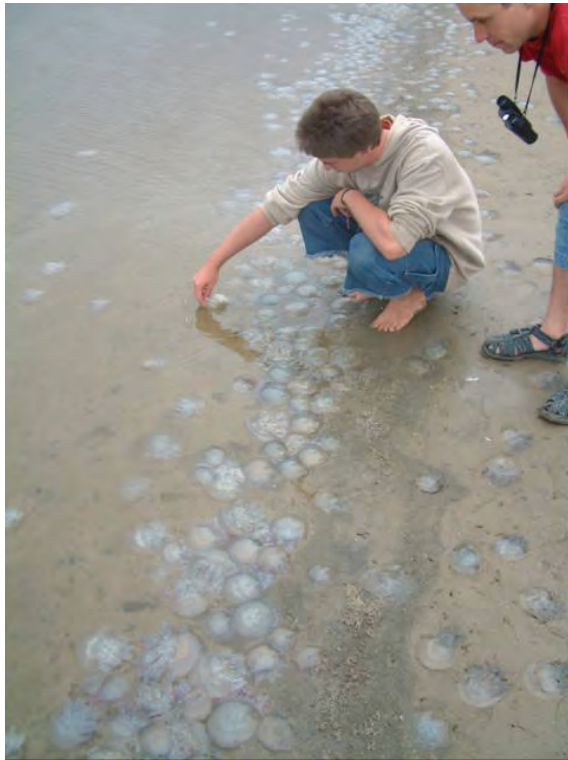
Figure 31. A jellyfish die-off along the eastern shores of Catalina Bay. (18 December 2005, R Taylor).

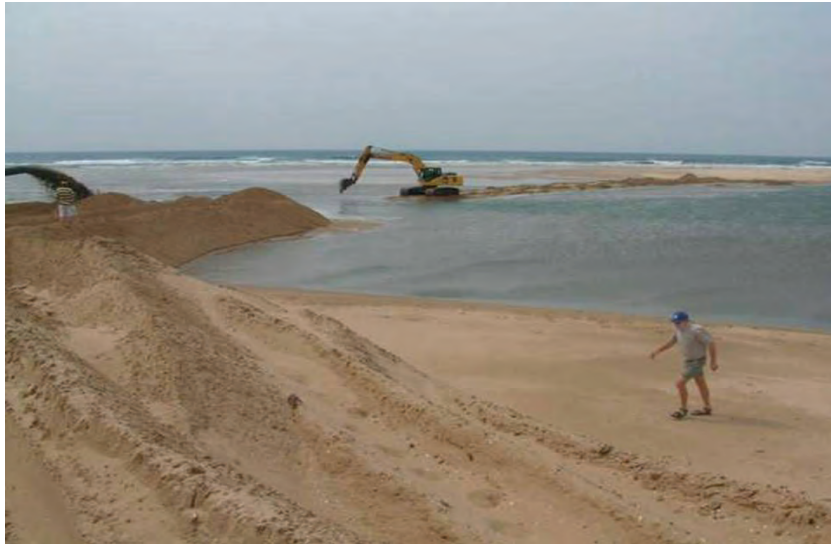
Figure 35. The closure of the Mfolozi about to be effected.

“We have successfully closed the Mfolozi mouth. We have prevented the sea breaching into St Lucia. We have opened a new mouth near Maphelane. This has been a very large job. We used land-based equipment as well as the dredge.” (Figure 35).

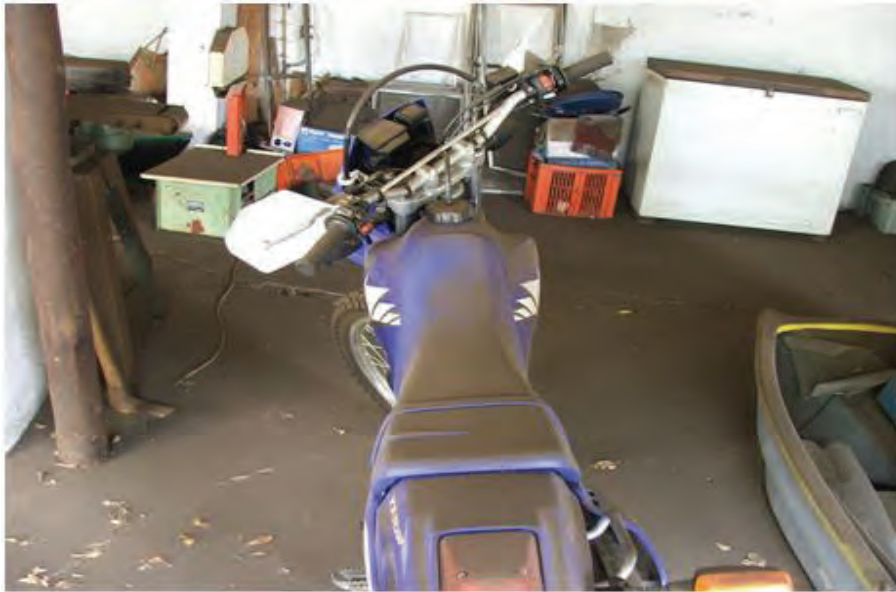
Figure 37. Dust storms occurred when the wind picked up the fine sediments from the dry lake bed. A store room at Listers Point covered in dust from the lake (Photo Jos Ackerman). This dust contains about 4% (by mass) of salt.

The Lake basin was a dust bowl as 65% of the lake surface area was dry (Figures 36 and 37).

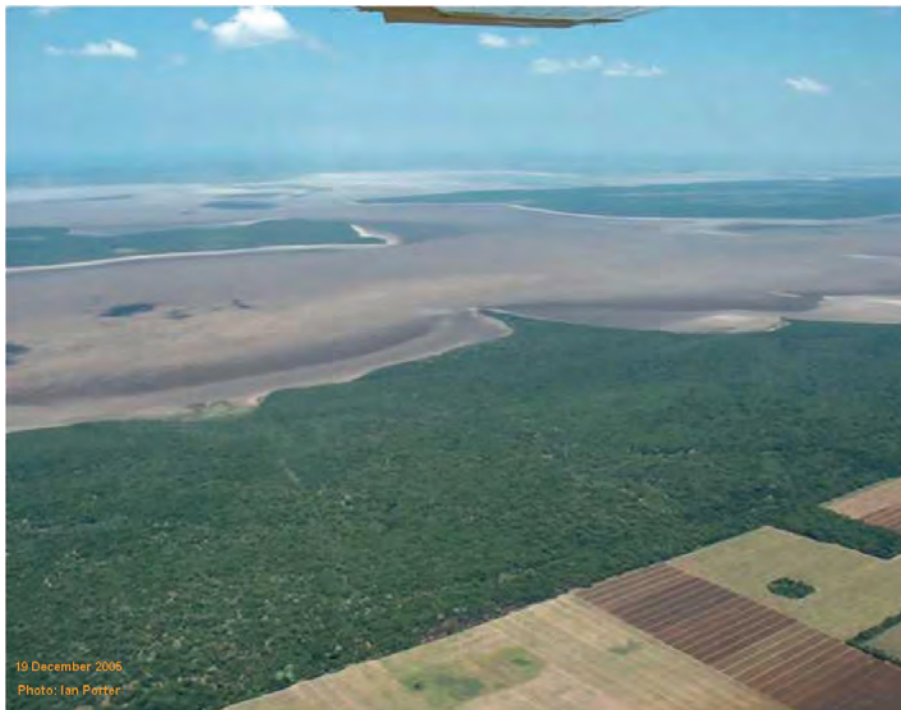
Figure 40. By December 2006 virtually the whole of False Bay and North Lake were dry. This photograph was taken over False Bay Park. Listers Point is central in the photograph, and beyond it is Hells Gate. (19 December 2006, I Porter).

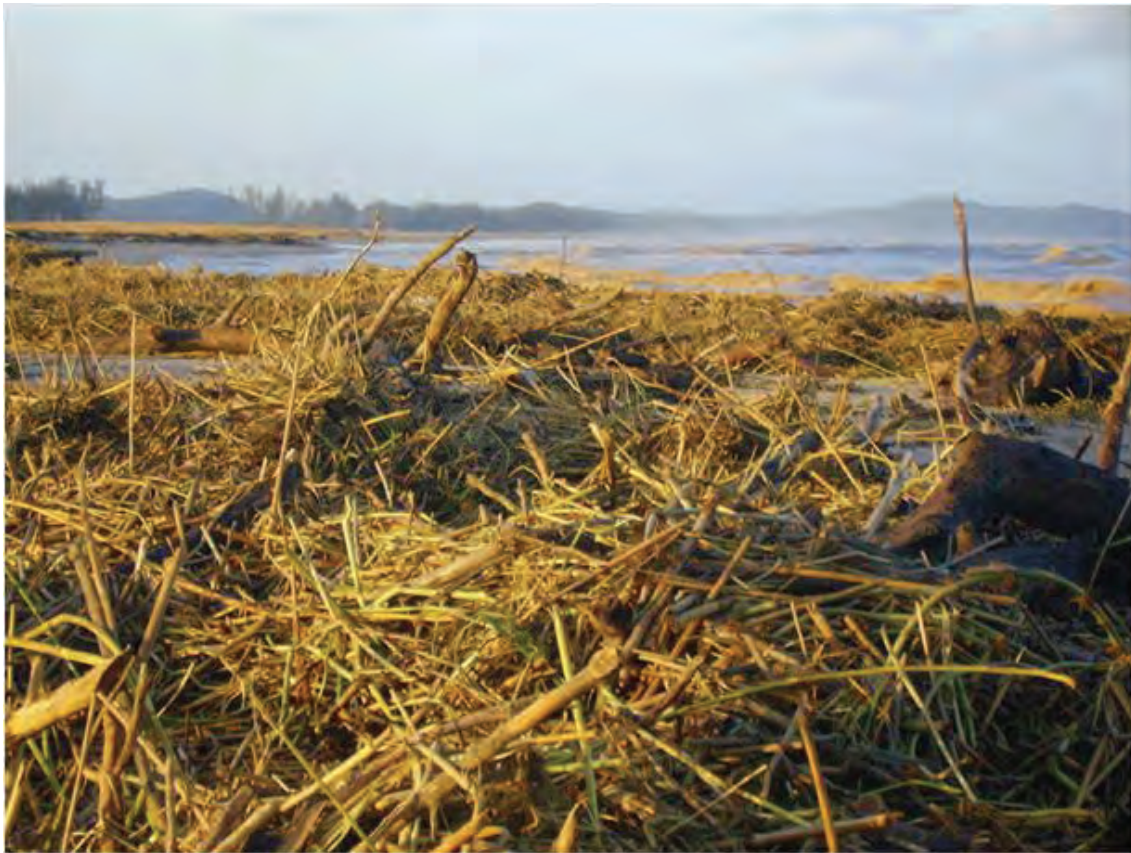
Figure 41. Debris, carried by the Mfolozi in flood, on the St Lucia beach. (Photo R Taylor).

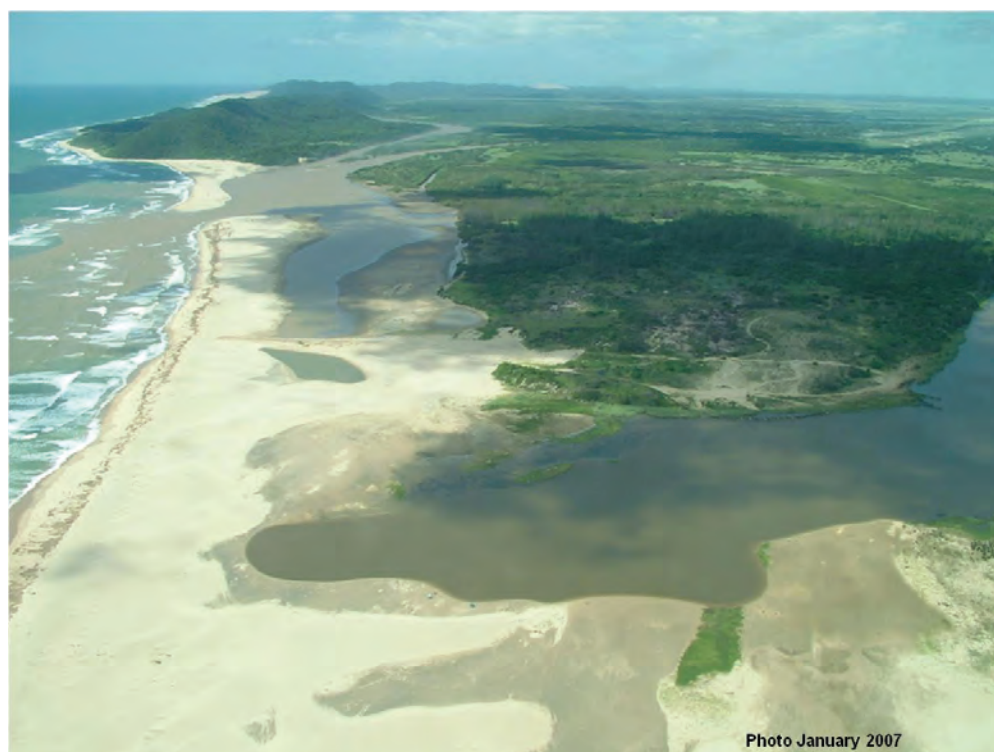
Figure 45. The configuration of the two mouths in January 2007.

Since opening, the Mfolozi mouth had migrated 500 m. This is an average rate of 1.9 m per day. “The Mfolozi Mouth is currently (10 January 2007) 850 m from the berm where we closed the Mfolozi the last time” (Figures 45 & 46).
