ST LUCIA

2001 to 2012: A decade of drought

**Management interventions and what
we have learnt about the ecosystem**

WRC Report No. TT 576/13

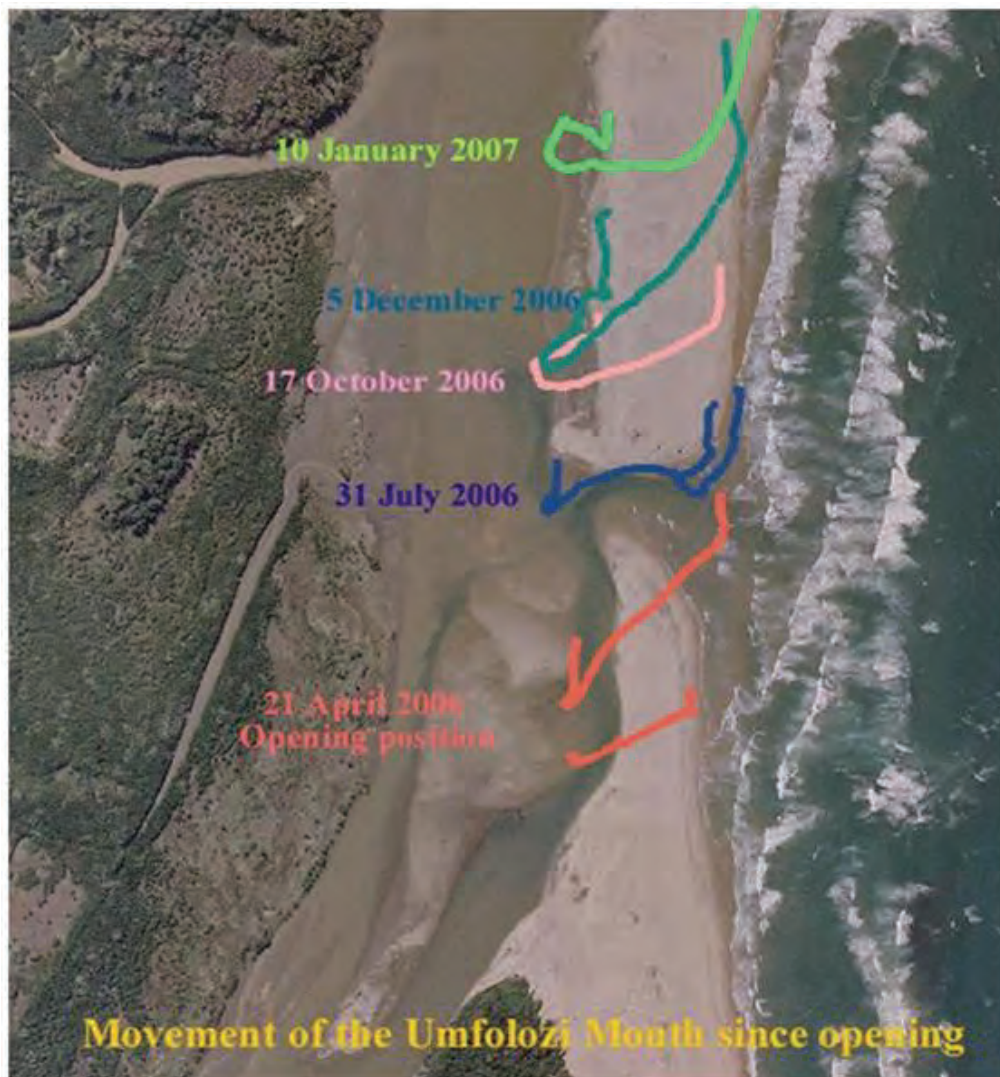
Figure 46. Regular mapping of the north bank of the Mfolozi Mouth using a GPS shows how it advanced northwards at a constant rate.

The monitoring was effective in providing management with information needed to manage the mouth, but it has not informed us about the processes that cause the northward movement. It is strange that the rate of movement for a specific period is very constant, but between different breaching events can differ from 1.7 m to 3.08 m/day. This is unexplained, but is likely to be due to the location on the beach as well as the quantity of sediment on the beach berm.

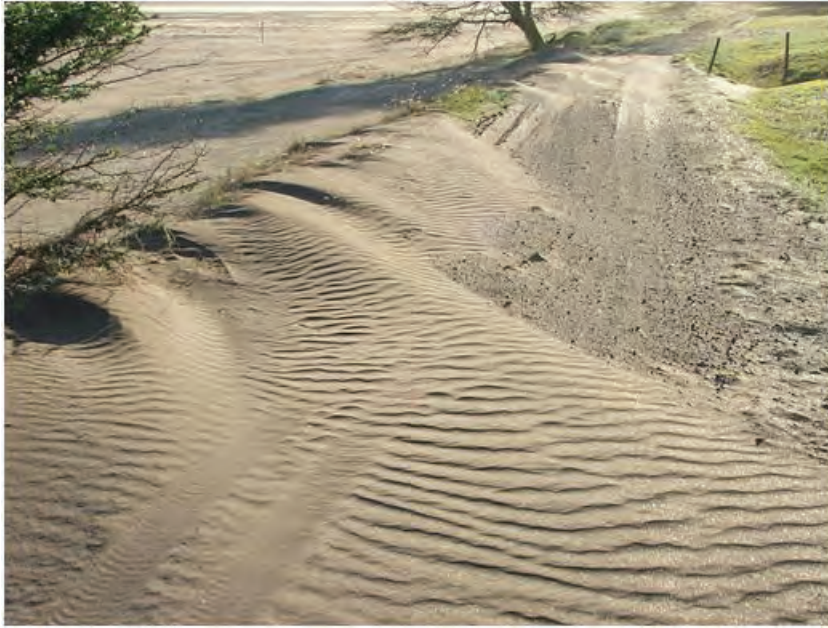
Figure 47. Dust from the lake bed blowing across a road at False Bay. A significant quantity of material was moved within, and out of, the system by the wind. In the system it accumulated against patches of vegetation forming mounds. (Photo R Taylor)

The salinity figures throughout the system were now much lower than expected. It is believed that a considerable amount of salt had been blown out of the system by the wind, and also that salt had been trapped in the sediments of the lake bed. We do not know how much dust had blown out of the system. Residents in Hluhluwe town complained about the dust blowing into their houses. Figure 47 shows dust accumulated on the lake margins at False Bay.

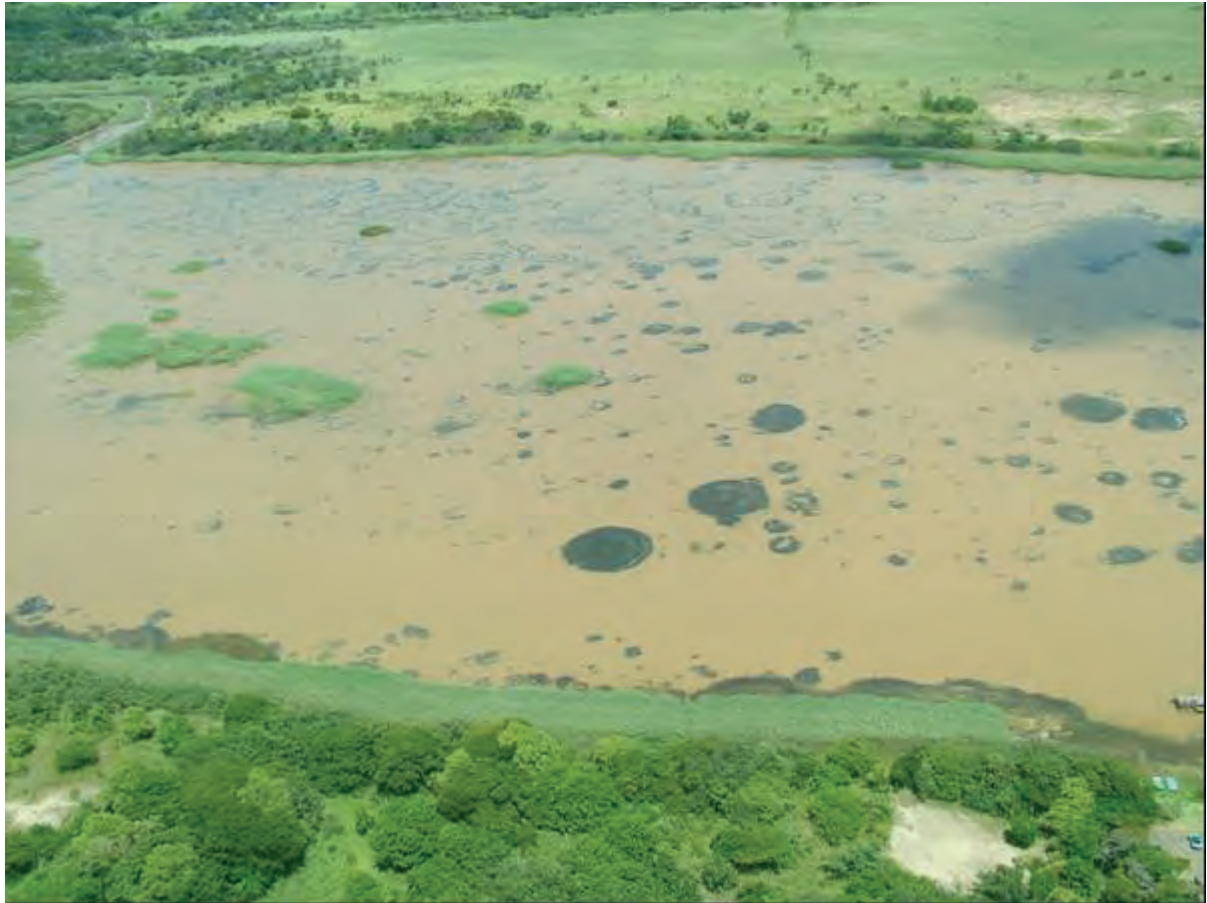
Figure 48. Aerial photograph of vegetation in the Narrows between Honeymoon Bend to the left and the Mullet Close jetty (bottom right). Note the dark circular patches of *Stuckenia pectinata*. Also note the lush growth of *Phragmites* reeds fringing the Narrows and on the oyster-bed islands (mid-left). The water is discoloured by the sediment-laden Mfolozi water that flooded into the Link Canal (the outlet of this is top left). (12 January 2007, R Taylor).

Normally no submerged water plants grow in the Narrows. But, with the Mouth closed there had been a lowering of salinity and the stopping of tidal or wind-induced currents. Beds of submerged water plants had been growing. In December 2006 these were mainly the plant *Stuckenia pectinata* (Figure 9), but there was also *Ruppia cirrhosa* and *Najas marina*. In Makakatana there were *Stuckenia pectinata*, *Ruppia cirrhosa* and *Lamprothamnion* sp. In Catalina Bay there were mainly *Stuckenia pectinata* with traces of *Ruppia cirrhosa*. In Dead Tree Bay only *Ruppia cirrhosa* was recorded in December.

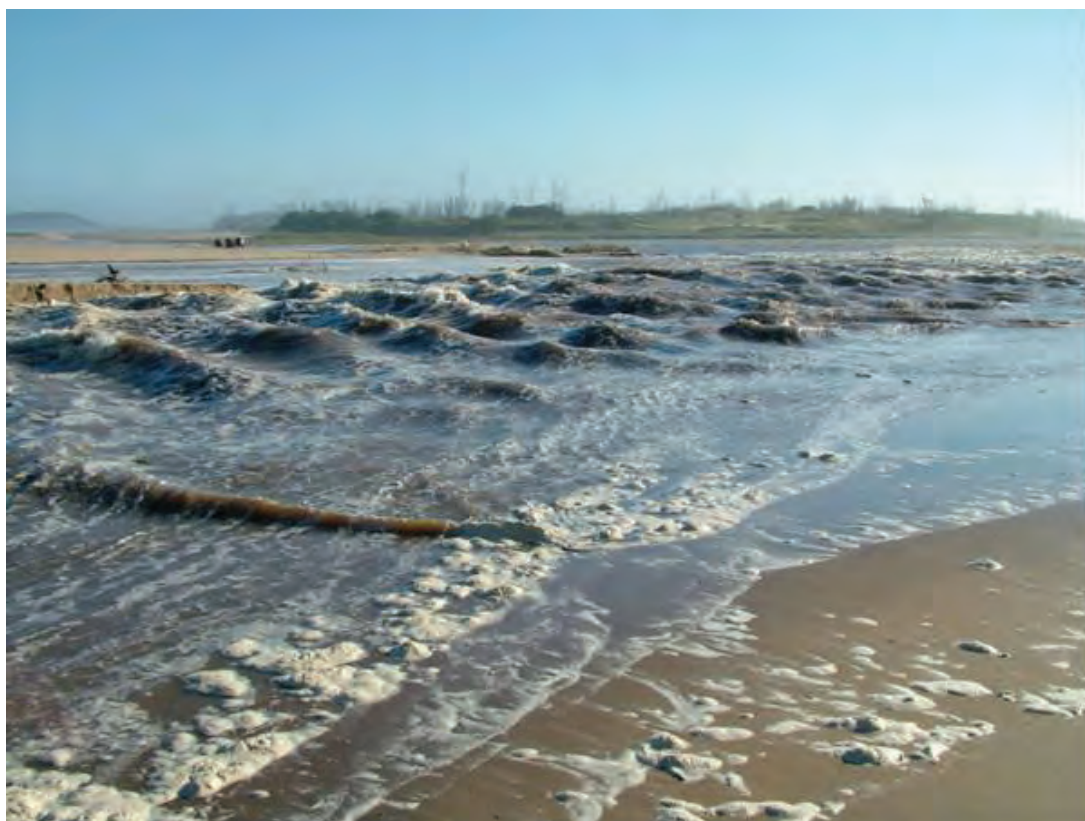
Figure 49. Heavy seas breach the mouth of St Lucia in March 2007.

Combined extreme tides and high seas and effects of Cyclone Gamede caused the mouth to breach on 2 March. (Figures 49, 50 & 51)

The breach was caused by the combination of very high seas caused by Cyclone Gamede south of Reunion Island, a strong onshore wind and spring high tides on the afternoon of 2 March. The waves washed over the whole beach area in front of St Lucia Mouth. The inflowing water eroded several gullies, and where the beach was at its narrowest, the mouth breached in the early hours of 3 March. “With each successive high tide since then the mouth has eroded wider and wider – and is now more than 100 m wide. A large amount of water enters at each high tide and moves northwards into the lake. We estimate that in excess of 3 million cubic metres of water have entered the lake each day since the breach – carrying dissolved in it 125 000 tonnes of salt each day. In the week since the breach the lake level has risen by an estimated 10 cm”.

In hindsight, the breach was encouraged by the sand-trap excavated into the beach berm by the dredge a few years previously. This created a steep slope into which the overtopping sea eroded.

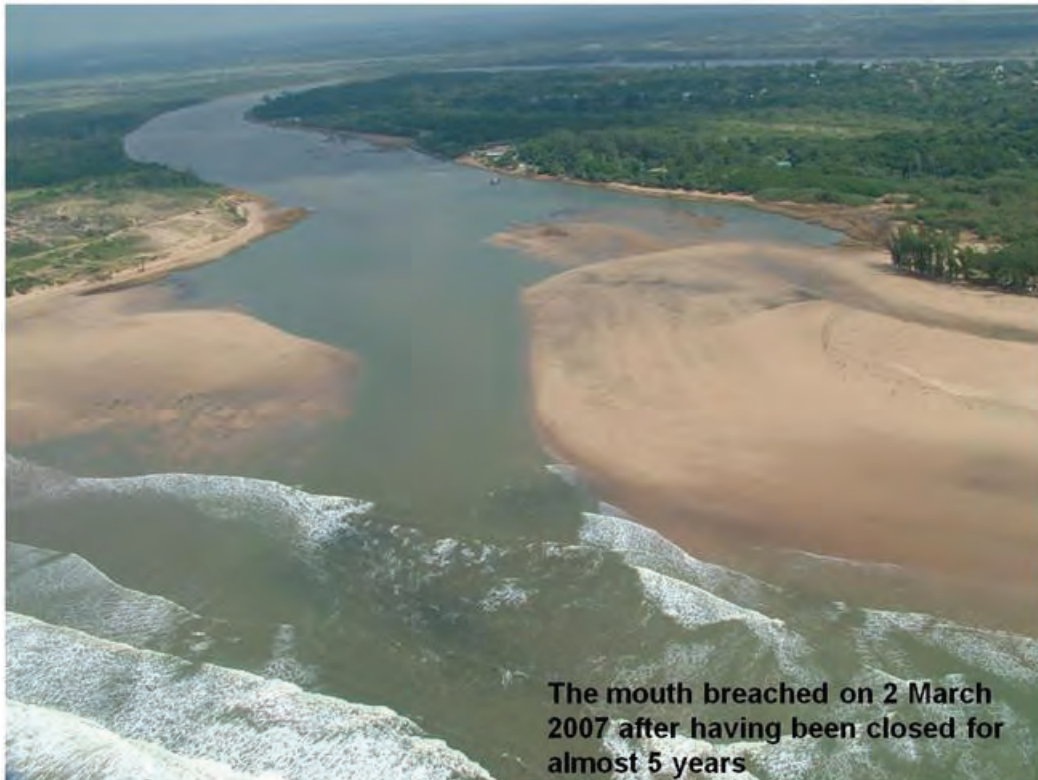
Figure 51. The St Lucia mouth stayed open for 6 months after breaching. In that period a considerable amount of water entered St Lucia. The mass of salt in St Lucia doubled in that time.

In March 2007 extreme high seas, caused by the coincidence of very high tides, storm surges and the influence of Cyclone Gamede, breached the St Lucia Mouth. This stayed open for six months before closing naturally. In this time seawater flowed into St Lucia, raising water levels and introducing a large quantity of salt. In March 2012 Cyclone Irina brought a lot of rain to St Lucia, but not to its inland catchment areas. This was not adequate to open the mouth. Starting in early September 2012 heavy and consistent rains caused the rivers to flow for the whole of the 2012-13 summer period. The drought that had persisted for over a decade was broken.

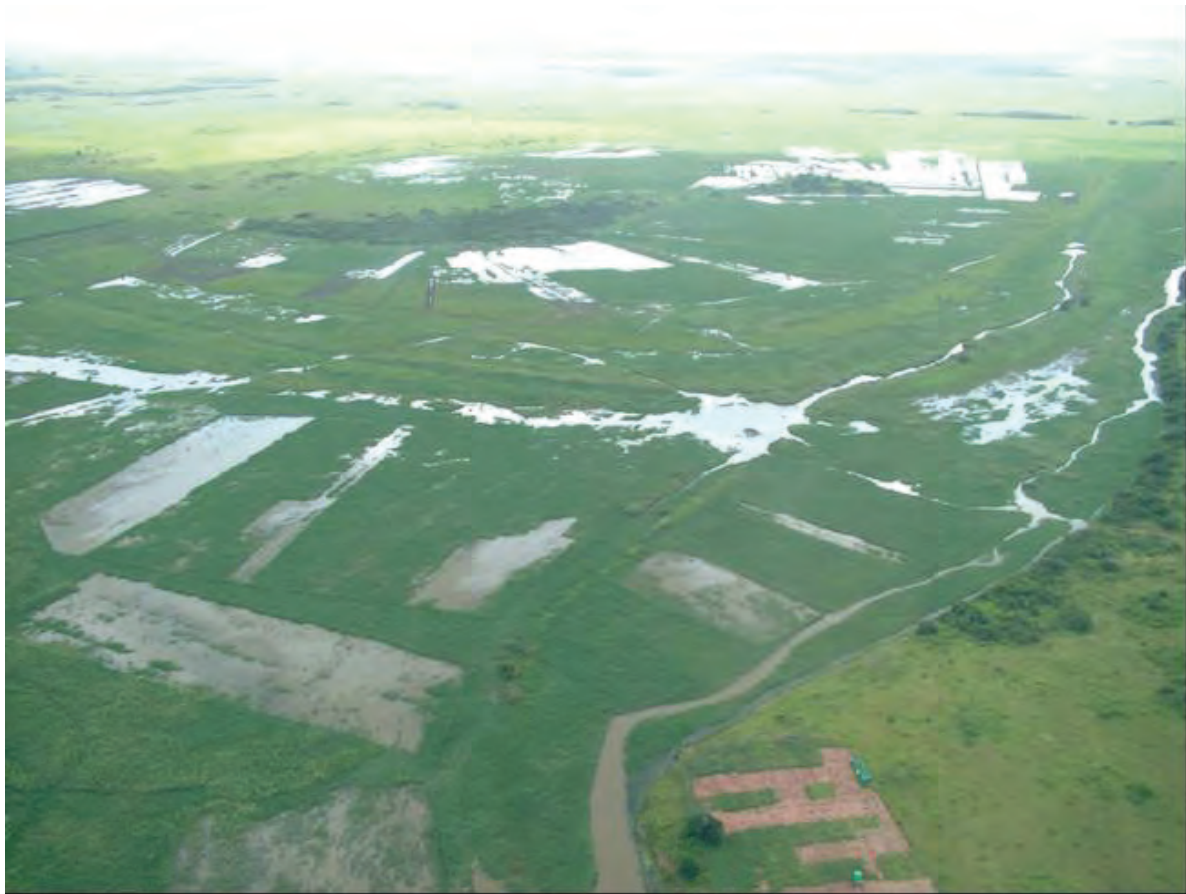
Figure 53. Photograph taken on 12 January 2007 showing the fields that had been ploughed in the middle reaches of the Mkhuze Swamps. Although this is outside the boundary of the Wetland Park, ploughing in wetlands such as this is illegal. If this persists and expands, it will result in altered drainage through the swamp and an eventual loss of the sediment trapping ability of the swamp. The sediments in the Mkhuze River will then be deposited in Lake St Lucia.

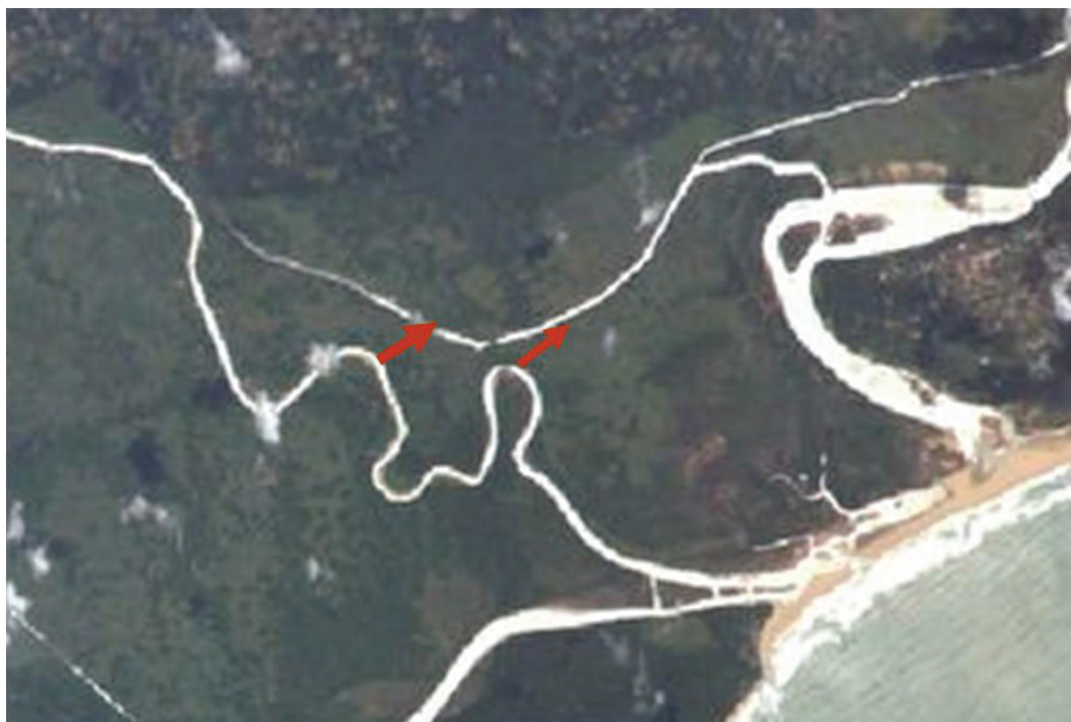
Figure 54. Flood protection may be needed to prevent overtopping of the Mfolozi River into the Link Canal.

The Link Canal was built in the early 1980s to bring water into St Lucia from the Mfolozi. It has a structure with sluice gates on the Mfolozi to bring water in only at low flows when the river contains relatively little sediment. The project was close to completion when the 1984 floods filled the excavations with sediment and damaged the canal. At that stage the canal was not needed as St Lucia was in a wet phase, so the canal was 'put in cotton wool' by being blocked by several cross-berms.

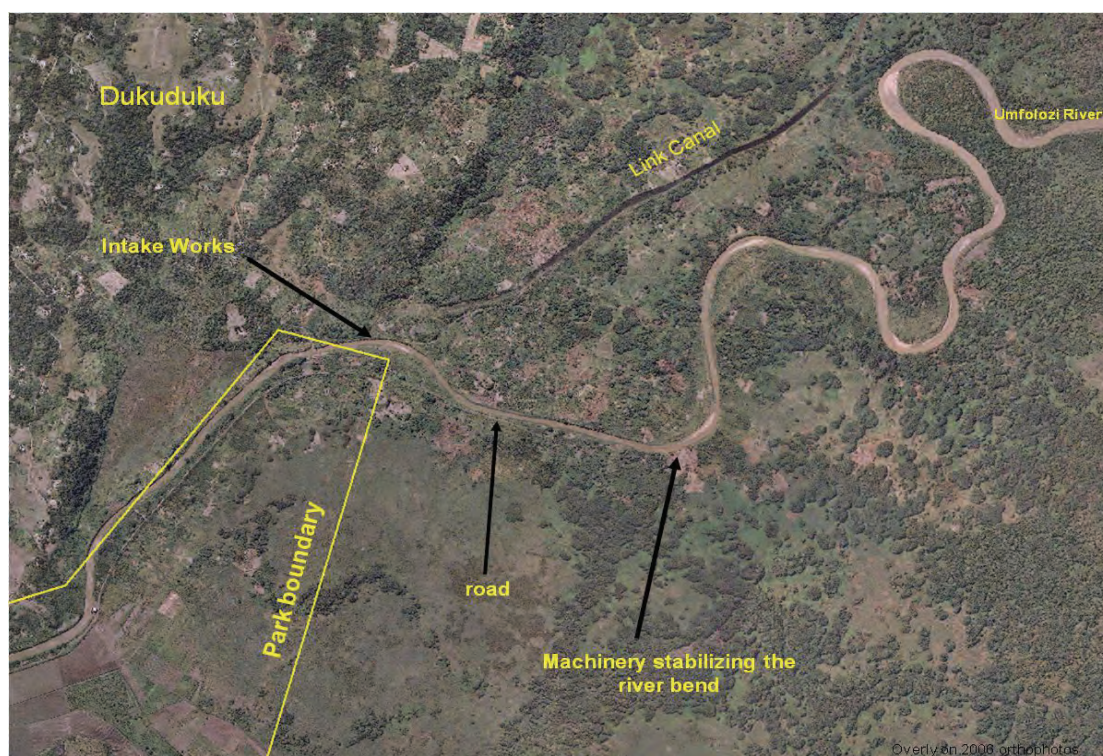
Figure 55. The UCOSP had been building up the south bank of the Mfolozi River to prevent it from breaching southwards and flooding sugarcane fields. This action prevents the southward channel switching of the river.

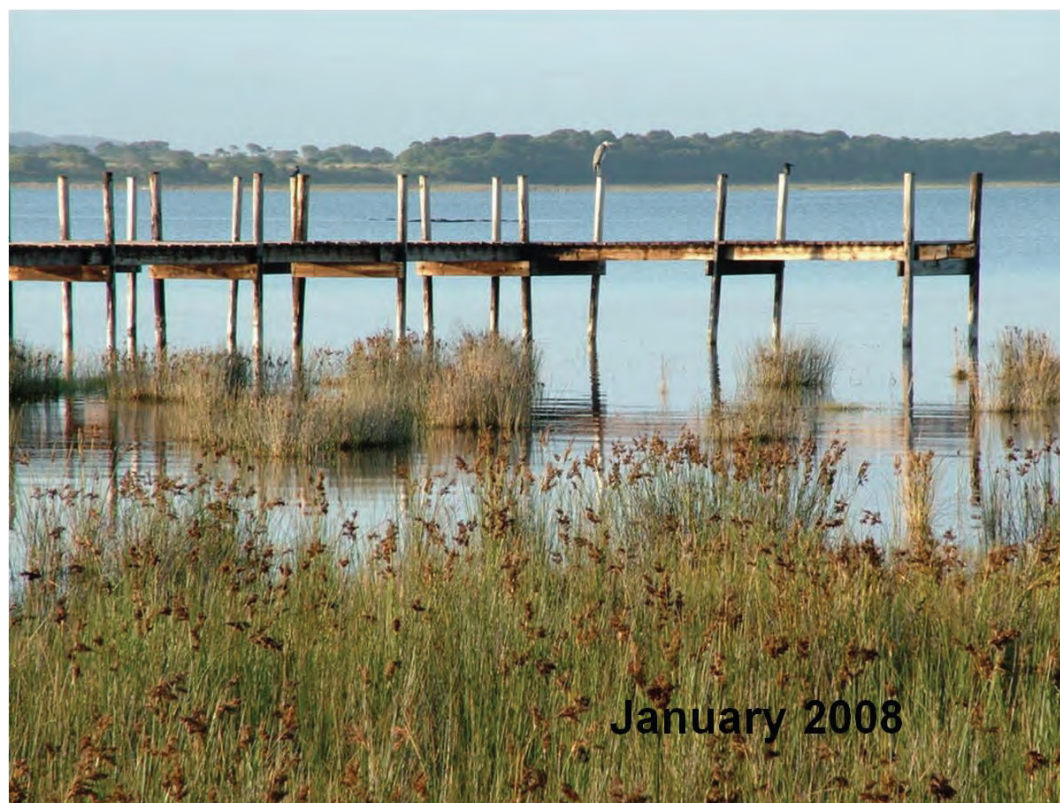
Figure 57. Emergent plants along the margins of the lake created ideal nursery conditions for fish and crustaceans. Old jetty, January 2008.

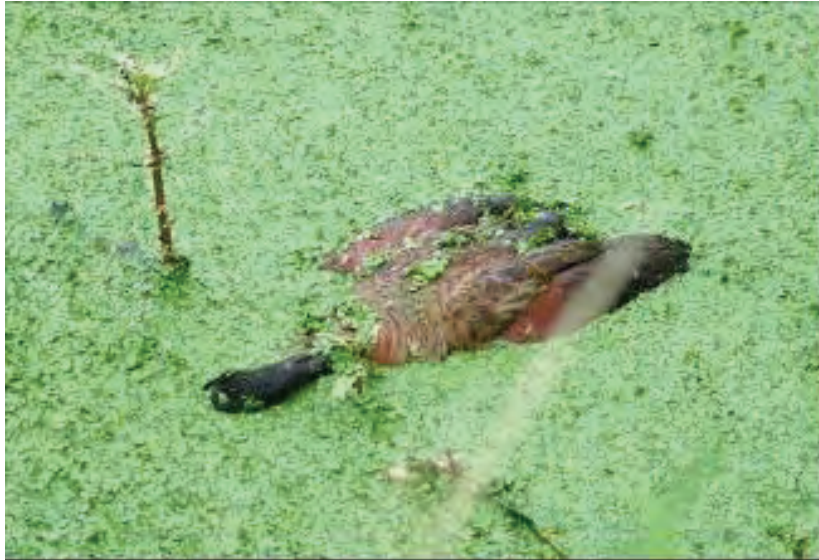
Figure 58. A dead white-faced duck at the sewerage works at St Lucia. A number of dead birds were found, but the cause of death was never confirmed. The dead birds were removed and burnt to prevent spread in case it was botulism.

Suspected botulism poisoning killed waterbirds at St Lucia sewerage works (Figures 58 & 59). This caused concern because, if it was botulism, then the disease could spread to birds throughout the St Lucia system.

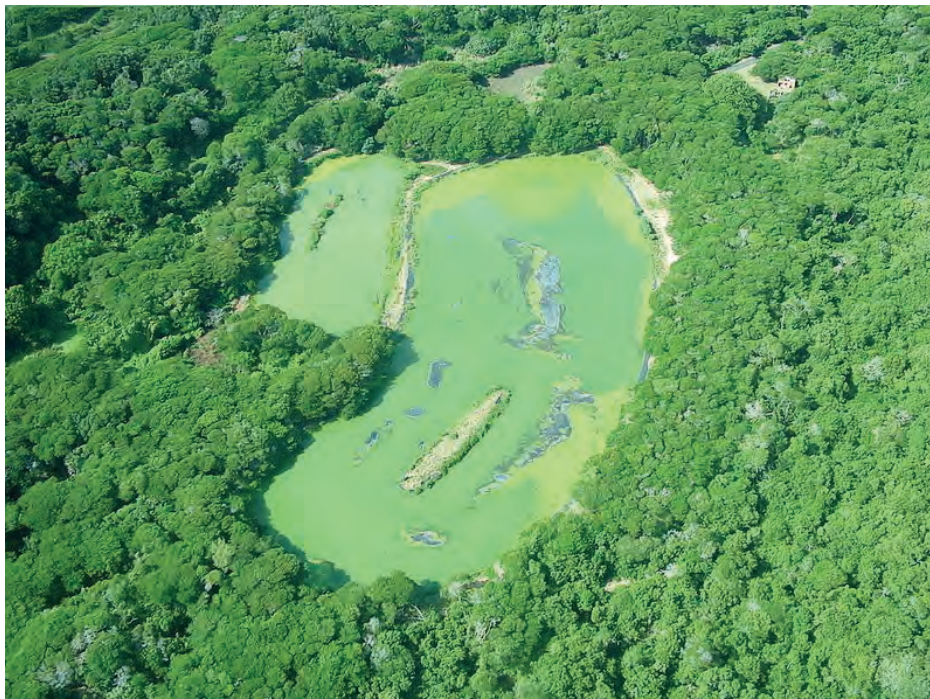
Figure 59. The hyper-eutrophic St Lucia sewerage works. It is important to be vigilant for diseases associated with nutrient enrichment of water.

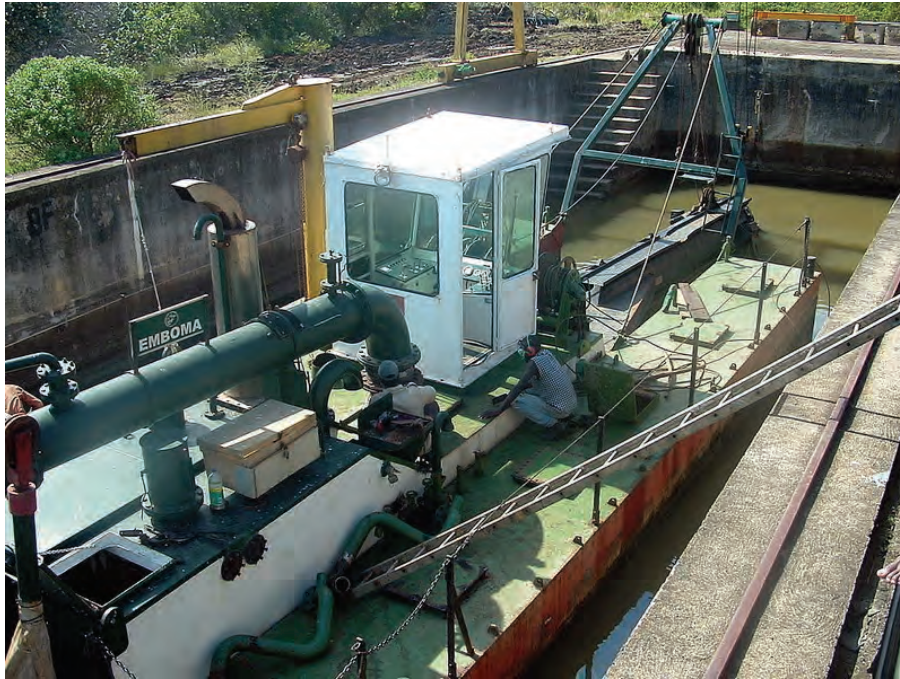
Figure 60. The dredge in the dry-dock for much-needed hull maintenance.

Dredge refurbishment was undertaken (Figure 60). The hull was repaired as it had corroded. Everything was painted.

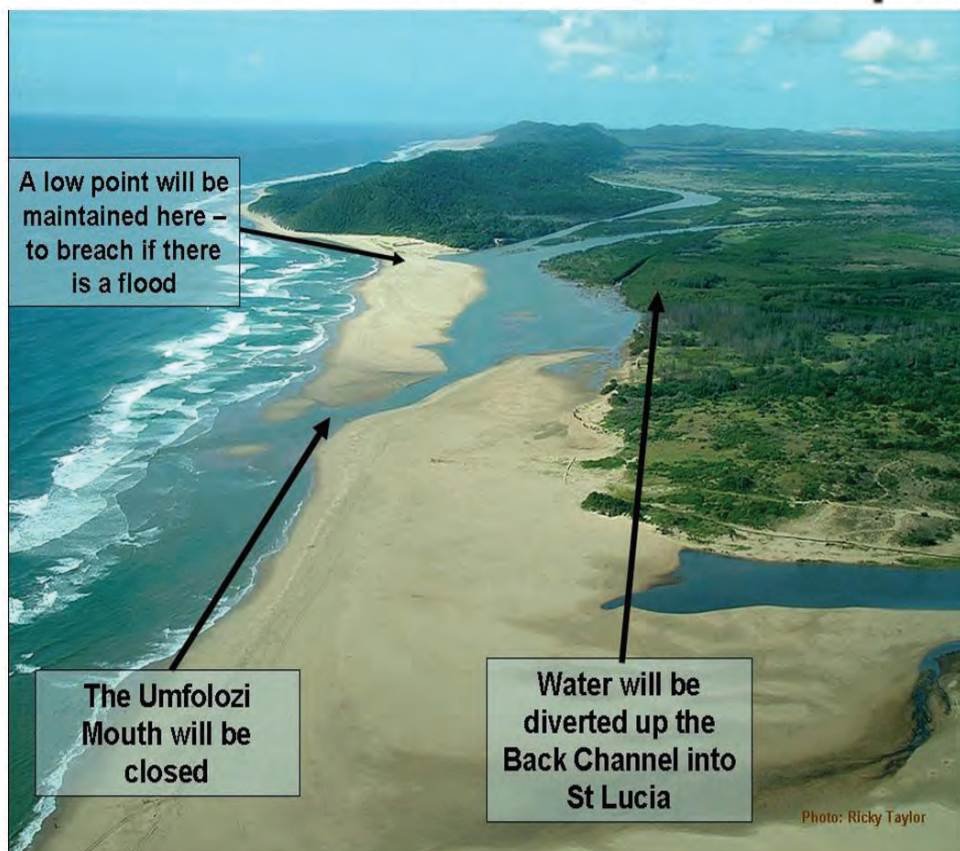
Figure 61. A plan to bring the winter low-flows of the Mfolozi into St Lucia via the Back Channel.

Monitoring the operation of the Back Channel provided insights into how it functioned. The main parameters controlling the amount of flow through the Back Channel were found to be: The quantity of water flowing in the Mfolozi River. If this was greater than what the channel could carry then water level in the lower Mfolozi floodplain area would rise.

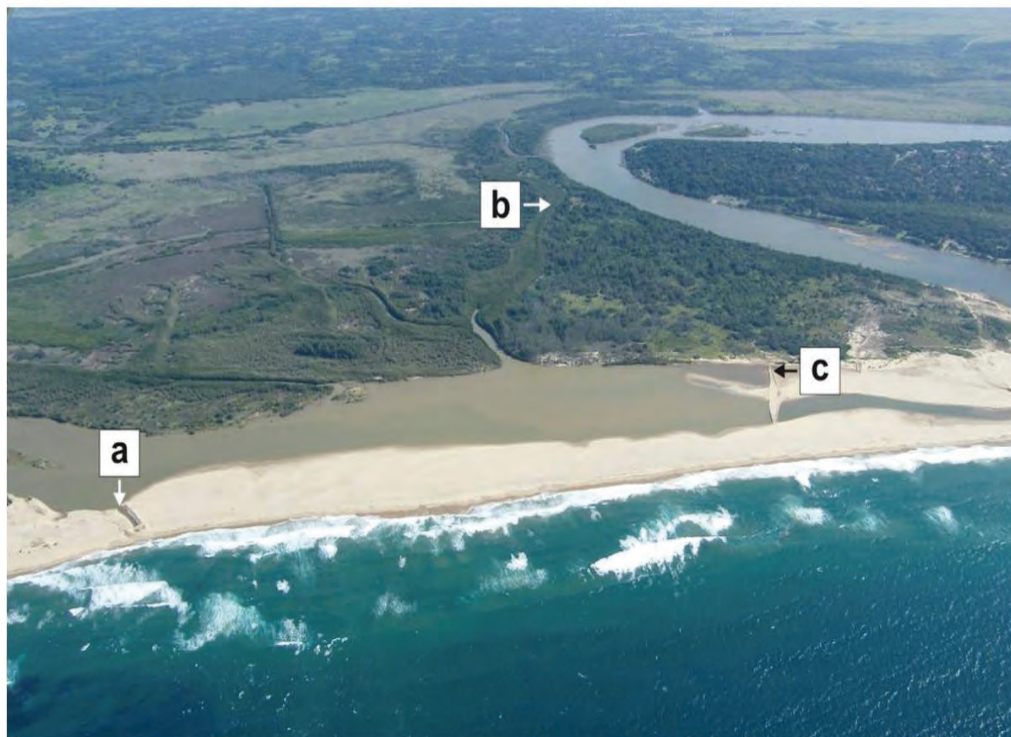
Figure 63. The plan to activate the Back Channel was implemented – by closing the Mfolozi Mouth (c) and creating a “weak link” near Maphelane (a). The backing up Mfolozi water would flow via the Back Channel (b) into St Lucia.

At the Mouth Management meeting of 11 April 2008 it was resolved to artificially close the Mfolozi Mouth (as we have done on several occasions in the past), but, instead of re-opening it close to Maphelane, to keep it closed and allow the Mfolozi water to divert through the Back Channel into St Lucia. It was hoped that the amount of water thus gained would stabilise the St Lucia system. (The modelling by D Stretch indicated that a quantity in the order of $2 \text{ m}^3\text{s}^{-1}$ will achieve this). At the same time, it was planned to cut a low point in the beach at Maphelane so that, should there be a flood in the Mfolozi, it would overtop there and burst out to sea – thus creating its own mouth near Maphelane. Thus Mfolozi flood sediments would not enter St Lucia.

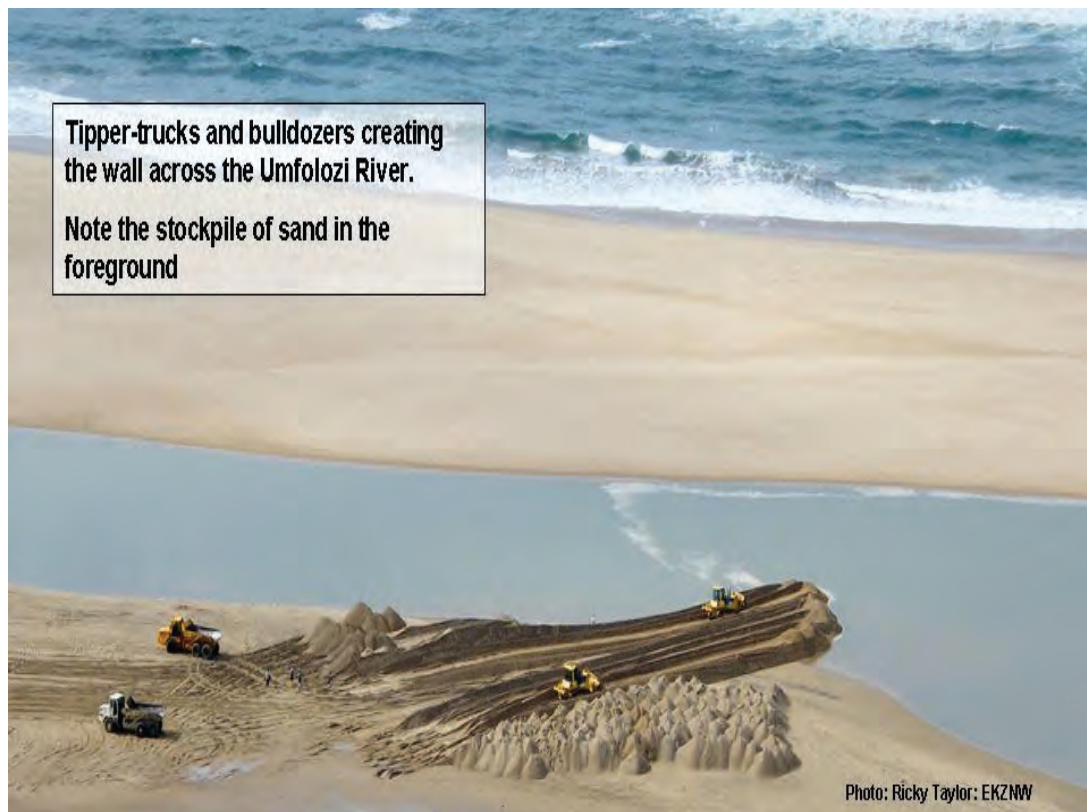
Figure 64. Closing the Mfolozi Mouth

Sand was stock-piled on the banks of the Mfolozi River in preparation for blocking it (Figure 65). Then, luckily for us, the Mfolozi closed naturally on Sunday 27th. As all the necessary equipment was in place, we were able to place a berm across the river on Monday 28th

(Figure 64). Then on the following day we were able to excavate the “weak link” at Maphelane. The berm across the Mfolozi was strengthened and the ‘weak link’ touched up and most of the job has been completed. By Friday morning, the Mfolozi had risen to the extent that the water was starting to push through the Back Channel and into St Lucia (Figure 66). All that remained now is some minor ‘touching up’, and the monitoring of water levels and flows.

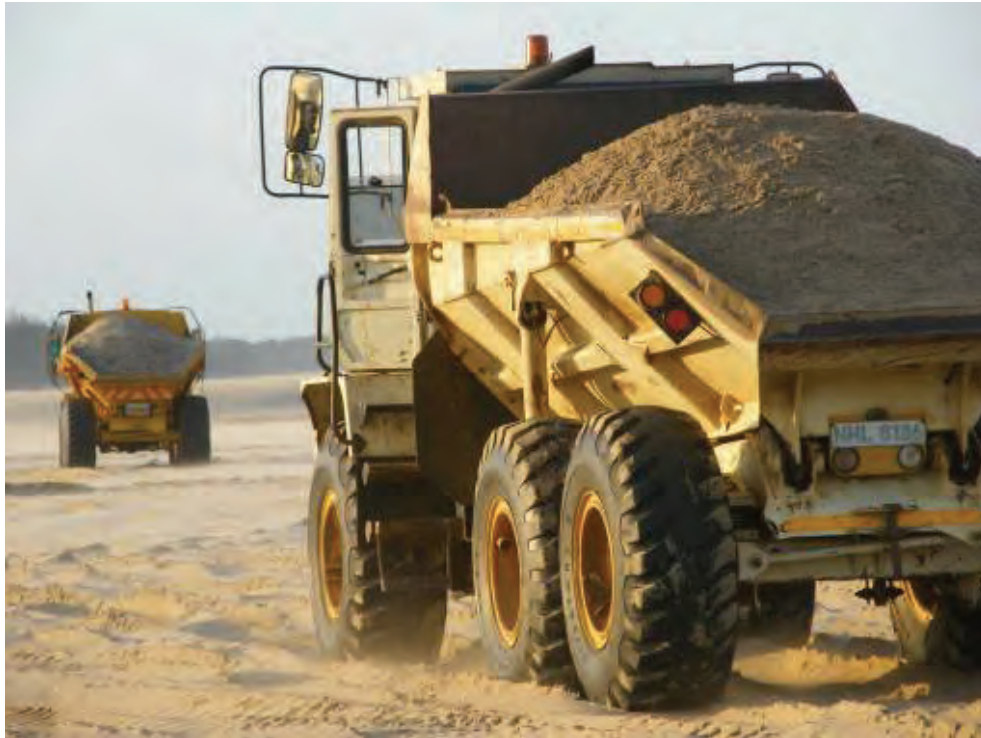
Figure 65: Tippers bringing sand to a stockpile area on the beach to be able to close the Mfolozi Mouth. (Photo R Taylor).

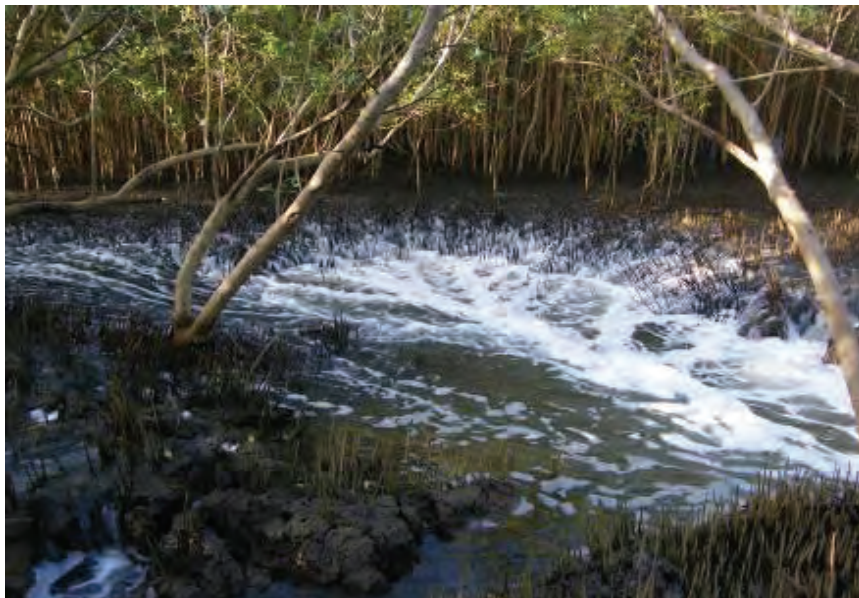
Figure 66. The outcome; sediment-free Mfolozi water flowed into St Lucia.

This year, instead of immediately breaching the new mouth at Maphelane, water was allowed to flow from the Mfolozi through an old channel into St Lucia – and in this way gained about 3 million cubic metres of water for St Lucia.

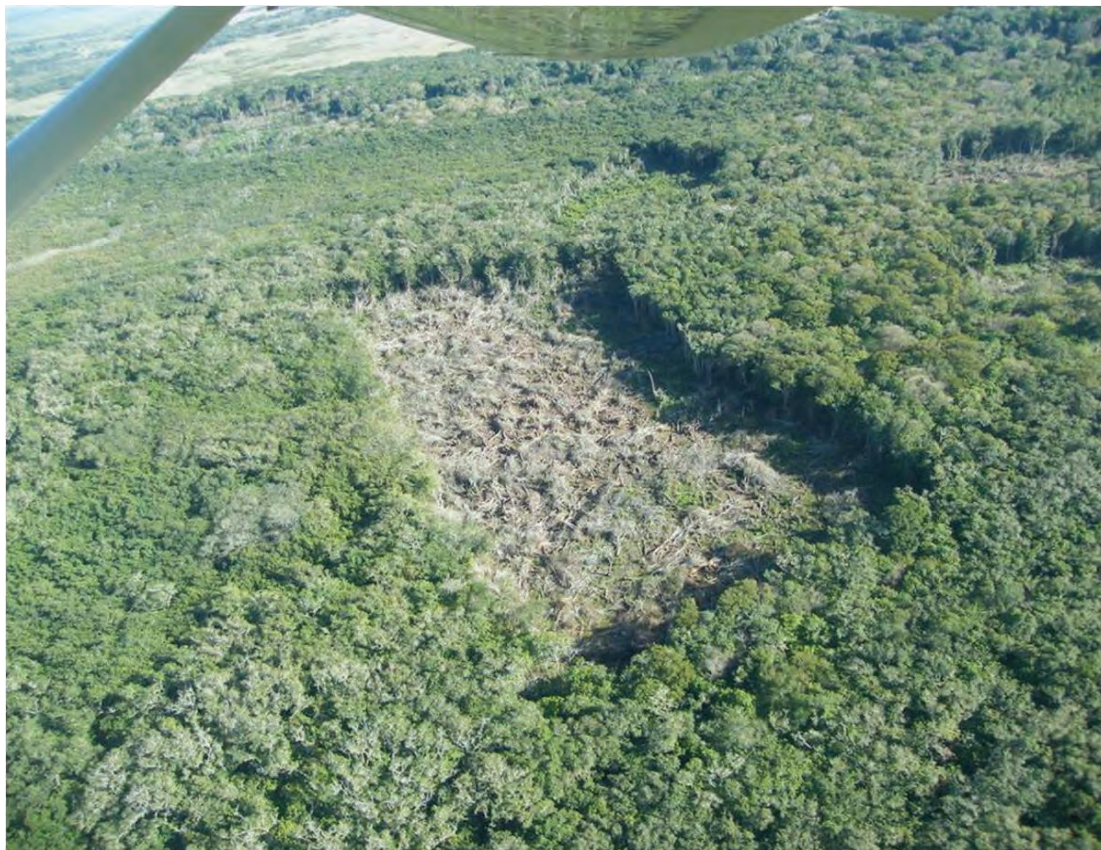
Figure 68. There were ever-increasing concerns about the amount of clearing of swamp vegetation in the Lower Mfolozi area to plant gardens.

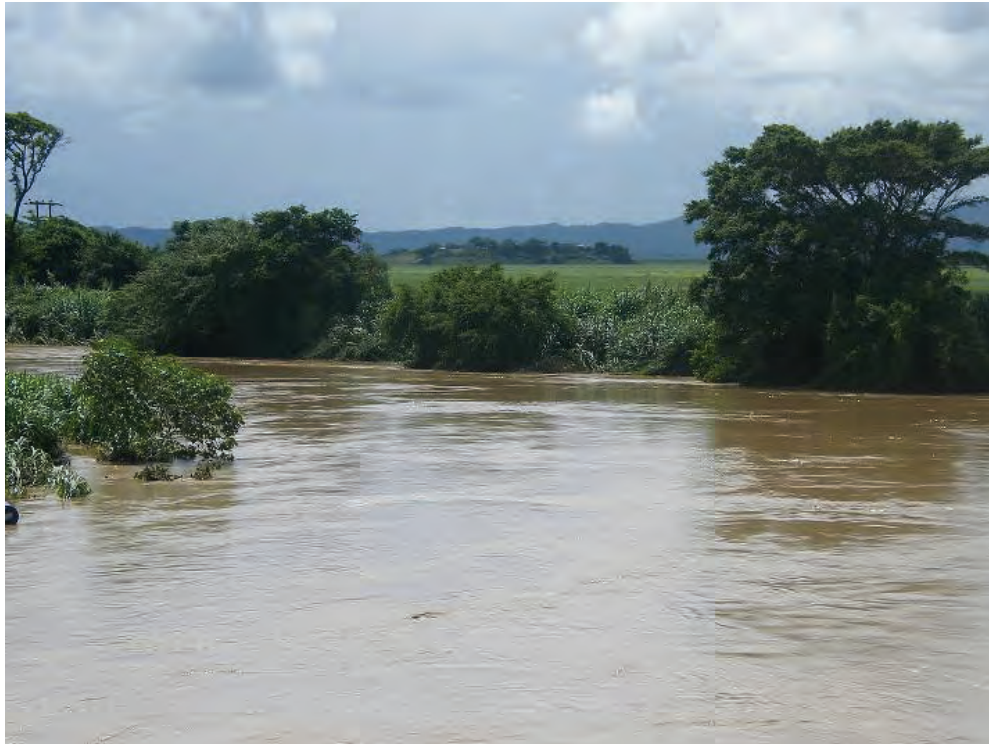
Figure 71. The Mfolozi floodwaters at Monzi – where the river is still contained within the artificial levees of the Warners Drain. (Photo R Taylor).

In the first two days of March the Mfolozi came down in flood (Figure 71). The quantity of water exceeded $80\,000\text{ m}^3\text{s}^{-1}$. During its peak (of about 24 hours) it overtopped the spillway at Riverview which shunts excess water down the Msunduzi River. The quantity of water was such that it also overtopped the river banks flooding the lower Mfolozi and also flowing into the Link Canal bringing water into St Lucia. (Figure 72). The water obtained was welcome for St Lucia, but the sediment it carried was not.

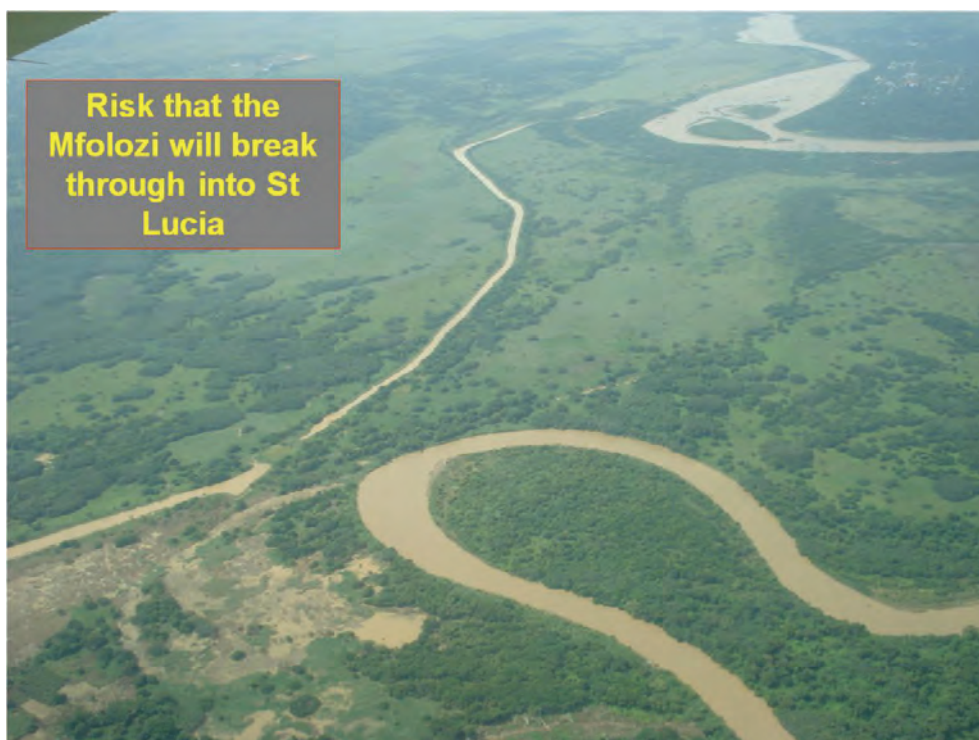
Figure 72. After the flood had again overtopped into the Link Canal there were concerns about the Mfolozi River taking this as a permanent route. The Link Canal is in the upper left of the photo, the meander in the Mfolozi River in the bottom right and the St Lucia Estuary in the upper right.

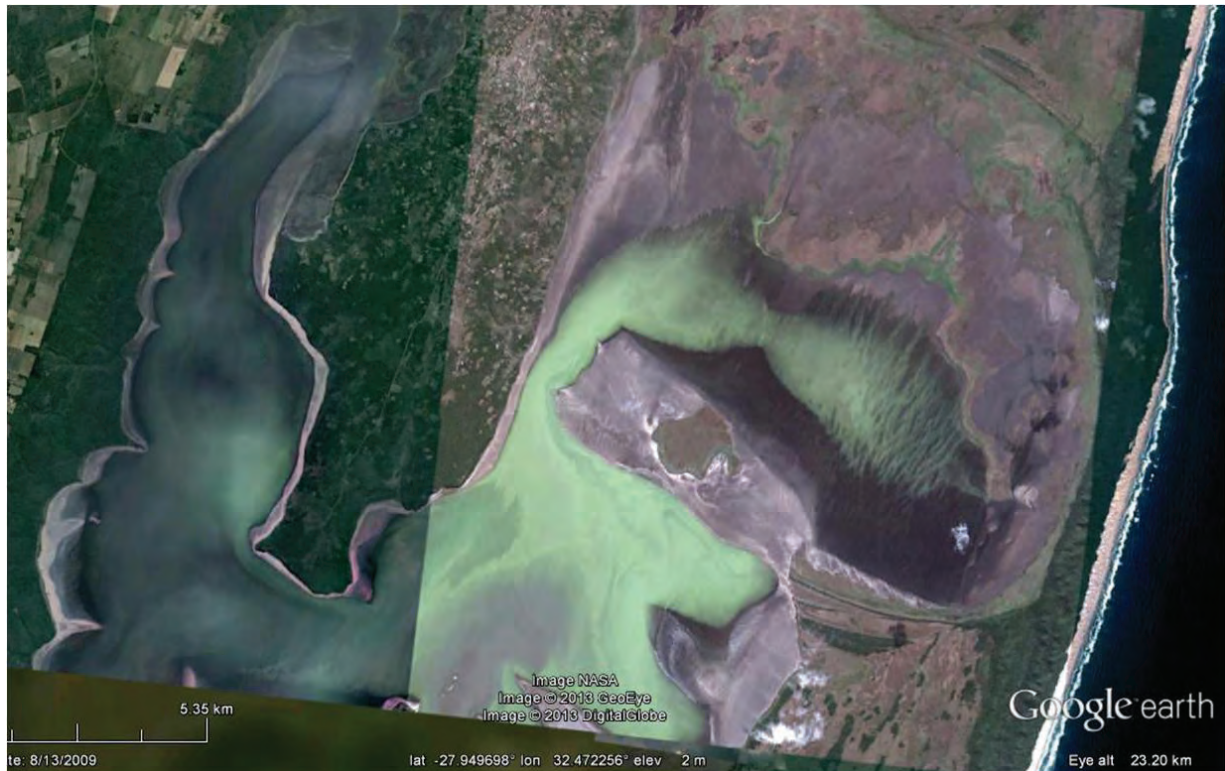
Figure 81. Google earth image of the northern Lake St Lucia (August 2008) showing the extent of the cyanobacteria bloom that discoloured the water. Note also the low water level and how much of the northern parts of St Lucia were exposed.

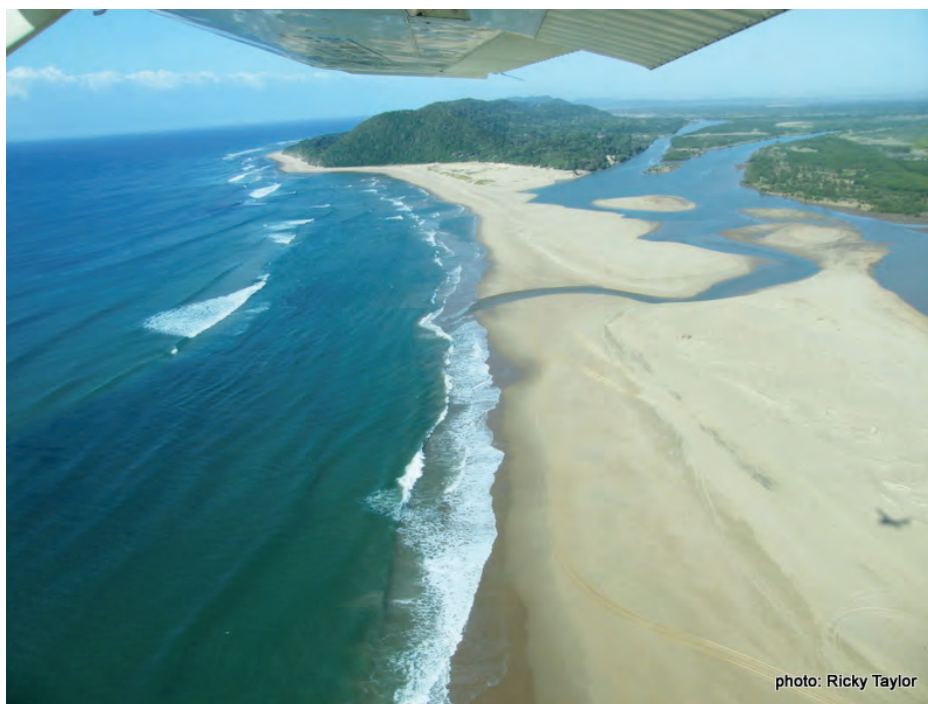
Figure 82. Aerial photograph from 20th July 2009 showing a constricted Mfolozi Mouth.

This last neap tide the Mfolozi Mouth came very close to closing. We were hoping that it would close. We would then be able to divert the Mfolozi water into St Lucia – which at the time, was desperately short of fresh water.

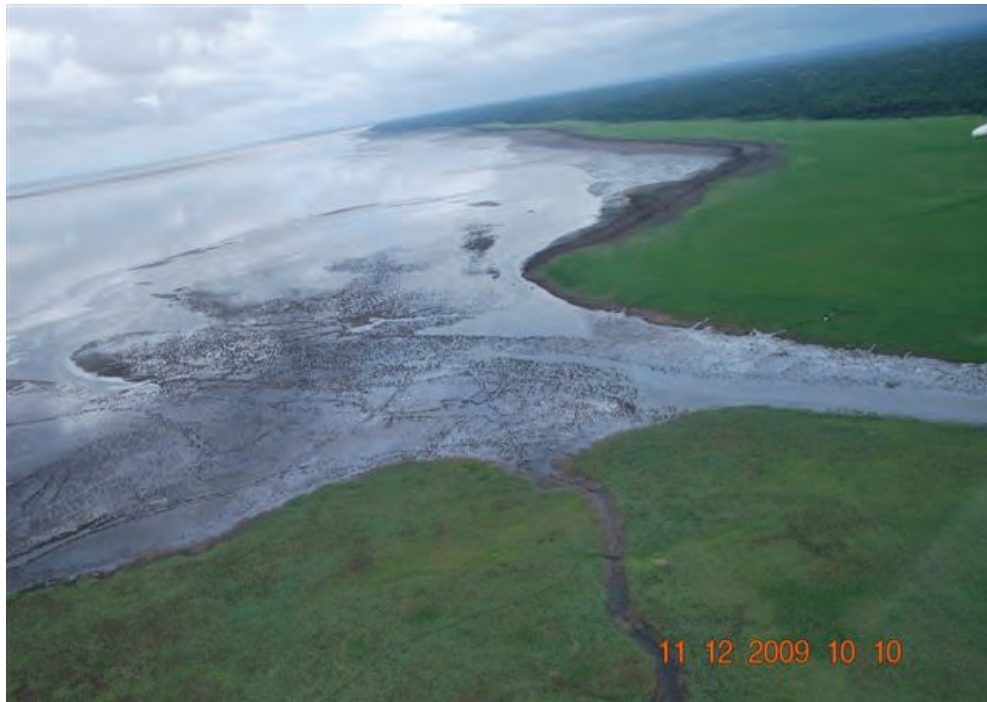
Figure 88. The Mkhuze Mouth showing that the water level in St Lucia had risen and it looked as if water was flowing from the Mkhuze Swamp into the Lake. (Photo: Terry Ferguson).

Good early-summer rains, Mkhuzi River was flowing into the lake (Figure 88).

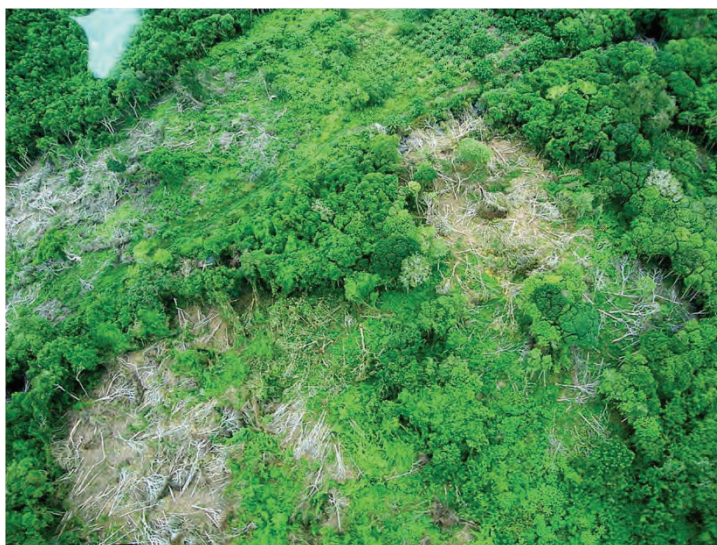
Figure 92. There is continuous insidious expansion of the swamp gardening in the lower Mfolozi Swamp. The trend is for them to evolve from subsistence to commercial use. The photo shows swamp forest trees being felled to expand a garden.

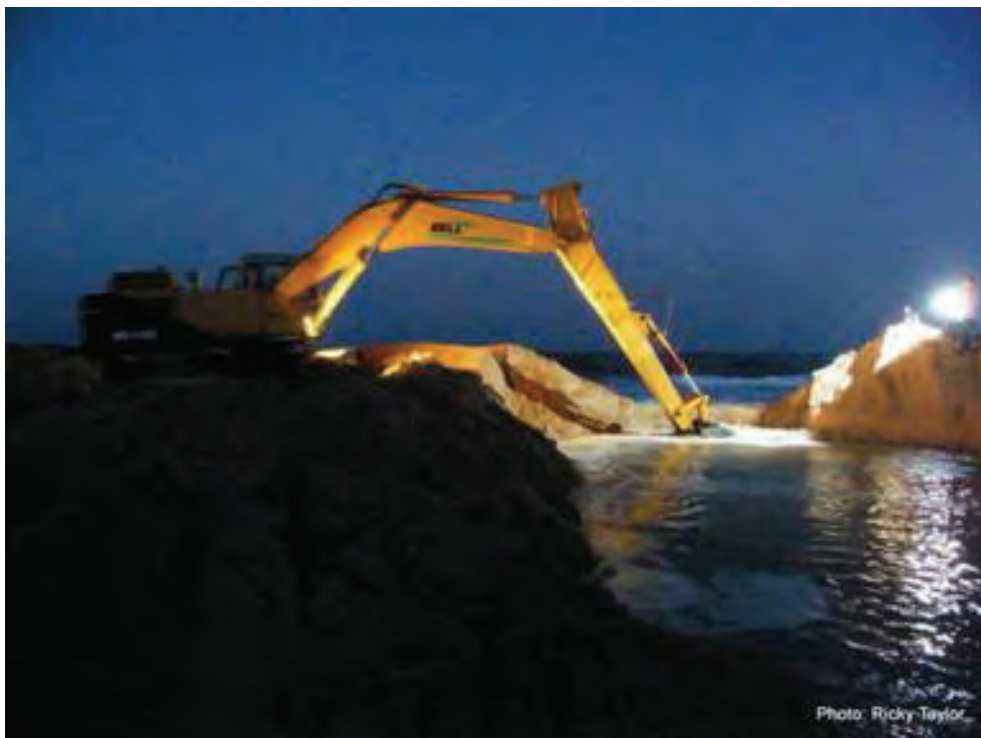
Figure 96. Breaching the Mfolozi estuary mouth on the evening of 14 May 2010.

Mfolozi was breached artificially on 14 May after flooding farms (Figure 96).
