ST LUCIA

2001 to 2012: A decade of drought

**Management interventions and what
we have learnt about the ecosystem**

WRC Report No. TT 576/13

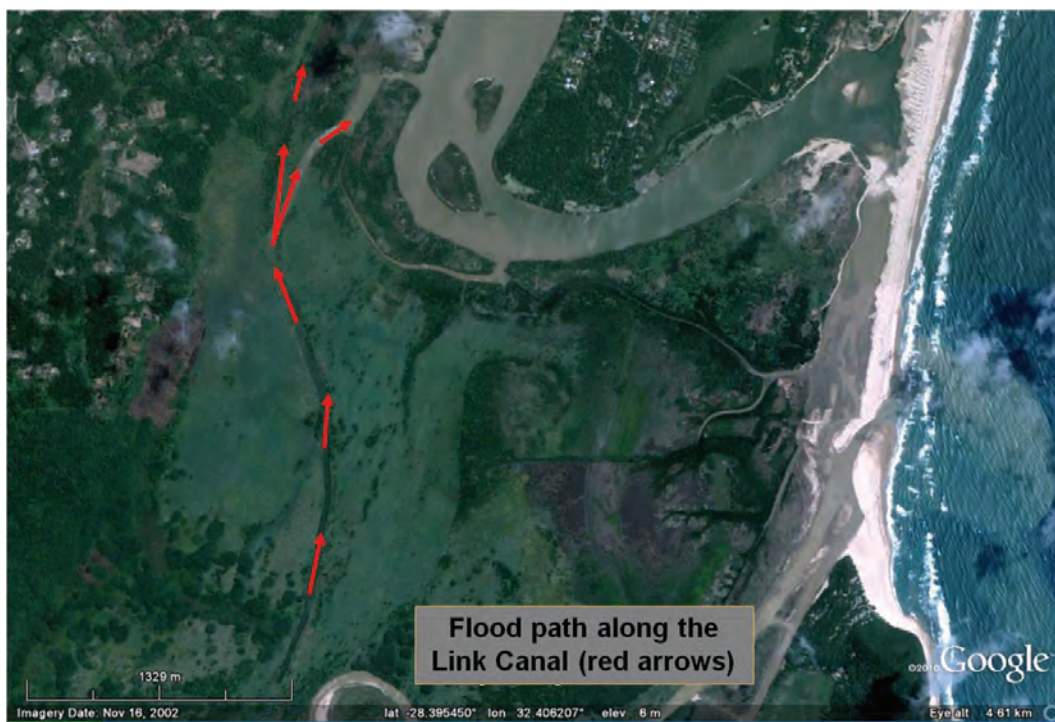
Figure 101. The path for flood waters that overtop from the Mfolozi River during flood events. This water passes into Honeymoon Bend.

The need for flood protection of the Link Canal was discussed at the Mouth Management Meeting of 22 November 2010. There could be channel-switching of the Mfolozi – then all the Mfolozi flows would come into St Lucia (and the sediments). (Figure 101).

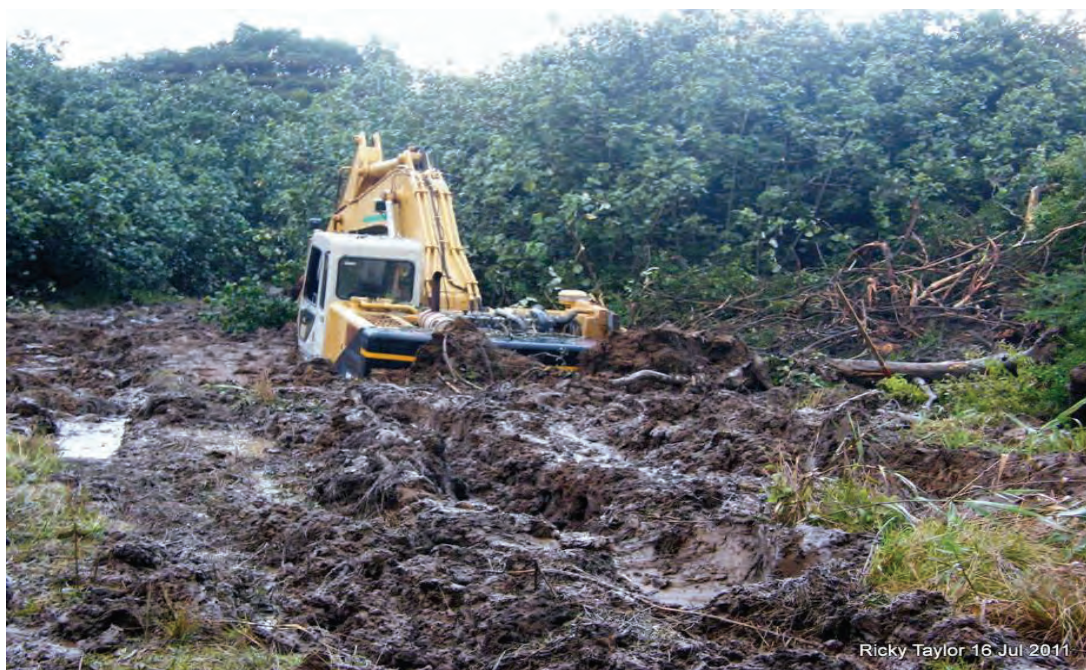
Figure 107: The long-boom excavator stuck in the silt while working on the additional outlet for the Back Channel. Its tracks are not visible as they are completely under the mud.

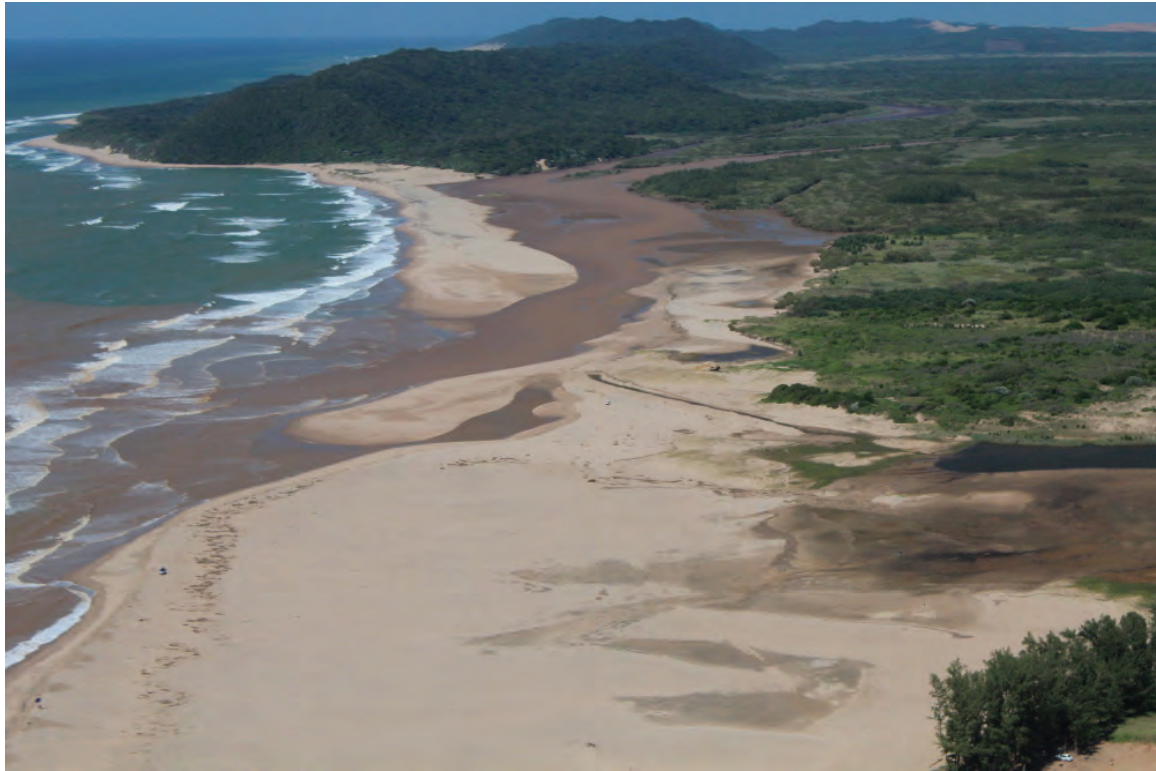
Figure 114. The canal excavated to link St Lucia with the Mfolozi Estuary. It had not yet been joined to the Mfolozi Estuary.

In February 2012 the Beach Channel was excavated immediately behind the beach berm to link the Mfolozi to St Lucia. It was hoped that the Mfolozi Mouth would migrate northwards to link into this channel. However in early March the area was affected by the close proximity of Cyclone Irina. Its winds and associated waves affected the Mfolozi Mouth. Waves overtopped the berm to the south of the Mfolozi Mouth and caused it to create a new mouth some 300 m south of the existing one. The connection of the Mfolozi via this channel was finally effected on 6 July 2012.
