# CONSIDERATIONS IN THE HYDRAULIC DESIGN OF PIPELINES

Report to the  
**Water Research Commission**

**WRC Report No. TT 650/15**

**February 2016**

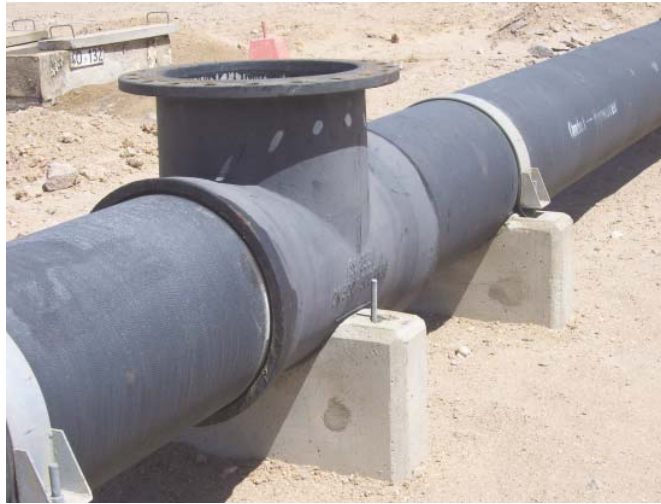
**Figure 2-6: Provision made for an air valve on a 700 mm diameter water main**

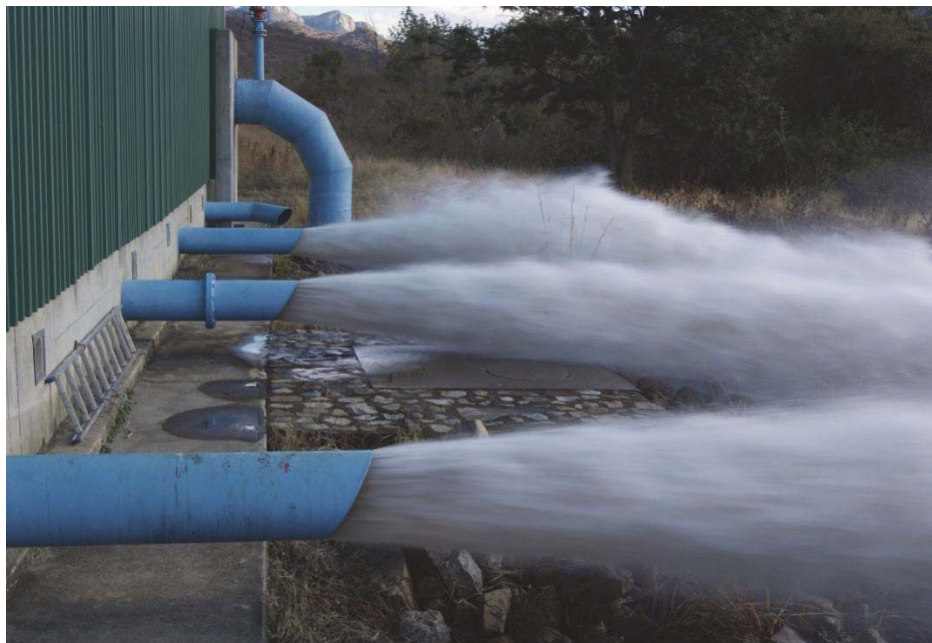
**Figure 2-11** shows the discharge through the scour valves during the field tests.

**Figure 2-11: Three scour valves opened during the field test on the LBIS (July 2010)**

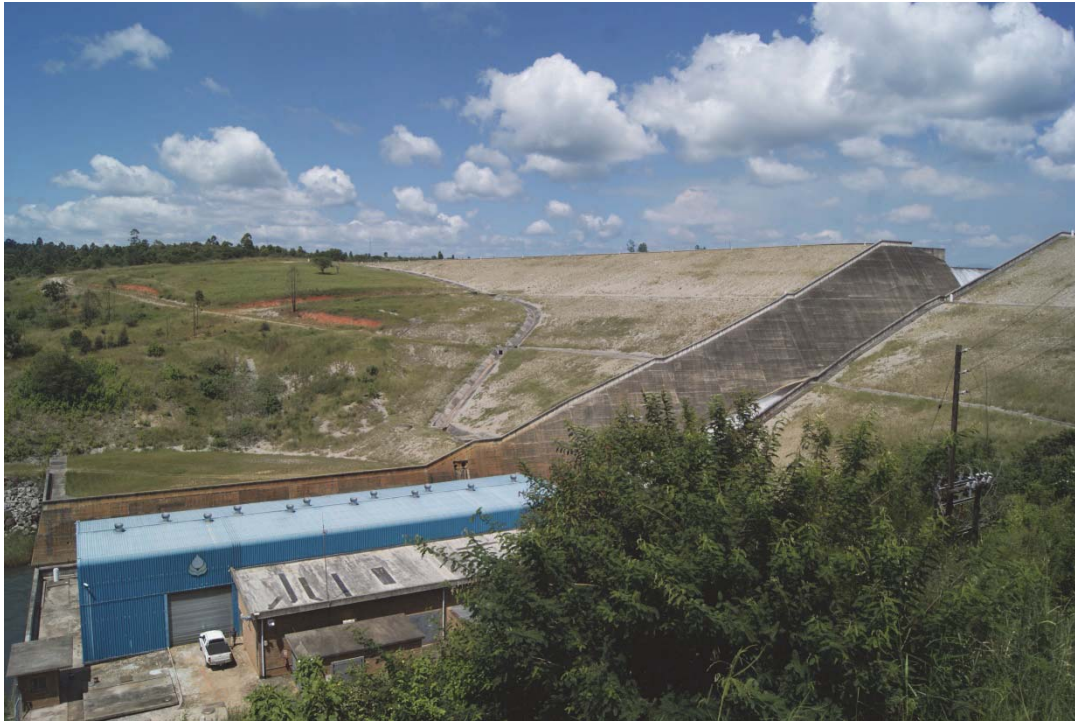
**Figure 2-12: Pump Station at Inyaka Dam**

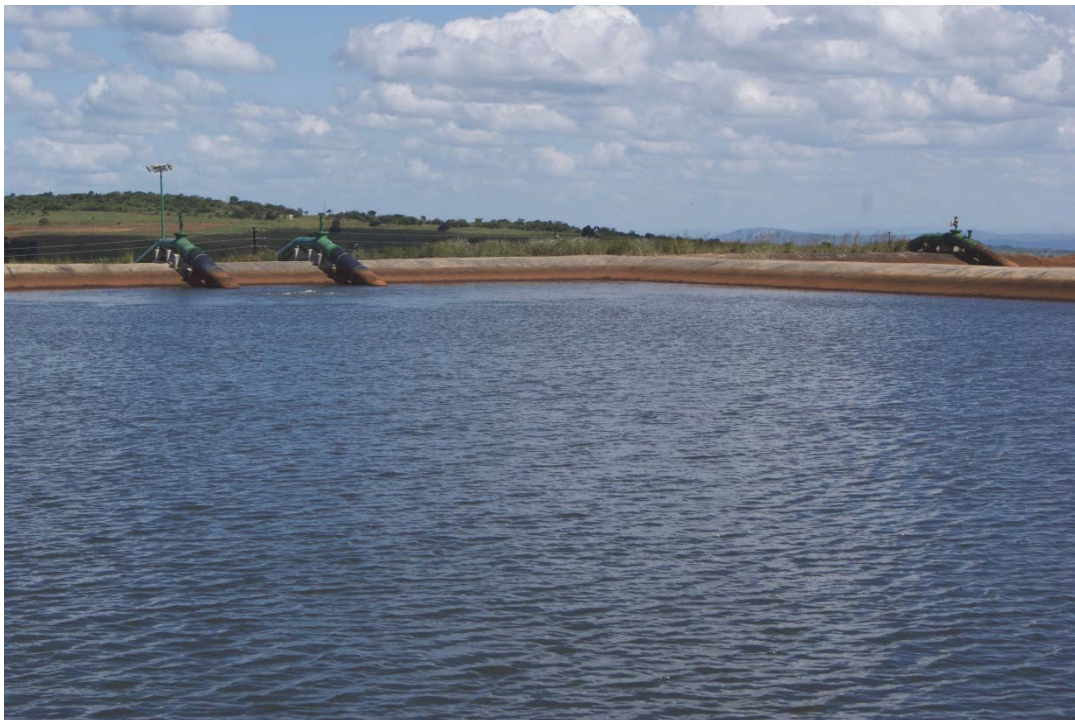
**Figure 2-13: View of the balancing dam at the BRWTW**

The water supply system to the Bushbuckridge Water Treatment Plant consists of two 700 mm diameter steel pipelines with an internal epoxy coating. Field tests were conducted during February 2014 on the new 700 mm diameter pipeline which was installed in 2012/2013. The pipeline has a length of about 2 km, conveying the water from the raw water pump station at Inyaka Dam (**Figure 2-12**) to the raw water balancing dam (**Figure 2-13**) at the Bushbuckridge Water Treatment Plant (BRWTW).

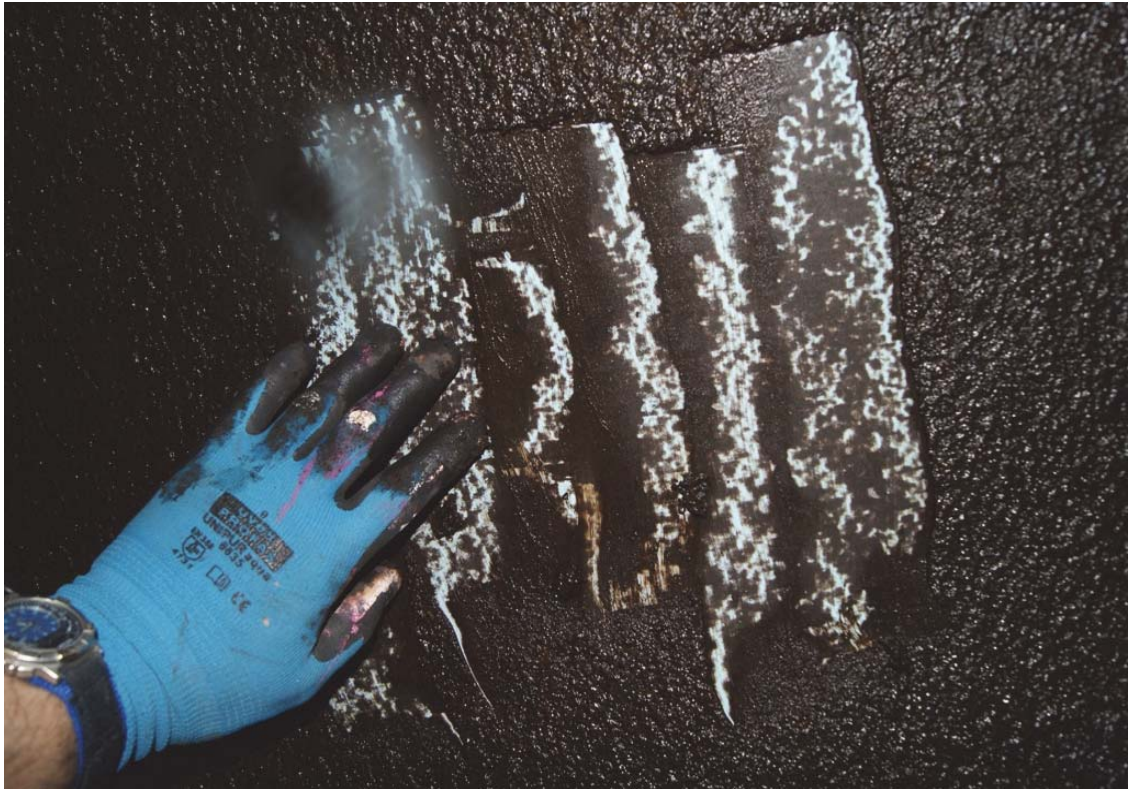
**Figure 4-1** shows the residual layer of deposited material resulting from biofouling in the LBIS. In **Figure 4-2** the biofilm residual in the 700 mm diameter steel pipeline after 6 months in operation is shown.

**Figure 4-1 : Example of biofilm growth (MOB) in large diameter pipelines (Blyde River Irrigation System)**

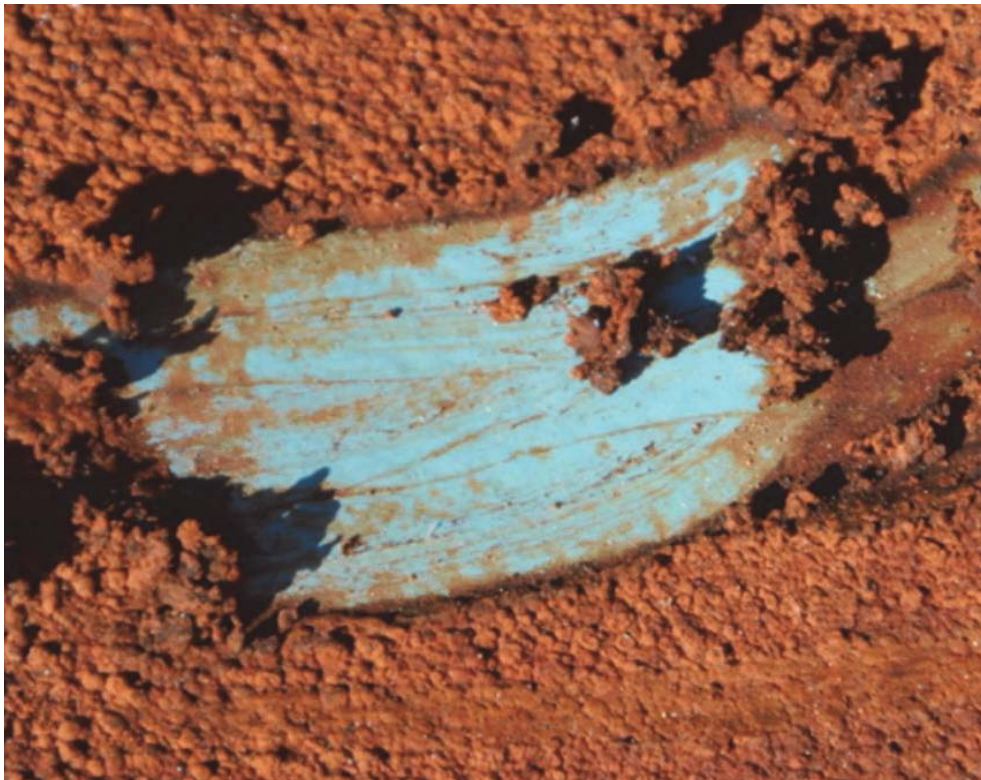
**Figure 4-2 : Example of biofilm growth (Inyaka Pumping Main) in the raw water pipeline supplying the Bushbuckridge Water Treatment Plant**

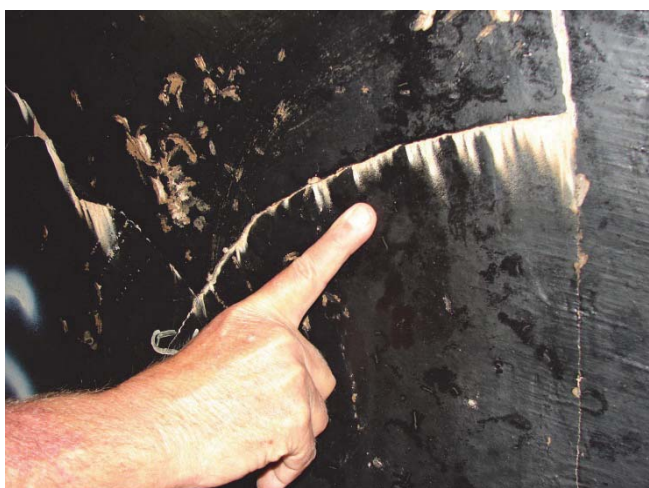
**Figure 4-3: Typical view of the internal conditions of a pipeline with little or no biofouling  
(Option 1)**

**Figure 4-3 to Figure 4-6** show examples of typical biofouling “options” in water mains, mimicking the three options catered for in the BRM (biofilm Options 1 to 3).

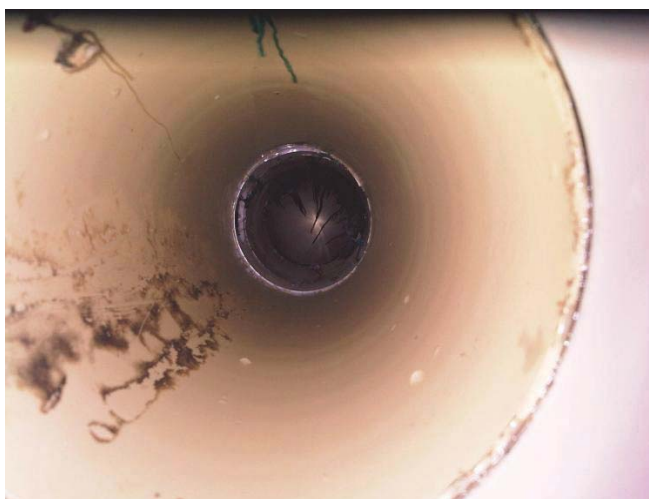
**Figure 4-4: Typical view of the internal conditions of a pipeline with some biofilm growth but  
without residual material in the biofilm (Option 2A)**

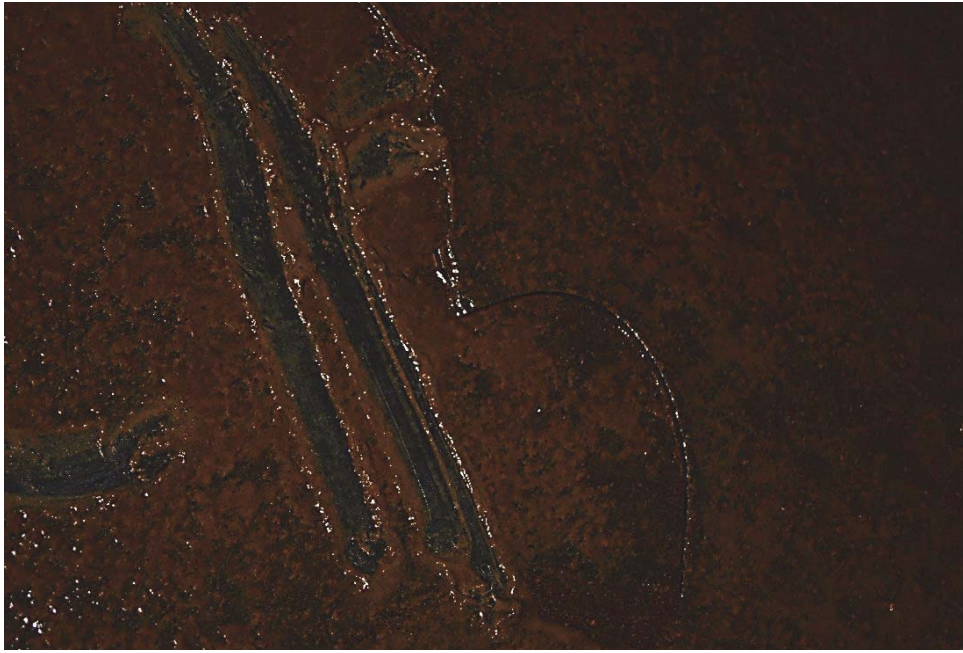
**Figure 4-5: Biofilm growth on bitumen liner (Option 2B)**

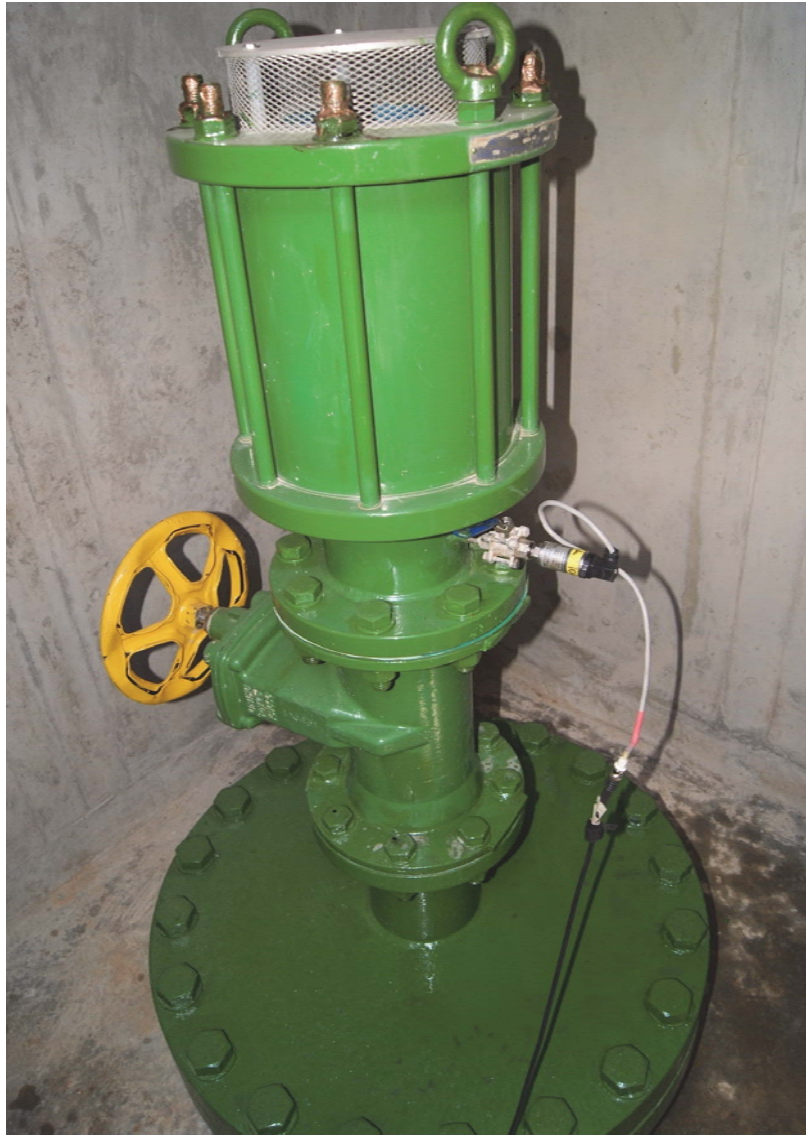
**Figure 5-3** provides photographic details of a typical pressure tapping position.

**Figure 5-3: Pressure tapping position on an air valve body**

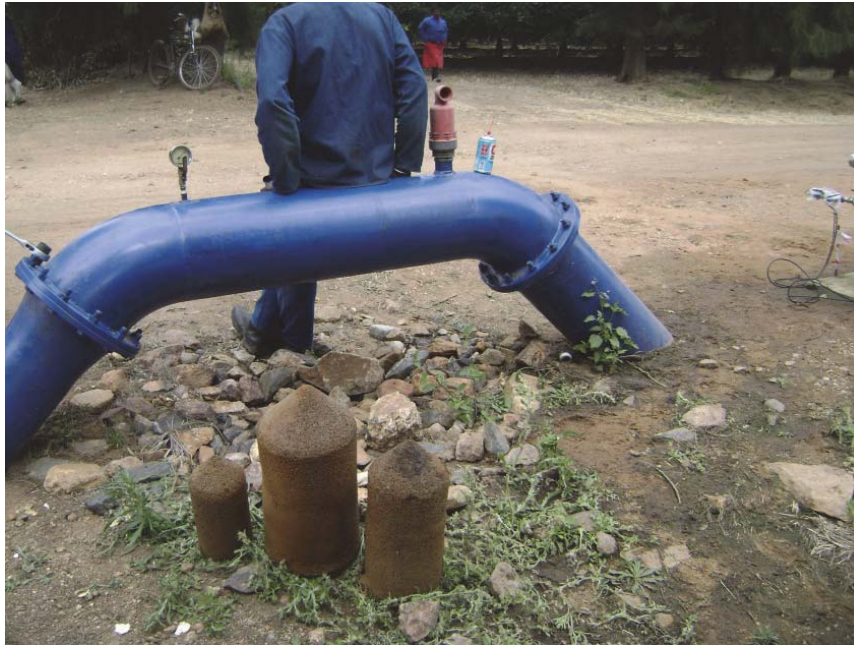
**Figure 5-6** reflects a typical pigging station on a 250 mm pipeline where the gooseneck is dismantled to function as receiving station from the upstream side as well as the launching station for the downstream (here diameter changes can be accommodated).

**Figure 5-6: Examples of a pig station on a 250 mm pipeline**
