SFD Promotion Initiative

Dannhauser Local Municipality

SFD Lite Final Report

SFD Lite Report Dannhauser Local Municipality, South Africa, 2018

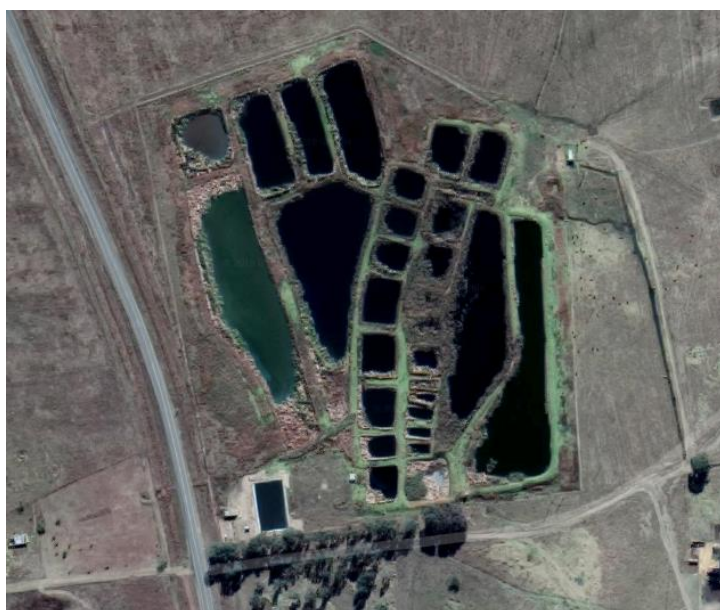
Figure 3: Ariel view of Dannhauser WWTW (Tweediedale Ponds)

The Dannhauser WWTW (Tweediedale Ponds) (design capacity: 2 ML/d) consists of 14 ponds and also accepts tankered effluent (if there is no access to Dannhauser #7 Pump Station). The works are properly fenced with controllable access via a security guard. At the time of the site inspection, there was however evidence that animals had recently entered the site (visible droppings – likely goats). Sludge appears to be accumulating in the ponds, and access to some of the ponds is challenging.

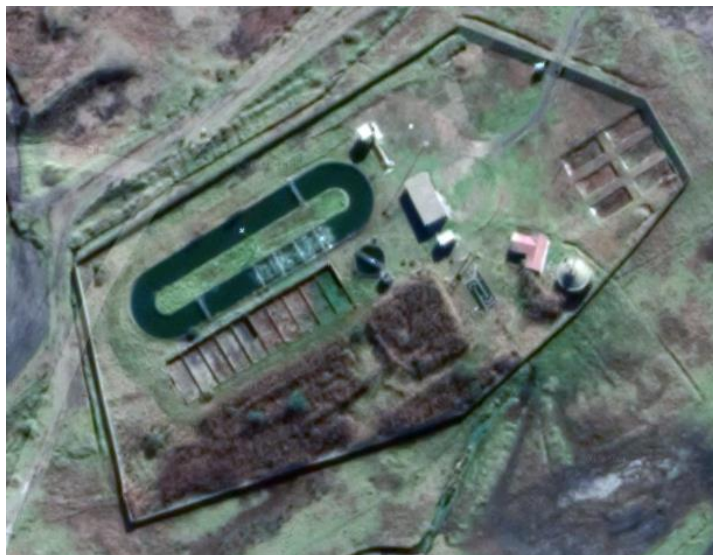
Figure 4: Ariel view of Durnacol WWTW

The Durnacol WWTW (design capacity: 2 ML/d) is an oxidation ditch system based on activated sludge treatment technology. Final effluent is disinfected before it is released to the nearby wetland. The works are properly fenced with controllable access via a security guard. Only 3 of the on-site drying beds are in use, and the sludge digester is no longer in use.

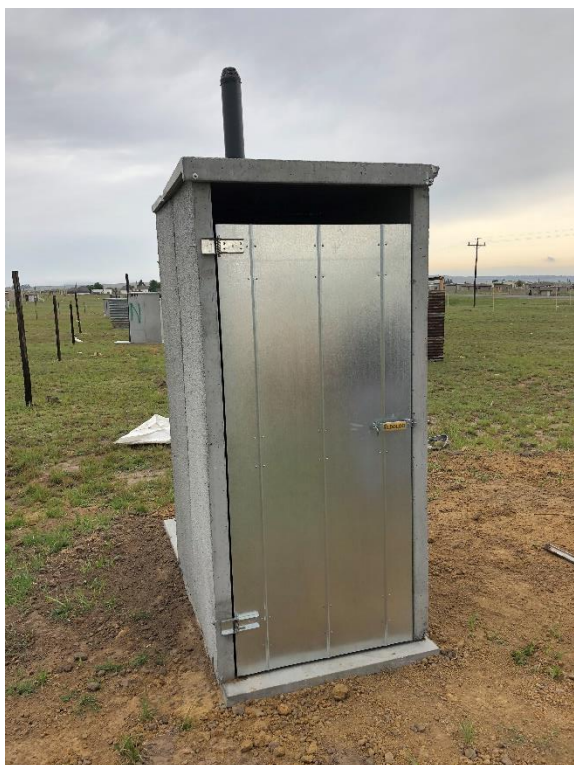
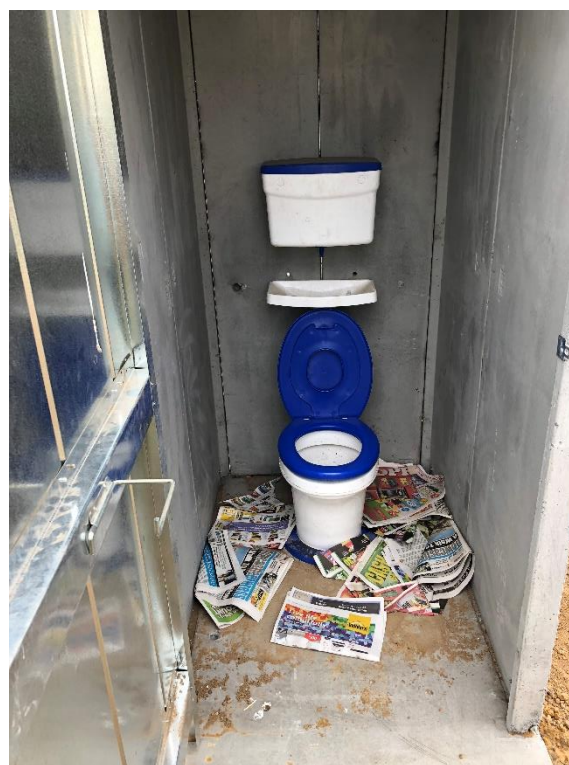
Figure 9: Newly constructed VIP and indicating ability to be connected to water supply (in future, if required)

There are parts of Ugie urban and rural areas where communities use VIP toilets. All VIPs installed within Dannhauser LM are thought to be fully lined (i.e. both on sides and bottom, due to high groundwater table/risk of groundwater pollution). To-date, these toilets have never been emptied, and indications are that some of these VIPs are filling rapidly (i.e. were they all dug deep enough?). In rural areas, communities are used to covering up and abandoning a full VIP and relocating the VIP to a new location. In the urban context, limited space could prohibit this practice.

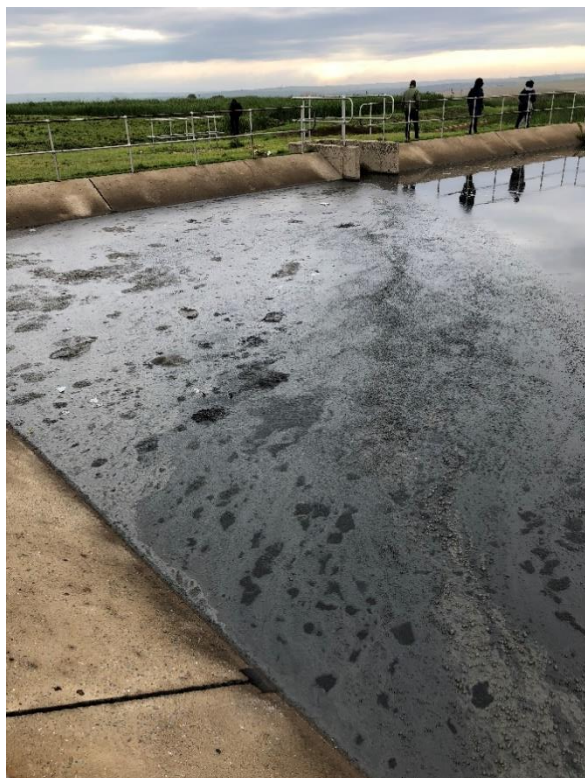
Figure 11: Pond showing accumulated sludge at Dannhauser WWTW (Tweediedale Ponds)

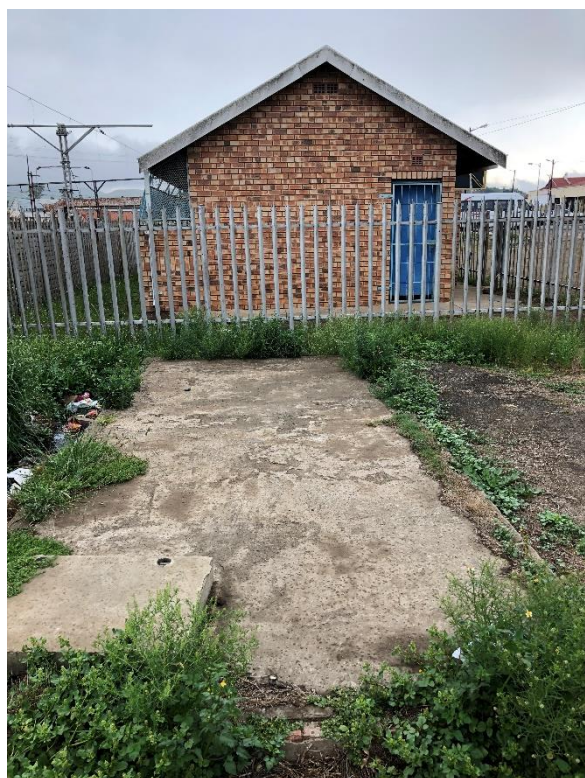
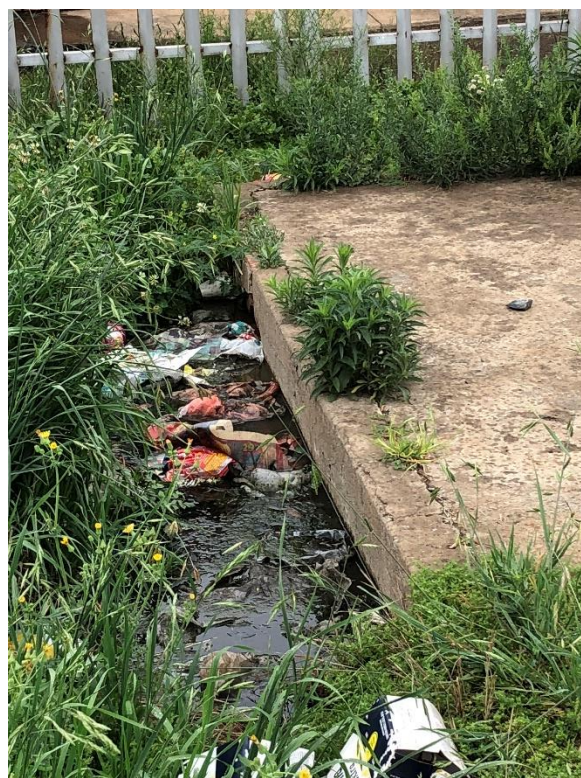
Figure 12: Evidence of leaking from taxi rank public toilet conservancy tank (Dannhauser)

- Fully lined tank (sealed, no outlet or overflow) – these are:
 - Buried concrete or plastic tanks, both from individual households (flush toilet connected to a conservancy tank) and businesses/light industry (flush toilets connected to a conservancy tank). As there are no municipal standards for the construction of these structures, some of these tanks might not have been constructed appropriately. During the site visit, it was observed that the conservancy tank at the taxi rank was leaking.

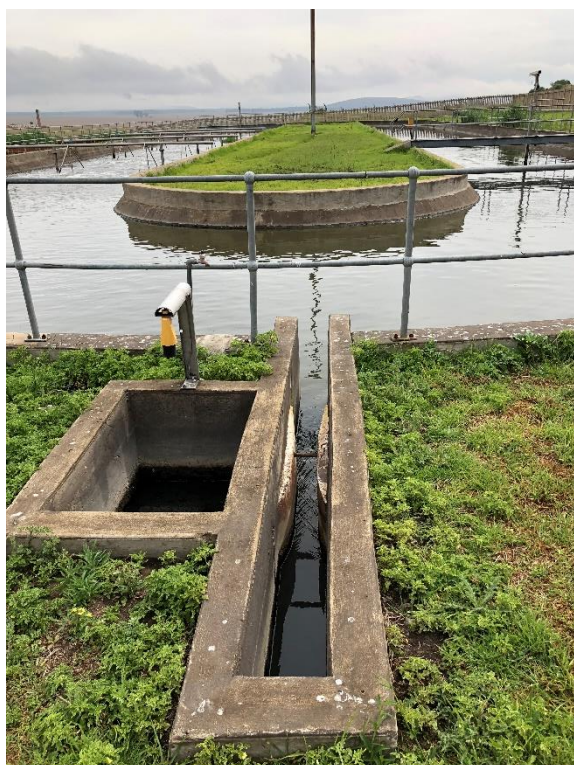
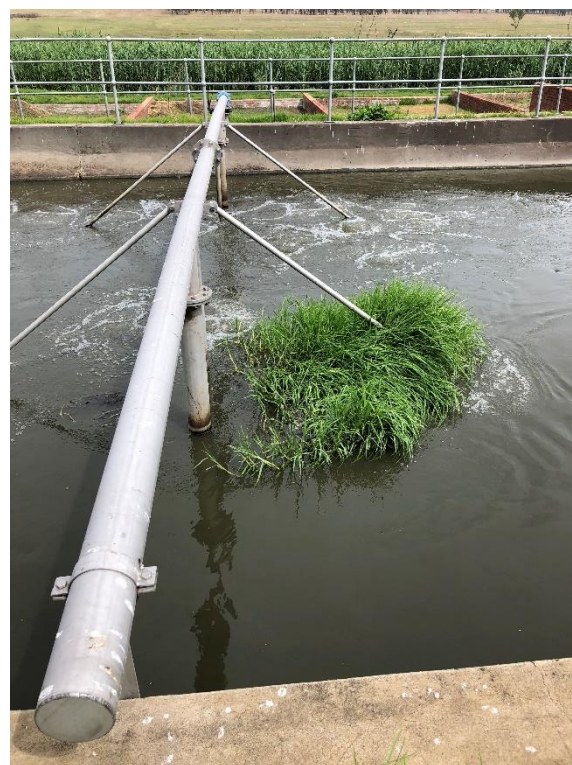
Figure 13: Durnacol WWTW with indication of required maintenance
