IRRIGATION WITH MINING-INFLUENCED WATERS IN MPUMALANGA

Final Report

to the
Water Research Commission

Report No. TT 960/25

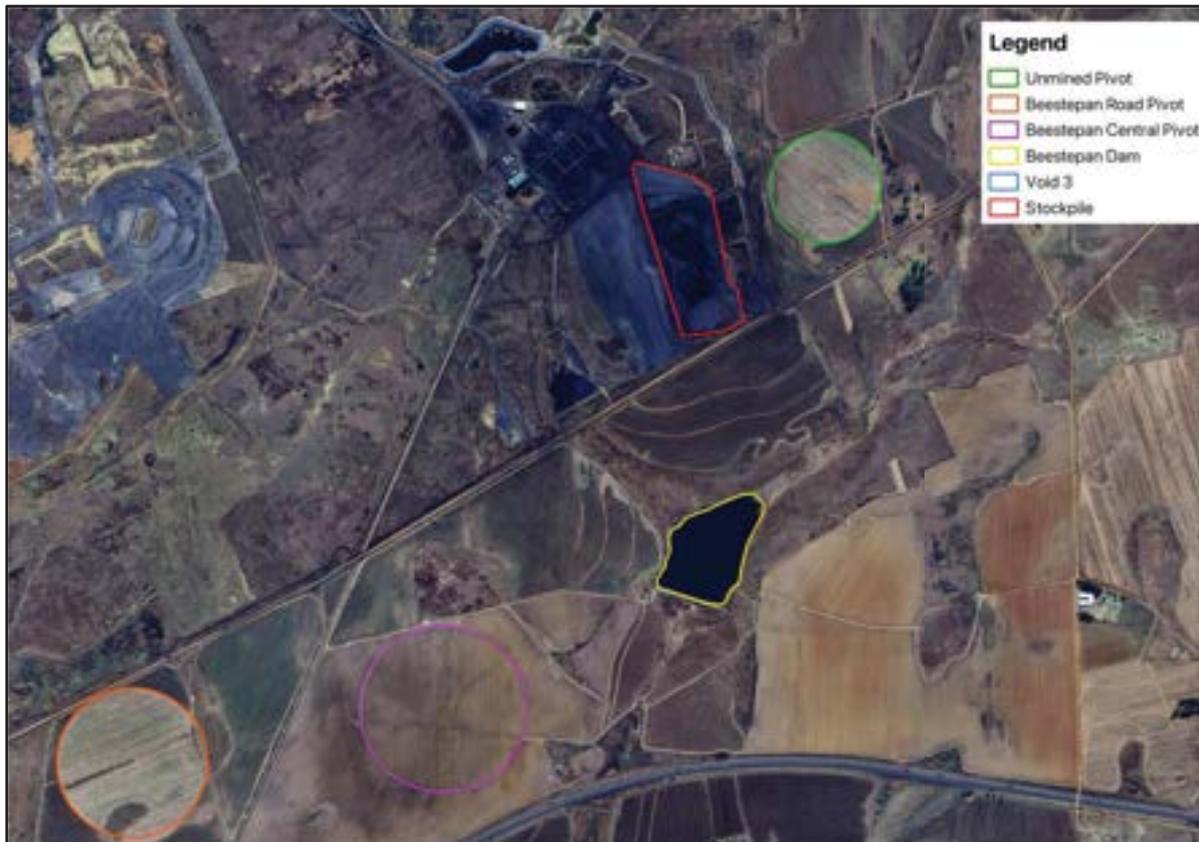
Figure 1-1: Google Earth image of the study site with the three pivots

The Mafube demonstration site was established in 2017 with WRC and industry funding (Heuer et al., 2021). Continued maintenance and monitoring of the site are vital for facilitating informed, evidence-based decision-making. Irrigation with poor-quality water can often be performed successfully in the short term, but once salinity levels or specific constituents of concern have built up in the profile to unacceptable levels, such irrigation schemes may fail. Therefore, sustainable irrigation with mine water must be demonstrated, and this site is ideal for this purpose. Three consecutive maize cropping seasons, from season 5 to 7, were monitored as part of this project. Three unmined sites, each with an irrigated and dryland area, were monitored to demonstrate the advantage of having mine water available to increase production over that of dryland agriculture. The research team refers to these irrigation sites as the Beestepan Road Pivot (31 ha), Beestepan Central Pivot (38 ha) and Unmined Pivot (19 ha) and are presented in Figure 1-1.

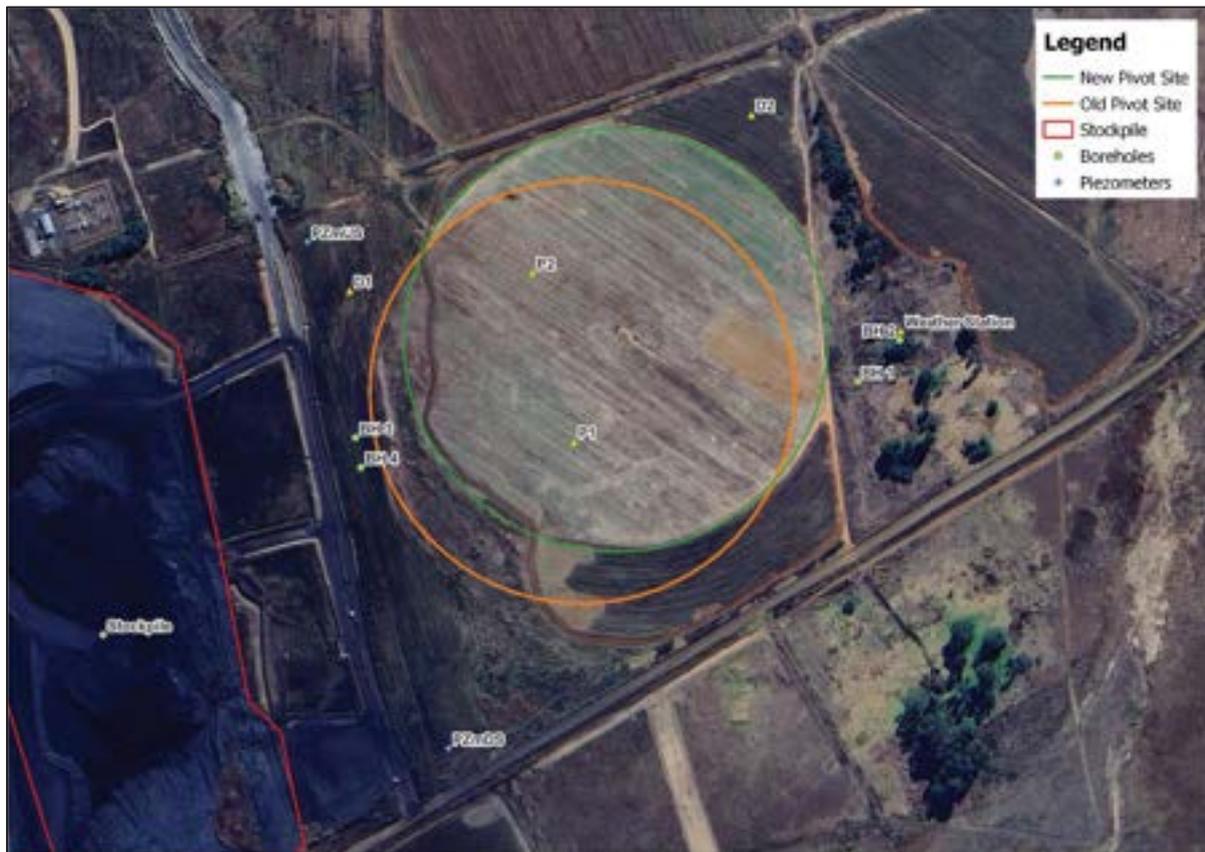
Figure 1-2: Unmined Pivot layout and monitoring sites

The Unmined Pivot was initially located near boreholes BH3 and BH4 (orange outline in Figure 1-2). However, this area was prone to ponding after rainfall and this was exacerbated by irrigation. During high rainfall events, the ponding restricted any access to that part of the pivot so cultivation and planting could not be undertaken. Even when cultivation and planting were successful, the ponding would create waterlogged conditions, impacting crop growth and development. It was, therefore, resolved to move the pivot northeast to the position outlined in green in Figure 1-2. This change was implemented at the end of the 2021-2022 season.

As seen in Figure 1-2, an automatic weather station is situated close to BH2. Any change in weather conditions is accurately monitored by the weather station. This station consists of a data logger (CR 300) with an automatic tipping bucket rain gauge (TE525MM-L), a pyranometer (LI-200R M5), an anemometer (Model 03101), and a temperature and relative

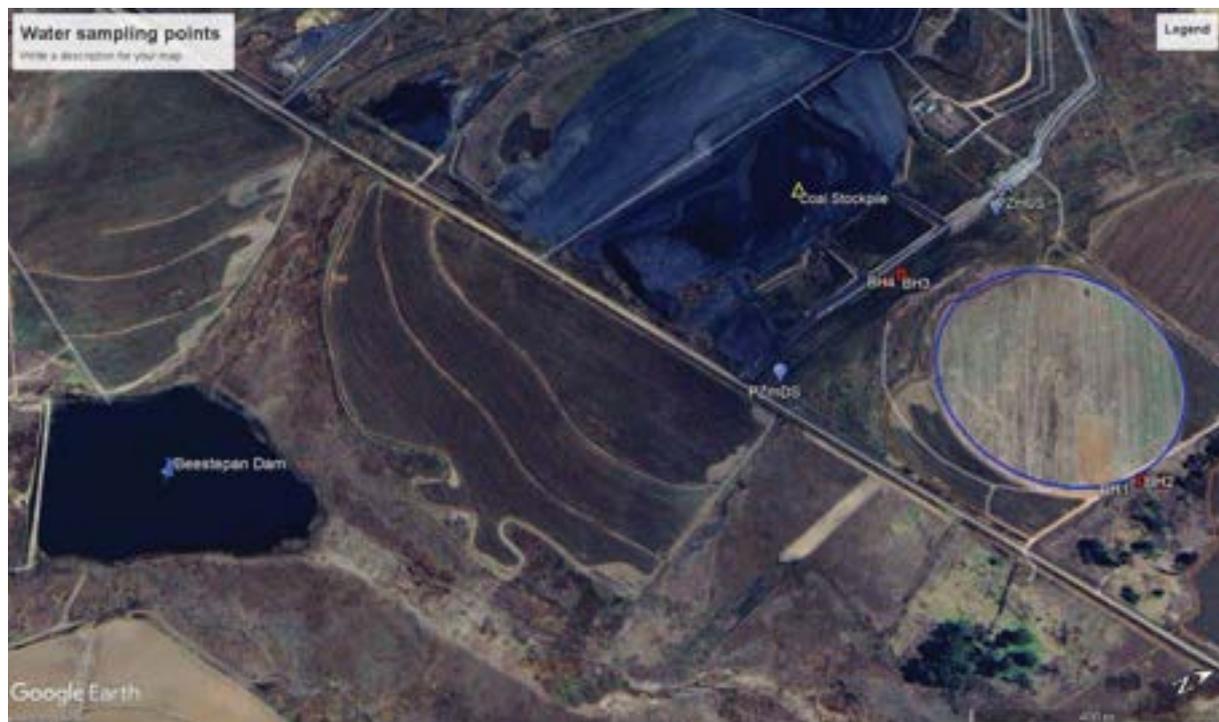
Figure 1-21 shows the locations of the piezometers and boreholes used to monitor groundwater impacts of irrigation. The piezometers and boreholes enabled the research team to sample both shallow and deep waters, with the understanding that potential impacts are likely to initially become apparent in the shallower waters.

Figure 1-21: Water monitoring stations at the Unmined Pivot

Water samples were taken regularly from the two piezometers, analysed in the laboratory, and their water qualities are presented in Table 1-10. Even though the concentrations of the various elements were generally similar, they were often higher in the downstream piezometer (PZm_{DS}). This is probably due to surface runoff from the coal stockpile directly next to Unmined Pivot (see Figure 1-21). Runoff water from the stockpile, combined with the low-lying nature of the area where this piezometer has been installed, results in almost constant waterlogging conditions throughout the summer months, which has a visible effect on the water quality at PZm_{DS}. There were slight differences in selected constituent levels between Season 6 (2022-2023) and Season 7 (2023-2024). However, these changes are not substantial, indicating minimal impact.

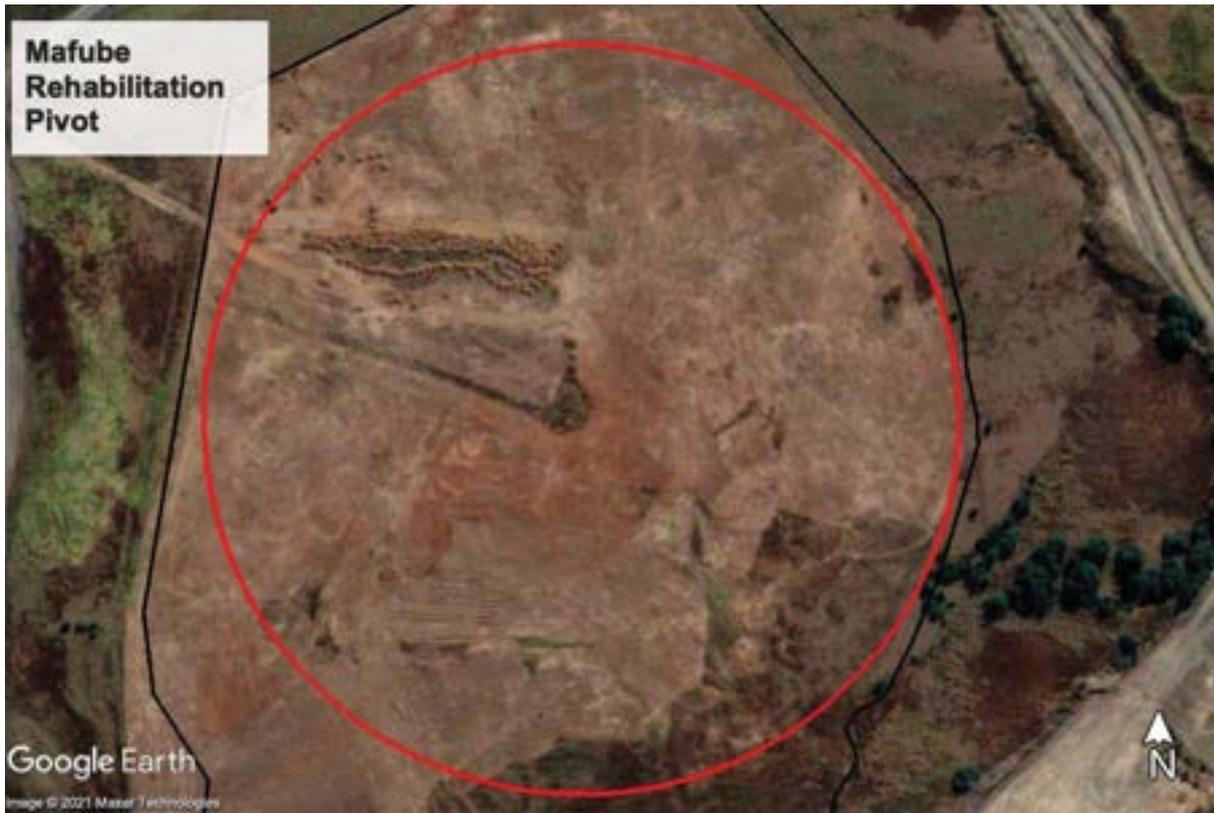
Figure 2-2: Google Earth image from May 2019 showing heaps of soil trucked in to fill additional depressions.

The subsidence and settlement that occurred as a result of the heavy rainfall necessitated additional remediation work. Suitable stockpiled soil around Mafube was selected with which to fill the depressions. In 2019, large volumes of this soil were trucked in to fill hollows, and reshaping was done with a bulldozer and grader to create a free-draining surface. Figure 2-2 and Figure 2-3 show Google Earth images of the rehabilitated site from May and July 2019. Heaps of soil that were trucked in to fill the depression that caused the ponding are visible in Figure 2-2. This soil shown in Figure 2-2 was levelled, as can be seen in Figure 2-3. Unfortunately, the additional soil trucked in was not of the same quality as the stockpiled soil originally selected for this task. This resulted in marked soil variability throughout the site.

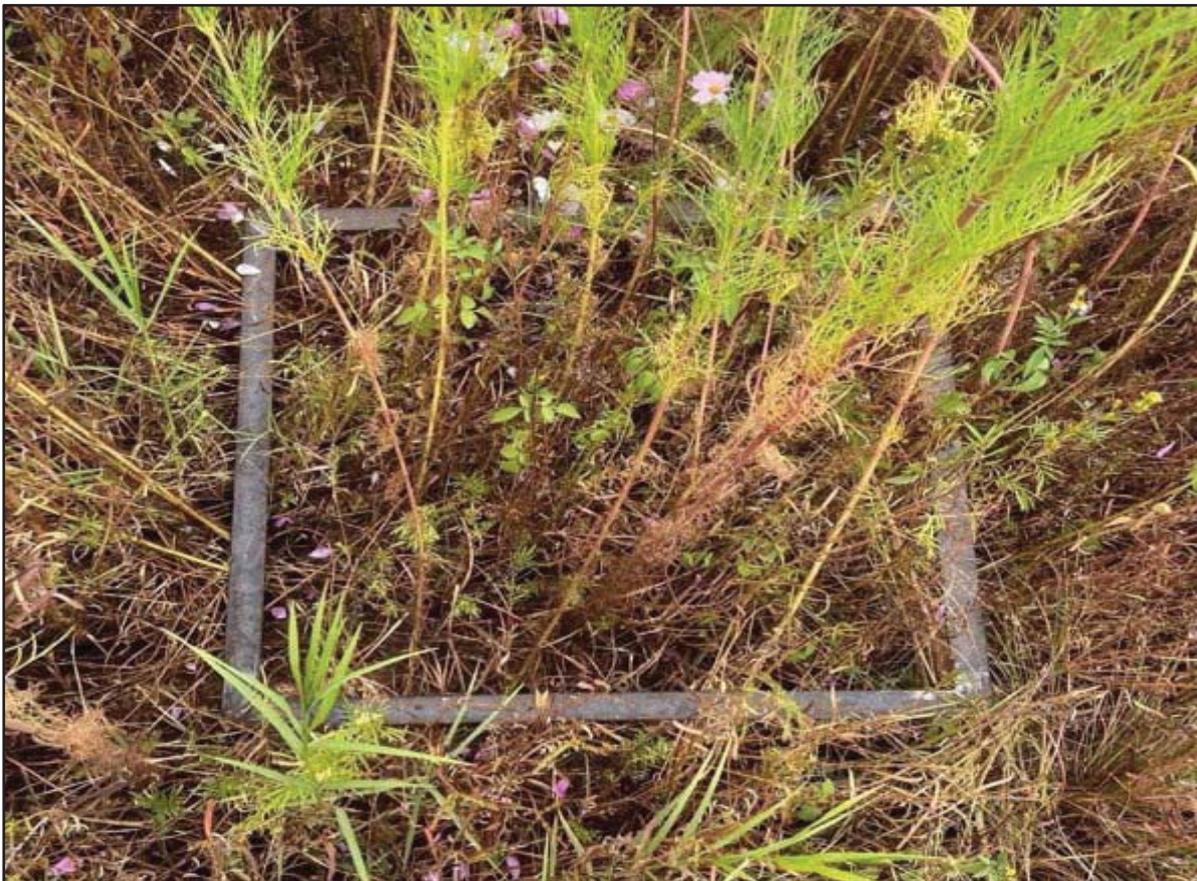
Figure 2-7 demonstrates plant material sampling. The composition of the weeds collected was 90% Cosmos (*Cosmos bipinnatus*), and occasionally Johnson grass (*Sorghum halepense*).

Figure 2-7: Steel square (0.75 m x 0.75 m) within which all plant material was sampled

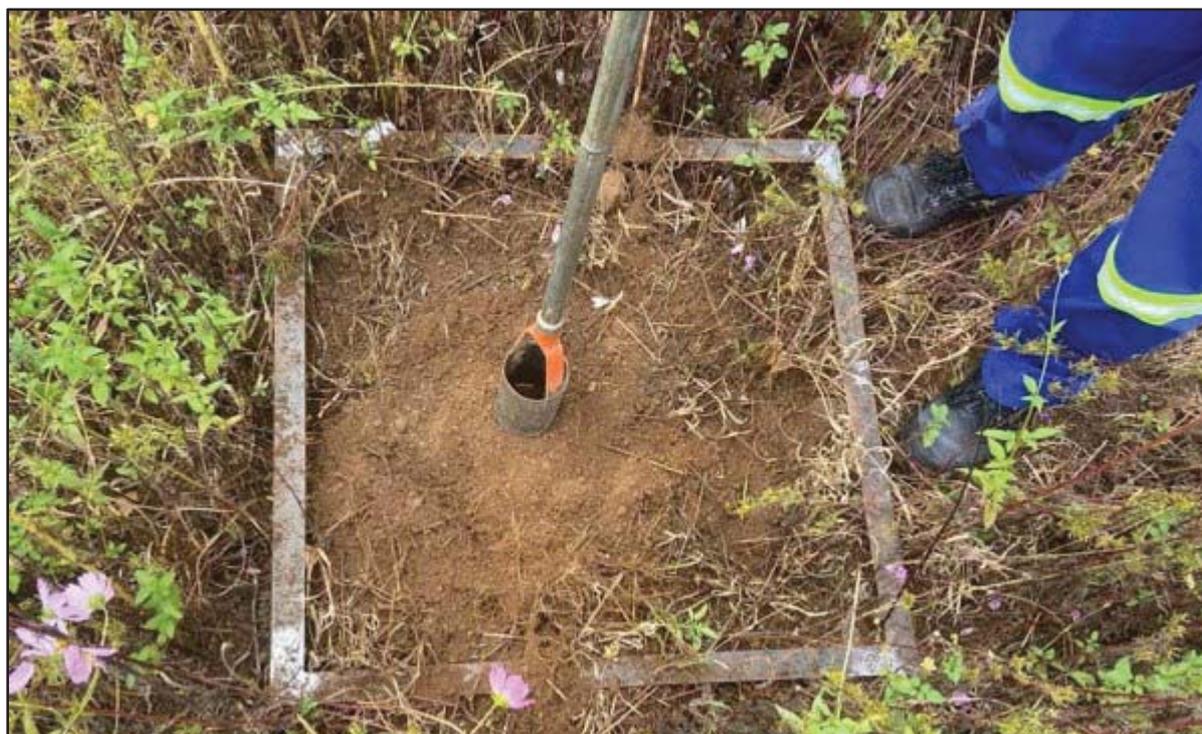
Soil samples were taken for chemical analysis of the rehabilitated area. As shown in Figure 2-8, four soil samples were taken at each sample point at a depth of 0-300 mm. The four samples were mixed, and a composite sample was taken to represent the sampling location. High variability was expected.

The short-term objective in this section was to determine if weed growth could be related to soil fertility. Figure 2-8 shows soil sampling, which was done directly after the weeds had been sampled. Sample R34 was contaminated during lab analyses and discarded.

Figure 2-8: Soil sampling in the rehabilitated field

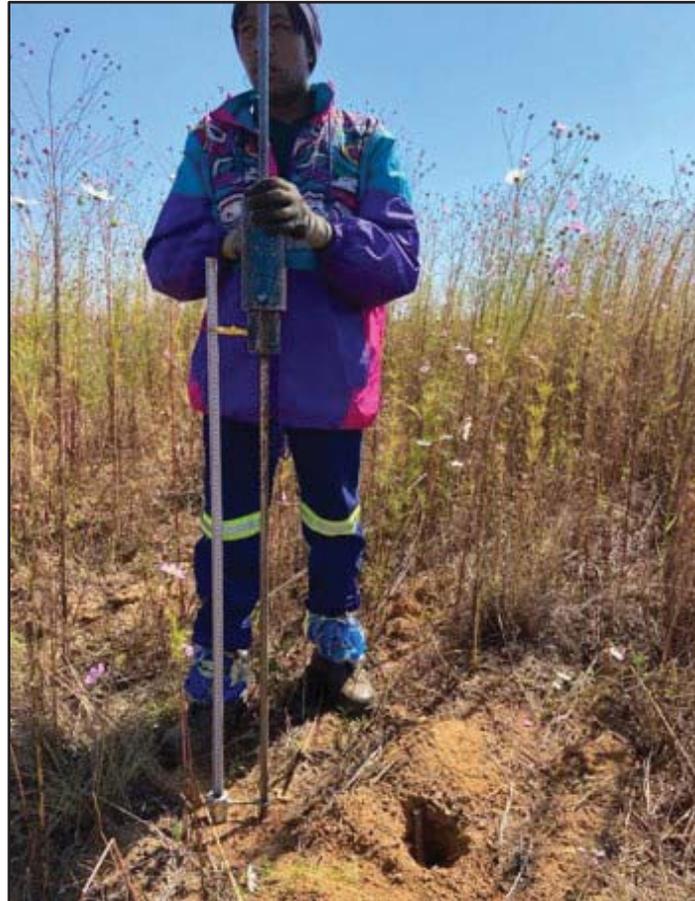
Figure 2-9: a) Schematic illustration of a Dynamic Cone Penetrometer⁵ and b) photograph of the penetrometer being used infield

Within each sample location, nine penetrometer measurements were made, three within each square (as seen in Figure 2-5). Two of the sampling points, R28 and R30, were unreachable during penetrometer sampling due to high snake activity in those specific areas. Sample locations R3 and R4 were also not measured due to the penetrometer breaking and soil preparation commencing for the winter crop.

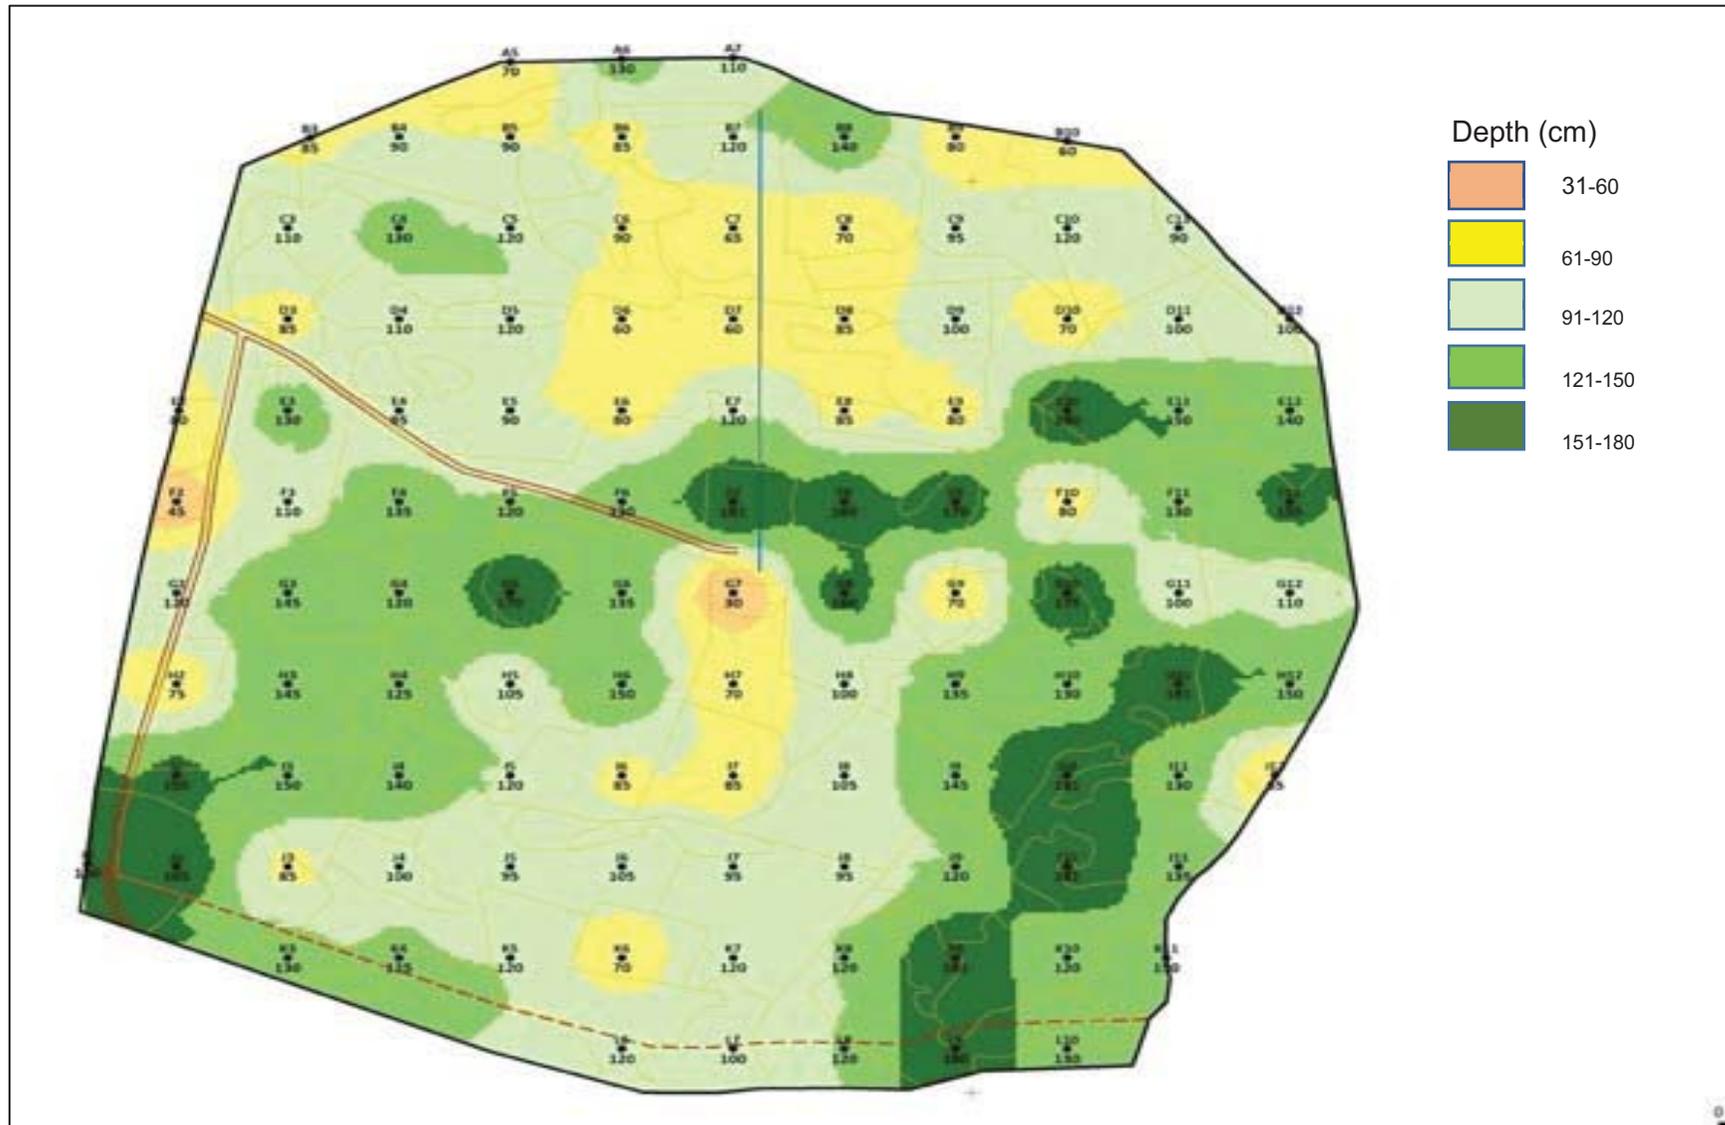
Figure 2-16: Depth to spoil at the rehabilitated area

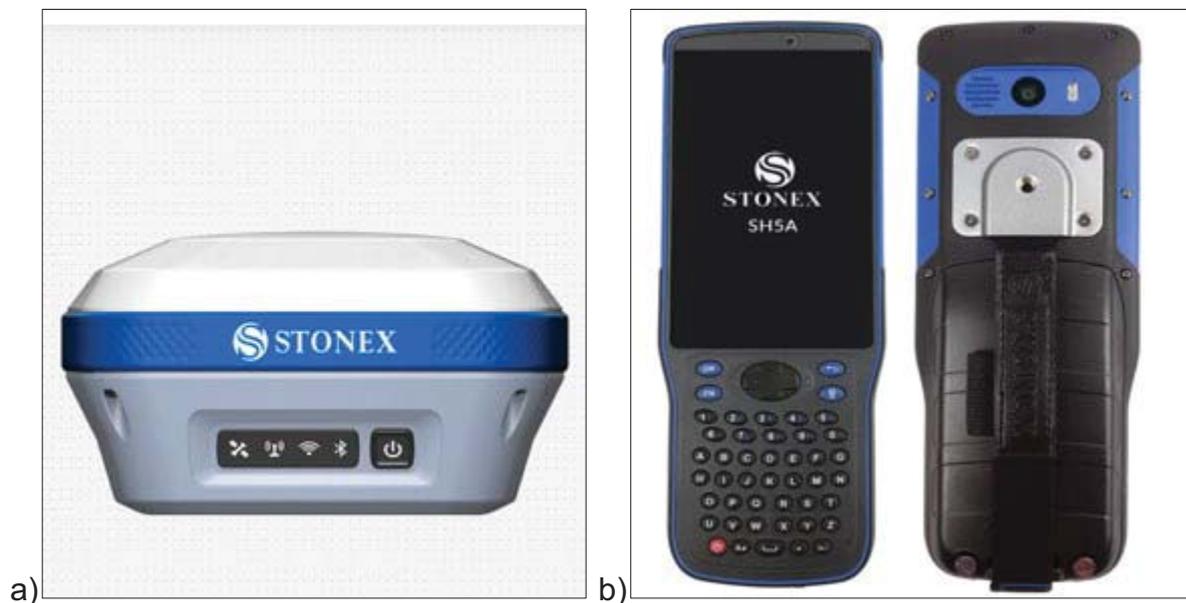
The setup consisted of two Stonex S850+ GNSS receivers, one Stonex SH5A Controller, a tripod stand for holding the base receiver, and a prism pole for holding the rover receiver and controller. One receiver was mounted on the tripod and used as part of the set up for the base station (Figure 2-26) and the other receiver was mounted on a prism pole, together with the controller (Figure 2-26 and Figure 2-27) and moved from point to point on a 25m x 25m grid taking longitude, latitude and altitude readings.

Figure 2-25: GNSS survey equipment consisting of a) Stonex S850+GNSS receiver and b) Stonex SH5A Controller.

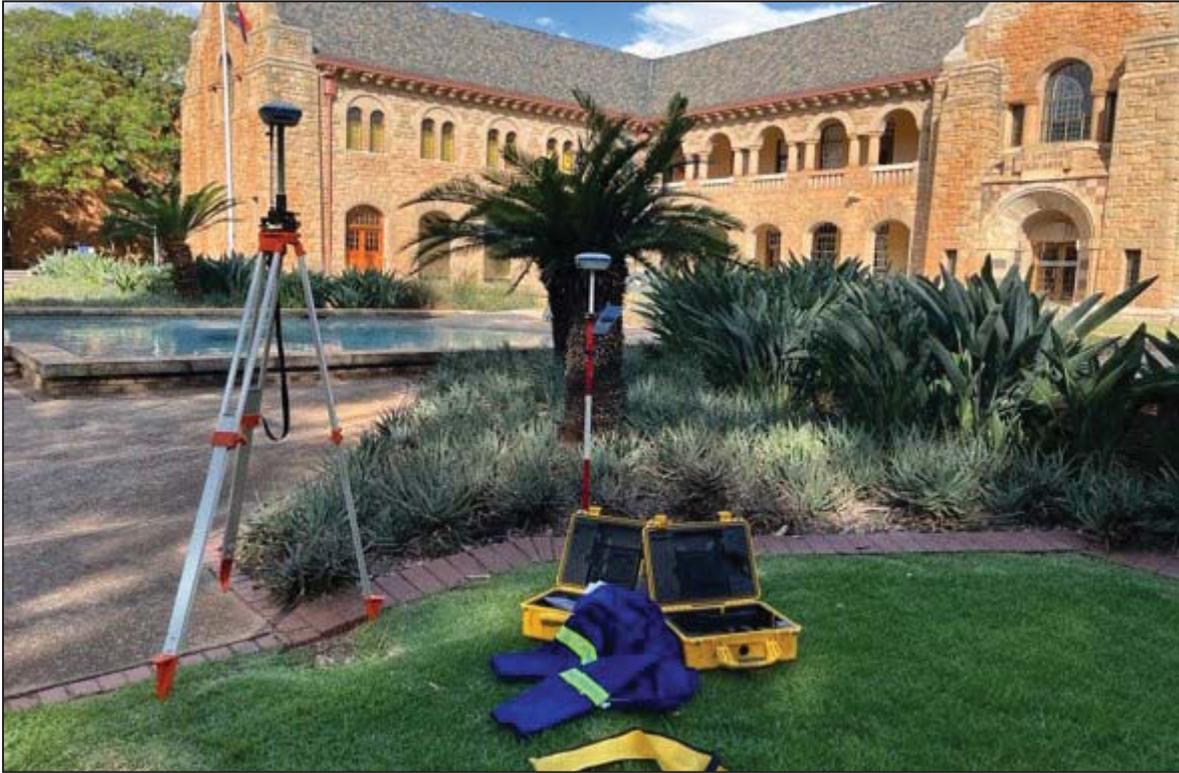
Figure 2-26: Full GNSS system set up

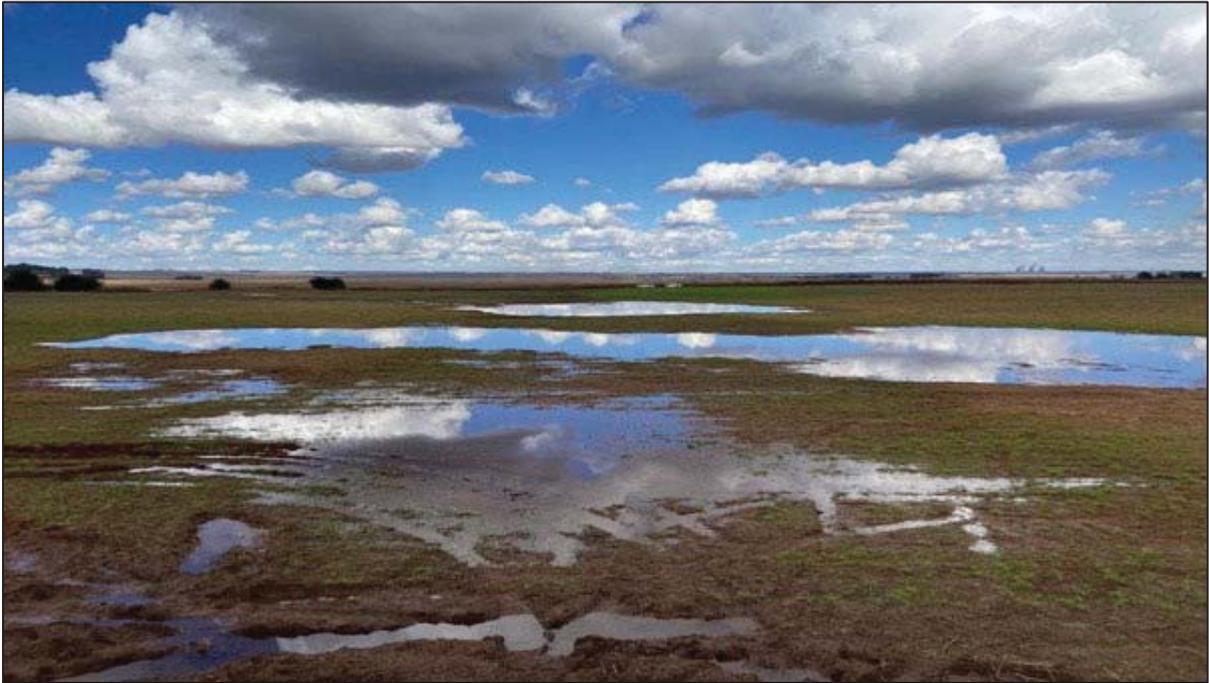
Figure 2-32: Ponding at the Rehabilitated Pivot site

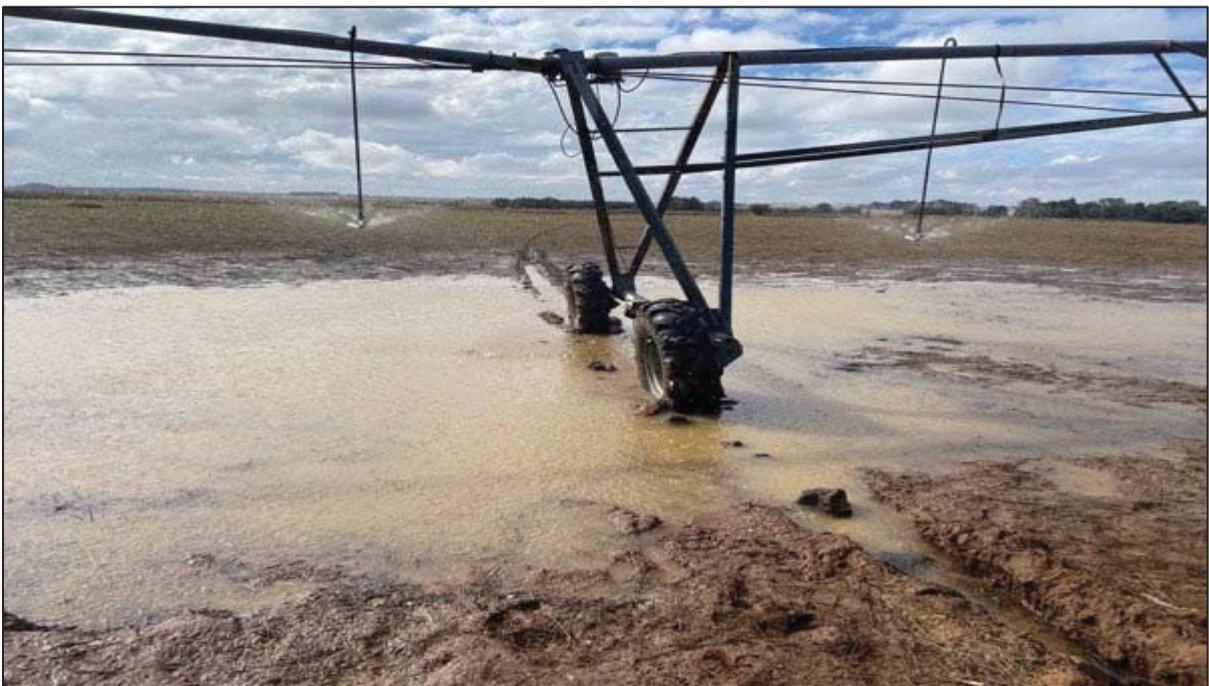
Figure 2-33: Water ponding due to surface subsidence and insufficient infilling

The ponding visible in Figure 2-33 was present for a long period of time, and whilst irrigation was at times necessary for the rest of the irrigated field, this continuously added water to ponded areas, further limiting germination in these low-lying areas.

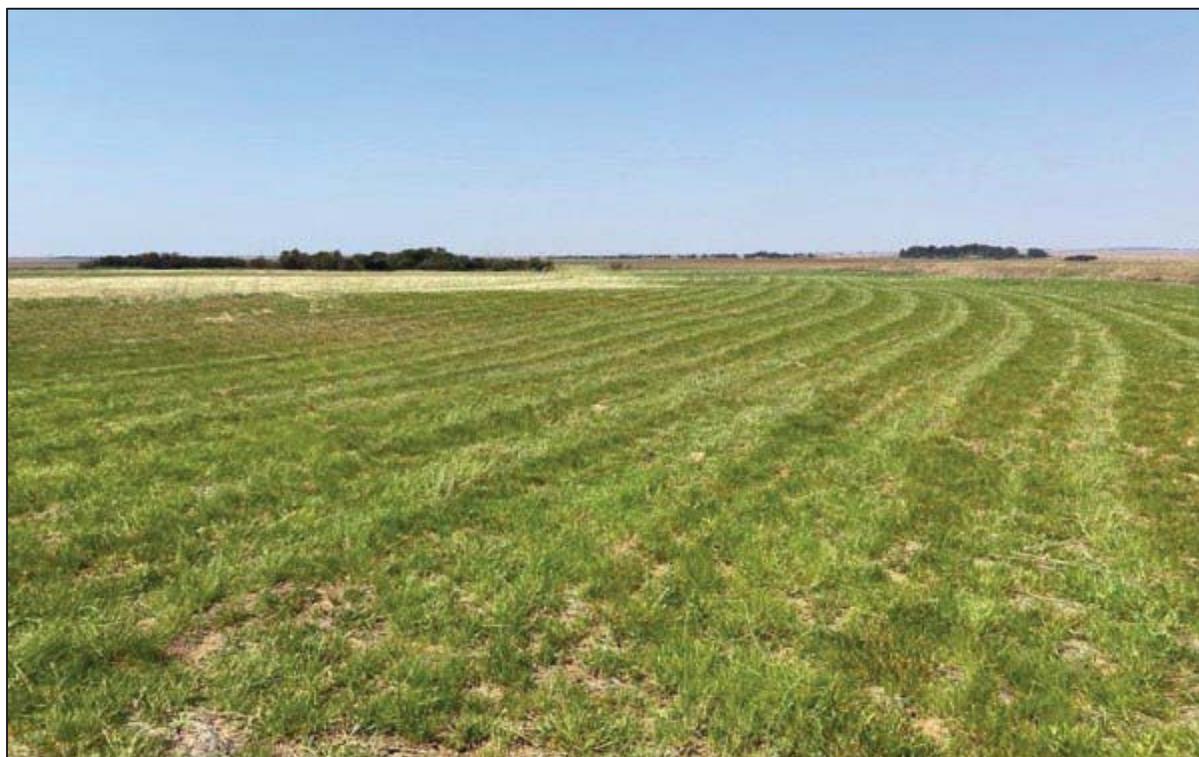
Since lucerne, which is a perennial crop, requires 6 to 12 months to be well established, and some weeds and volunteer crops establish more rapidly than this, it is normally prudent to reduce weed pressure by mowing the pasture in the early stages of establishment. This is usually done after winter and is referred to as a “winter cut”. This was carried out from 1st to 3rd October 2022. Figure 2-34 and Figure 2-35 are from the winter cut at the rehabilitated field.

Figure 2-34: Winter cut at the Rehabilitated Pivot, early October 2022

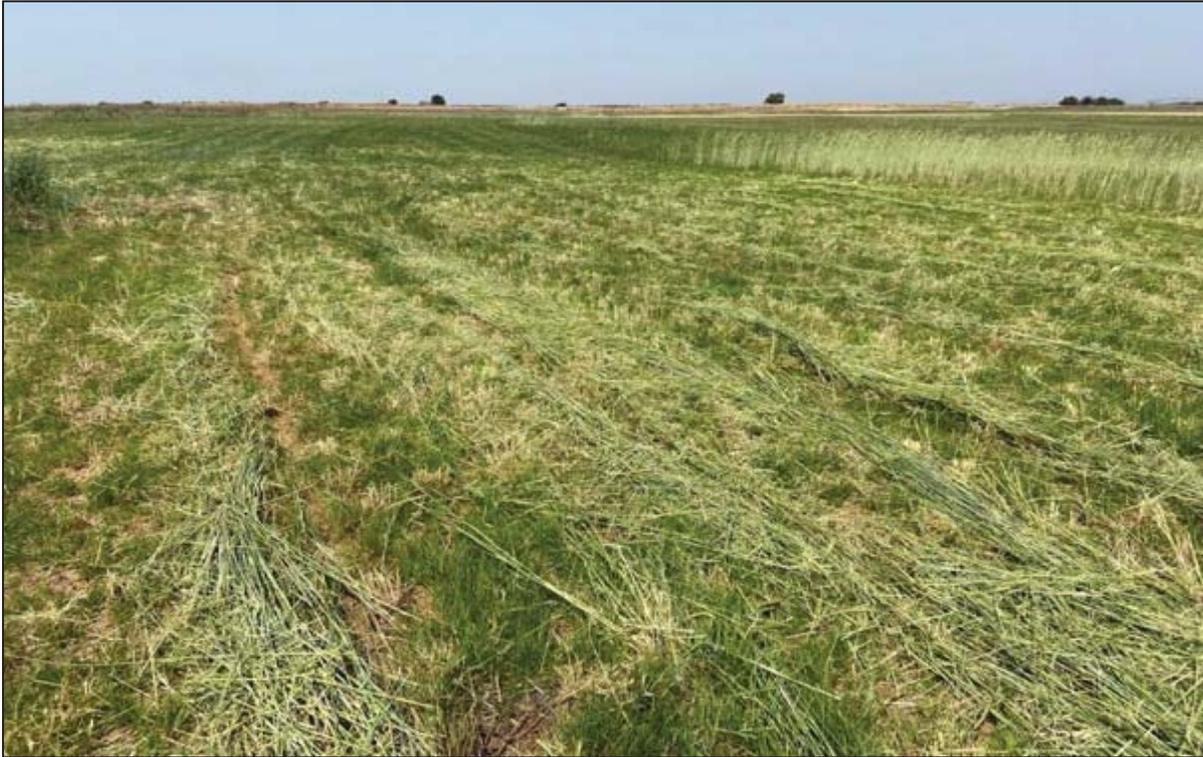
Some wheat and other temperate small grain crops germinated from previous failed attempts at establishing crops due to irrigation system challenges, and this was also removed with the winter cut, as can be seen in Figure 2-35. The regrowth of volunteer small grains in the warm season was, as expected, poor, giving the Lucerne/fescue mixture an ideal opportunity to establish. With each hay harvest hereafter, the weed population should decrease, and the pasture should become more dominant.

Figure 2-35: Remnants of volunteer small grain regrowth cleared with the winter cut, early October 2022

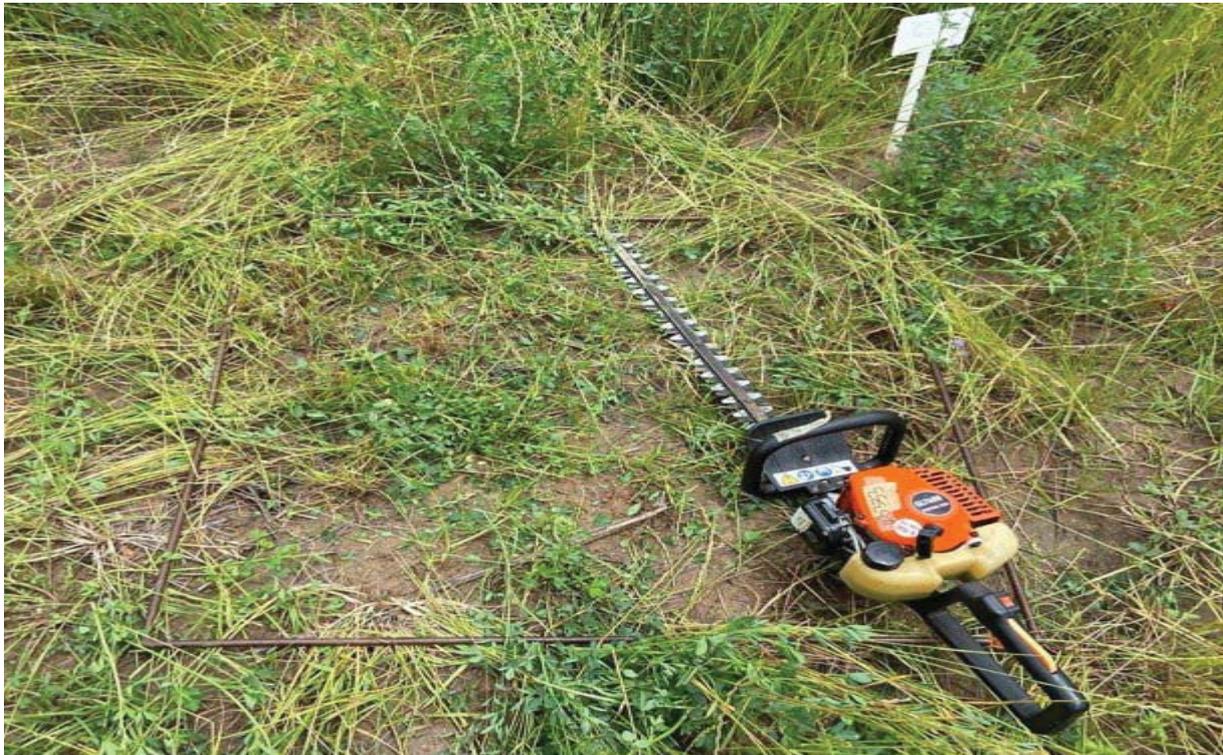
Plant samples were taken on 6-7 December 2022, the first opportunity to access the site after persistent rains. Samples were harvested 7 cm above the ground using a hedge trimmer. Figure 2-38 shows the sampling square where the material still needs to be raked up and collected after being cut. Samples were collected and dried at 65°C for 72 hours before being weighed.

Figure 2-38: Hedge trimmer and sampling square

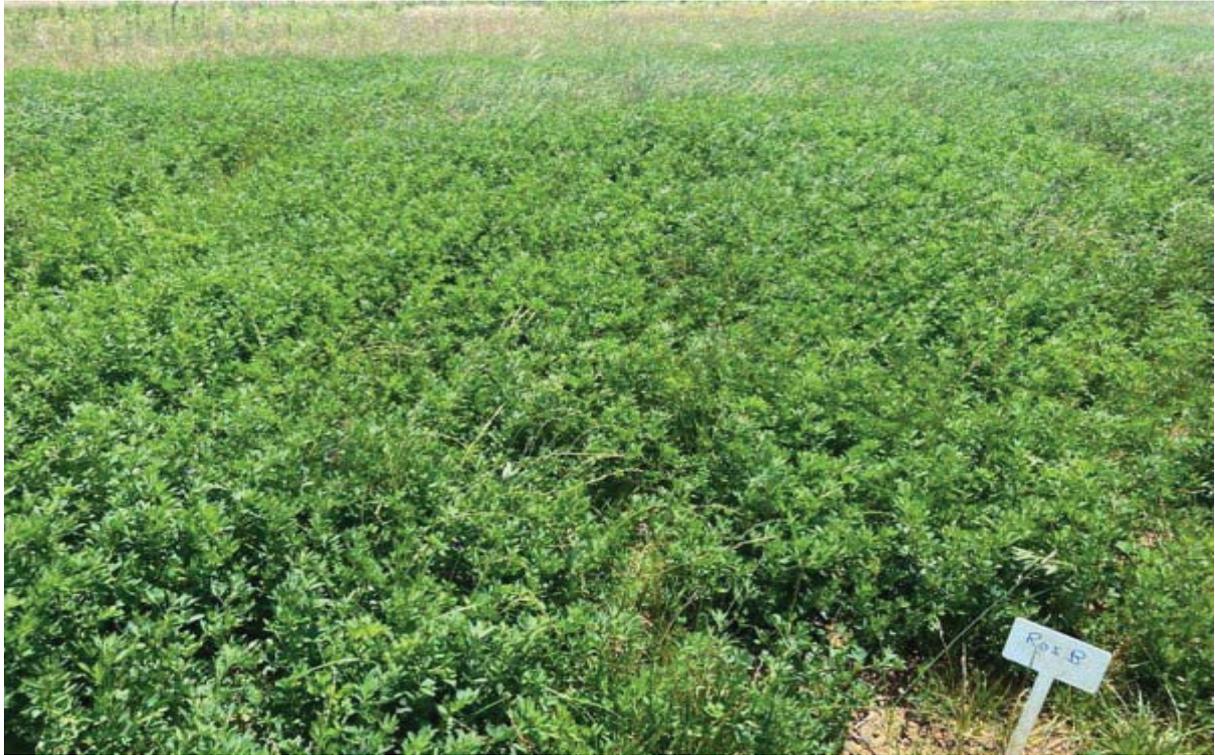
Class C was classified as areas with only grazing suitability under the dryland classification system, but were deemed suitable for irrigation. Yield and LAI were highest for class C, with an average of 2.5 t/ha and 2.9 m²/m², respectively. Good infiltration and drainage were expected due to the greater amounts of coarse material in the profiles for these sites. This seemed to be the case, and it was the reason for the higher growth in these areas. Most of the sampling classified as “grazing” showed more promising results than the areas classified as arable. Figure 2-40 is from site R 05B, where good growth of the pasture is visible with a yield for the first harvest of 3.1 t/ha.

Figure 2-40: Site R 05B with a yield of 3.1 t/ha

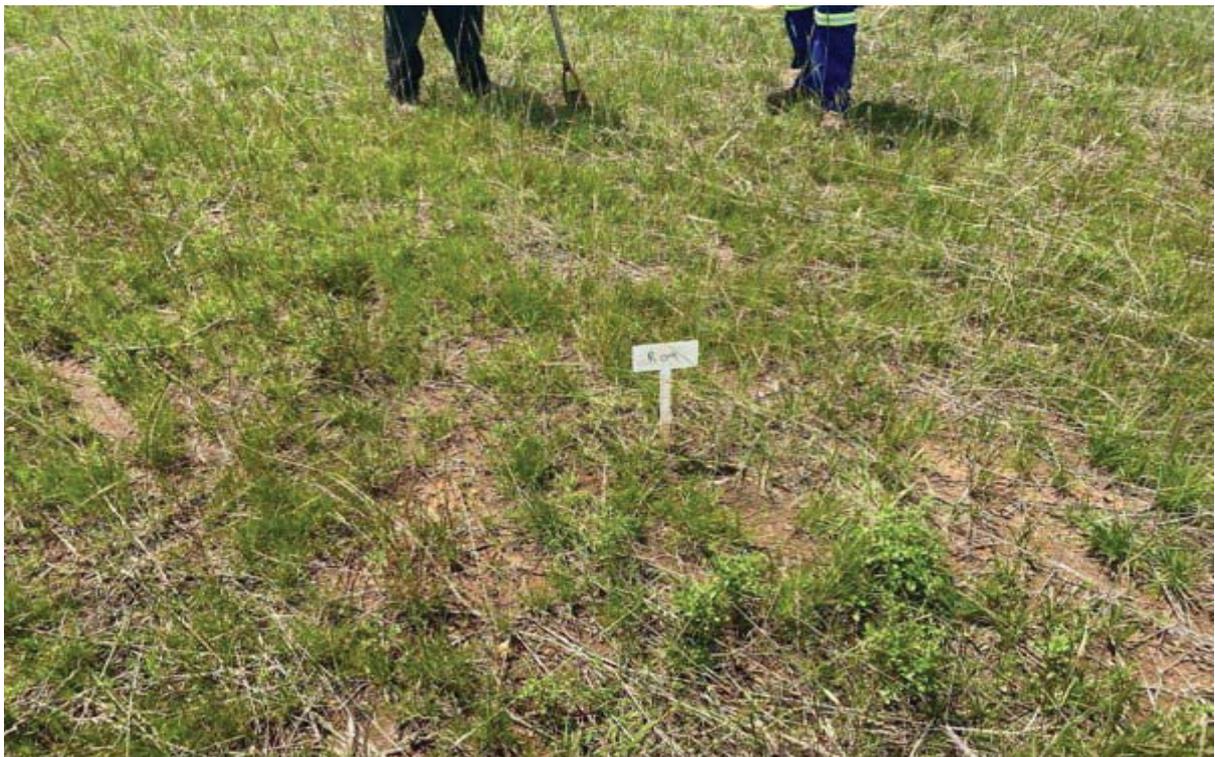
Class D was classified as wetland areas with poor arable potential according to the dryland system. Poor irrigation suitability was also predicted. R 09 and R 14 recorded very poor growth and low yields as expected. The G horizon (very high clay content) formed a sealing layer limiting aeration and water infiltration which resulted in poor growth. Figure 2-41 shows site R 09 where only 0.7 t/ha was recorded. This indicates the high variability in the rehabilitated field, as the areas depicted in Figure 2-40 and Figure 2-41, are situated less than 30 m apart.

Figure 2-41: Poor growth at R 09

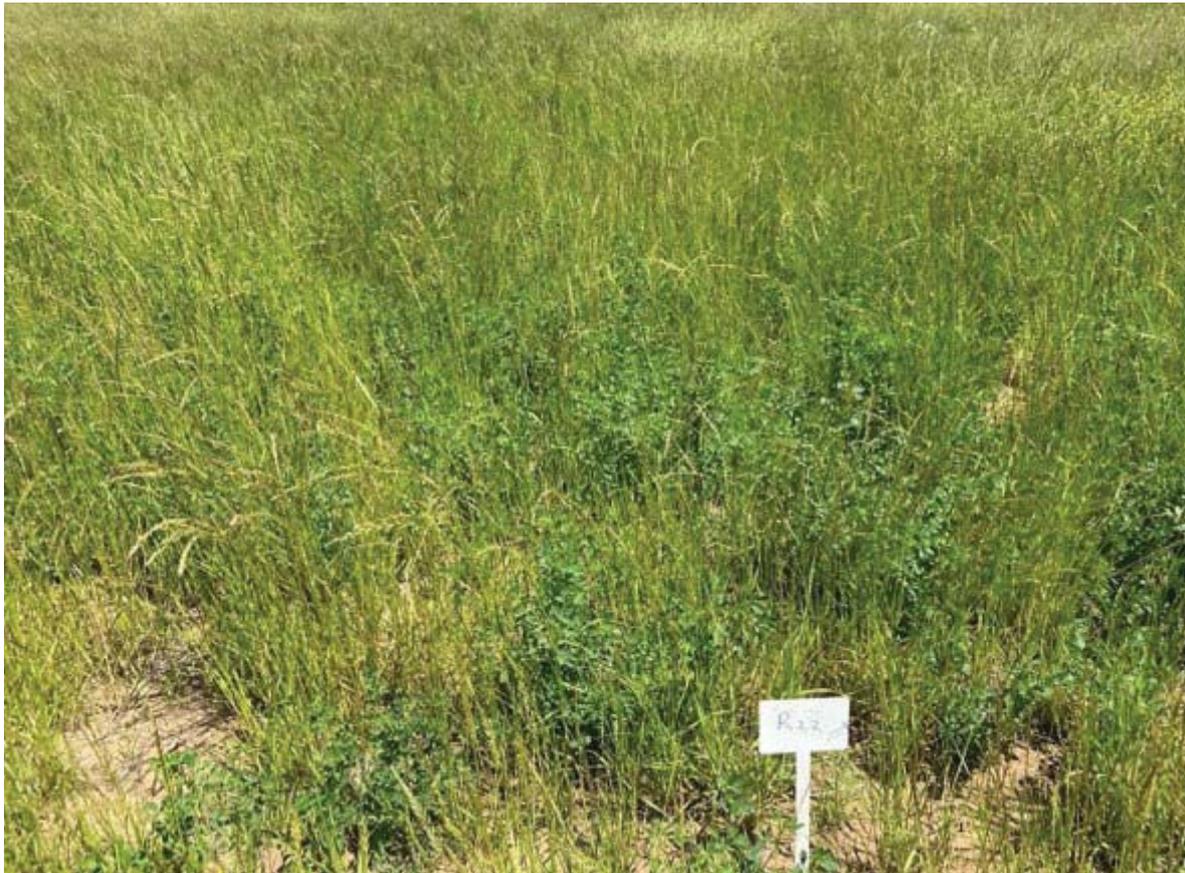
Site R 22 produced high yields and good growth which was not expected. Cracks in the clay surface were observed, and different types of clay react differently to water. The cracks in the clay at R 22 are likely the result of the ability of the clay to swell and shrink. These cracks allow better water infiltration and aeration. This was not observed for sites R 09 and R 14, so it appears that R 22 had a different clay type. Figure 2-42 represents site R 22. Fescue dominated lucerne at this site because the legume is more sensitive to soil with low infiltrability, and this indicates that although the mixture yield was high, infiltration was low enough to affect lucerne germination.

Figure 2-42: Fescue dominated over lucerne growth at site R 22 (December, 2022)

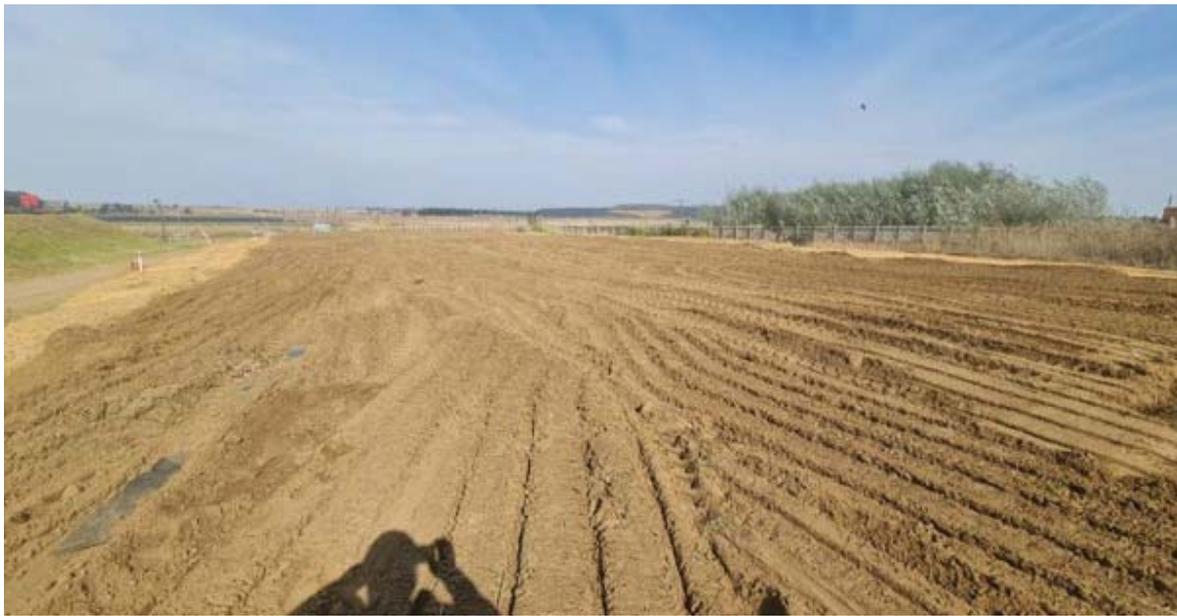
Figure 3-27: Uneven surfaces created by earthmoving machinery.

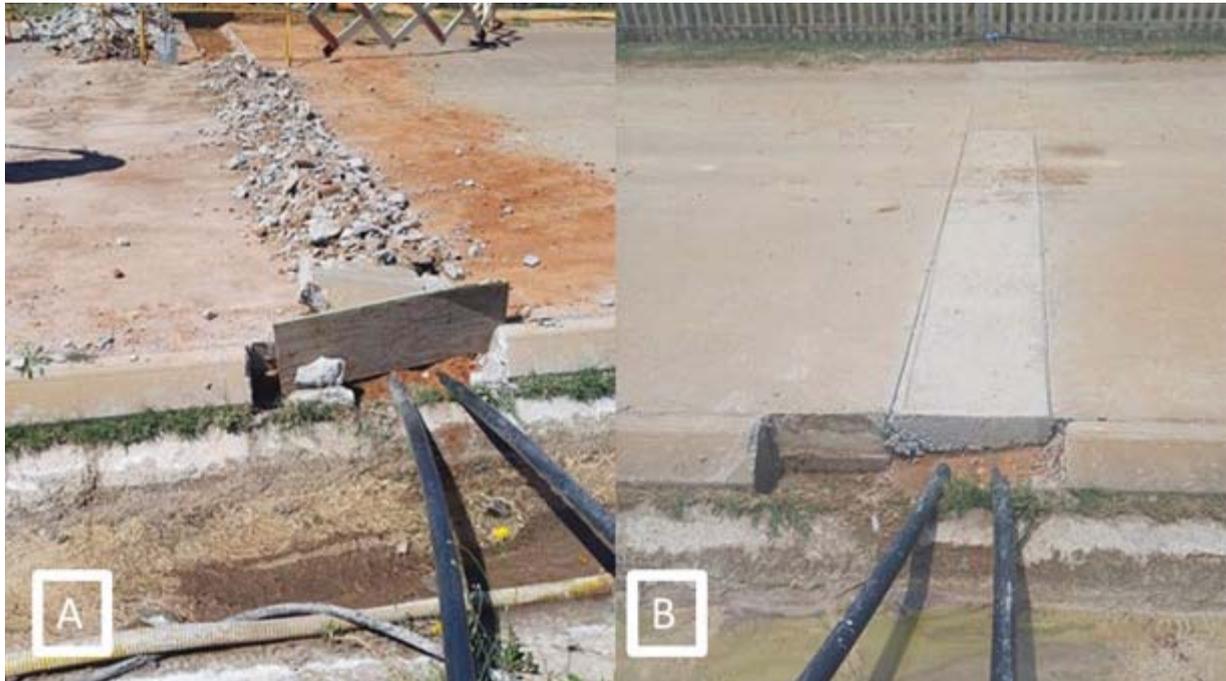
Work on the irrigation system installation commenced in the second week of September 2023. The work entailed digging trenches and laying out the pipes from the water sources to the tanks and from the tanks to the irrigation plots as shown in Figure 3-33 and Figure 3-34.

Figure 3-33: Piping for the passively treated water.

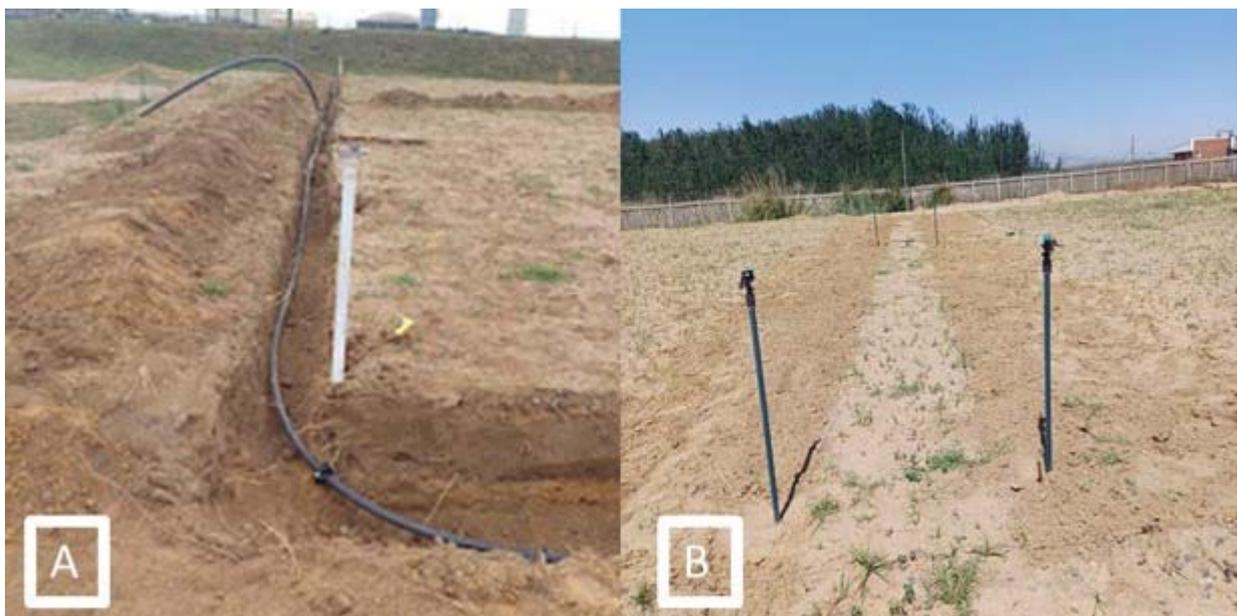
Figure 3-34: Lateral pipes during installation a) and sprinklers installed b).
