IRRIGATION WITH MINING-INFLUENCED WATERS IN MPUMALANGA

Final Report

to the
Water Research Commission

Report No. TT 960/25

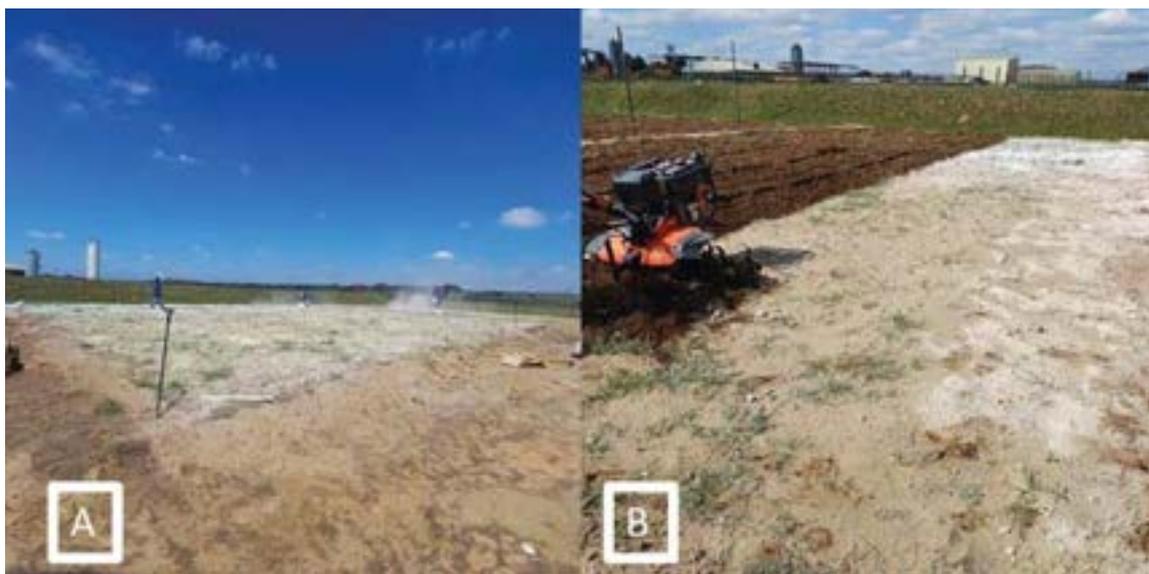
The block irrigated with untreated AMD received calcitic lime to buffer the acidity of the water (Figure 3-37). All plots received inorganic fertilizers: Limestone Ammonium Nitrate (LAN), Potassium Chloride (KCl), and CalSiPhos. The application rates were recommended based on soil chemical analysis and crop requirements as discussed in Section 3.4.2.2. The lime and fertilizer were worked into the soil using a diesel powered tiller.

Figure 3-37: a) Lime and fertiliser application and b) soil tillage.

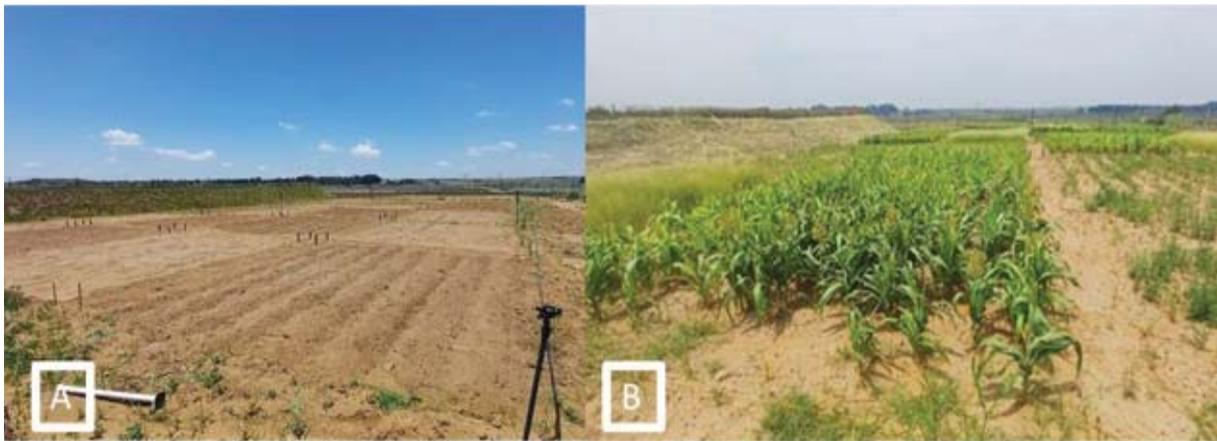
Figure 3-38: Summer crops under dryland production at planting (a) and during the growing season (b).

Following seedbed preparation, sorghum, soybean, teff, and lucerne were planted (Figure 3-38). Planting was done in the first week of December. Unfortunately, the irrigation system installation was not completed as planned, therefore the crops were rainfed for the entire growing season. Despite the challenges posed by the lack of irrigation water, this presented a unique opportunity to establish a baseline using these crops grown under dryland conditions. The crops were harvested in April, as shown in Figure 3-39. However, the soybeans did not reach maturity as they had to be replanted due to poor germination, caused by animals feeding on the seedlings. This challenge was later addressed by covering seedlings with shade nets to protect them.

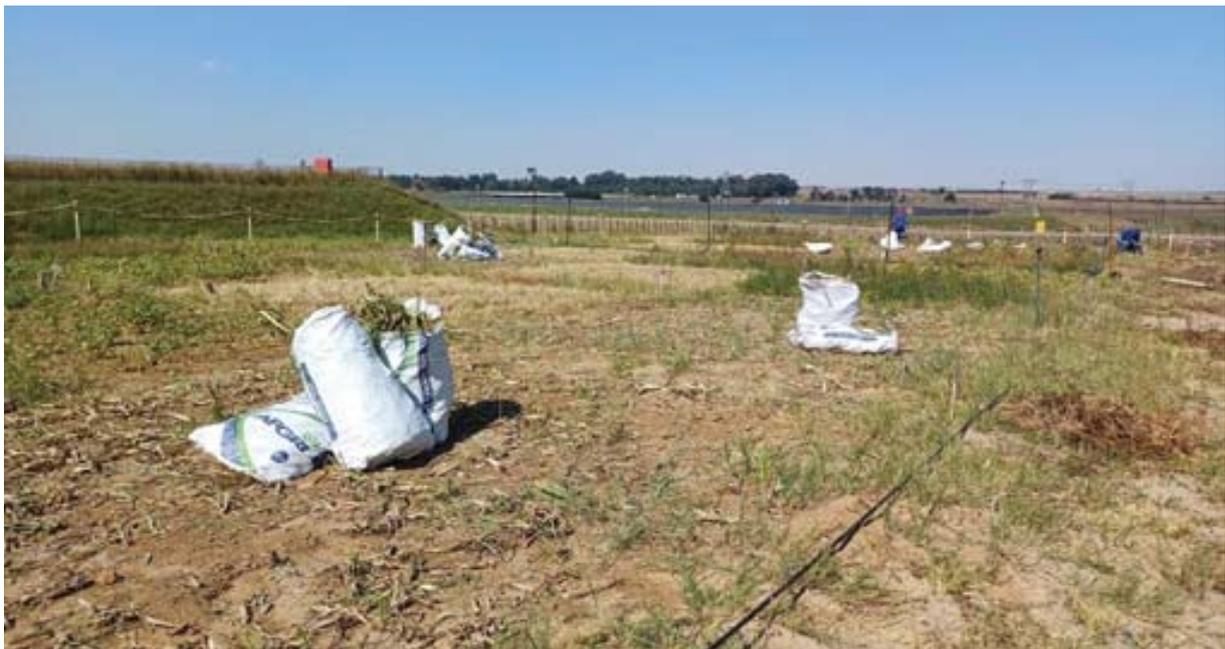
Figure 3-39: Harvesting of plots.

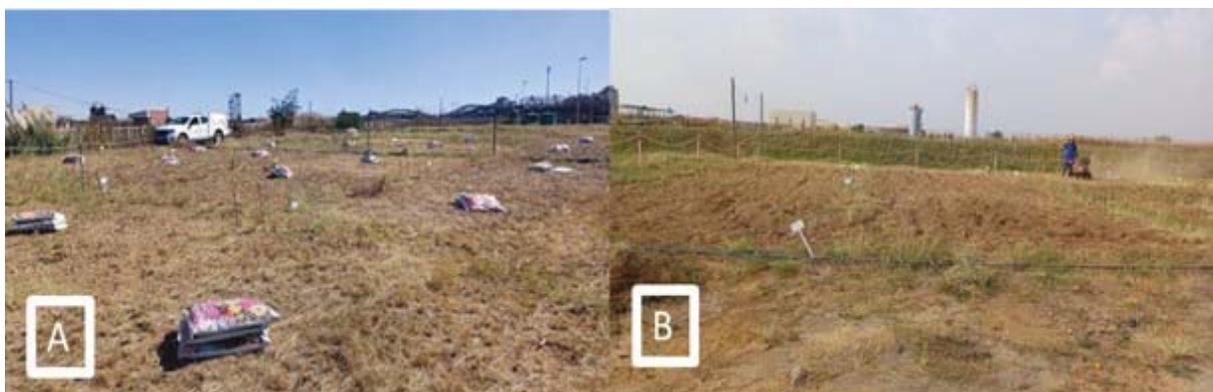
Figure 3-41: a) Compost application and b) soil tillage.

The soil was prepared to ensure optimal conditions for winter crops, particularly in response to challenges experienced during the summer season. One of the key limitations identified was the crusting of the topsoil. To address this, compost was incorporated into the soil (Figure 3-41). The addition of compost was not only aimed at improving soil structure and reducing crusting, but also at enhancing soil fertility by increasing the organic matter content.

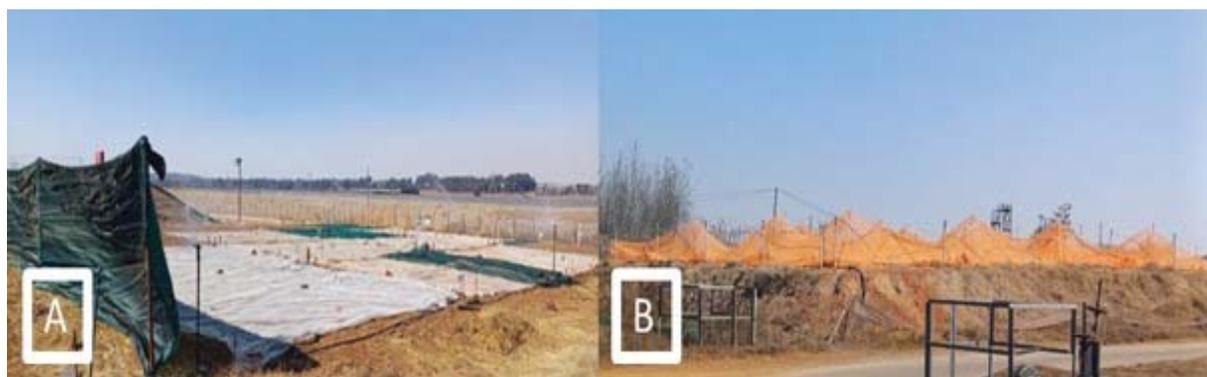
Figure 3-42: Shade netting at planting with vertical net separating main blocks (a) and shade net during growth period (b).

The winter crops were planted in July of 2024 (Figure 3-42a) and only irrigated using BSR-treated mine water, as the reinstatement of irrigation systems for untreated and circumneutral waters was still ongoing at this time. After planting, the plot was carefully covered with shade netting. The team continued to use shade netting even after the crops were established to prevent birds from feeding on them (Figure 3-42b). To limit the expected drift of irrigation waters beyond the designated plot boundaries of each water treatment, a vertical shade net (80%) was erected as a barrier between main plots (Figure 3-42a).

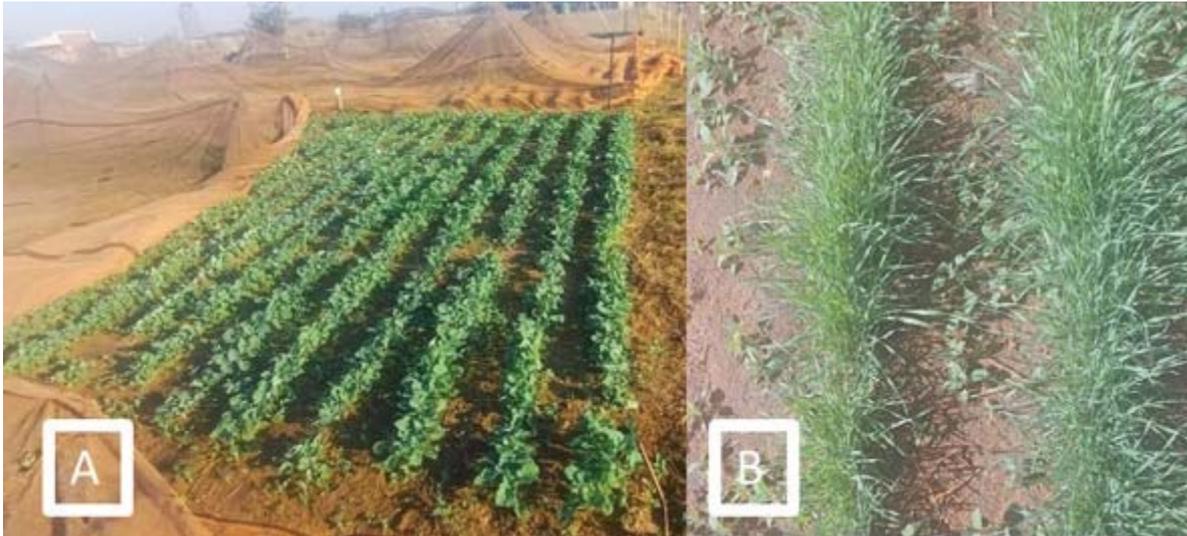
Figure 3-44: a) Canola and stooling rye b) at five weeks after planting.

Plant heights are presented in Figure 3-43. As there are no reference values for comparison, the plant heights are shown as unique data points. Crops established very well, as illustrated by Figure 3-44. This depicts a healthy, well-developed crop, indicating the potential to use BSR-treated water for irrigation. The crops had to be harvested 5 weeks after planting to prepare the site for summer cropping; therefore, conclusions about the suitability of these waters for irrigation could not be drawn at this stage.
