INVESTIGATION OF THE REHABILITATION POTENTIAL OF THE BAAKENS RIVER, GQEBERHA, EASTERN CAPE, SOUTH AFRICA

REPORT 1: CURRENT STATE OF THE RIVER

Report to the
Water Research Commission

**WRC Report No. TT
910/1/23
ISBN 978-0-6392-0350-8**

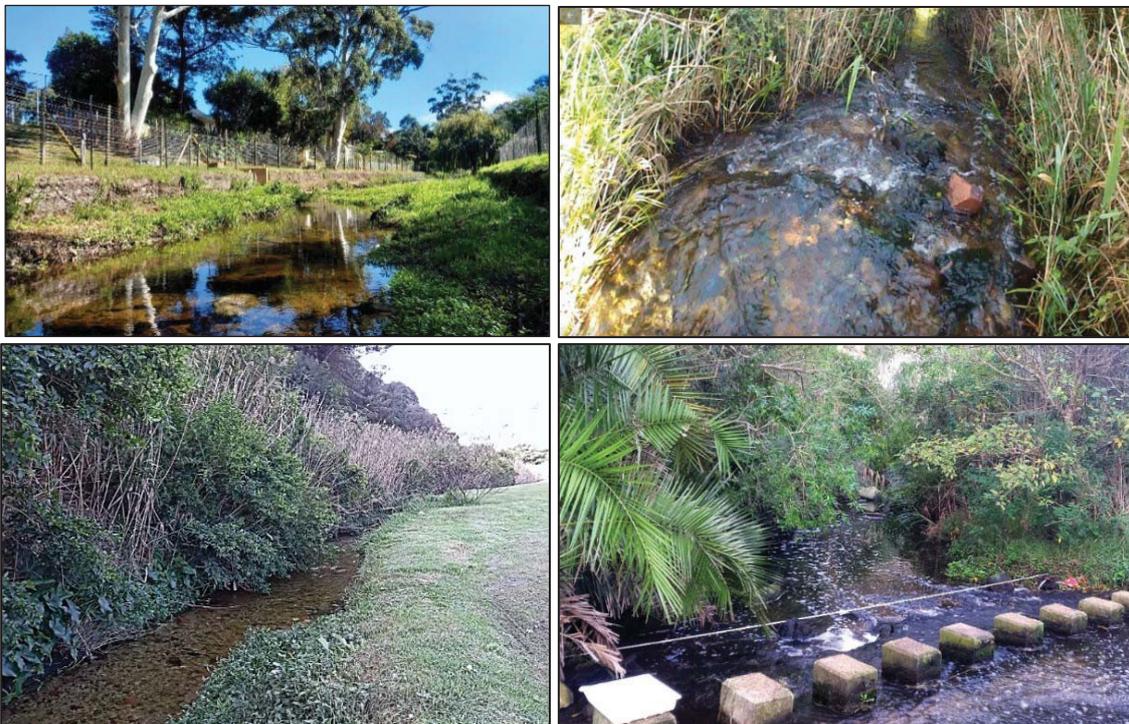
Photographs of one portion of each of the four sampling sites (Clockwise from Left Top: Sites 1-4)

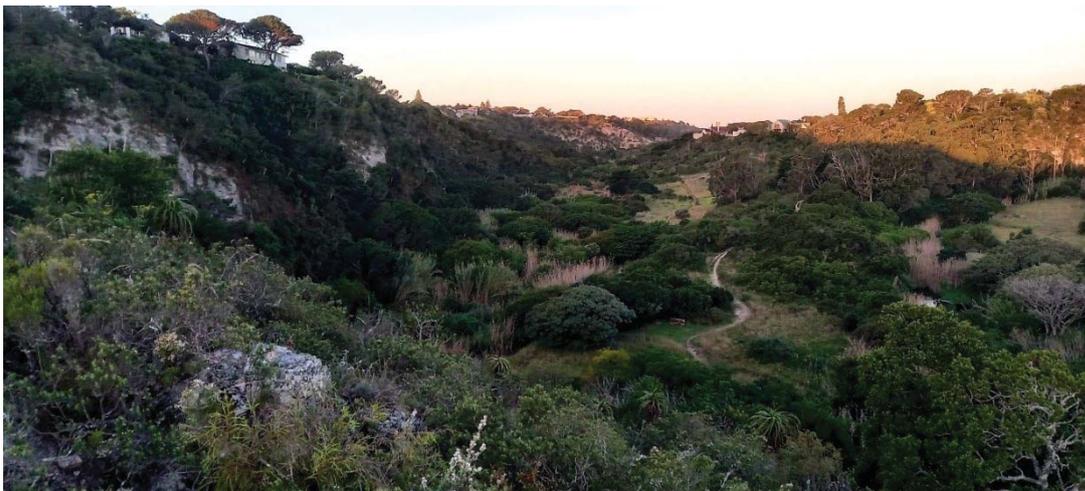
Figure 2.3 The topography of the middle and lower catchment. Looking towards the sea from Dodd's Farm, from a high point looking downstream. North-facing slopes located on the left, south-facing slopes on the right of the image.

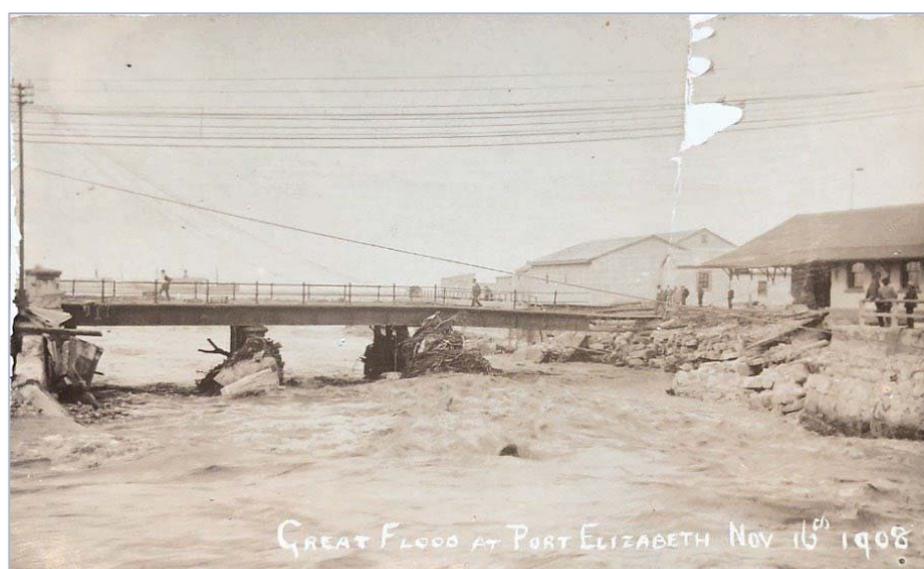
Figure 2.5 Water levels at the Baakens lower bridge during the 'Great Flood' of 16.11.1908. Source: McClelland 2018

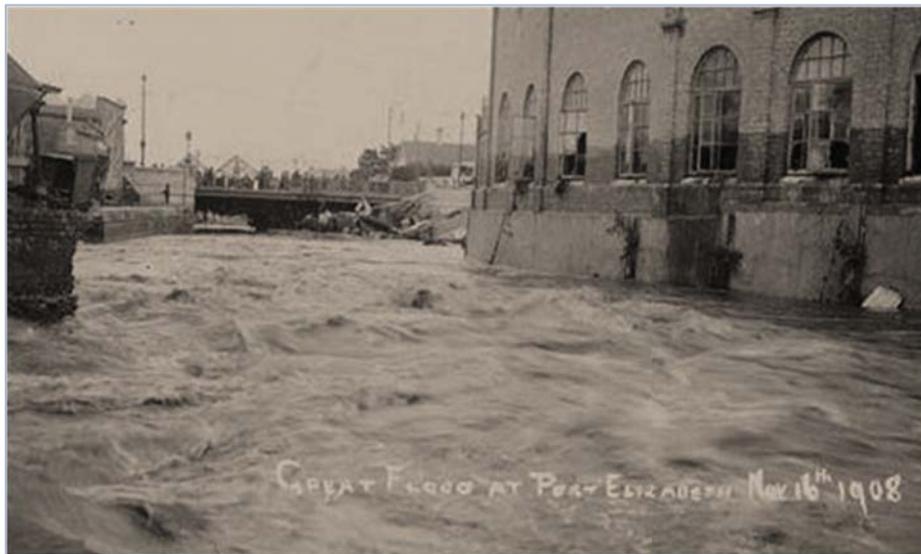
Figure 2.6 Water levels alongside the Tramways building during the 1908 'Great Flood'. Source: McClelland 2018.

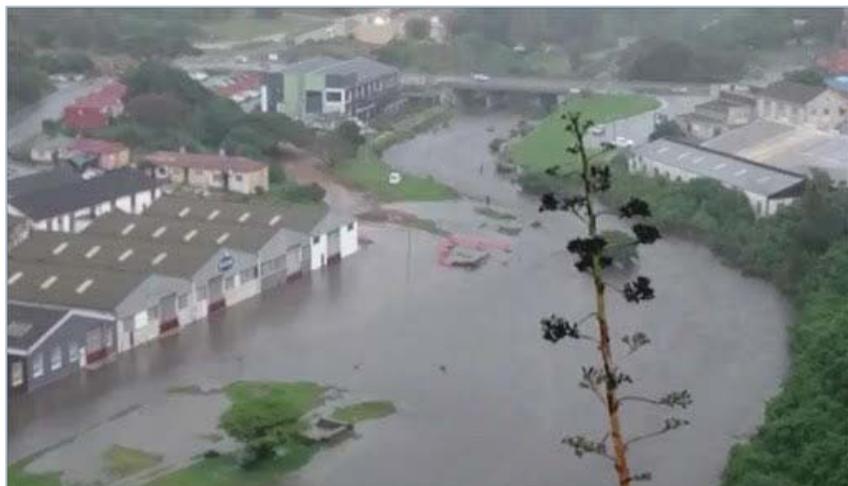
Figure 2.7 Water levels in the lower Baakens River during floods in July 2015. Looking upstream towards Brickmakerskloof Road Bridge. Source: Herald Newspaper online.

The most recent floodlines for the Baakens focus on the lower river (Figure 2.8) and were produced in 2014 (SRK 2014). As is clear (and well known), there are numerous historic developments in this lower section which are located in the floodplain, and well within the 1:100 floodline. An example of the water level in this lower area, during the flood of July 2016, is shown in Figure 2.7. Any new developments – or indeed rehabilitation plans – in the valley need to take account of this serious and as yet unmitigated threat. To this end, updated floodline studies are to be commissioned in the foreseeable future (Davids, pers. comm. 2022)

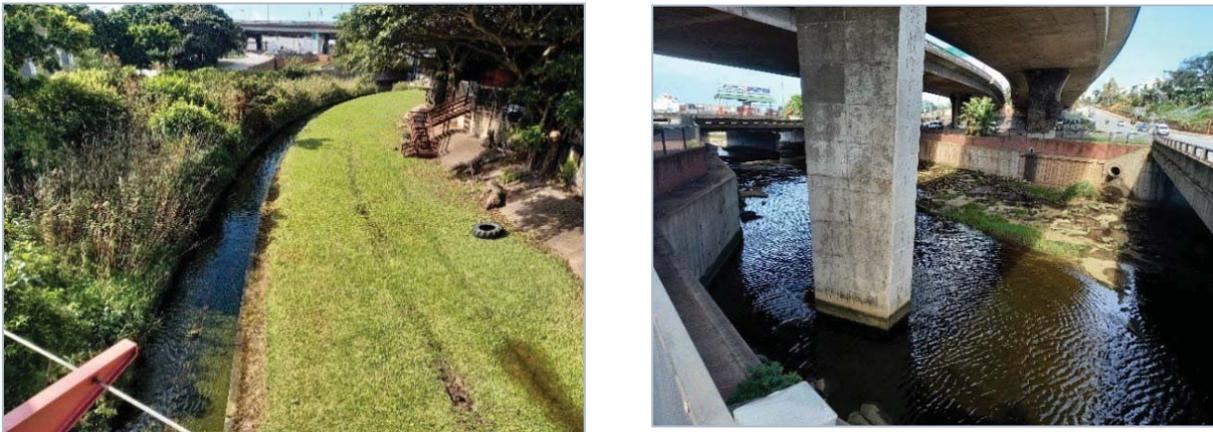
Figure 2.12 Degradation of the lower Baakens. L: The canalised estuarine section to the west of the Tramways building. R: The estuary below the freeway (low tide).

A bedrock sill is located at the lower end of the estuary. This is no longer visible except as the foundation for the present-day freeway piers across the estuary. Prior to the substantial changes inflicted on the estuary, the bedrock sill was the major hydraulic control, and resulted in the formation of a tidal lagoon. High tides would flow in, and at low tide, the bedrock sill behaved like a dam wall, retaining a raised water body upstream of it until the next high tide. At that time, the flow of the river was still unimpeded at low tide, and it could still flow over this sill. The columns of the freeway bridge that crosses the estuary are founded on the bedrock sill (Figure 2.12, McClelland 2017).

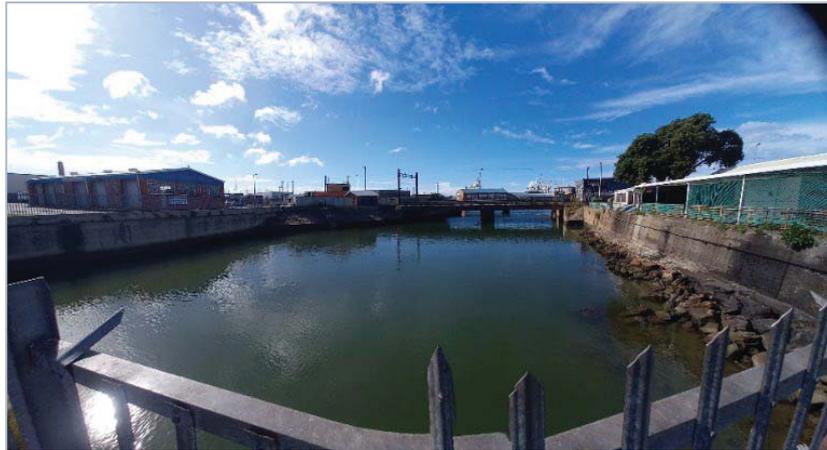
Figure 2.13 The Baakens estuary just upstream of its entry to the Port of Gqeberha

Historically during high tide, small sailing vessels with a very shallow draft could make it over the bedrock sill and sail into the lagoon. Larger vessels were not able to enter, and for this reason, the estuary was never dredged as a harbour, and one was built in the ocean just beyond the river (Figure 2.13, McClelland 2017).

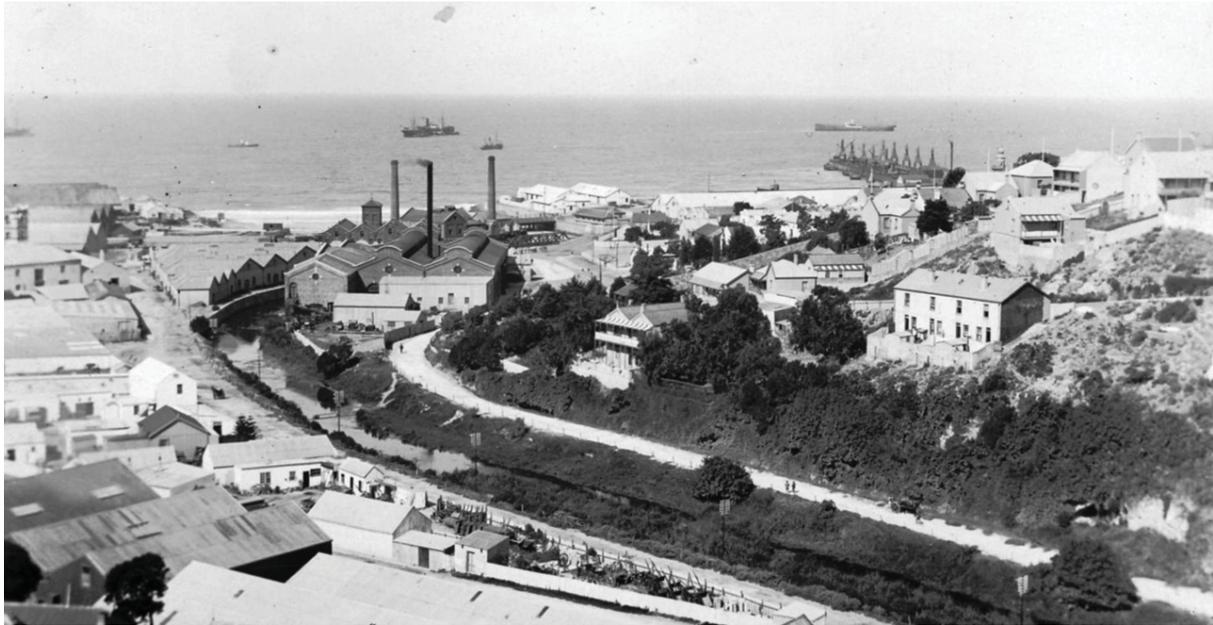
Figure 3.6 Late 1800s after the river had been confined into a canal. The Tramways Building is visible with its 3 chimneys. (Source: McClelland 2018)

By 1900 the whole area of the river and its floodplain downstream of Brickmakers Kloof had been completely transformed by development (McCallum 1981). The lower estuarine area was largely reclaimed for development, and the remainder confined into a narrow, shallow concrete canal. Where the canal opens to a more natural-width estuary, highways have been constructed overhead, and the estuarine quality and functionality has been diminished by deposition of concrete and rubble, shading, and the presence of the large piers.

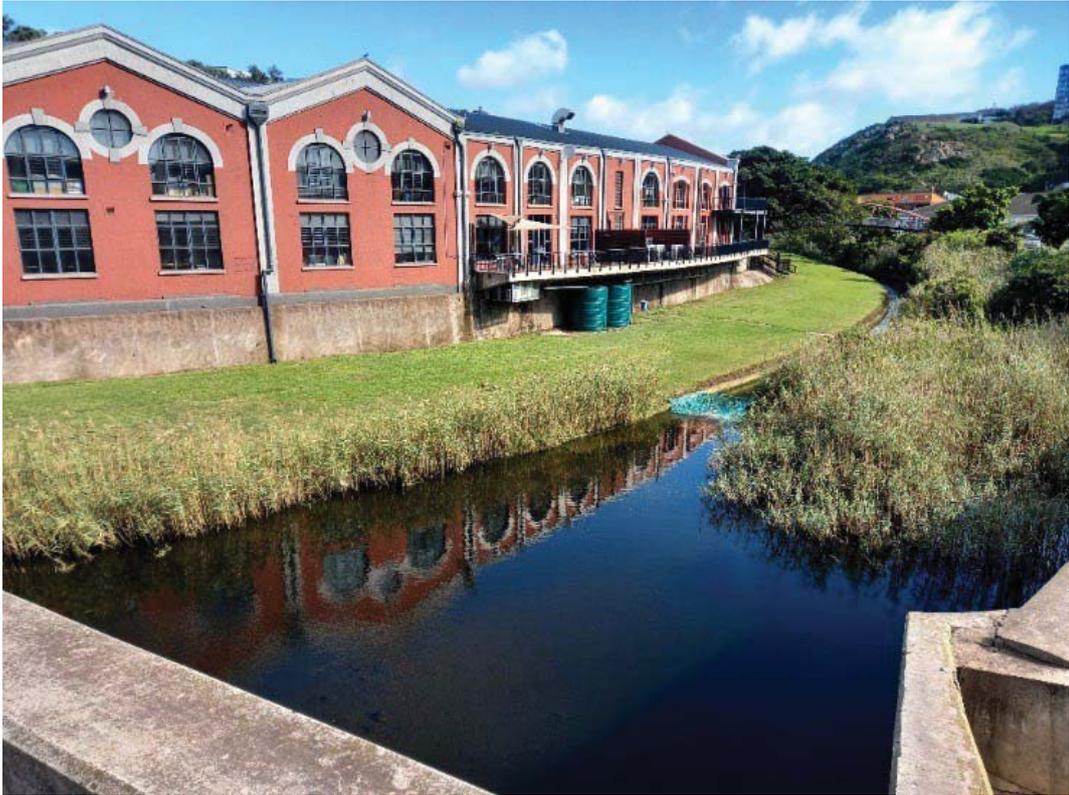
Figure 3.7 The lower section of the canal, where the estuary opens up slightly. The Tramways building is on the left of the picture. Photo: Uys 2022

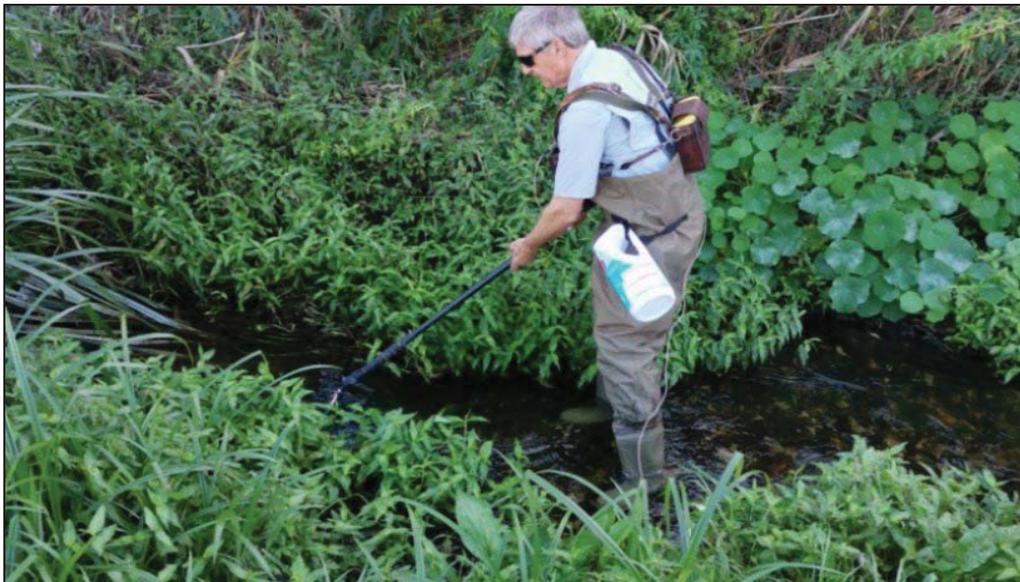
Figure 4.3 Dr Bok samples fish in the Baakens River using electro-fishing equipment, May 2022

Fish surveys were undertaken at the four sampling site/s on the Baakens on 15 and 16 May 2022. The equipment used was an electro-fisher (Samus 725G) fixed into a back-pack and fitted with a cathode dip-net and anode cable (Figure 4.3).

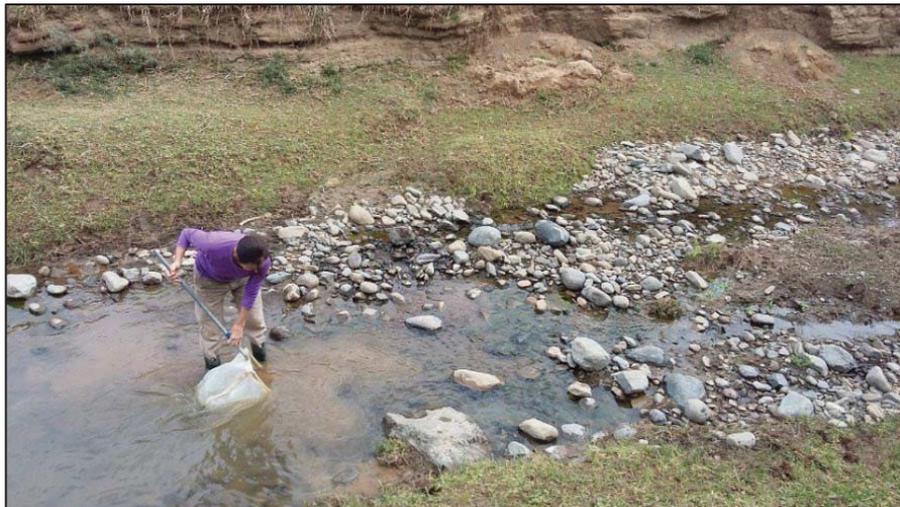
Figure 4.5 A SASS5 sample underway

The following habitats are sampled (where available): Stones (in and out of current, bedrock); Vegetation (marginal and aquatic, in and out of current); Gravel/Sand/Mud; and hand-picking, using standard sampling techniques. The sampling period is standardised for different habitats and conditions. The samples are then carefully tipped into separate trays by inverting the net and flushing it with water to ensure that biota do not remain in it. A period of 15 minutes is spent identifying the live invertebrates present in each tray, assessing their abundance, and recording this information. Following the identification, the live sample is carefully returned to the river.

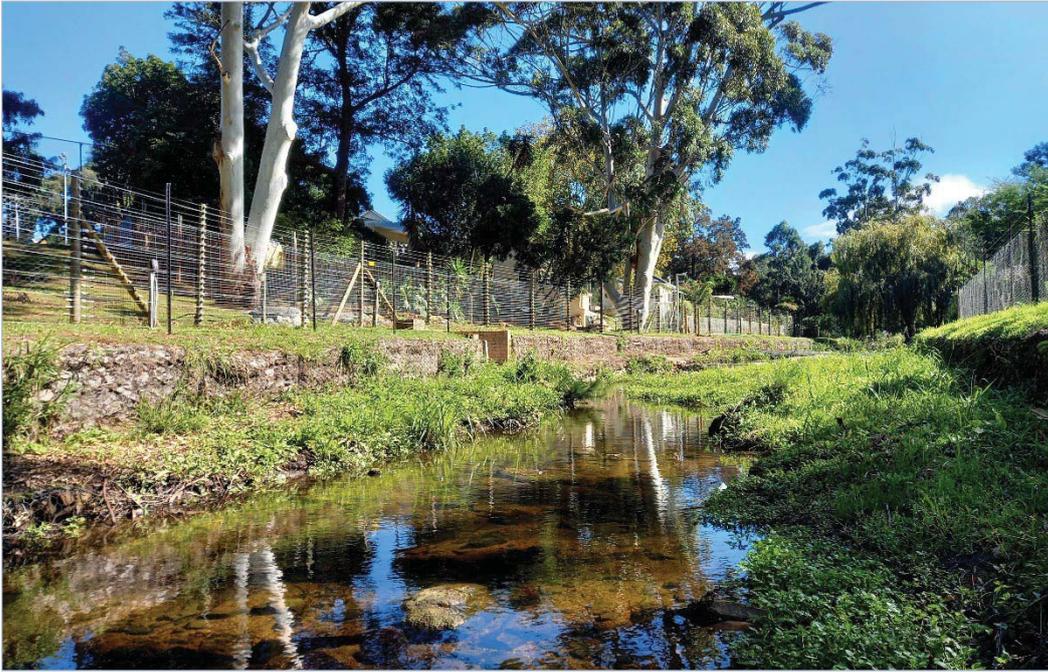
Figure 5.3 The upper portion of the Hawthorne Road Site 1 (see Figure x for downstream view)

The upper section of this site is highly modified (Figure 5.3), while the lower section has low accessibility due to large woody debris and the extent of alien invasion. Nonetheless it was considered necessary to situate the site here as there was the possibility of collecting the critically endangered *Pseudobarbus after* fish, as they had been previously collected here. The site is also a DWS water quality sampling point.

The upper portion of the site has been modified by the land-owner, and the channel is flanked by electrical fencing which also extends across a low-level weir and crossing. Sandbags have been installed across part of the channel in an attempt to create deeper areas upstream. Instream habitat is further degraded by the presence of rubble and other building materials in the channel. The site is described further in specialist results.

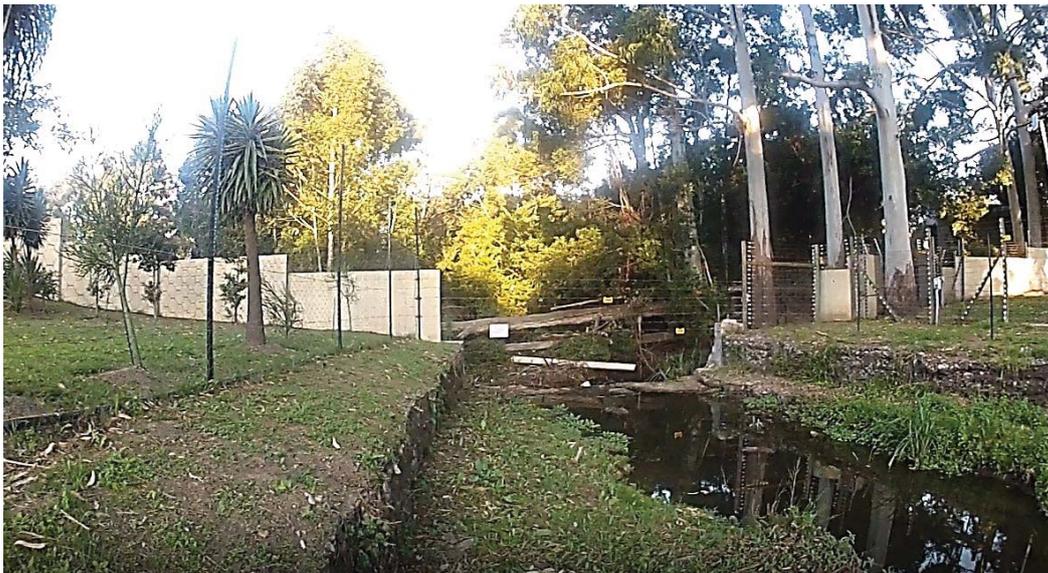
Figure 5.4 Site 1 looking downstream to the small weir and downstream channel.

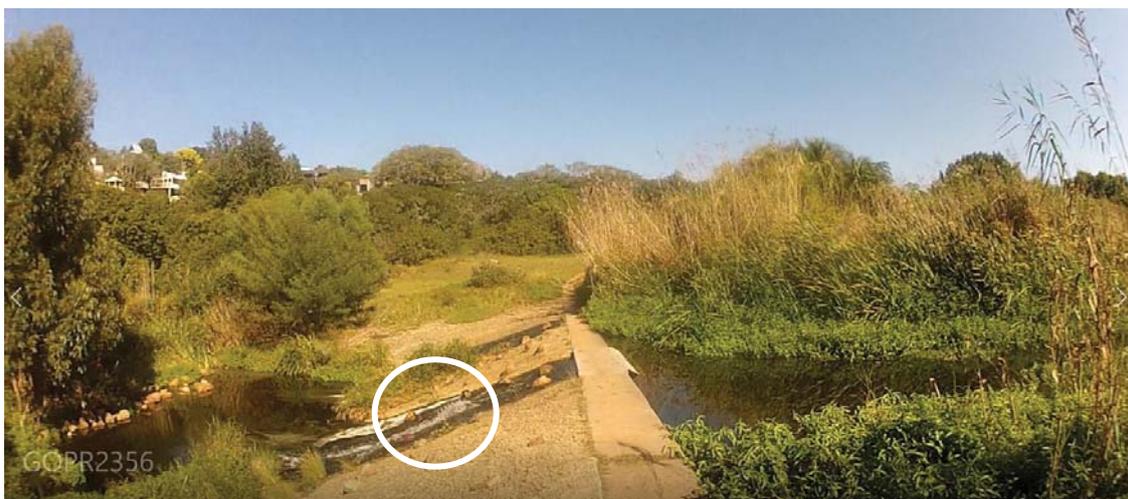
Figure 5.5 The large weir at Dodd's farm, upstream of the sample site. At the time of sampling raw sewage was discharging from a pipe on the downstream wall (circled).

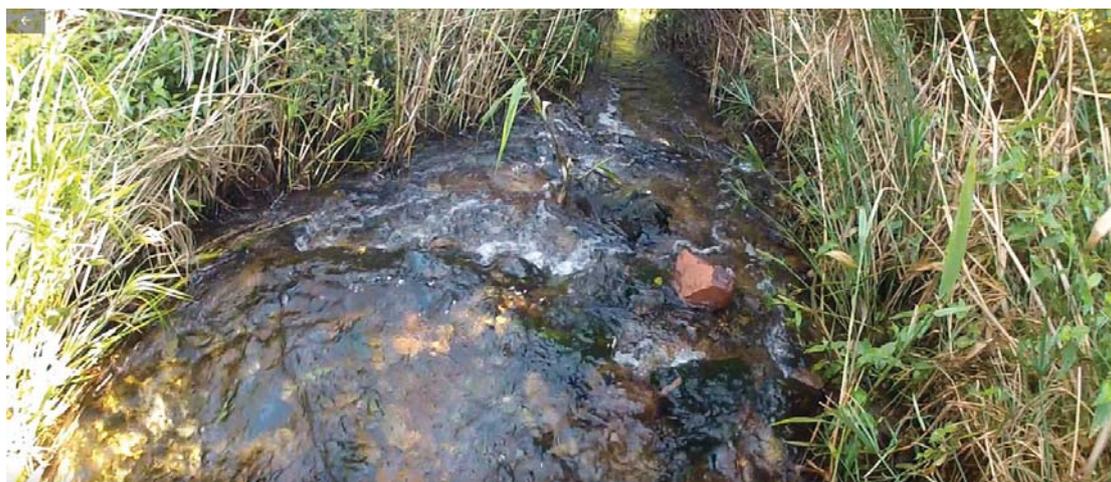
Figure 5.6 Site 2 at Dodd's Farm, looking downstream from the small bridge crossing the river

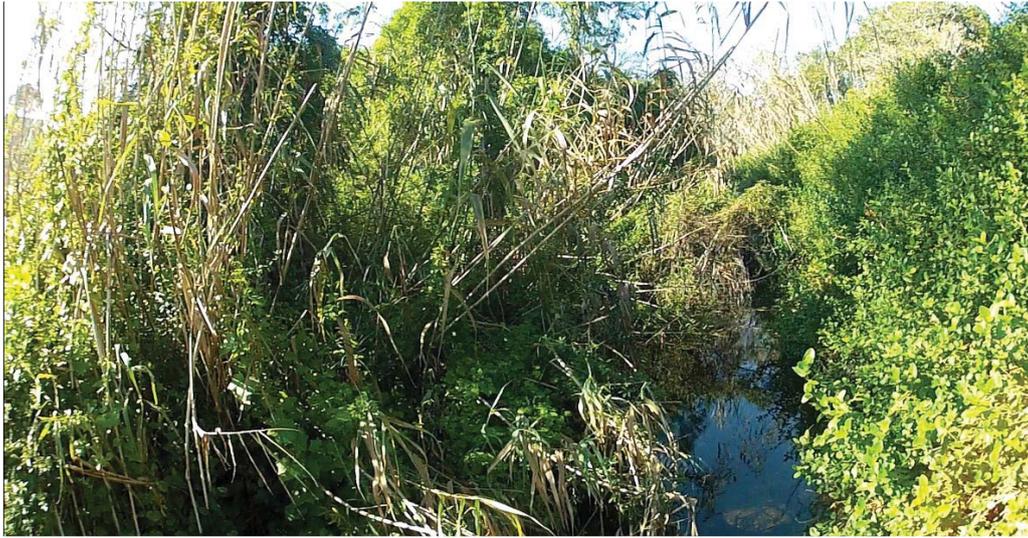
Figure 5.7 Site 2 at Dodd's farm, looking upstream from the small bridge crossing the river

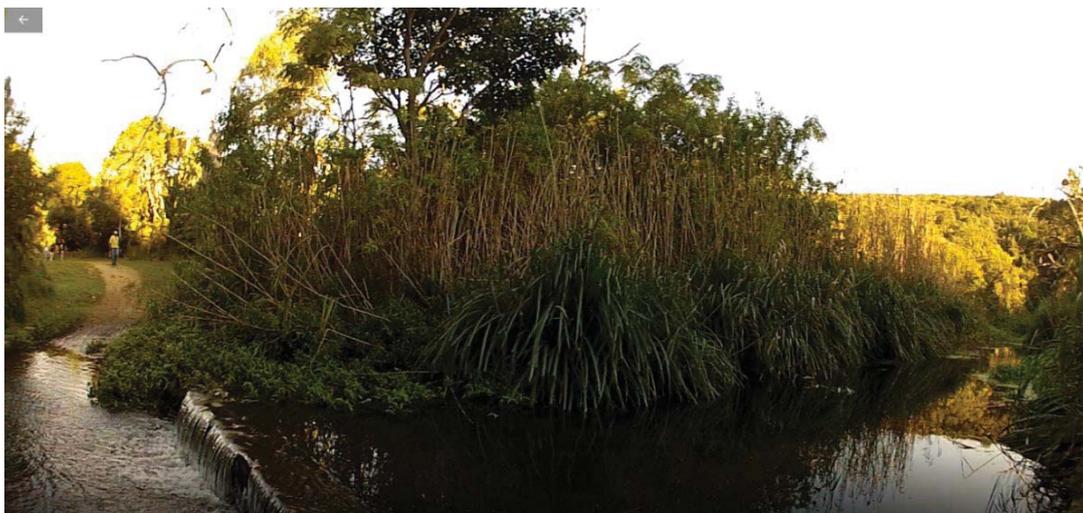
Figure 5.8 Site 3 at Essexvale in Settlers Park looking upstream to the pooled section. Note the causeway which impounds upstream water and prevents upstream fish migration.

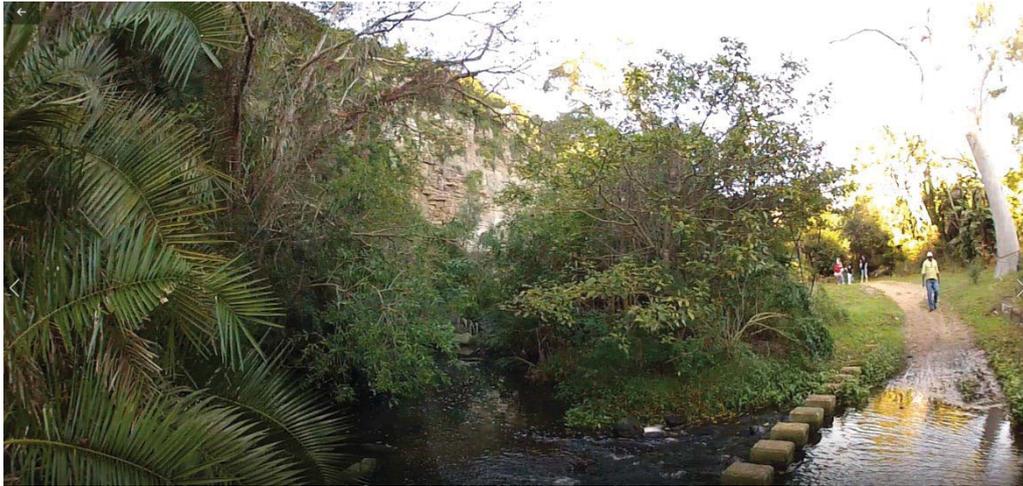
Figure 5.9 Site 3 at Essexvale looking across the low-level crossing and downstream.

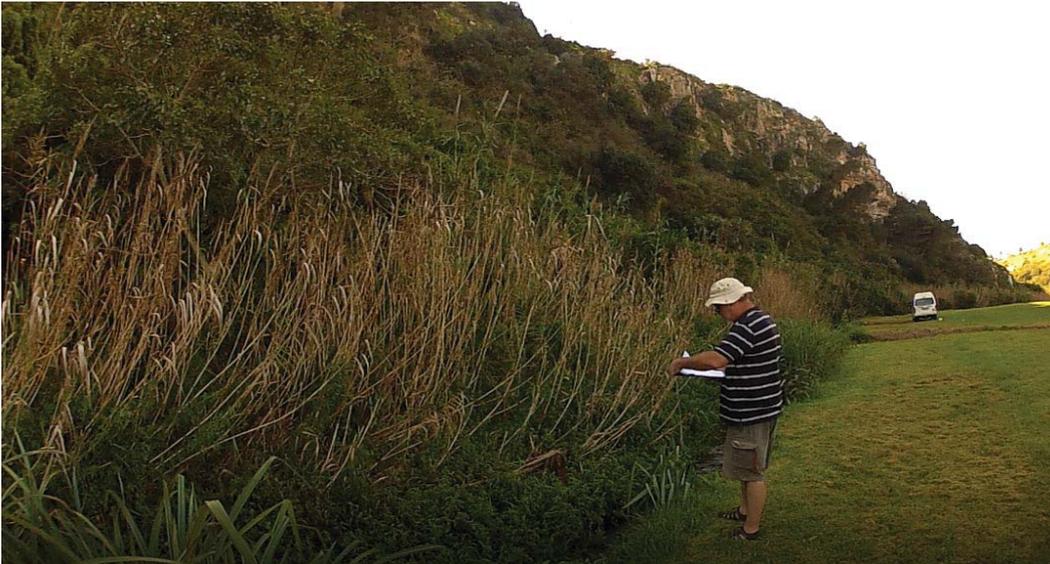
The river in this section is confined to a narrow gabion-clad canal. In some sections of the canal, cobble and stone substrates are present, these possibly originate from damaged gabion baskets. On the left bank, the topography is steep and well vegetated, and provides habitat to a suite of indigenous and alien plants. The right bank and floodplain have been cleared of trees and other riparian plants and is maintained as a lawn. This is the area set aside for a picnic and recreational area within the South-End Precinct development plans.

Figure 5.11 The left bank and right floodplain at Site 4

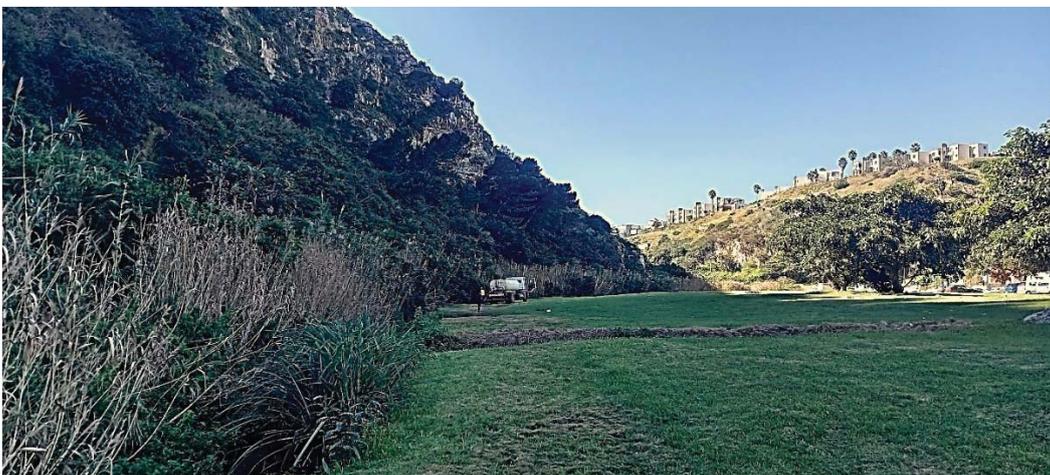
Figure 5.12 The area upstream of Site 4, showing the steep topography of both sides of the valley in this area. Note also the cleared floodplain on the right bank.

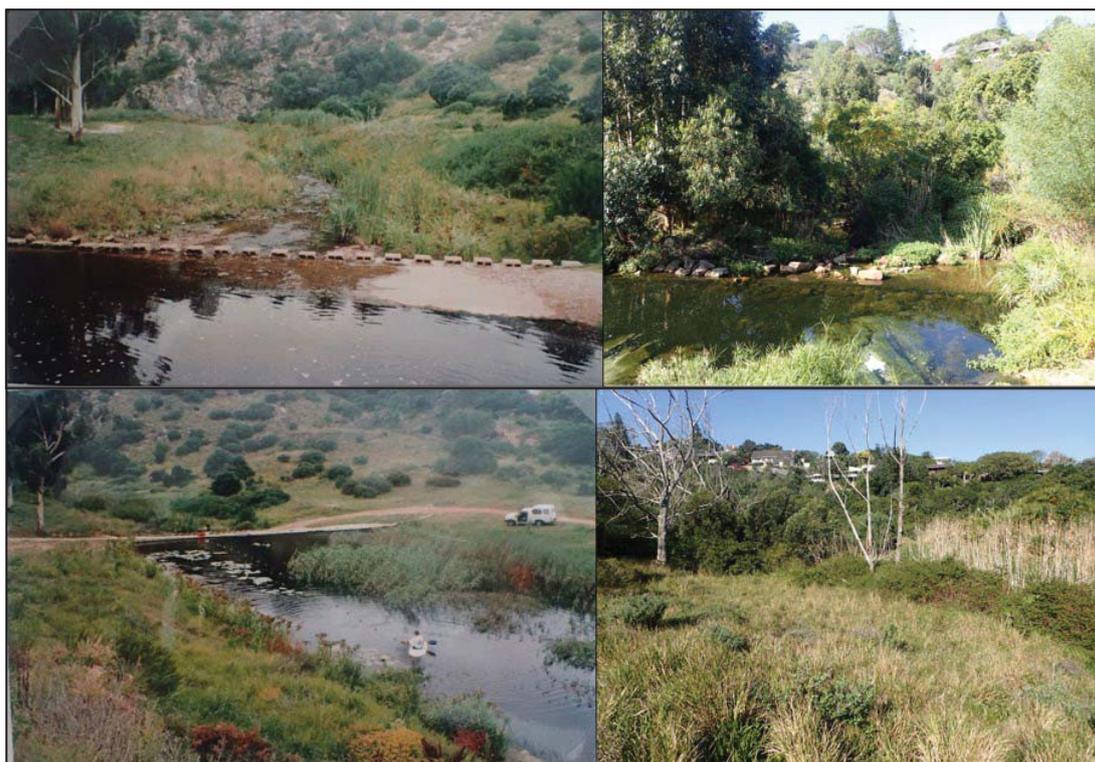
Figure 6.4 L (top and bottom): Photographs of Dodd's Farm weir crossing taken in 1994 (Source: Anton Bok, 1994) and R (top and bottom): In 2022 (Source: J MacKenzie).

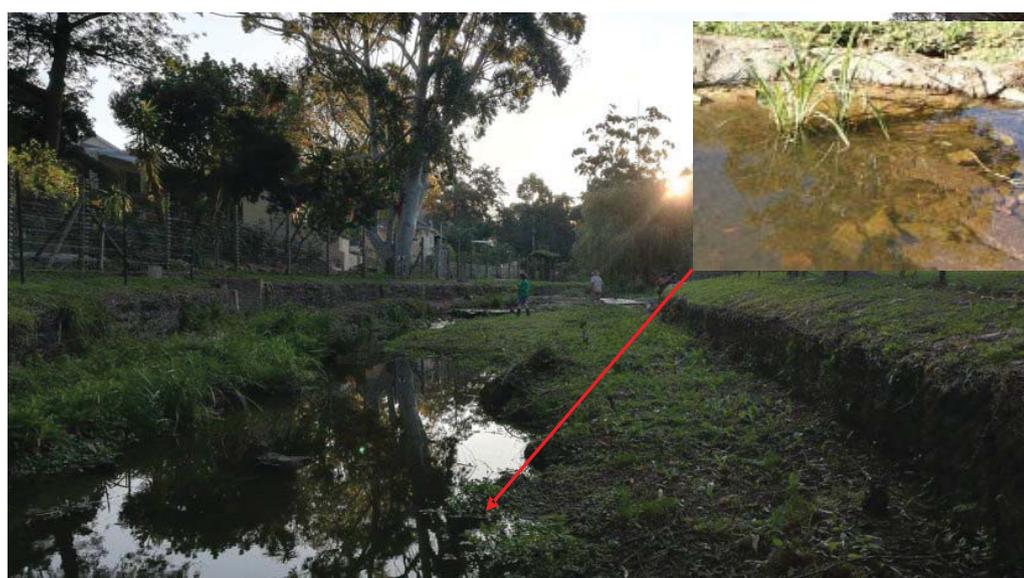
Most of the area upstream and downstream of the site has been invaded by perennial alien species comprising dense shrub and tall trees, notably *Eucalyptus camuldulensis* and *Acacia saligna*, which has resulted in the exclusion of indigenous flora (Figure 7.2 and Figure 7.3)

Figure 7.2 Photographs of Site 1 taken in May 2022 looking upstream

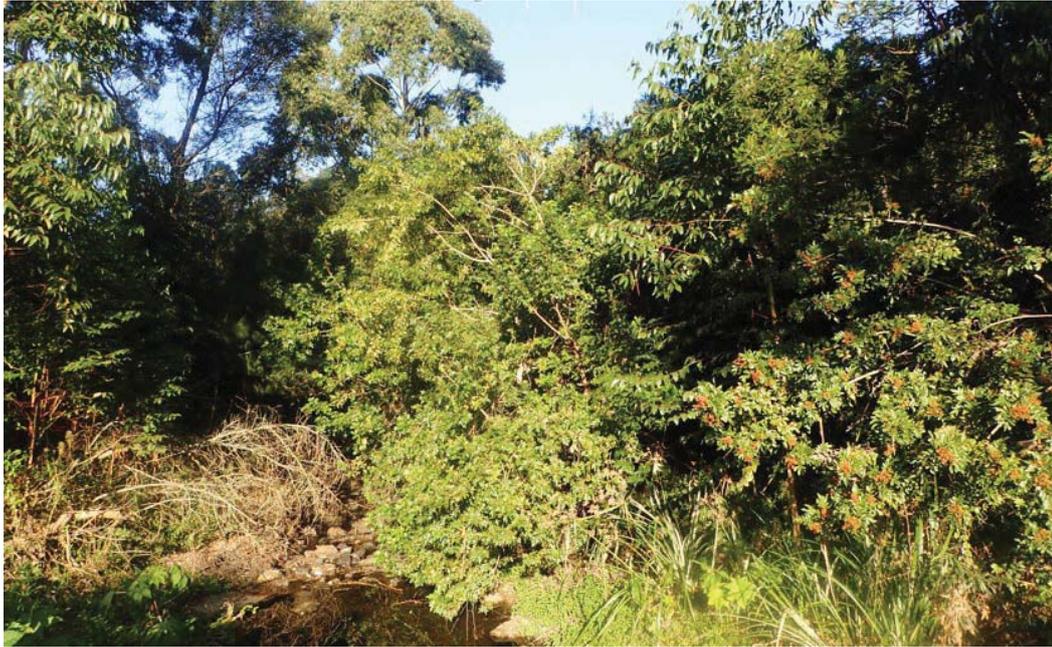
Figure 7.3 Photographs of Site 1 taken in May 2022 looking downstream.

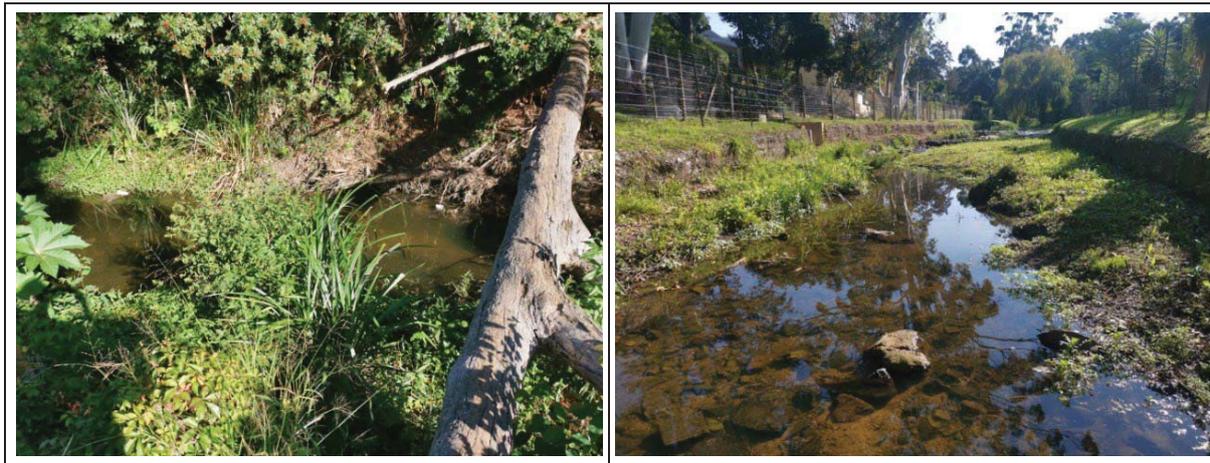
Fish sampling was undertaken both upstream and downstream of a low weir in the Baakens River adjacent to the Hawthorne Avenue sewer pump station – see Figure 7.5 and Figure 7.6. As can be seen, the river channel upstream of the low weir has been ‘cleaned out and rehabilitated’ by the landowner on the one bank.

Figure 7.5. The downstream (L) and upstream (R) sections of Site 1 sampled for fish.

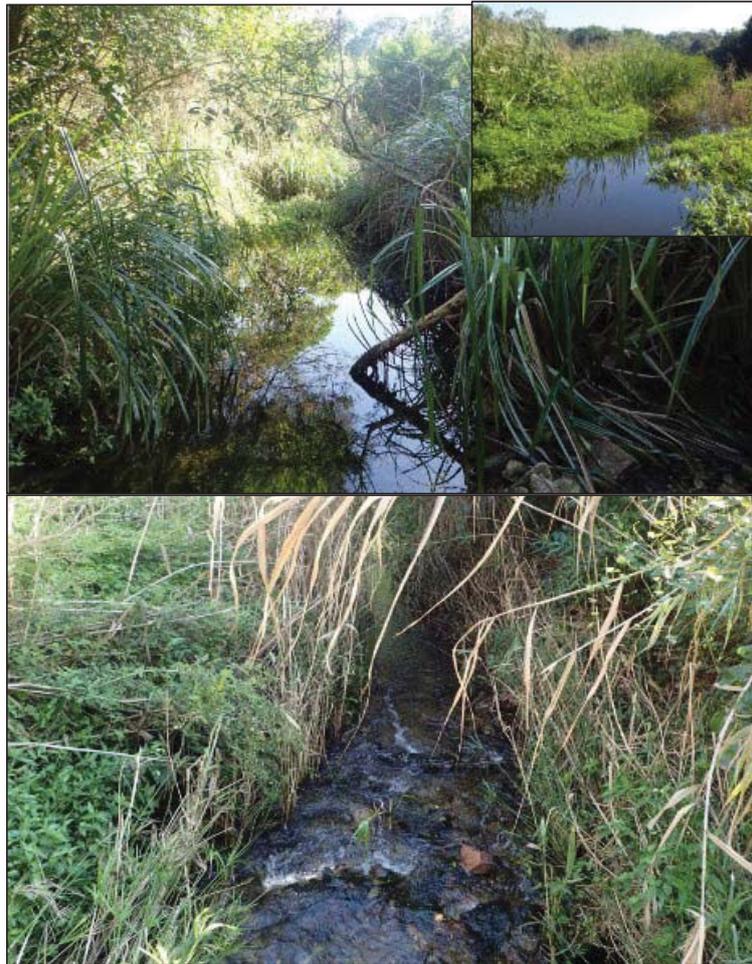
Figure 7.7 Photographs of in-channel habitats at Site 2 taken in May 2022 looking upstream (top) and downstream (bottom). Inset indicates pool habitats (not natural) in the backup zone of weirs / river crossings.

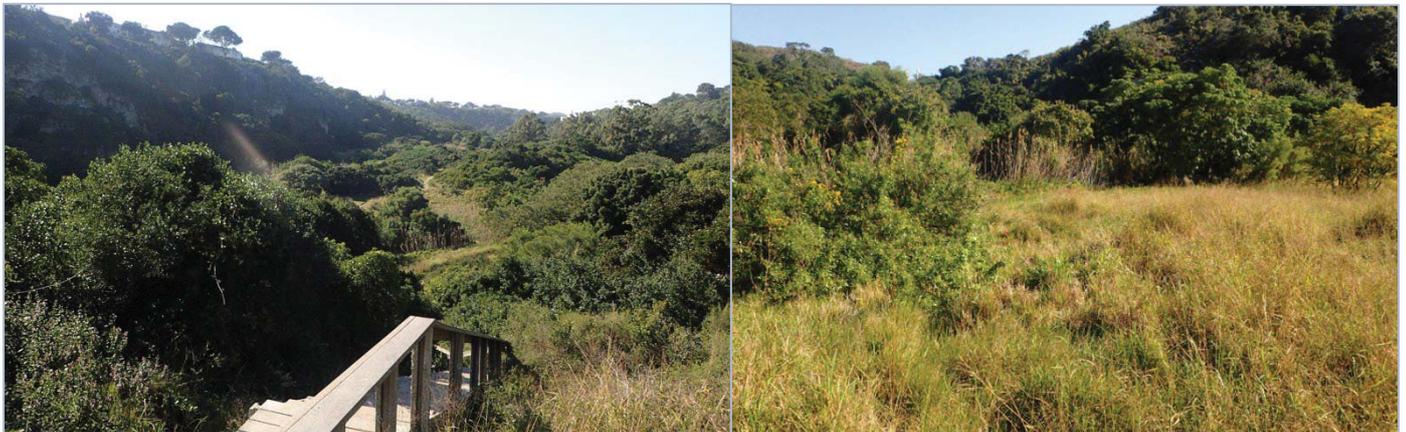
Figure 7.8 Photographs of valley habitats at site 2 taken in May 2022 showing (L) a landscape view and (R) bank habitats.

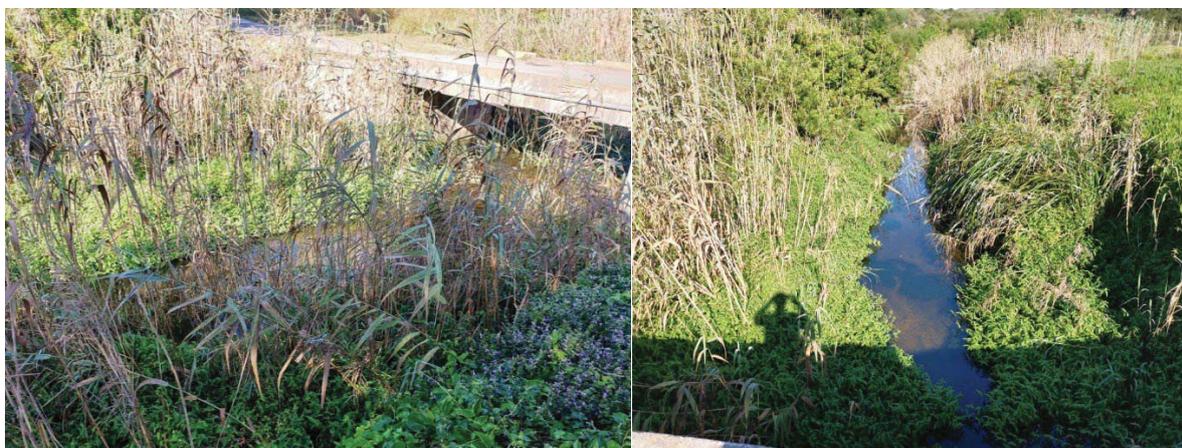
Fish sampling was undertaken upstream and downstream of the Ninth Avenue bridge over the Baakens River (33° 58' 09.8" S; 25° 34' 39.1" E), as well as at a pedestrian gabion causeway (33° 58' 02.9" S; 25° 34' 38.4" E) located about 490 m upstream of the bridge. Habitats consisted of slow-deep and slow-shallow habitats with dense marginal and overhanging vegetation with soft sand and mud substrate.

Figure 7.10 Fish sampling for Site 2 at the 9th Avenue Bridge, (left) downstream and (right) upstream

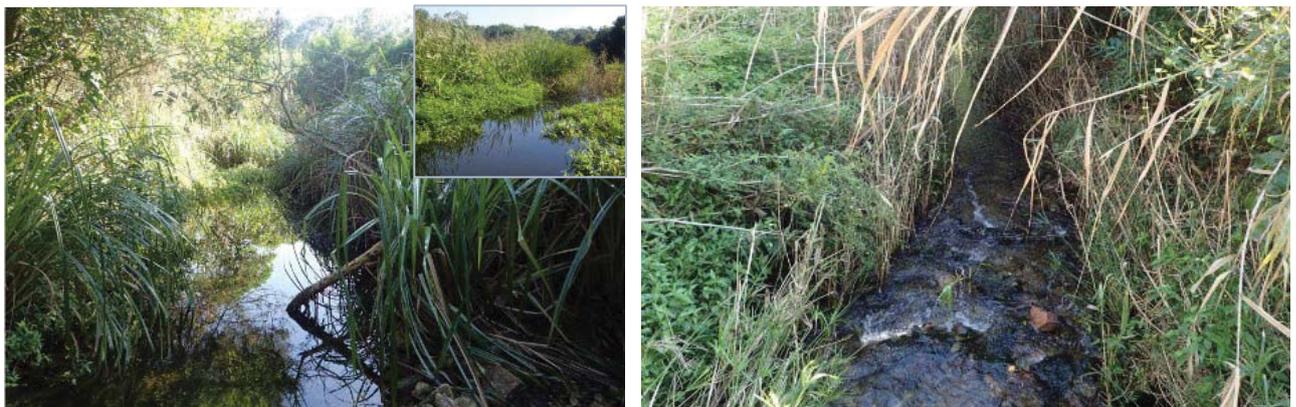
Figure 7.11 Photographs of in-channel habitats at Site 3 taken in May 2022 looking upstream (top) and downstream (bottom). Inset indicates pool habitats (not natural) in the backup zone of weirs / river crossings.

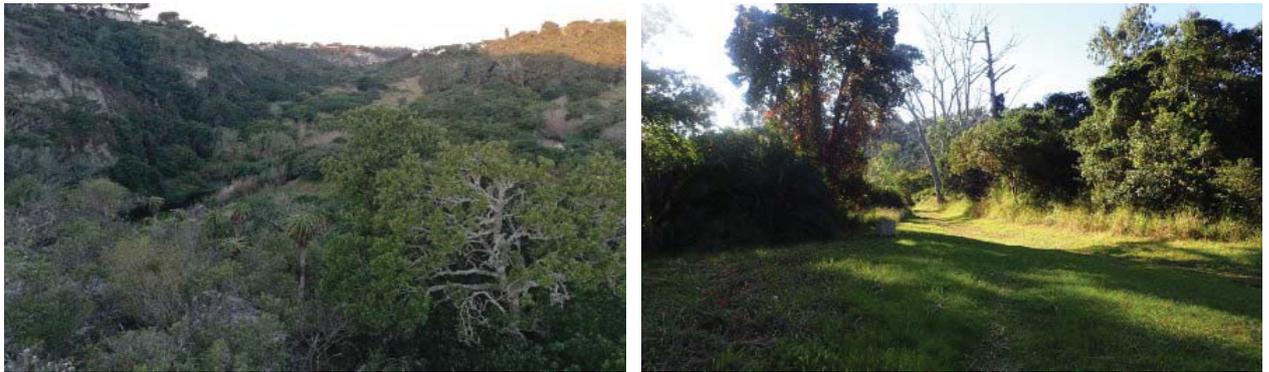
The non-marginal zone is characterised by high aerial cover and dense vegetation, both woody and non-woody. The patchiness of woody to non-woody appears to be maintained by mowing and clearing of certain areas for public access, a task that naturally would have been performed by much higher grazing and browsing pressure (Figure 7.12,

Figure 7.12. Photographs of valley habitats at site 3 taken in May 2022 showing a landscape view (top) and bank habitats (bottom).

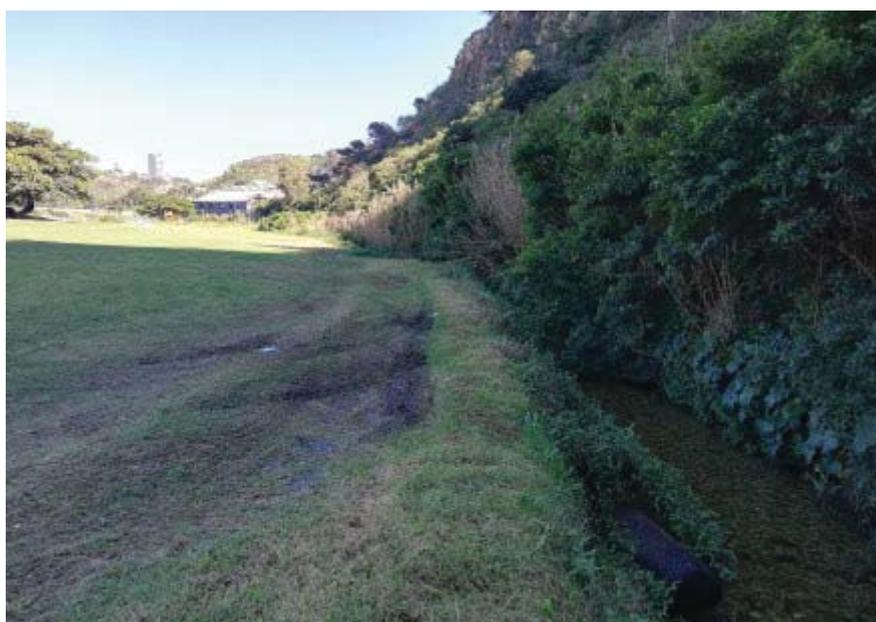
Figure 7.16 Photograph of in-channel habitats at Site 4 taken in May 2022 looking upstream.

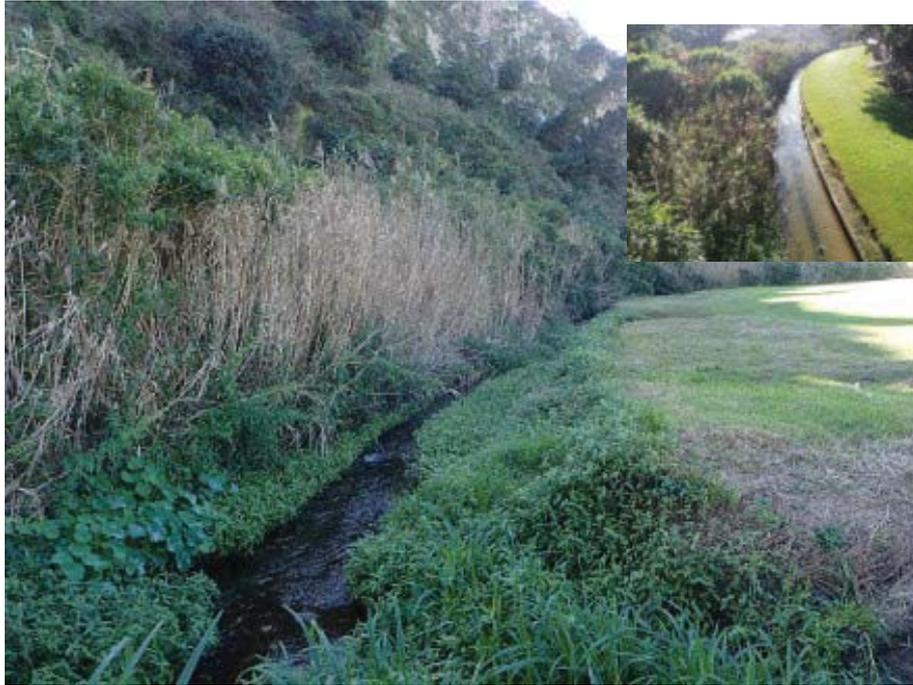
Figure 7.17 Photographs of in-channel habitats at Site 4 taken in May 2022 looking downstream. Inset indicates canalised stream farther downstream towards the estuary.

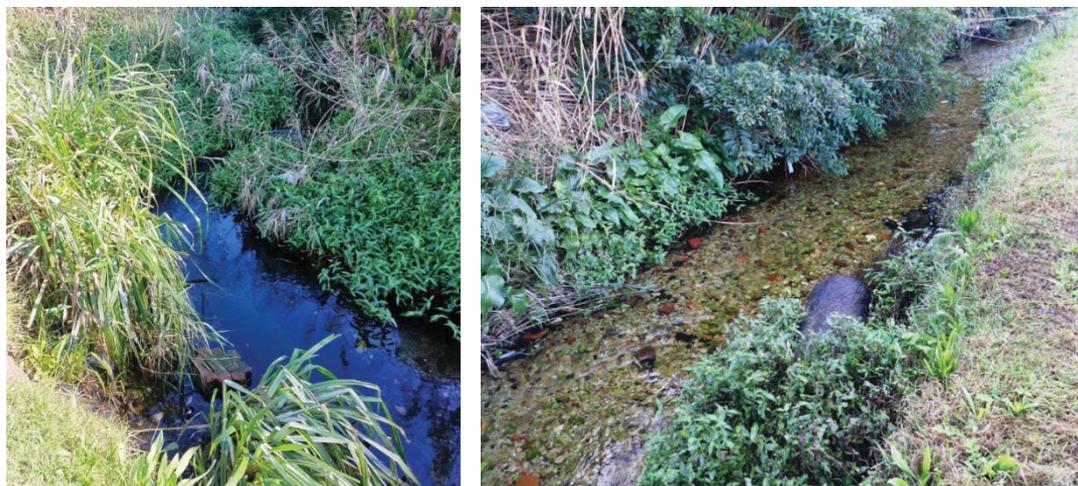
Fish sampling was limited to a 100 m section of the canalised river bed in the lower Baakens River where there was suitable habitat for fish (33° 58' 02.7" S; 25° 37' 13.4" E). The original ca. 2 m wide concrete channel is semi-intact in this area with marginal vegetation growing on the sides providing some cover for fish, with limited substrate cover for fish in the form of a few rock and gravel.

Figure 7.18 L,R: Fish sampling area in the canalised river, Site 4
