# AN INVESTIGATION OF THE REHABILITATION POTENTIAL OF THE BAAKENS RIVER, GQEBERHA PART 2: REHABILITATION SCENARIOS

## ***Part 2: Rehabilitation scenarios***

**WRC Report No. TT 910/2/23**  
**ISBN 978-0-6392-0351-5**

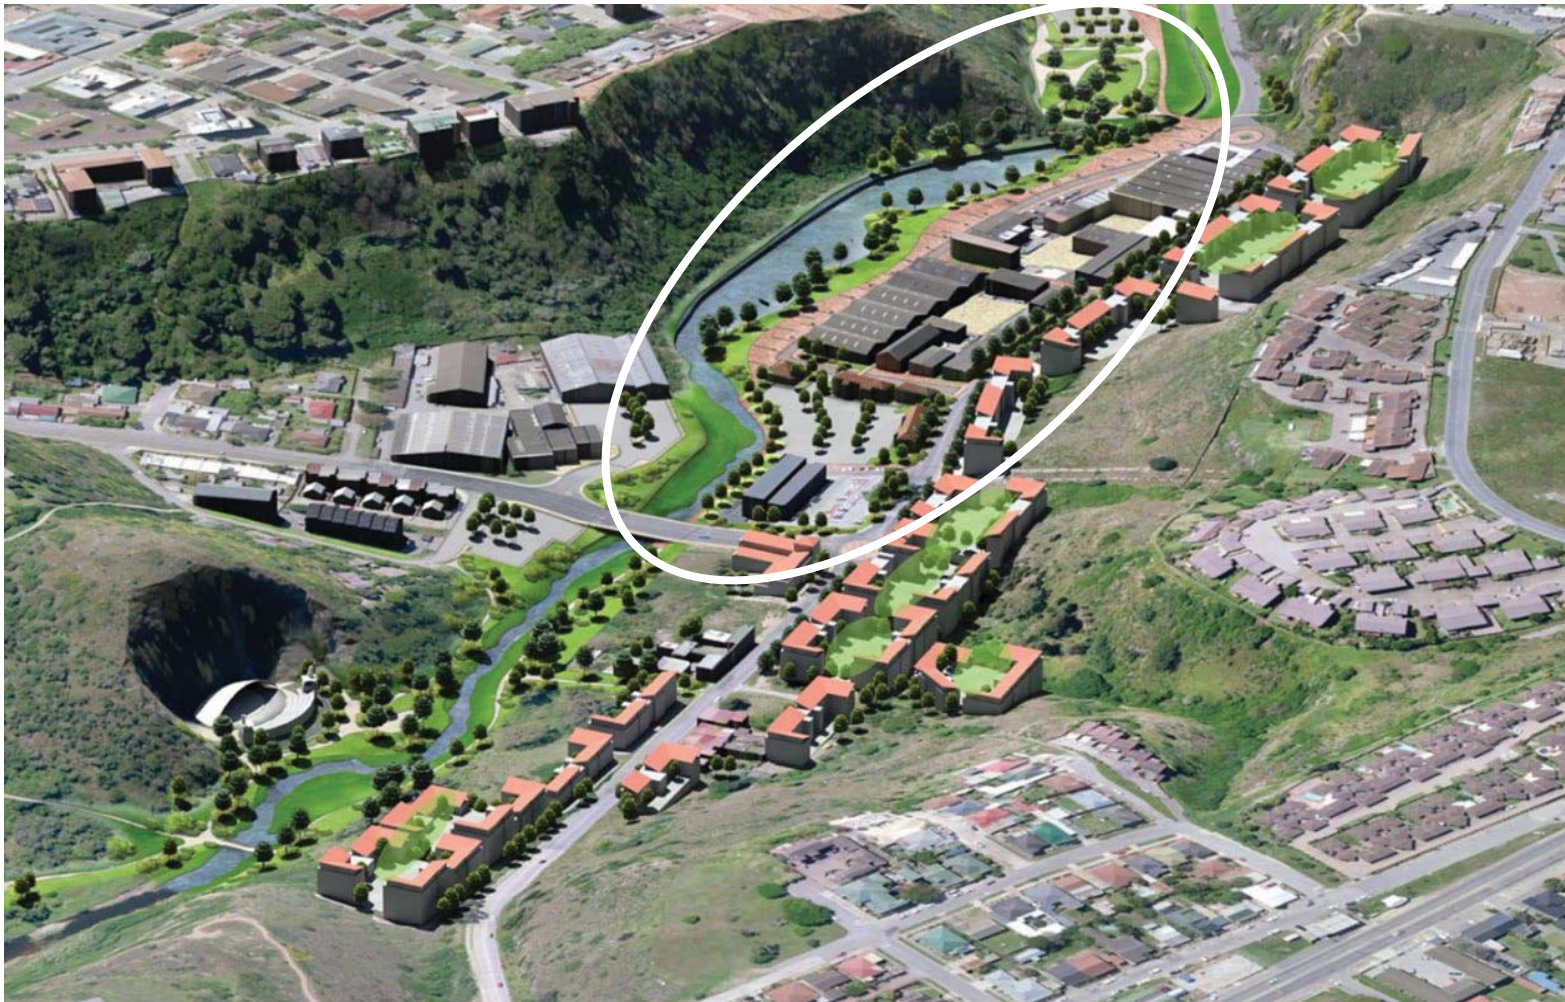
Figure 2.3 A conceptual plan of the Lower Baakens Precinct and Baakens Parkway (GAPP Consortium 2014)

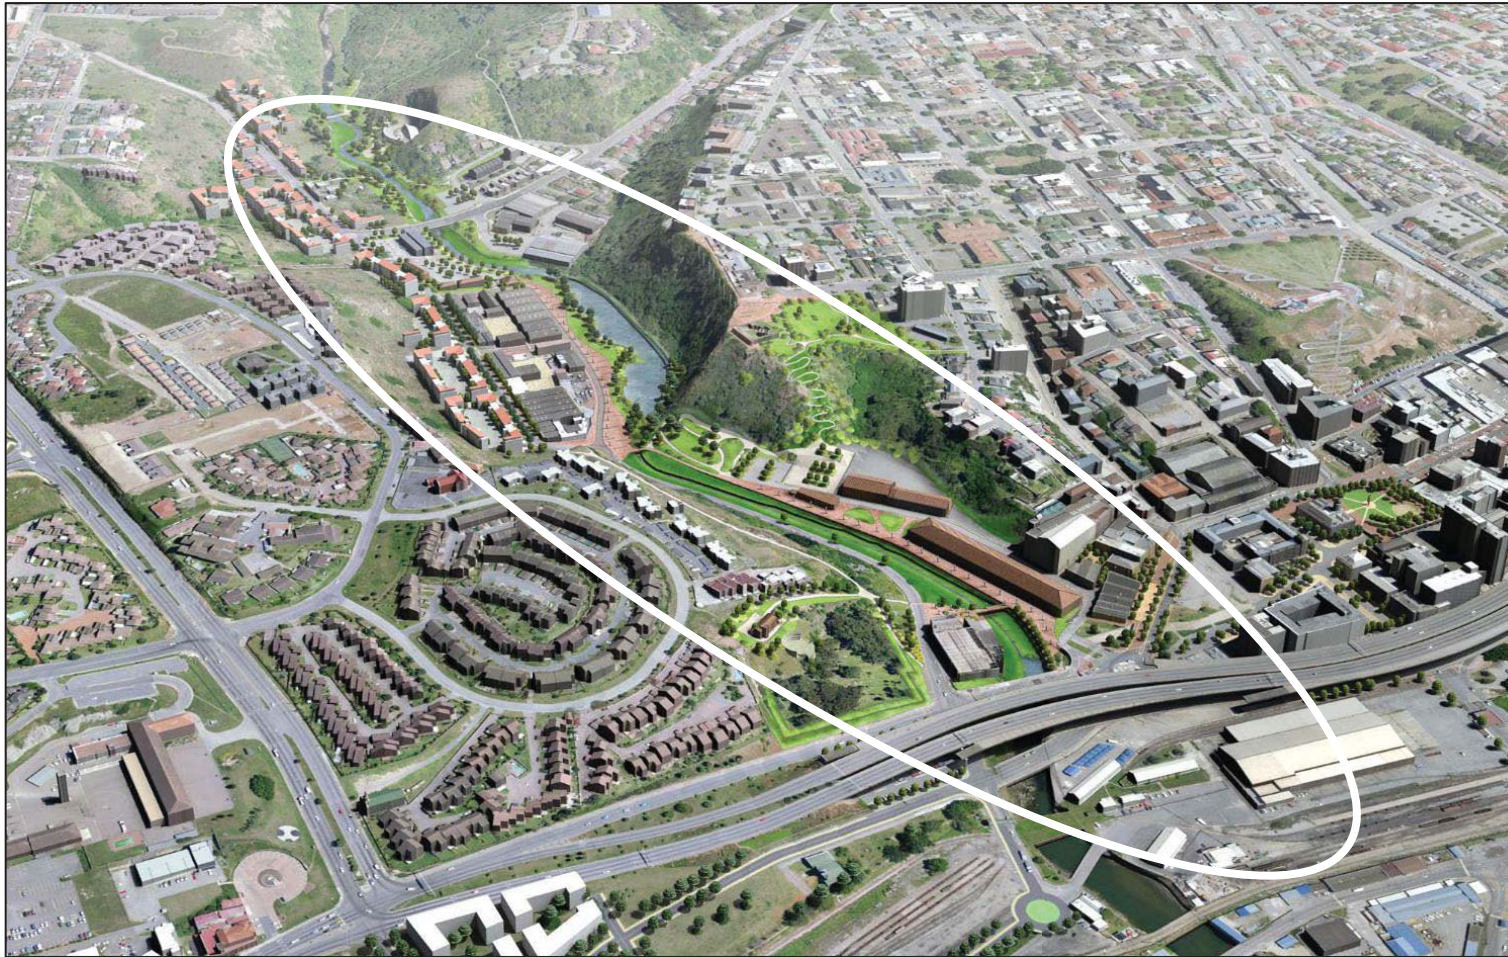
Figure 2.4 The conceptual plan of the GAPP Consortium (2014) lower Baakens Precinct Plan and Parkway

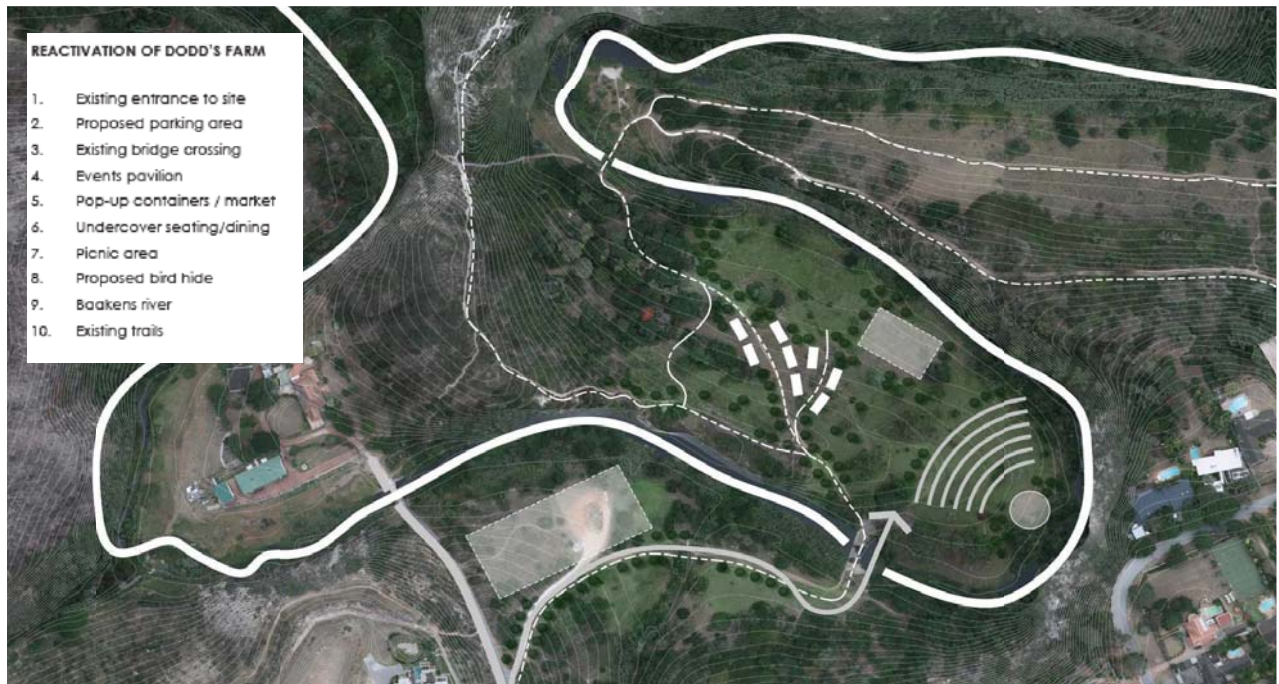
Figure 2.10 The proposed development of Dodd's Farm in Pilot Phase 1.

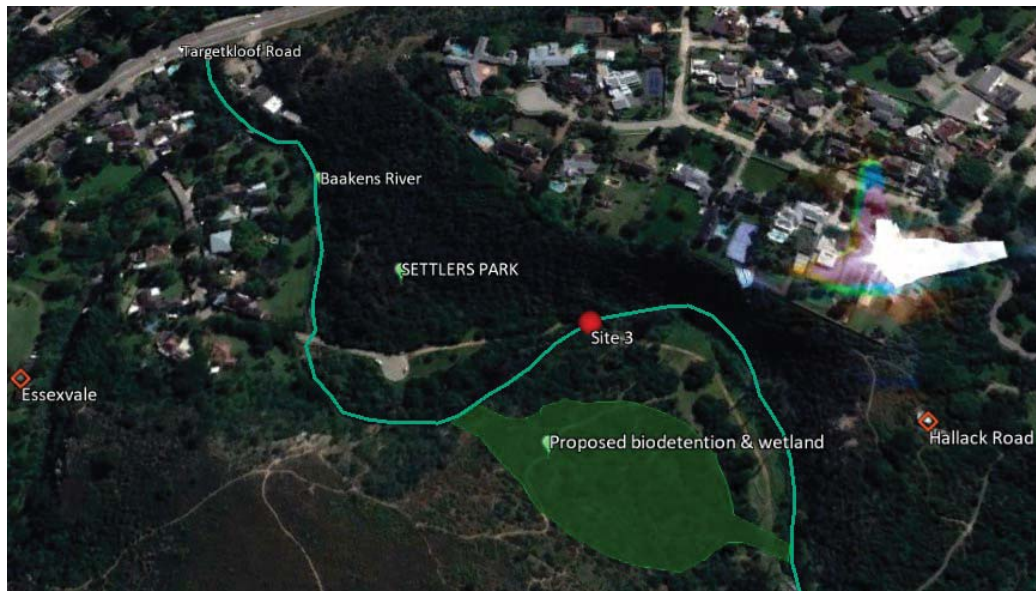
Figure 6.3 An optional location for one of the proposed bioretention ponds with a wetland component, downstream of an area demarcated as a flood hazard zone of the catchment. Within the Settlers Reserve. Note: The total surface area illustrated here is 14,000 m<sup>2</sup>

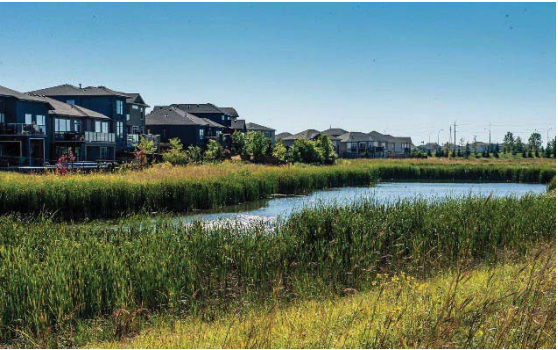
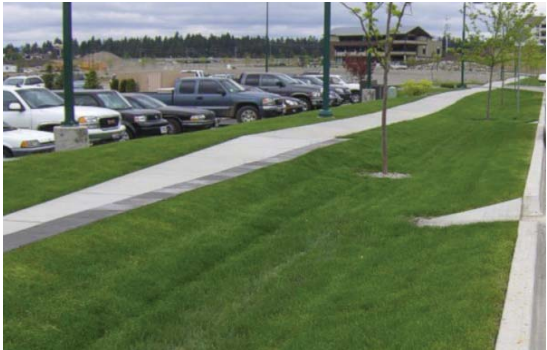
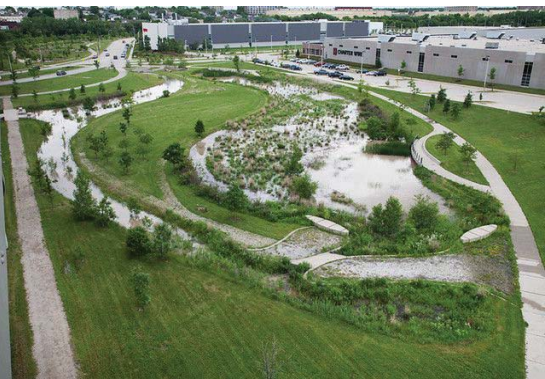
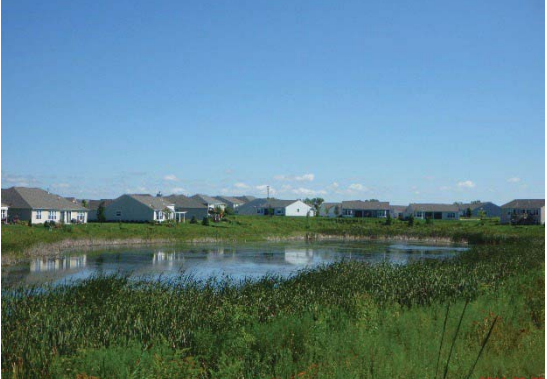
1. Constructed Wet Pond (bioretention system)	2. Constructed swale

3. Constructed stormwater detention system immediately after flooding	4. Storm water detention system (naturalised)

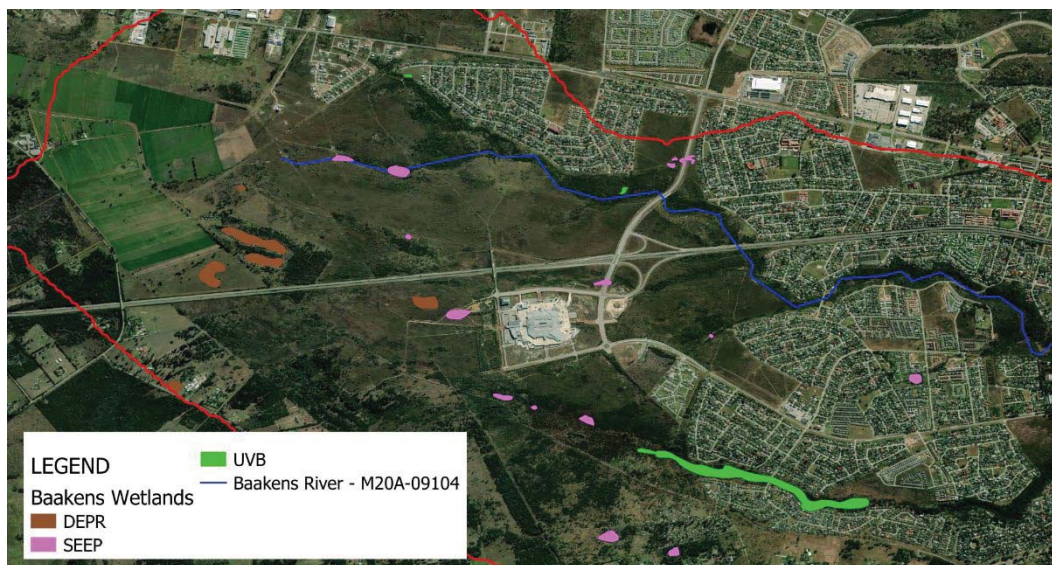
Figure 6.7 Map showing wetland hydrogeomorphic (HGM) types in the upper Baakens catchment (wetland delineation and typing from National Wetland Map 5, 2018). DEPR – depressional wetlands, SEEP – seep wetlands, UVB – unchanneled valley bottom wetlands

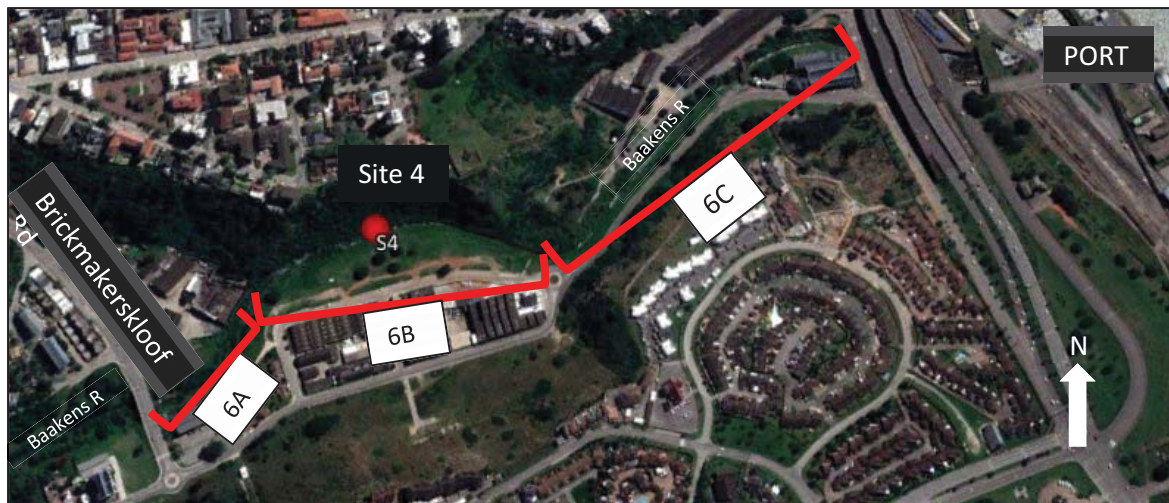
Figure 7.1 Aerial view of the lower kilometre of the Baakens River showing Reaches 6A, B and C and our study Site 4 (Google Earth ©)

For the purposes of this study, this section of river was referred to as **Reach 6**. It is further divided into **Reach 6A**, which is a section of natural channel extending from the Brickmakerskloof Bridge for 175 m downstream, **Reach 6B** which is a gabion-clad channel from end 6A to the area of the lower Valley Road traffic circle ( the river-estuary interface); and **Reach 6C**, the estuary, which is thought to have extended from more or less this area to the ocean (currently the Port).

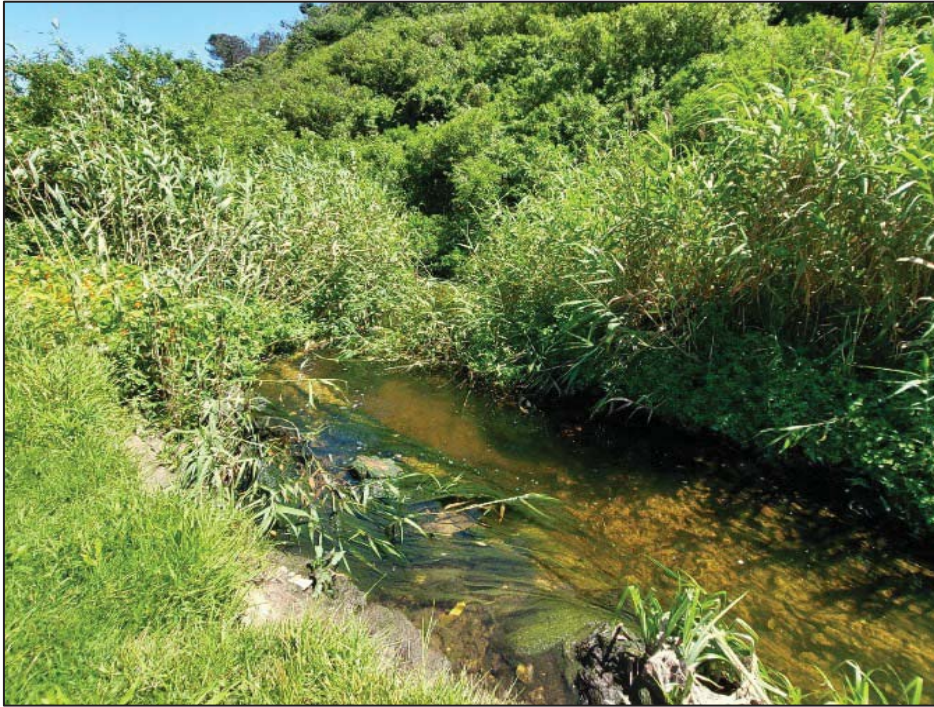
Figure 7.4 Reach 6B – the gabion-lined channel opposite the Valley Road complex. Note the broken gabions and the reed-infestation.

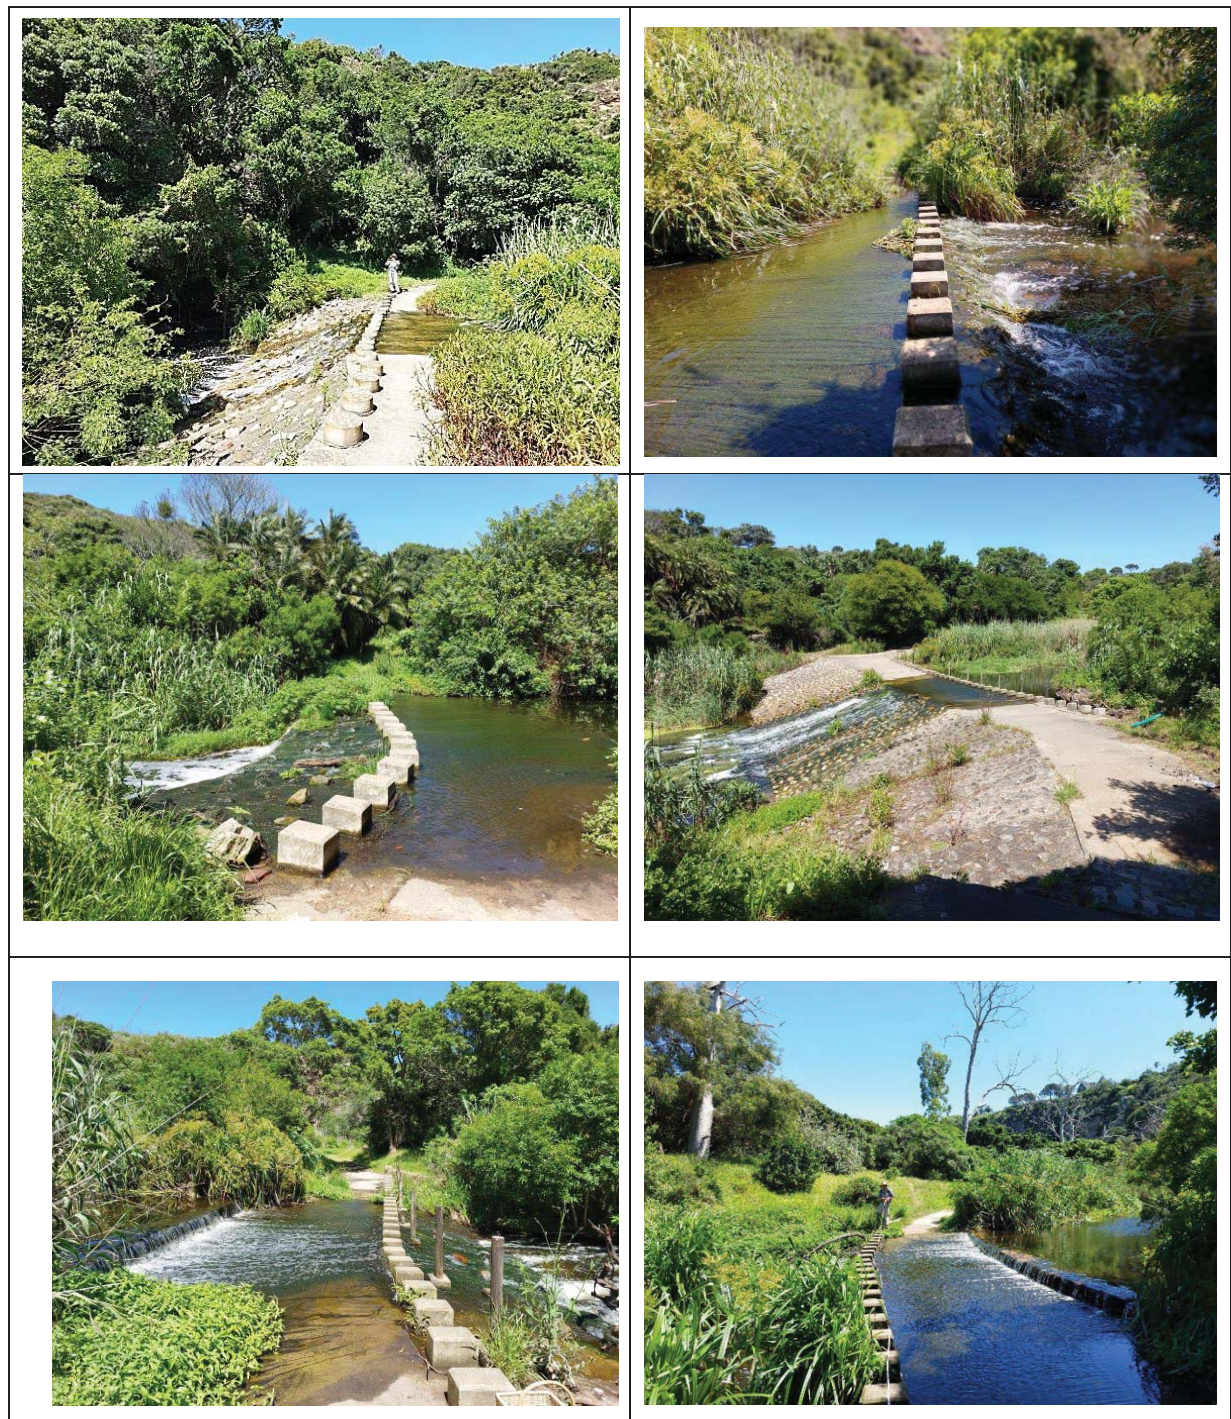
Figure 7.6 Six of the stream crossings requiring fishways in Settlers Park

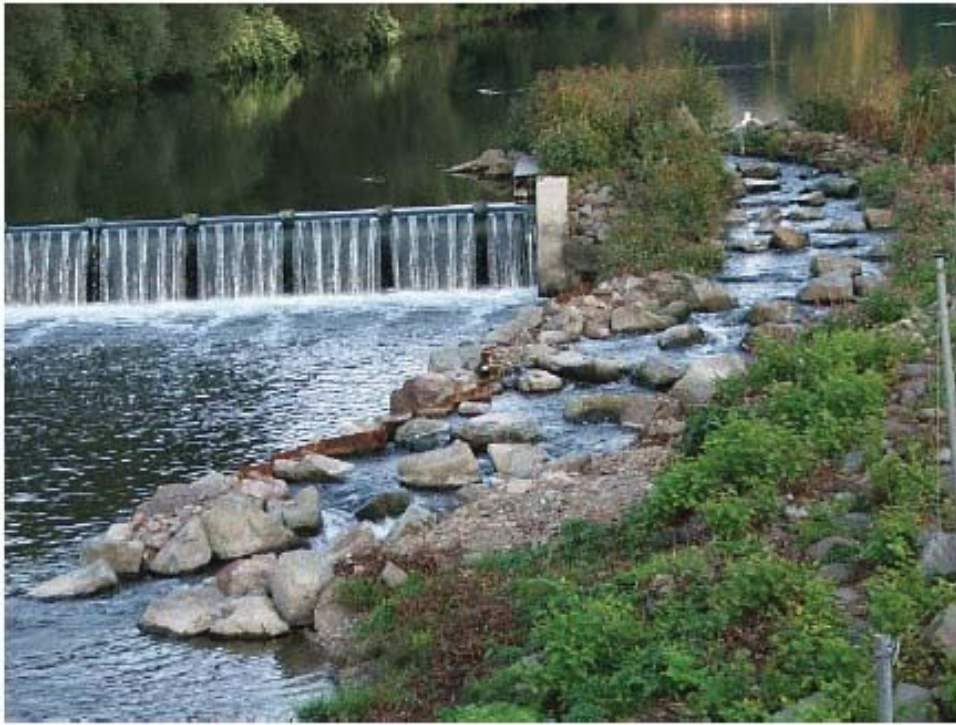
Figure 7.7      Rock-ramp bypass channel on a low weir in the Lenne River, Germany (from Bok *et al.* 2007).

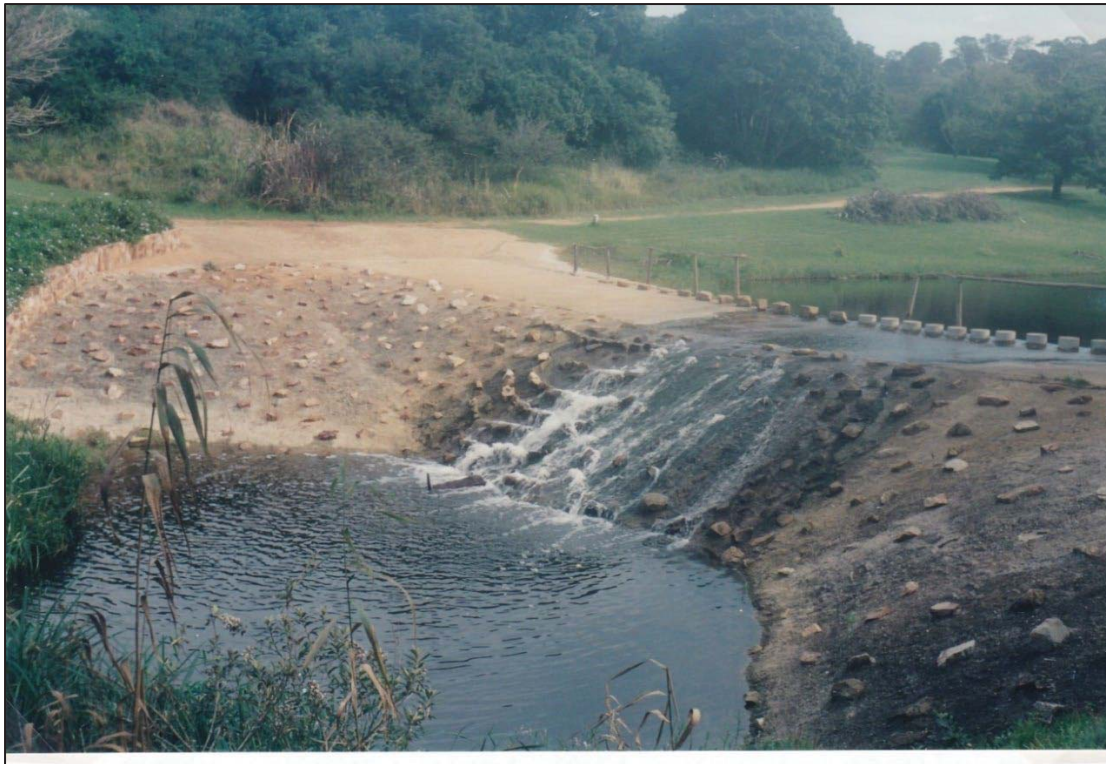
Figure 7.8 A 2007 photograph of Holland Weir (Settlers Park), seen from the left bank

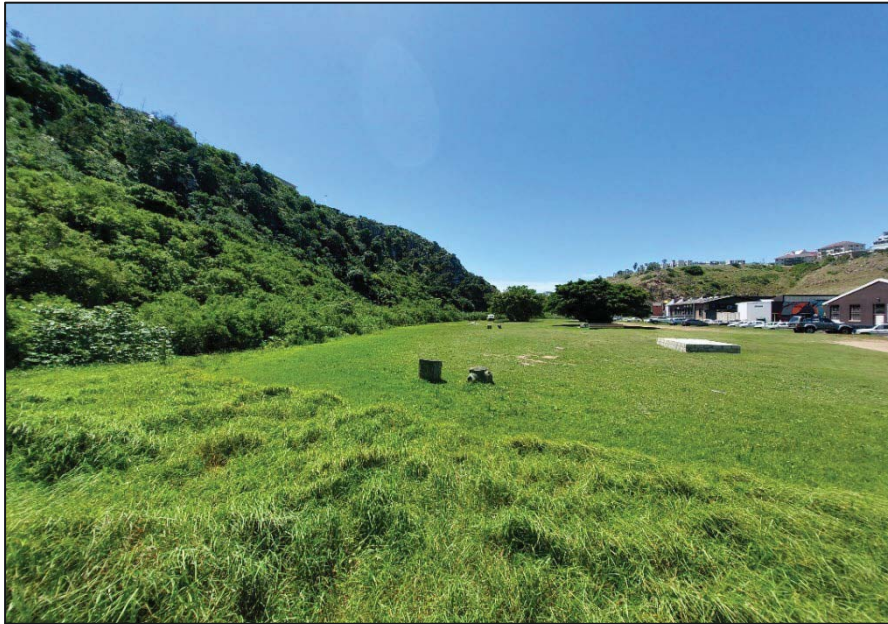
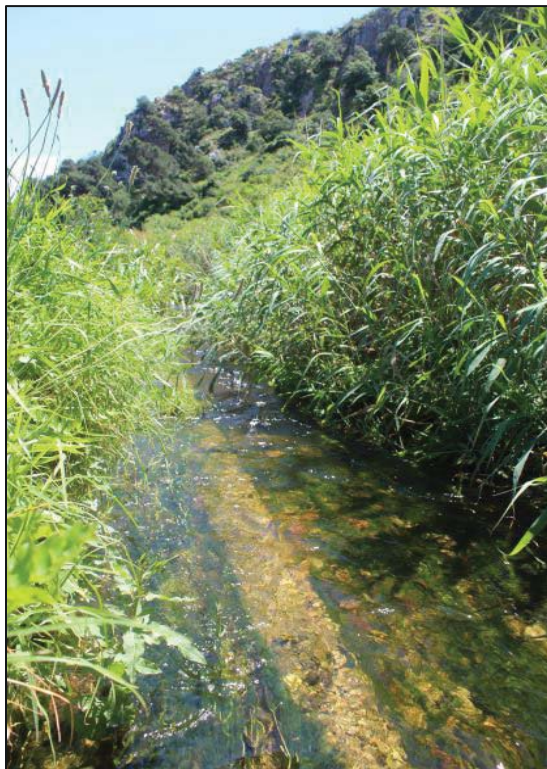
Figure 7.12 Images of the river channel in Reach 6B. The channel is not visible from the banks (Top). The gabions lining the canal have disintegrated in areas and the banks have been scoured. Dense stands of reeds form a (broken) marginal zone and provide some instream habitat (Bottom L and R).

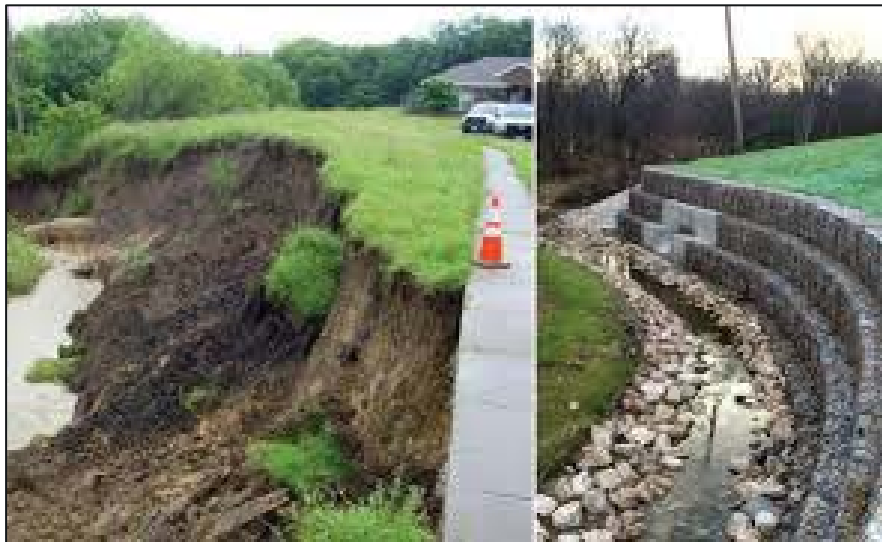
Figure 7.13 Bank stabilisation using the gabion-terrace approach. A lower slope angle and greater terrace width is advised.

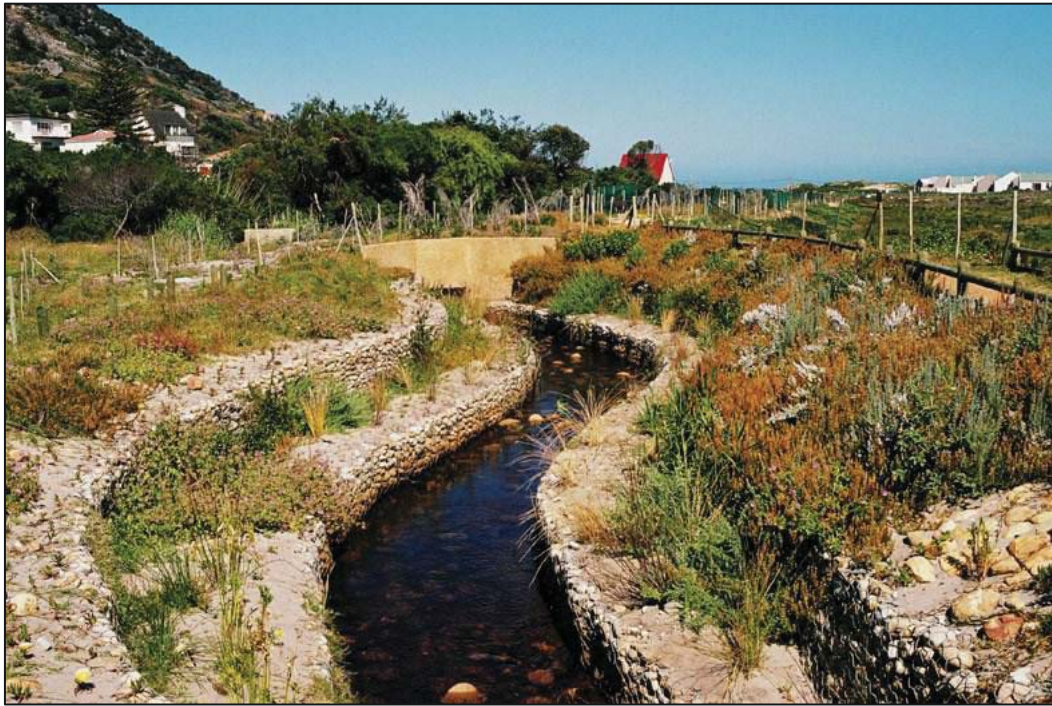
Figure 7.14 An example of cutting back and gabion-terracing the eroded right bank of the river, and armouring the bed with rock to create instream habitat. Constructed for flood management purposes at Silvermine Reserve (African Gabions Gallery)

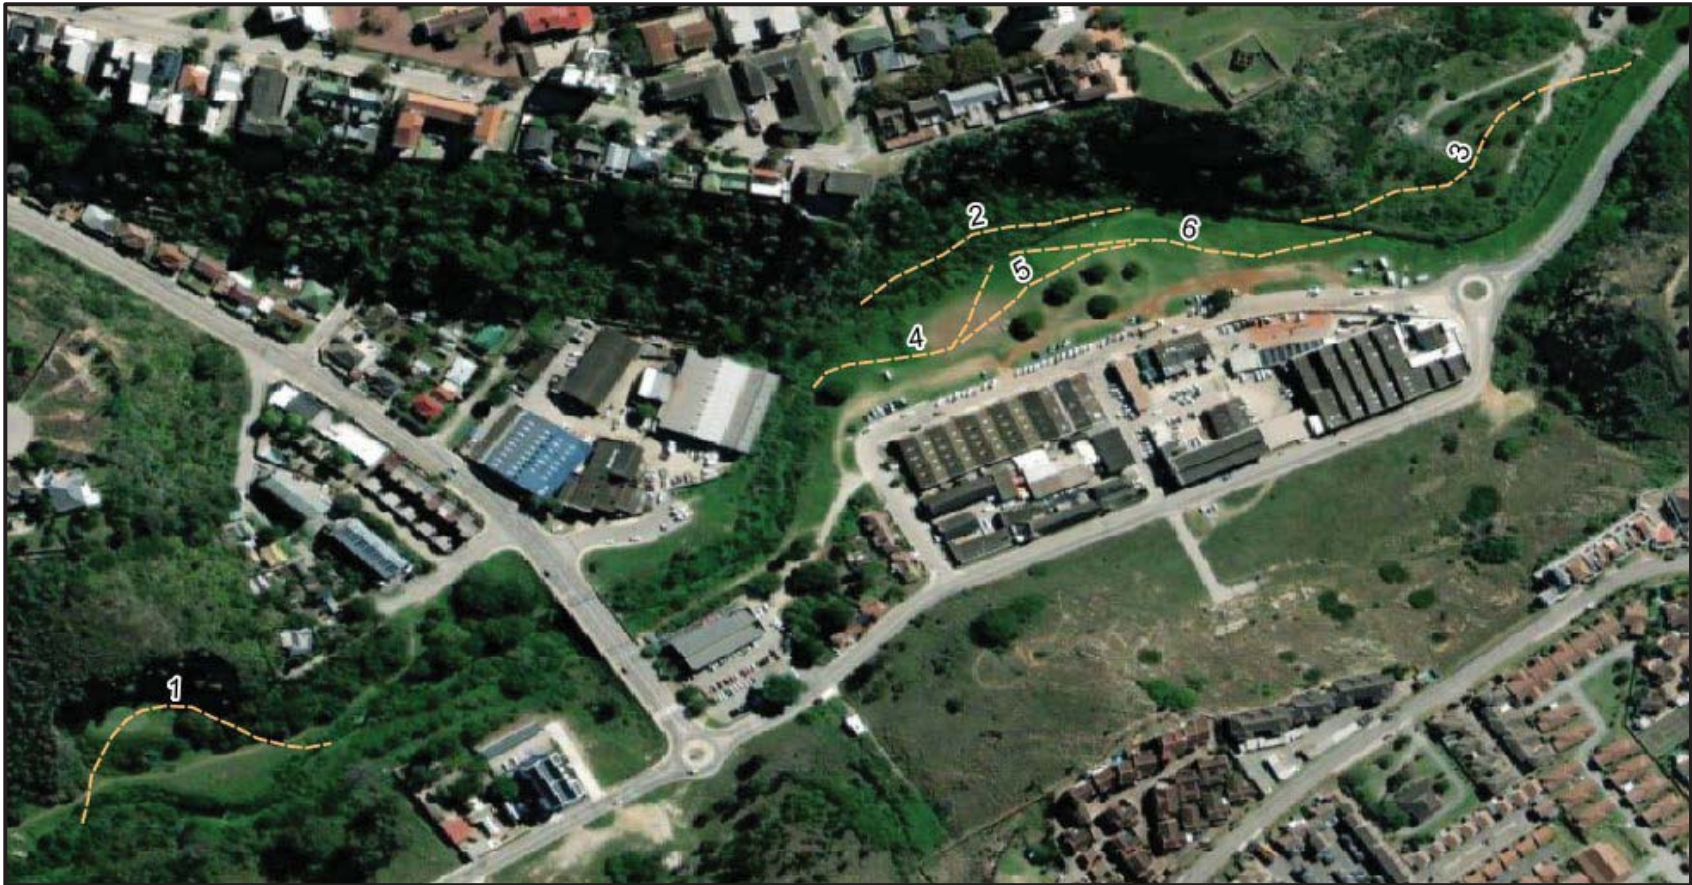
Figure 7.20 High flow / flood channel installation options 1-6, with additional wetland habitat features.
