# Kruger Rivers Post-Flood Research Programme

**Because of their size and social impact, the floods of February and March 2000 attracted the attention of the world. In Kruger National Park, flooding of the Sabie and Letaba Rivers caused significant damage to park infrastructure. Damage to bridges, buildings and roads has since been repaired, but what were the effects of the flood on river ecosystems?**

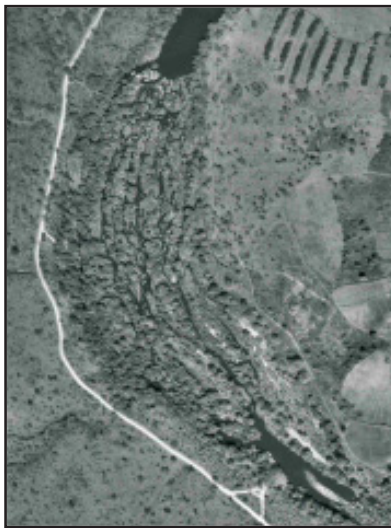
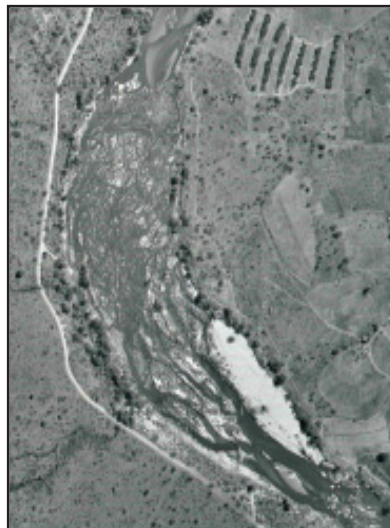
1999

Aerial photographs of a section of river before (1999) and after (2000) the flood.

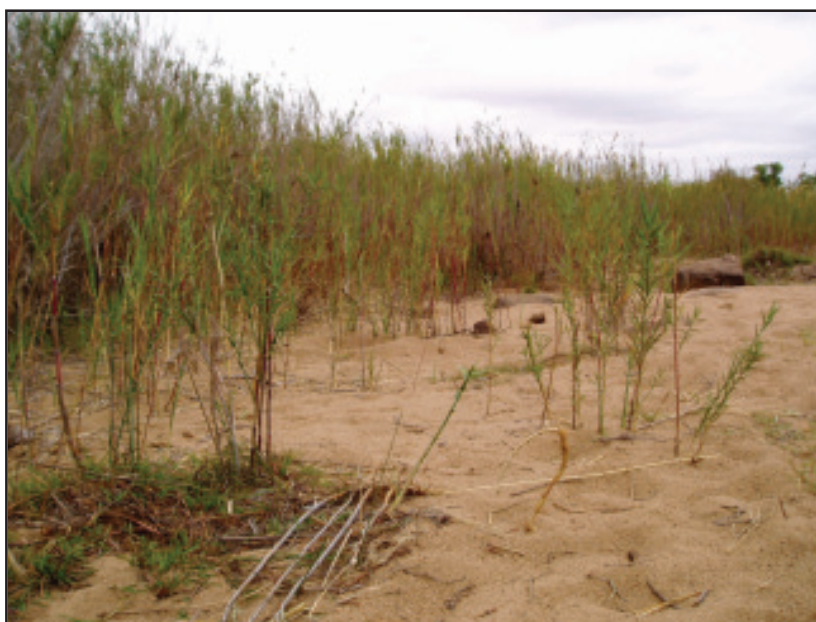
*Expansion of a surviving reed patch (Phragmites mauritianus) into sand deposited by the flood.*

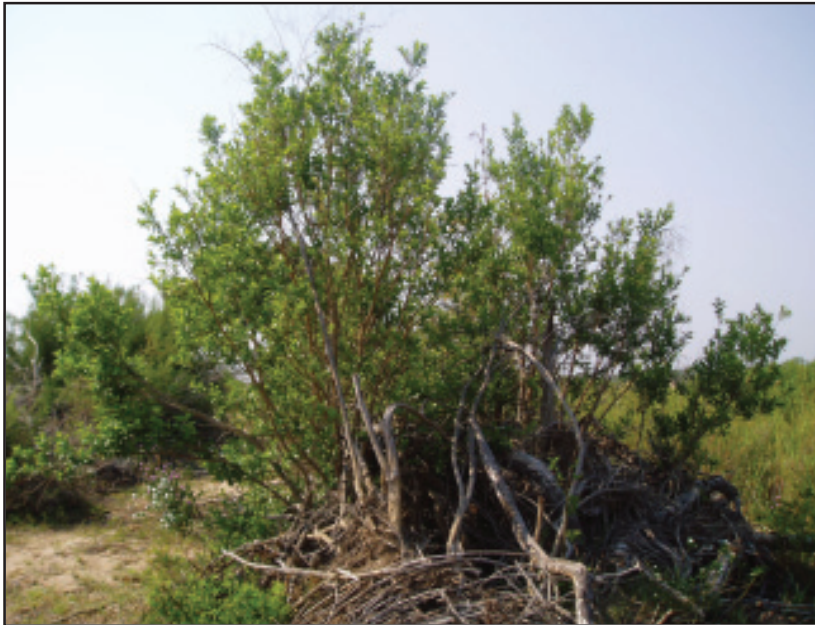
*River Bushwillow (Combretum erythrophyllum) regenerating from the broken parent plant.*

such as Cucumber Bush, Pigeonwood, Magic Guarri and Flame Climbing Bushwillow increased significantly after the flood because of recruitment from seed or regeneration from broken parts of the parent plant.

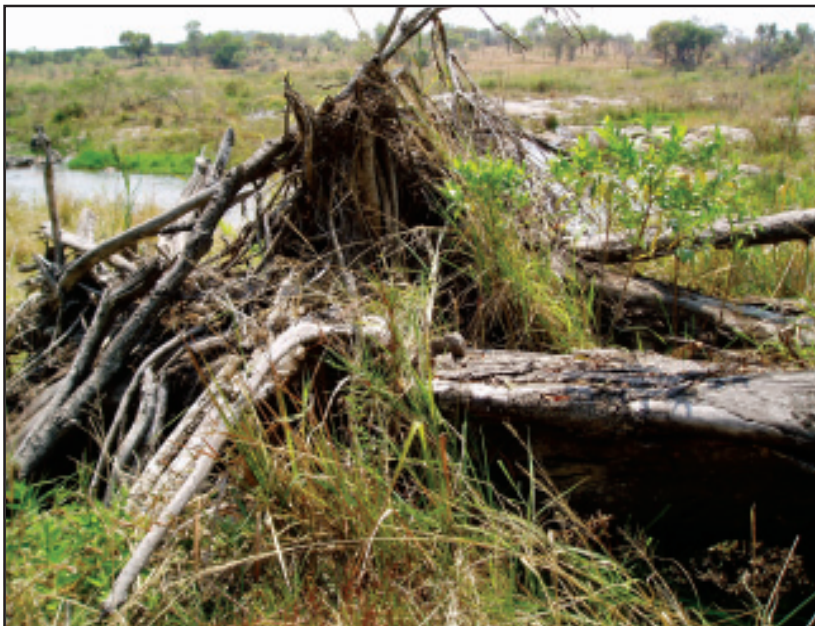
*The flood introduced a large number of woody debris piles, which offer favourable conditions for seedling recruitment.*
