**COMMUNITY BASED RESEARCH ON THE INFLUENCE  
OF REHABILITATION TECHNIQUES ON THE  
MANAGEMENT OF DEGRADED CATCHMENTS**

**WRC Report No. 1316/1/07**

**Water Research Commission**

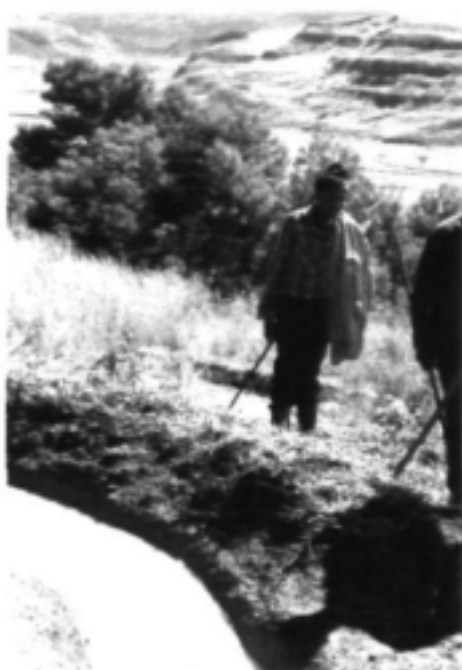
A swale is a combination of a ditch and a bank constructed along a contour line (Plate 1). It slows down the flow of runoff and enables the infiltration of water running down the slope. It is also used for water harvesting. The ditch and the bank should be approximately one metre wide, and have a height of one metre from the floor of the ditch to the top of the bank.

Plate 1. Swale filled with runoff water.

Swales need to have overflows designed and constructed. The bank of the swale should be planted with vegetation to stabilize the loose soil.

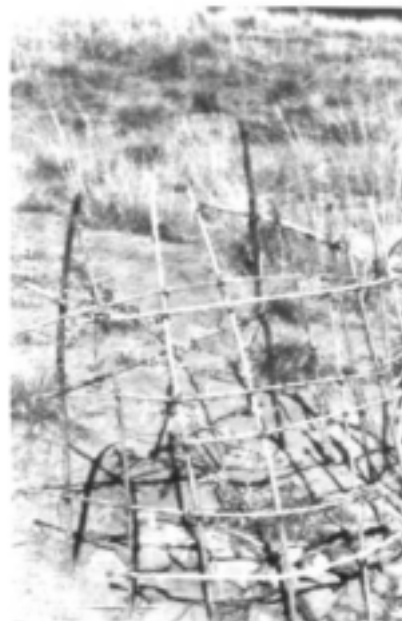
Trees are planted within micro-catchments to form a barrier against overland flow (Plate 2).

Plate 2. Tree planted within a micro-catchment

The micro-catchments are formed by placing a circle of rocks around the tree and covering the soil surface with grass. This forms a mulch which retains moisture for the growth of the tree. The community placed wattle branches around the trees to deter livestock from browsing them.

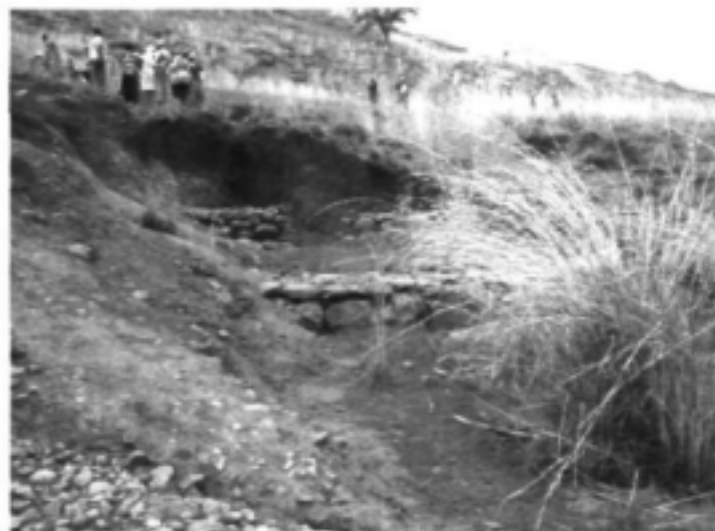
side of the slope and smaller stones were used to fill in the spaces. This enables water to seep through the stones and the soil to deposit above the trench.

Plate 4. Stone lines across an eroded slope.

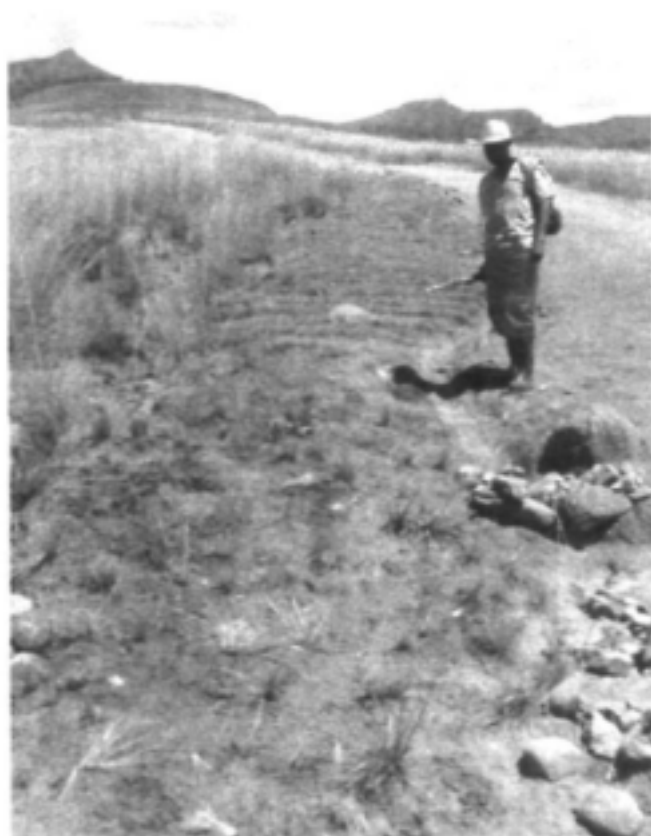
In terms of conservation, the restoration of eroded areas using indigenous grasses has many advantages. The plants occur naturally in the area and some can be utilized for income generation (e.g. the thatch grass, *Hyparrhenia*). However, indigenous grasses do not establish naturally once they have been lost from the system because of their poor seed germination. Indigenous grasses (e.g. *Hyparrhenia*, *Paspalum* and *Melinis*) established in seedling trays can be transplanted in areas where sheet erosion is severe (Plate 6). The seedlings are planted into shallow furrows containing fertilizer and lime. They must be watered regularly during establishment.

Plate 6. Indigenous grasses (lower slope) planted below Kikuyu (upper slope).

Kikuyu is an exotic grass that spreads rapidly through vegetative shoots called stolons. Vegetative material is collected from around homesteads and replanted in eroded areas (Plate 6). The application of lime and fertilizer is recommended to facilitate establishment of the grass.

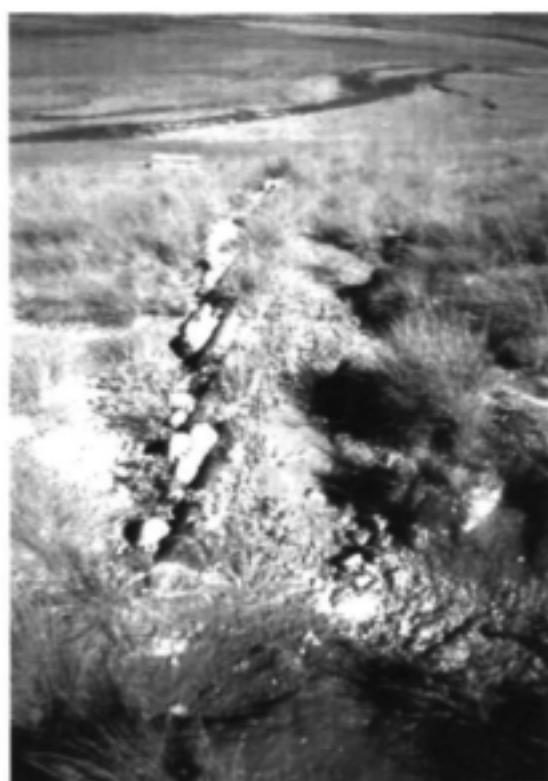
One of the main causes of dongas is erosion from badly sited cattle paths. In Okhombe many cattle access routes go straight up the mountain, resulting in heavy runoff and overland flow. Rehabilitation of cattle routes, paths and hiking trails is essential to slow down the degradation. Stone or creosote pole barriers across paths are recommended to slow down runoff (Plate 7). Creosote poles (100-150 cm in diameter) are keyed into a shallow trench dug across the slope at a 45° angle. The poles are pegged in place with droppers cut in half and bent to form a U-shape. If the path is very wide, additional poles could be added across the slope, ensuring that the ends overlap. These are kept in place with 45 cm laths hammered into the ground adjacent to the ends of the poles. The laths are tied together with wire in the form of a figure 8. If the path is so badly eroded that the poles are not flush with the soil surface, large stones need to be lodged in below the poles and the spaces filled in with soil and smaller stones. The critical part of path construction is the siting and construction of drains which take the runoff away from the path.

Plate 7. Creosote pole barriers across cattle access routes.

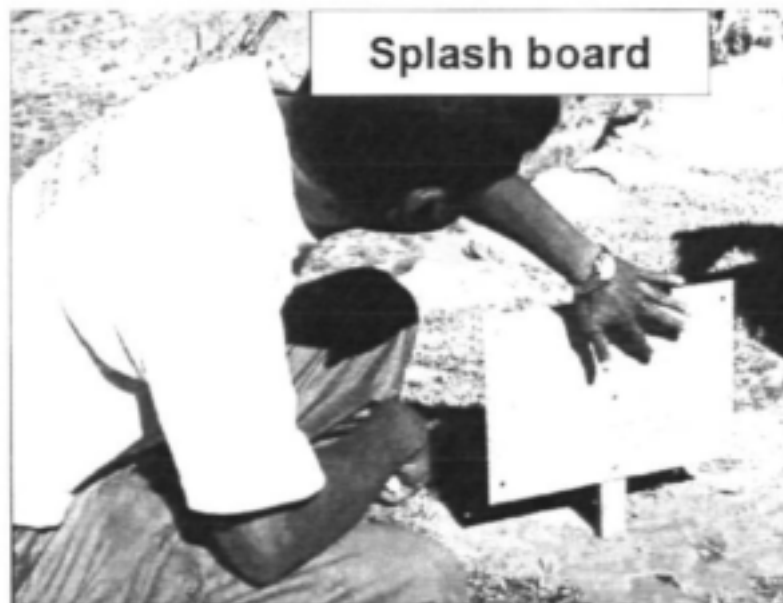
A splash board (Plate 8) is a simple method of measuring the extent of soil detachment (Ellison, 1944). The apparatus is constructed by attaching a central shaft to a rectangular

Plate 8. Splash board used to record height of rain splash.

board on which is drawn parallel lines equidistant apart. Each band within the board is numbered from 1 -14. The apparatus is placed within the area to be monitored such that the bottom edge of the board is approximately 5cm above the soil surface. Sediment that is detached from the soil during a rainfall event is ejected upwards some of which is trapped on the surface of the board. By noting the height of staining on the board it is possible to infer the extent of soil loss by rain splash. The higher the intensity of rainfall the greater will be the rain splash and equally the more erodible the soil the greater will be the extent of sediment detachment. In this way it is possible to develop an understanding of the factors that regulate rain splash. This technique has been particularly useful in communicating the importance of good vegetative cover as a means of combating soil detachment.

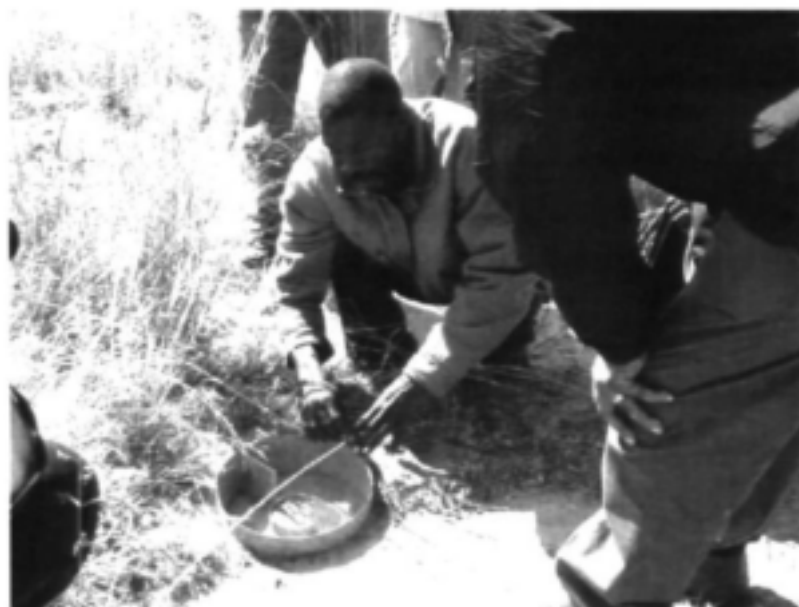
The Morgan splash cup (Plate 9) is used to measure the specific amount of sediment ejected from the soil surface. Morgan splash cups are circular "doughnut" shaped vessels roughly 15 cm in height and an approximate outer diameter of 30 cm (Van Dijk, Meesters & Bruijnzeel, 2002). The centre of the cup (15 cm) is open but surrounded by a circular wall the same height as the outer rim. The device requires an undisturbed central sphere of soil over which the cup is placed, so that the lip of the inner orifice is level with the soil. Soil particles

Plate 9. Splash cup used to measure up- and down- slope erosion.

that are displaced by rainfall fall into the outer ring, where they are retained. The device should be placed on level ground. The advantage of this technique is that displaced soil can be caught and measured, unlike with the splashboard. The displaced soil needs to be carefully collected using a small brush and scoop (without ever lifting the Morgan Splash cup off the ground) and weighed for record keeping. Depth of soil in a calibrated cylinder is one method of measurement. It is important to simultaneously keep accurate records of rainfall events against which soil displacement can be compared. It is important to only collect soil from the cup once the soil is dry and all excess water has evaporated. Any grass growing in the central soil area should be left to grow, as it is an indication of vegetation recovery and should reduce soil loss. If the grass gets too high it can be clipped back.

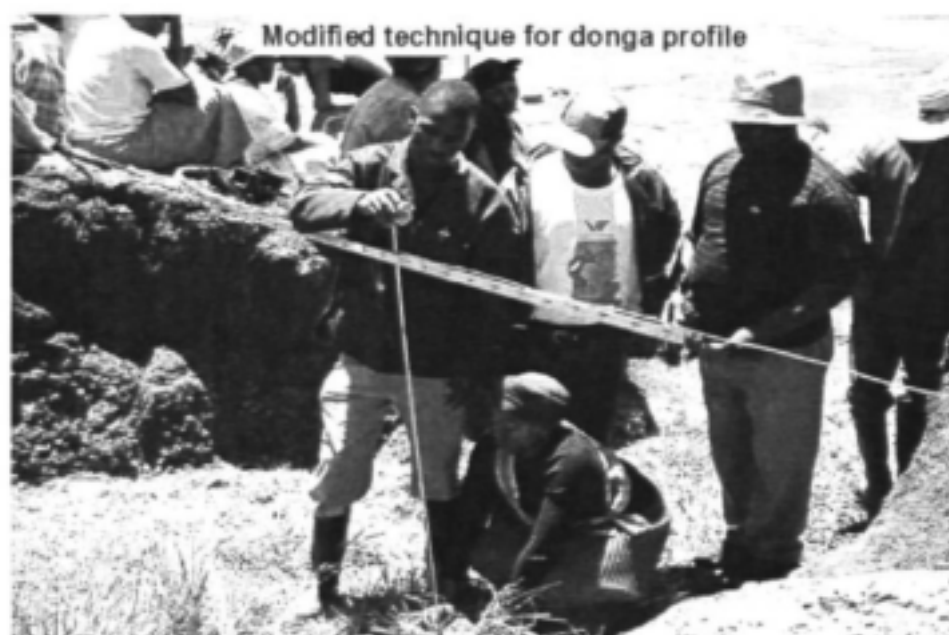
The previous two techniques were aimed specifically at evaluating the extent of soil detachment following rainfall. Gullies, which are much larger scale erosion features are extensive within the region and as before cost-effective simple techniques for monitoring gully development were needed. A common approach to assess gully development has been to measure its cross profile (Plate 10).

Plate 10. Community members measuring a donga profile.

A fixed frame of reference is constructed perpendicularly to the long axis of the gully. For this fencing standards were hammered and secured on either side of the gully to which was attached a stiff strand of wire that served as a reference. Markings spaced at equidistant apart were attached to the wire. Beginning from the left hand side and always facing upslope the perpendicular distance from the wire (reference) to the gully floor is measured. These results are then plotted either electronically or on graph paper to derive the gully cross-profile. The first measurement is taken as the reference state for the system. This procedure is repeated at regular intervals of time. It follows that if the gully is expanding then the distance from the reference to the gully floor will increase and conversely filling in will shorten the distance. Thus over time changes in gully morphology can be determined and an assessment of gully stabilisation efforts carried out by the community can be assessed.

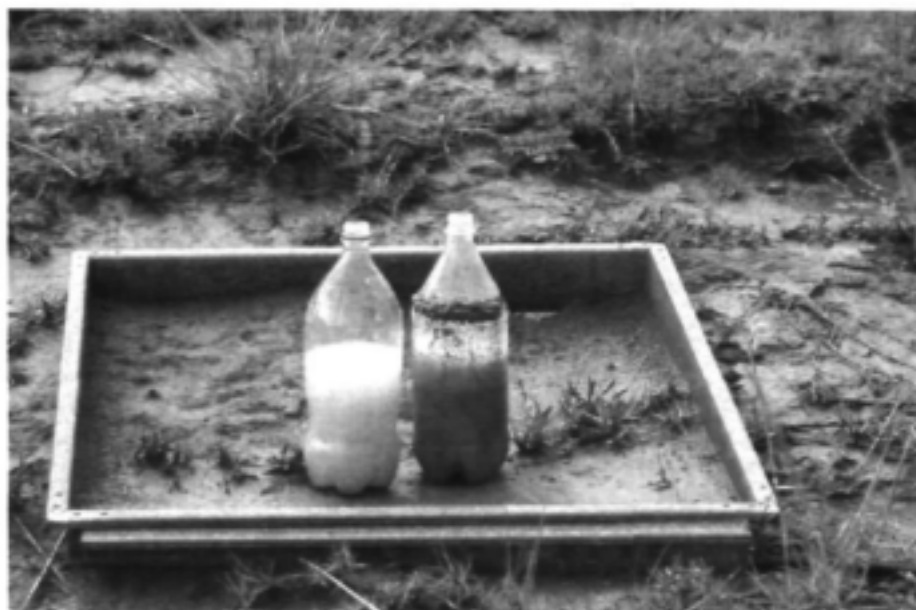
Square metre run-off plots are installed in the ground and connected via a plastic pipe to a two-litre coke bottle (Plate 12). All water runoff from the plot is collected in the bottle and measured as water quantity. The depth of silt from the plot is also measured as an indicator of

Plate 12. Runoff from plots in rehabilitated and eroded sites.

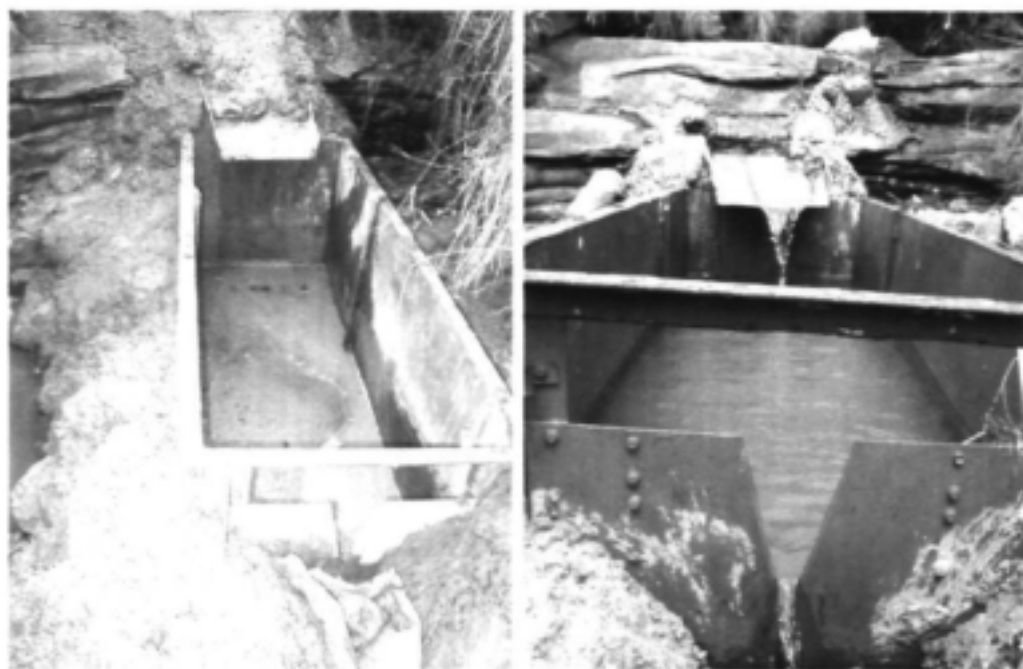
arranged on the tank side of the notch to trap debris likely to block the flow of water. A 300 mm deep 30° steel V-notch was fitted to the end of each tank. The weirs were fixed on a rocky outcrop and grouted into position with concrete. A metal flume guided the water into

Plate 13. Portable weir in the grazed catchment. Note the flume directing the flow into the

stilling portion of the weir and the 30° V-notch at the outlet.

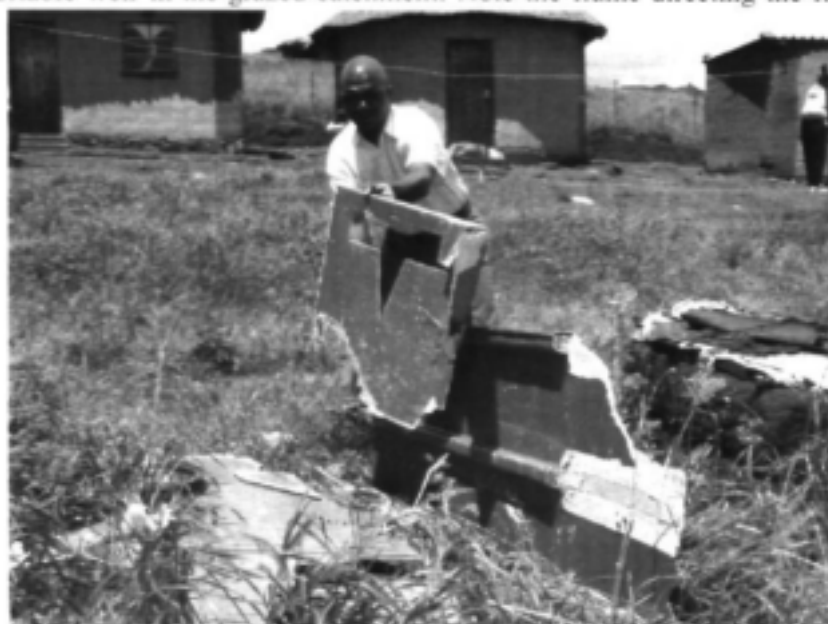
Plate 14. The weir destroyed in the January 2005 storm.

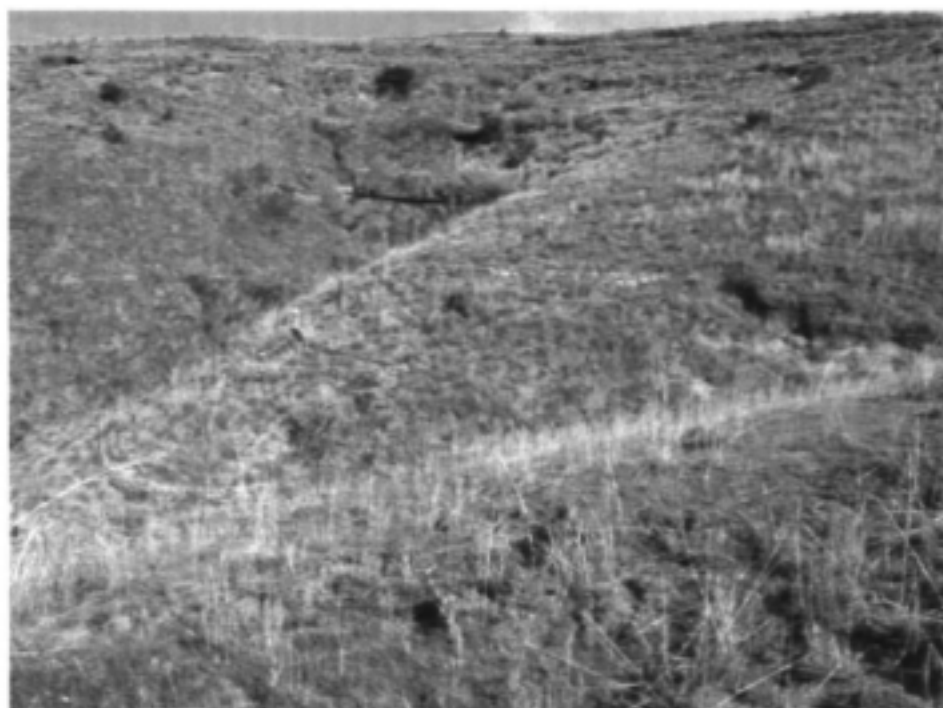
Rehabilitation work in the catchment began early in April 2005 by OMG members. Techniques used included vegetative features (planting of vetiver grass, *Acacia* trees and *Leucaena* trees along the contour) and physical structures such as stone lines (Plate 15). The OMG reported that the lack of stones was a problem in putting up stone packs and stone lines along the upper contours and small dongas. A tractor was therefore hired to assist with stone collection from the river. Two stone packs were constructed within the site and stone lines were placed at the top of the site. The planted trees had to be watered almost everyday because of the low rainfall. Bonox wire was used to close the fence gap to prevent goats from entering the site. A gate was installed for easy access for monitoring. Monitoring techniques installed in the contrasting sites were two splash boards and two run-off plots.

Plate 15. The paired catchments showing the raingauge, stone lines and logger enclosure in the rehabilitated catchment.

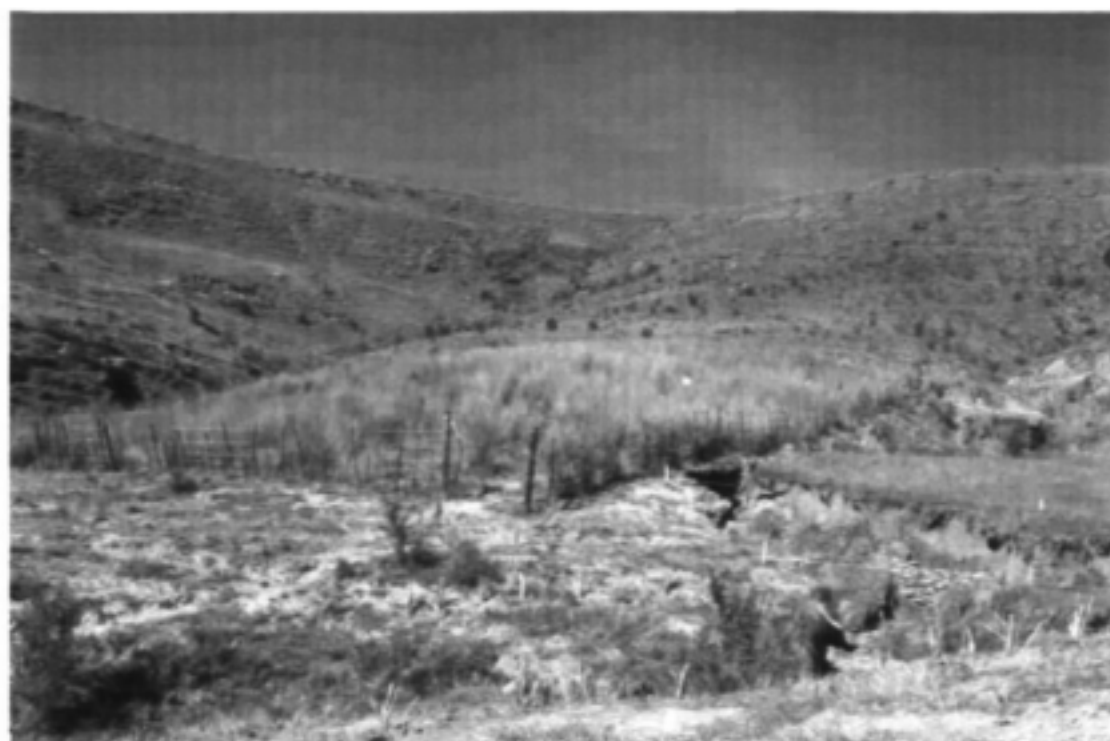
In their application of the monitoring techniques the community noted significant differences between the eroded and rehabilitated sites (Plate 16). Examples of the data obtained from the different monitoring techniques are presented below. The full data sets are available on the project CD.

Plate 16. Contrast between the eroded and rehabilitated sites at Mahlabatini.
