**PERFORMANCE TESTING OF  
OPERATIONAL BASIN SOLAR  
STILLS**

**WRC Report No. 1392/1/04**

**Report to the  
WATER RESEARCH COMMISSION**

**McCracken Solar Stills (Pty) Ltd (PTY) LTD**

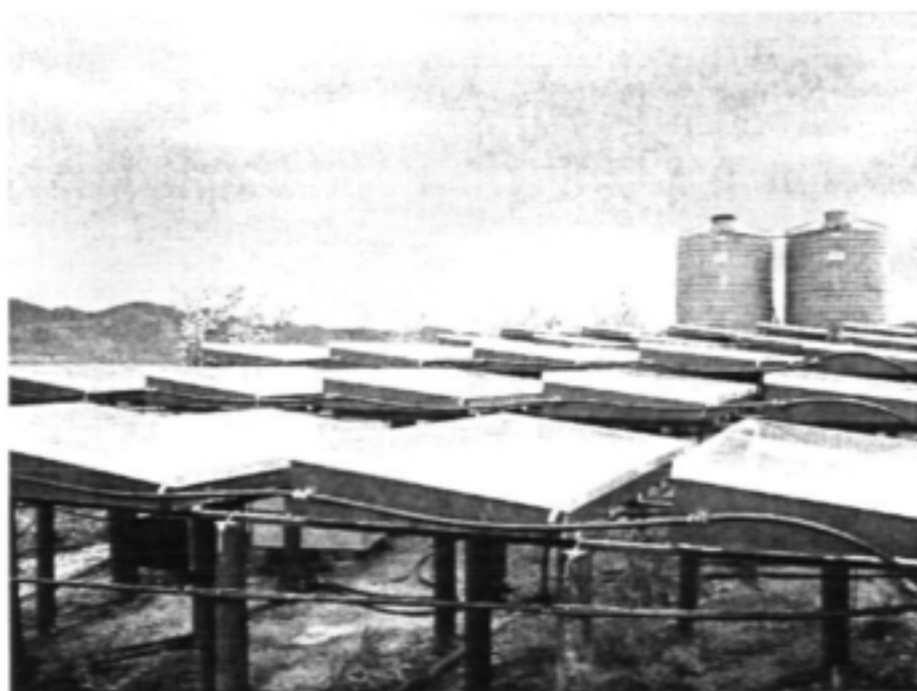
Figure 7: DWAF solar still plant at Algerynskraal in the Klein Karoo with Solardome-manufactured solar stills.

- The cascade design was discarded in the DWAF project at Algernyskraal in favour of individually flushed units. In this design all 30 solar still units were fed individually through an automated solar powered control valve system, and the overflow of each still was connected to the central waste pipeline (see Figure 6). (The waste water at Algernyskraal is suitable for sanitation purposes). This modification was successfully implemented and no scale-related feed water distribution problems have been encountered to date, although the feed water was significantly harder than at Kerkplaas.

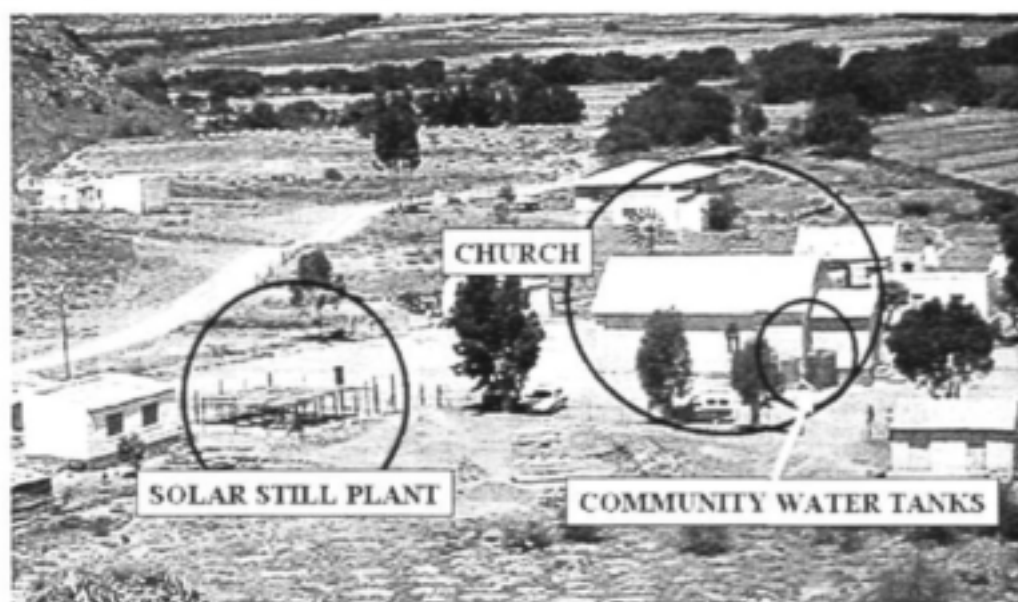
Figure 28: Kerkplaas with the solar still plant and community water tanks.

The existing rainfall harvesting infrastructure at Kerkplaas consisted of roof gutters (mostly in need of repair) and plastic collection tanks around the main church building.
