# **Appendix A**

## **Greywater survey questionnaires**

Within the developed world there are numerous systems (some patented) which aim to dispose of greywater by treating it to acceptable standards and reusing it in some form of irrigation system. The systems described in this report are a selection chosen to describe some of the innovative means of treatment and disposal worldwide. It should be noted that most of these technical solutions presuppose that normal (full) water services are provided. In South Africa the use of greywater in certain areas warrants further consideration since this country is prone to water shortages, but some form of “on-site” treatment would be required to render this water safe for use. The cost implications, maintenance requirements and social acceptability of such systems would however have to be taken into account before deciding which treatment technology to adopt.

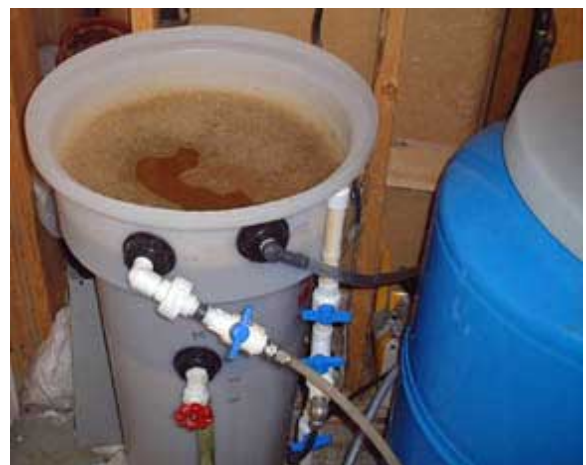
**Figure B1.2: Example of BioSand filter installation**

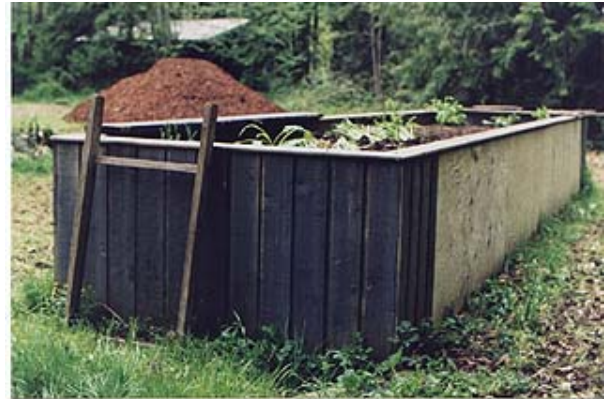
**Figure B10.2: Greywater planter in British Columbia**

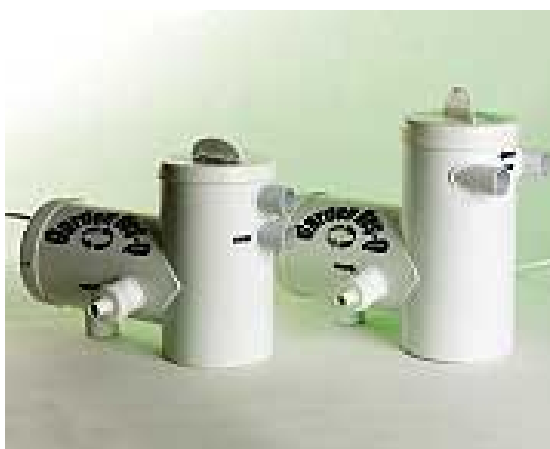
Another system similar to Water Rhapsody and GRS, the Garden Res-Q unit (Garden ResQ, 2006) uses greywater from a home bathroom to irrigate a small to medium-sized garden. The unit is connected directly to the outside drain-pipes of an existing bath or shower where the greywater is filtered of hair and lint, and then a low-pressure pump is activated to pump the water through a normal 20mm garden hose as soon as the sump starts filling with the greywater. Once the shower has been turned off or the bath emptied, the pump automatically switches off and ceases the irrigation process until the next bath or shower. A return to sewer mechanism / overflow has been included in the design of the system, and a small percentage of greywater is automatically diverted to sewer during each session, thereby assisting with solid waste removal and keeping rubber seals wet and lubricated.

**Figure B13.1: Garden Res-Q greywater system**

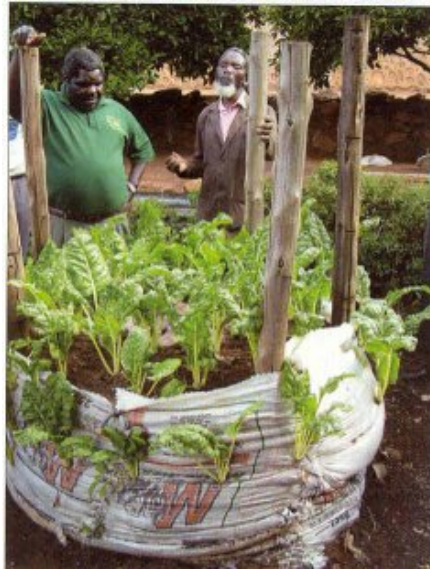
The tower garden is a concept that was derived from a project occurring in Kenya (Crosby, 2004). Vegetables are grown in a column of soil surrounding a central stone-packed drain, in a bag usually constructed out of shade cloth. The type of shade cloth used to form the “skin” of this system is important. It was found that in South Africa, shade netting was ideal and could be used in conjunction with nylon string or fishing line to join up the ends to form the cylinder. Each day, greywater is poured on top of the stones so that the flow of water is controlled into the bag and vegetables are planted in holes cut in the sides of the bag.

The system is relatively easy to maintain with some basic irrigation skills. To account for the often-soapy greywater, pouring two buckets of clean water into the column each week clears the system. This system favours the growth of leafy vegetables such as spinach.

**Figure B14.1: Example of a modified tower garden in use in Limpopo province**

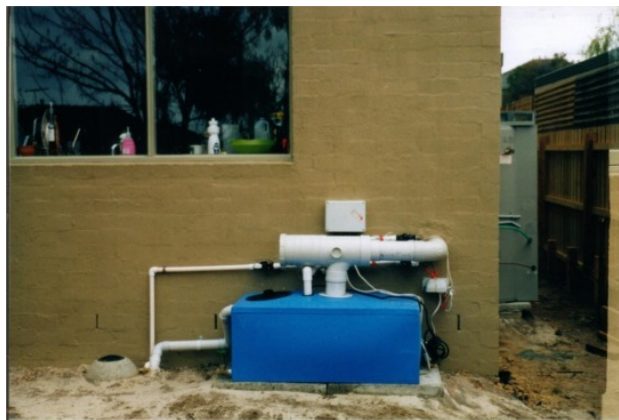
This system (Wattworks, 2006) uses greywater generated from the household to flush one or two toilets in the home. It stores water from the shower or bathroom in a holding tank which discharges excess water to sewer every 24 hours so as to not to cause any offensive smells.

**Figure B15.1: Example of Wattworks installation**

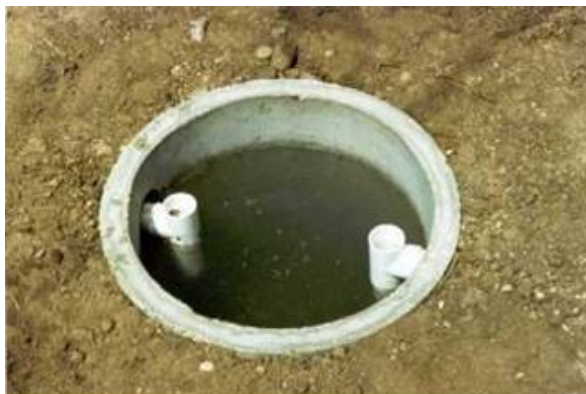
This system (Casa Juliana, 2006) has been designed to treat kitchen greywater and consists of a distribution hub from a 25l cement bucket and a 15mm PVC pipe which distributes the greywater to six small infiltration chambers. The kitchen greywater first passes through an interceptor which traps grease and fats before it is used for irrigation purposes.

**Figure B17.1: Grease interceptor**

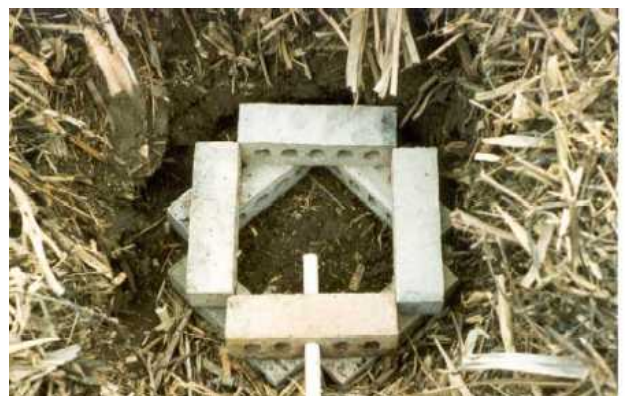
**Figure B17.4: Detail of infiltration chamber at end of pipes**
