THE USE OF NON-POTABLE WATER IN ROAD CONSTRUCTION

Report to the Water Research Commission

Frank Netterberg Construction Materials and Geotechnical Specialist

WRC Report No. 3035/1/22 ISBN 978-0-6392-0493-2

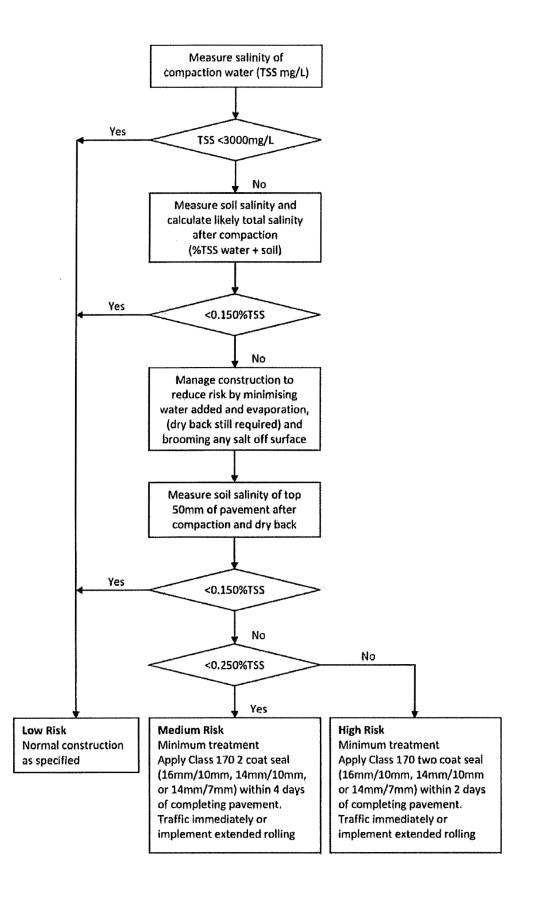
A risk assessment approach to the use of seawater was used for the construction of the airport runway at Onslow in Western Australia. The salinity risk management flowchart used for Western Australian roads (Cocks et al., 2018) includes specific reference to the salinity of the compaction water (Figure 3.1).

Figure 3.1: Salinity risk management flowchart (Cocks et al., 2015).

- 6. Within (say) one day of priming, apply a polymer modified binder (PMB) waterproofing seal. The recommended seal was a 14 mm PMB site blended S10E (i.e. about 3% SBS). Do not use cutter

- 7. Back-roll the waterproofing seal every day with pneumatic multi-tyred rollers until the asphalt is laid.
- 8. Asphalt (site blended A35P an EVA plastomer) to be laid as soon as practicable after the waterproofing seal."

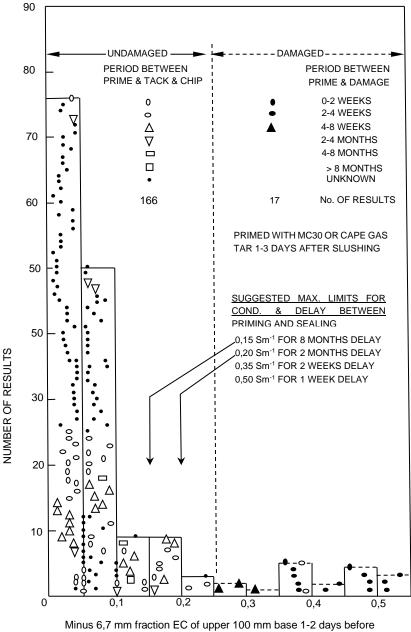
A relatively low salt content in the slushing water, perhaps as low as 0,15% was sufficient to add enough salt to the upper few mm of the base to cause salt damage to the primer if left long enough. However, 0,8% salt water was successfully used if the primed base was sealed quickly.

An analysis of some of the records for the southern contract clearly showed the dependence of the damage on both the total salt content of the completed base just before priming and on the length of exposure of the primed base (Figure 4.1) from which a conservative limit of 0,15 S/m was derived. This, together with others (Netterberg, 1979) is the sources of this limit in the CSRA: 1987 and later specifications.
