**RESEARCH ON THE CORROSION
PERFORMANCE OF VARIOUS
NON-METALLIC PIPING MATERIALS
AND COATINGS IN POTABLE WATER**

**Advanced Engineering and Testing Services
Division of Materials Science and Technology, CSIR**

WRC Report No. 381/1/99

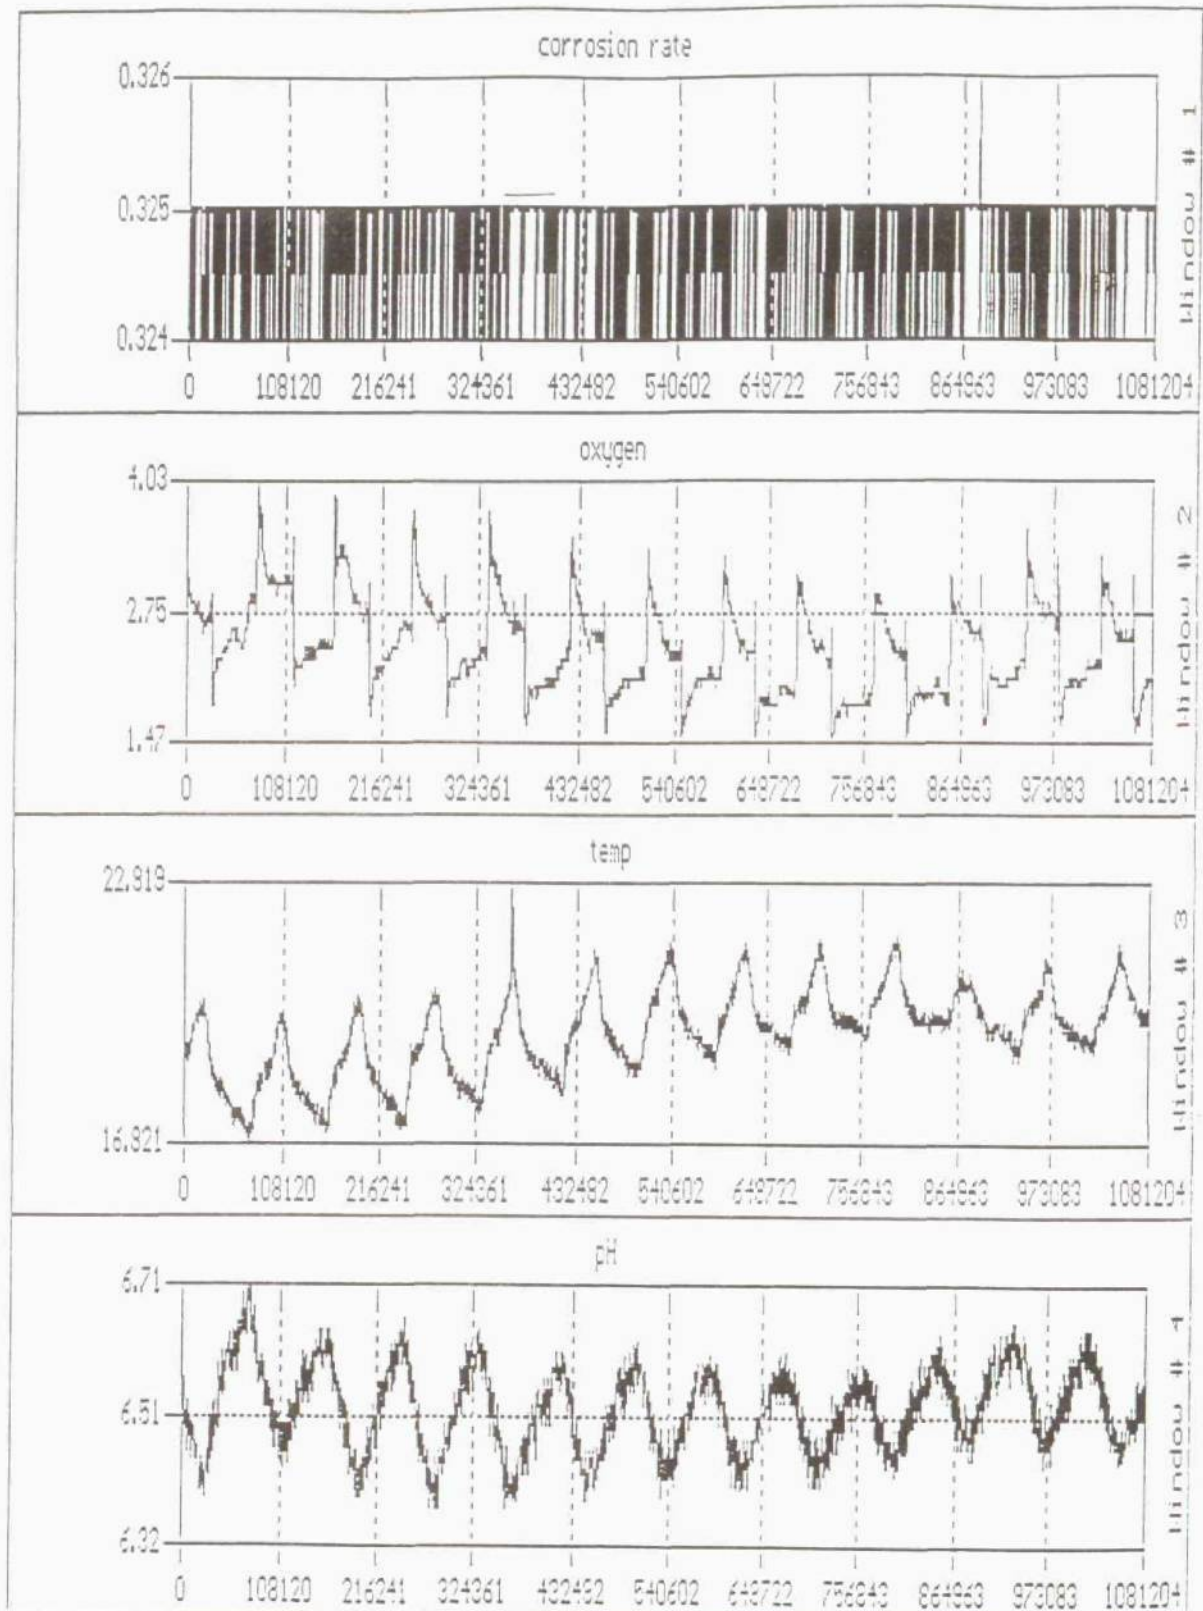
The following water quality parameters were monitored: pH, temperature, dissolved oxygen, pressure, conductivity and corrosion rate. Typical signal traces versus time for the different probes are shown in Figure 14. The averaged results are shown in Table 12. For comparison, the water analysis results from the flowloop are presented in Table 13.

Figure 14: Typical changes of measured parameters from water quality monitoring over 9 months.
