A Manual on Mine Water Treatment and Management Practices in South Africa

APPENDIX Volume 3 Gold Mine Site Visit Reports

WRC Report No 527/3/96

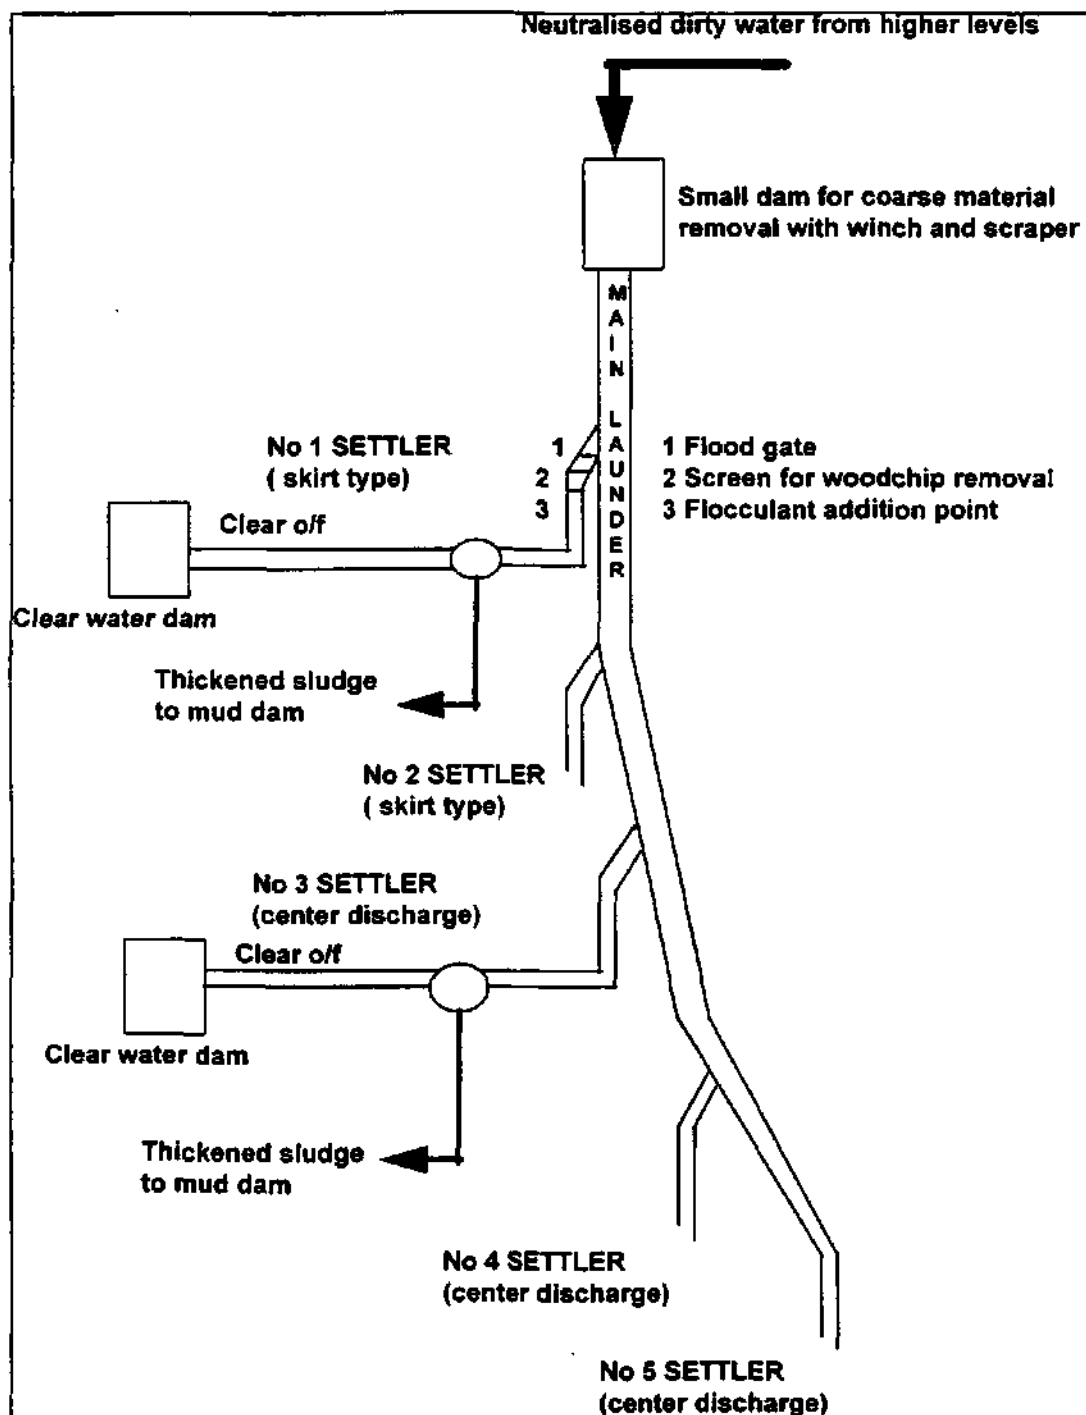
Figure 6 : Schematic of settler and launder system lay out on 103 Level

neutralising reagent, dosing occurs at 71, 73, and 91 level, from where it then gravitates down with the dirty water to 103 level. This allows for a longer reaction time for the lime.

In addition, as can be seen from Figure 6, the feed launder system has been designed, so as to minimise disturbance of the water after flocculation and thus reduce the floc breakage.

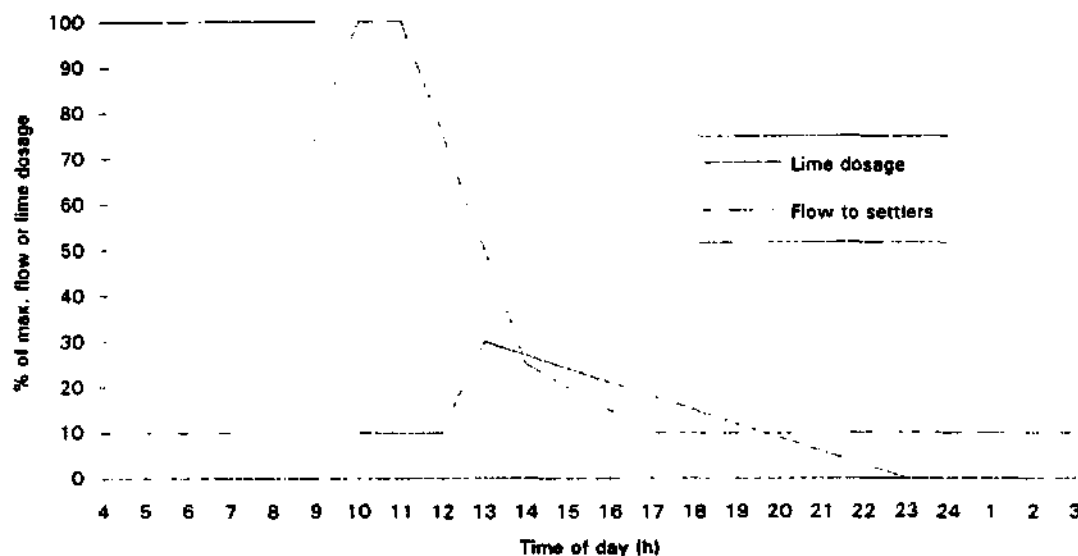
Figure 8 : The different phases during a 24h period for lime dosing and flow to the settlers.

Flocculant addition must be done at a point of high turbulence to get flash mixing, after which the flowrate must be reduced to such an extent to allow for flocculant formation to take place before reaching the central downpipe in the settler. This is not happening at the system that was visited.

The pH reaching the settlers can vary anything between 3 to 10 which influences the performance of the specific flocculant which has a negative effect on the suspended solids content in the overflow.

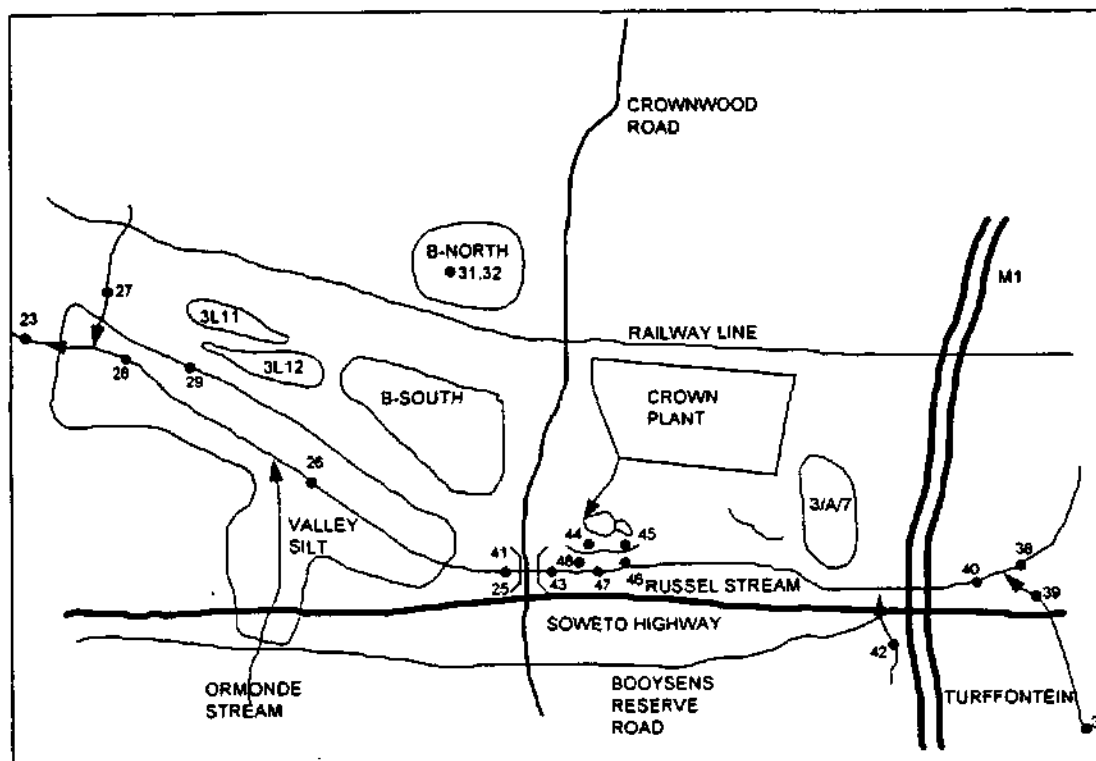
Figure 4 : Reclamation of sand dumps and slime dams sites in Crown plant area

The biggest water problem in this operation is seepage into the groundwater and the Russel stream. Figure 4 shows the layout of present reclamation areas feeding Crown Plant. The pH and conductivity sampling points are also indicated. The effect of seepage can be seen when comparing the conductivity reading of 155 mS/m at point 41 with a reading of 185 mS/m at point 28. The dilution effect of the urban runoff at point 27, with a conductivity of 62 mS/m, can be seen when compared to the conductivity of 127 mS/m at point 23.

It is also important to note that the whole Valley Silt Area is covered with a layer of slime of up to 5 m thick in some areas. The Russel stream flows through this area and in so doing is picking up pollutants from the slime, which increases the conductivity.

Ponding of water within monitoring sites should be minimised to prevent the formation of groundwater recharge sites which will cause pollution thereof. Two such stagnant ponds on top of B North Sand Dump measured pH readings of 3.3 and 2.3 and conductivities of 467 and 1740 mS/m.

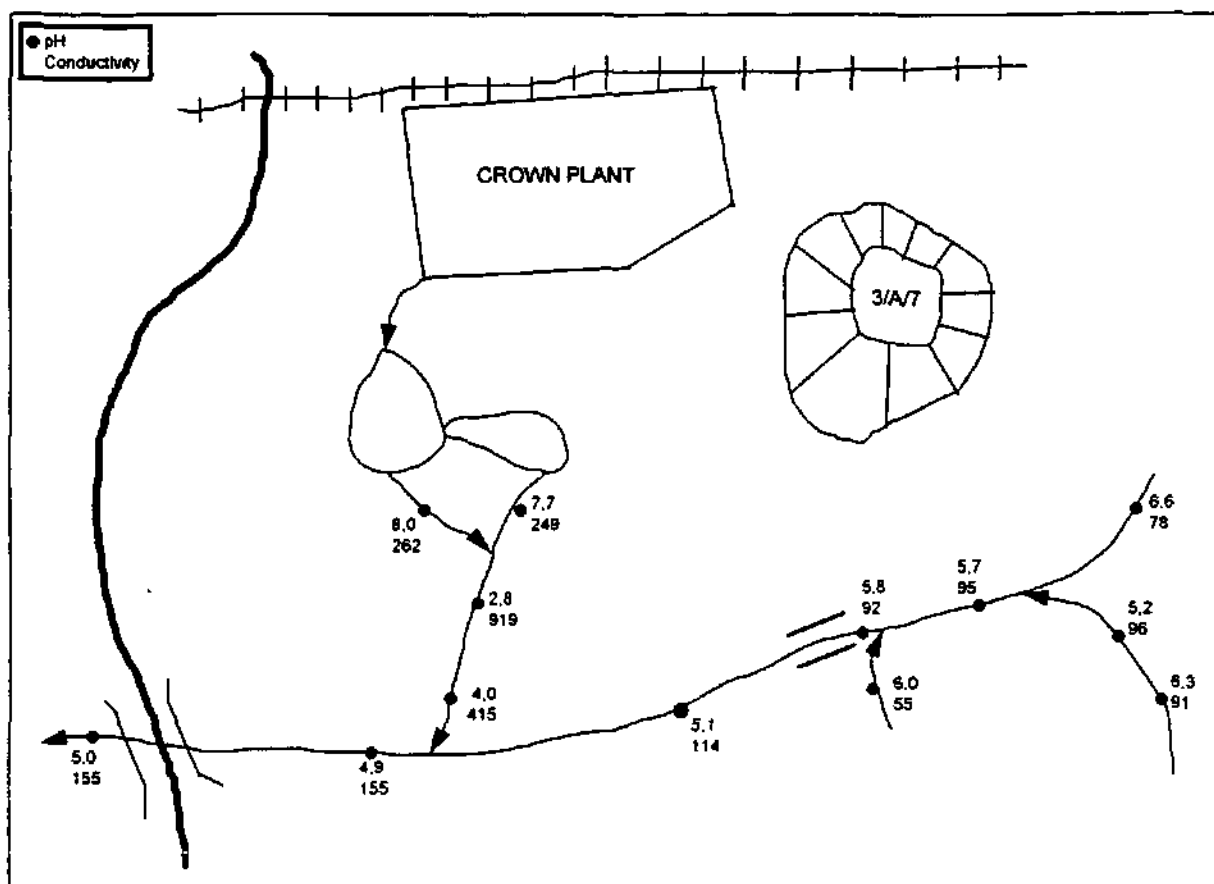
Figure 5 : pH and Conductivity measurements taken along the Russel spruit south of the Crown Plant

Figure 5 shows the contamination of the Russel stream south of Crown Plant. The pH and conductivity sampling points and results are also shown. The Russel stream has a conductivity of 95 mS/m just after the confluence of the NE and SE tributaries. This is diluted to 92 mS/m downstream of the pedestrian bridge due to the inflow of urban runoff at 55 mS/m. At the cement channel south of the 3/A/7 dump, severe precipitation due to seepage into the Russel stream was observed. A conductivity reading downstream confirmed the occurrence of seepage, as the conductivity increased to 114 mS/m.

Two separate seeps from the catchment dam measured at 262 and 249 mS/m combined before flowing to the Russel stream. Closer to the Russel stream, a conductivity of 919 mS/m was measured following the course of the seepage to the stream. This may be possible due to subsurface seepage from the surrounding areas and 3/A/7 dump. The decrease in conductivity to 415 mS/m closer to the Russel stream is the dilution of the seepage with the water from the stream itself. Downstream of this seepage inflow the conductivity was 155 mS/m, similar to the reading at Crownwood bridge.

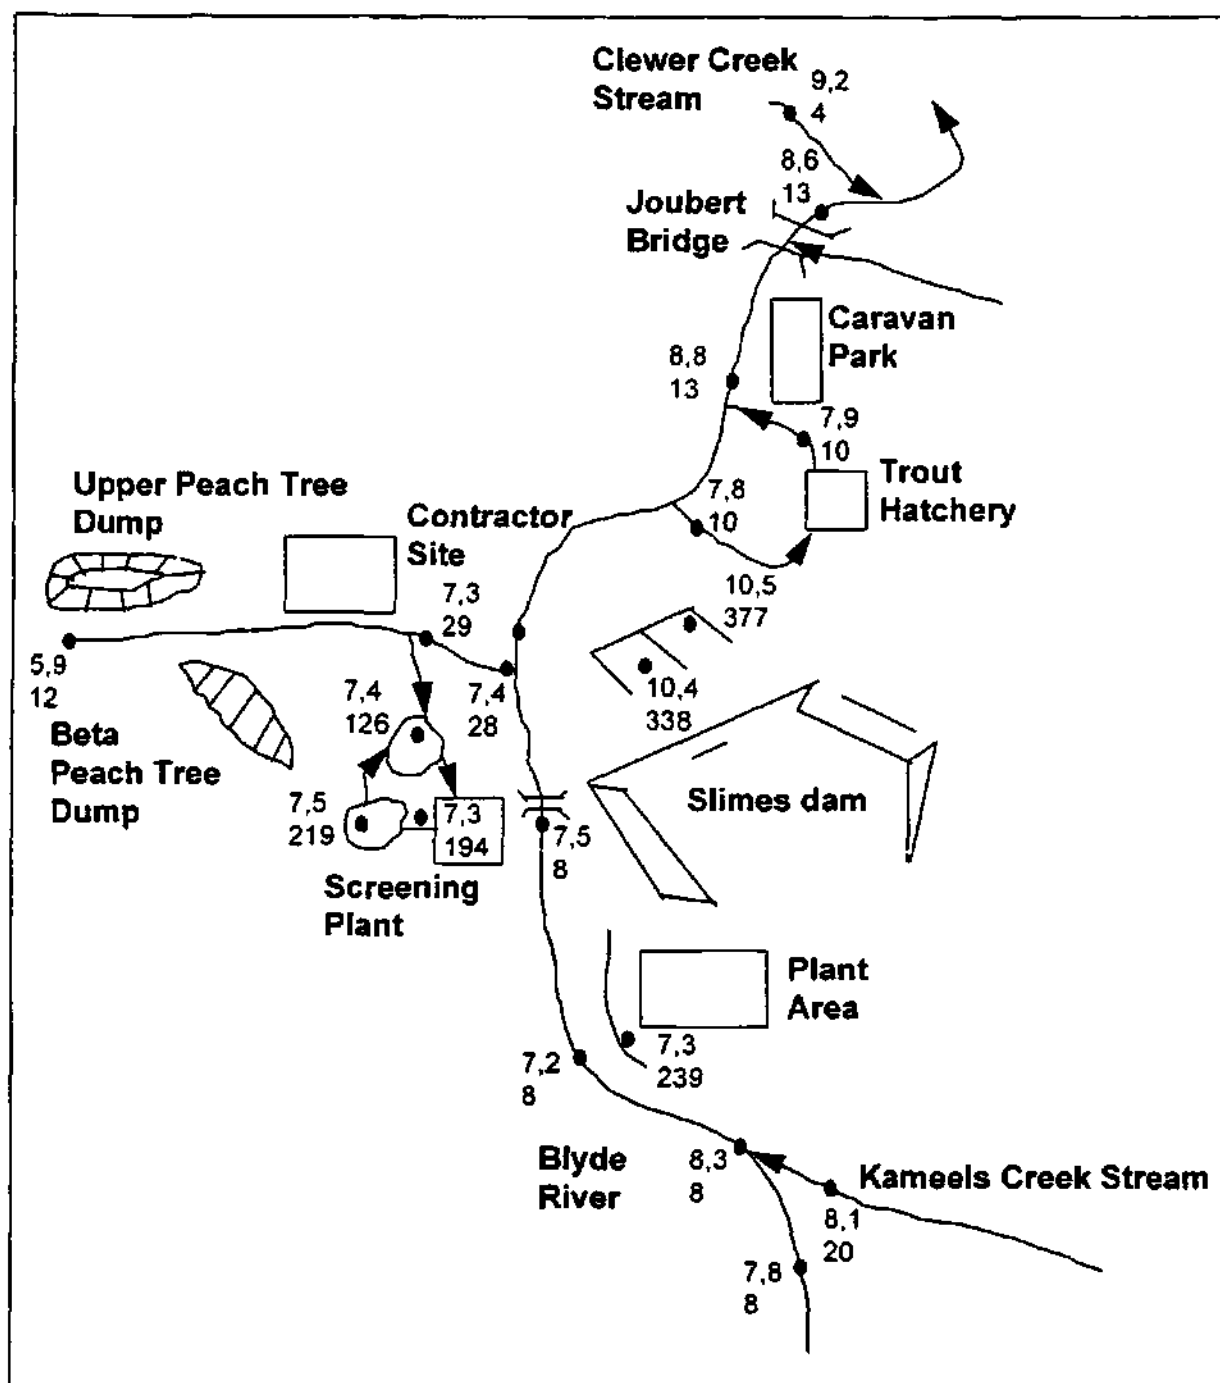
Figure 3 : Layout of the pH and conductivity readings taken during the site visit.

A great deal of erosion occurs on the side slopes and a large amount of solids are washed down into the evaporation paddocks. The erosion can be controlled by establishing vegetation on the slopes.

During the site visit plant residue was deposited primarily on the southern and western sides in an attempt to improve the dam level and reduce the pool area respectively.
