Causes and consequences of algal blooms in Loch Logan, an urban impoundment

AT Vos and JC Roos*

Centre for Environmental Management, University of the Free State, PO Box 339, Bloemfontein 9300, South Africa

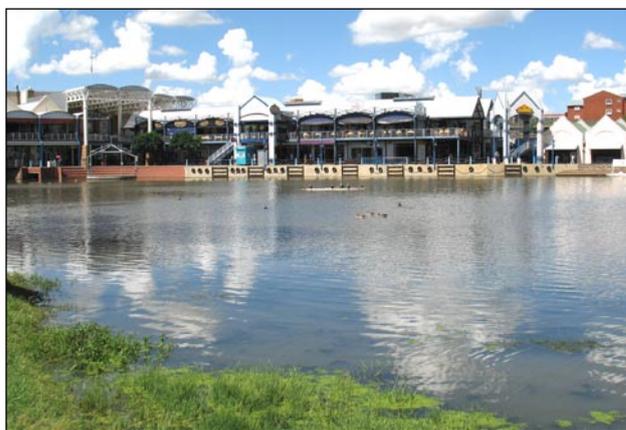
Photograph 1
Intrusion of Kikuyu grass and undesirable growth of Lemna gibba (duckweed) and Azolla filiculoides (red water fern) in Loch Logan, Bloemfontein

Water quality problems associated with urban impoundments are also not something new, e.g. Jan Smuts Dam in Brakpan has a documented record of such problems stretching back to 1940. Unfortunately many urban impoundments act as receptacles for upstream waste, resulting in silted up impoundments. The impoundments' enrichment with plant nutrients (referred to as eutrophication) often leads to the associated growth of undesirable algae and water plants, increased health risks due to bacteriological contamination; and aesthetic problems such as unsightly algal scum, floating debris and malodours (Freeman et al., 2000) – see Photograph 1.
