STATE OF THE RIVERS REPORT

# LETABA AND LUVUVHU RIVER SYSTEMS 2001

*This report is based on the findings of river surveys that were conducted as part of the implementation of the River Health Programme in the Northern Province. The surveys on the Luvuvhu System took place during 1999 and 2000 and on the Letaba System during 2000 and 2001.*

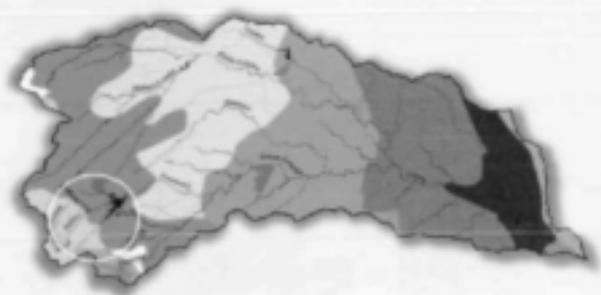
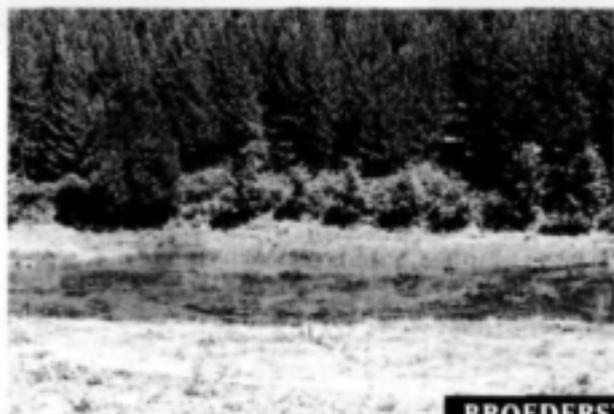
Riverbanks of the Broederstroom slope gently.

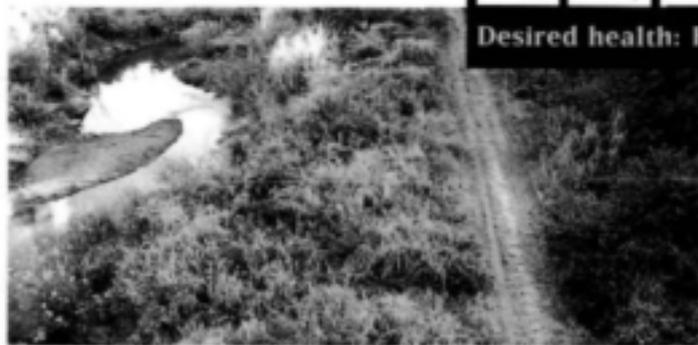
Erosion in the riparian zone from bridge construction works. Agriculture, forestry and informal settlements encroach on the riparian zone. Alien plants include bugweed, pines and eucalypts.

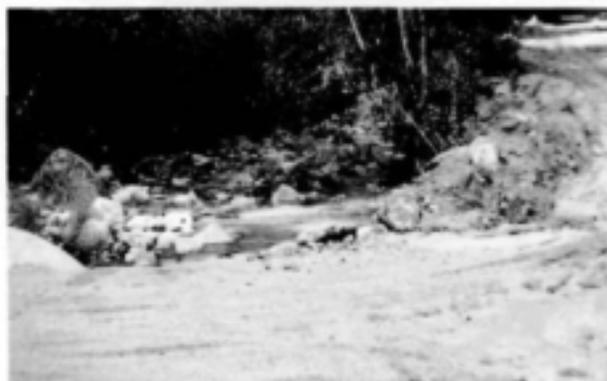
Plantations and roads impair the functionality of the riparian zone. Alien plants and pine plantations are very close to the river's edge.

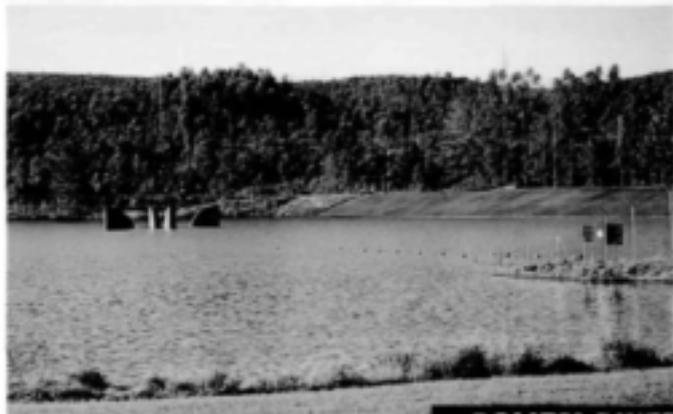
Magoebaskloof Dam, despite its small size, interrupts the natural flow pattern of the river. It is an irrigation dam with little capability for water releases, so that the resulting downstream flow pattern modifies river habitats.

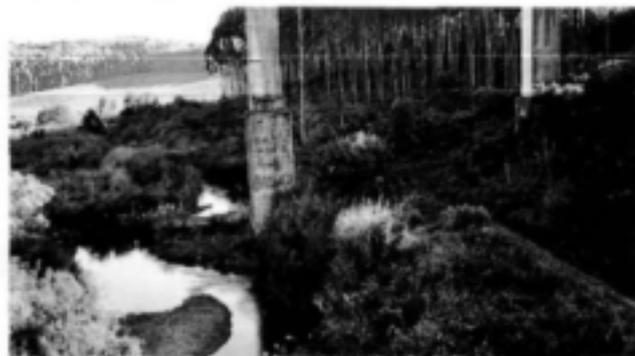
Roads next to the Politsi River and bridges across it cause erosion and siltation.

Lantana, jacaranda, bugweed and eucalypts are some of the alien plant species infesting this site.

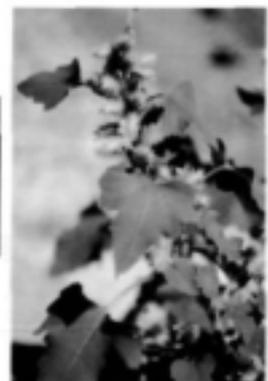
The riparian vegetation is in good condition, but invaded with numerous alien plants such as castor-oil plant, seshania, wild tobacco, large cocklebur (photograph) and sugar cane.

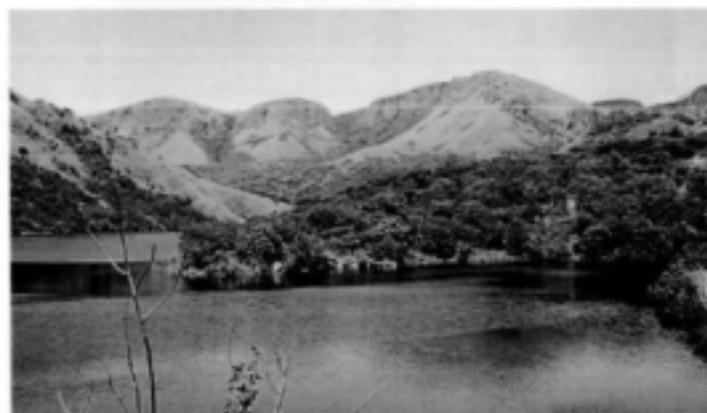
No water is released from the Thabina Dam for ecological purposes. The seepage from the dam, the tributaries and the runoff that feeds the Thabina River downstream of the dam appears to be sufficient to maintain the in-stream habitat in good health.

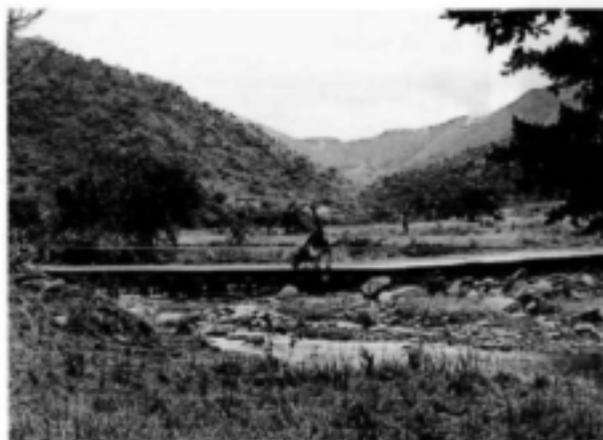
The riparian vegetation is under threat from excessive use by local communities and invasion by a host of alien plants, such as trifid weed (paraffin bush).

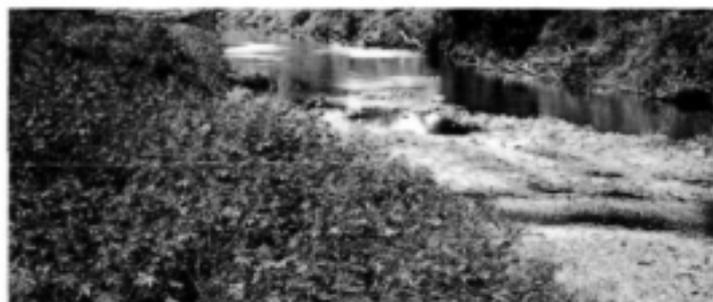
Bananas compete with invasive alien plants like lantana, castor-oil plant, bugweed, large cocklebur and peanut butter cassia for a place amongst the natural riparian vegetation.

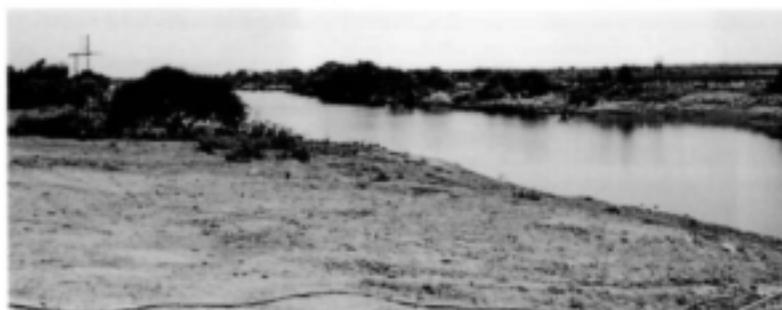
Towards the eastern part of the Letaba River, local communities over-utilise the vegetation in the riparian zone through cutting and grazing. Alien plants have invaded the remaining riparian vegetation. The condition of the northern bank is worse than that of the southern bank.

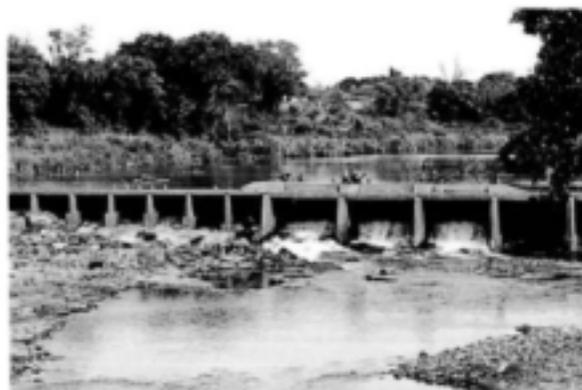
Large weirs disrupt flows in river systems: apart from impeding fish migration, they cause bank scouring, sedimentation and loss of riparian vegetation.

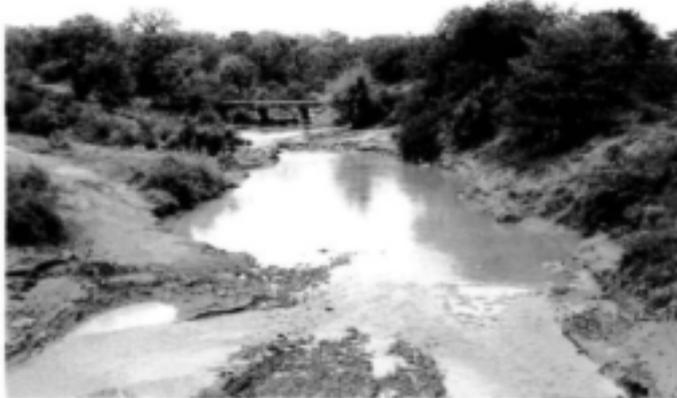
Vegetation cutting by local communities and occurrence of alien invasive vegetation have negative impacts on the riparian habitats.

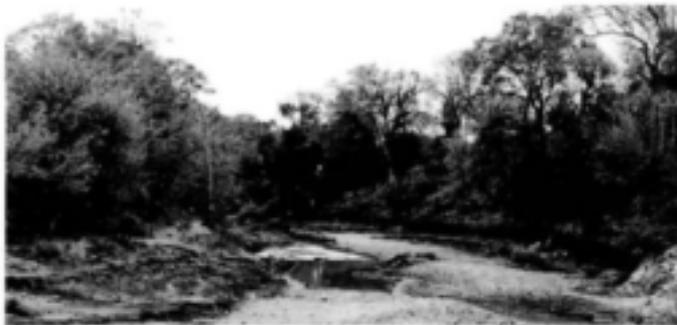
The Molototsi River downstream from the Modjadji Dam.

The Modjadji Dam, which stores water for domestic use, restricts flow downstream. The dam management programme does not include water releases that benefit the river ecology. This loss of flow is detrimental to the next 20-30 km of river.

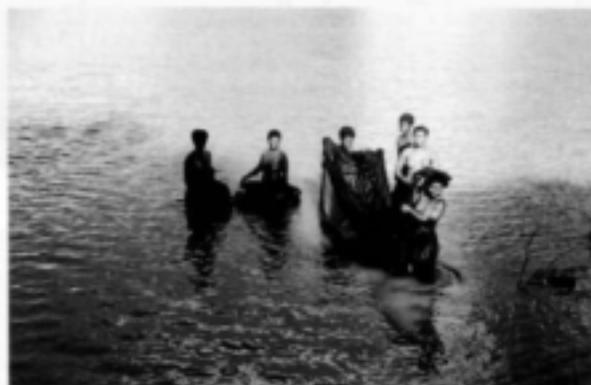
Fishing with shade nets is not a sustainable harvesting practice.

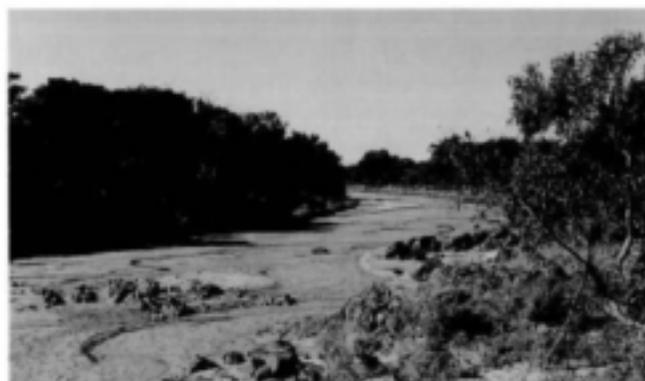
The Molototsi River after the 2000 floods.

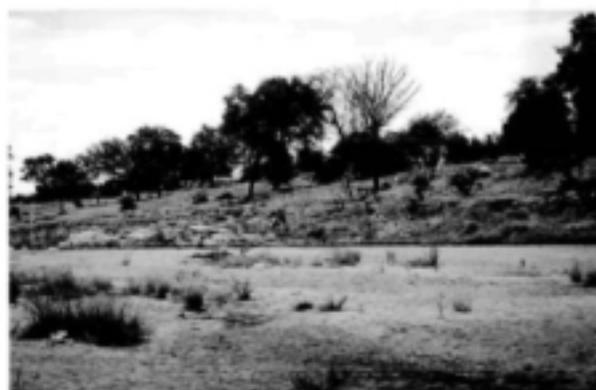
Environmentally unsustainable land-use practices such as overgrazing result in accelerated erosion. Alien invasive plants occur within the riparian zone.

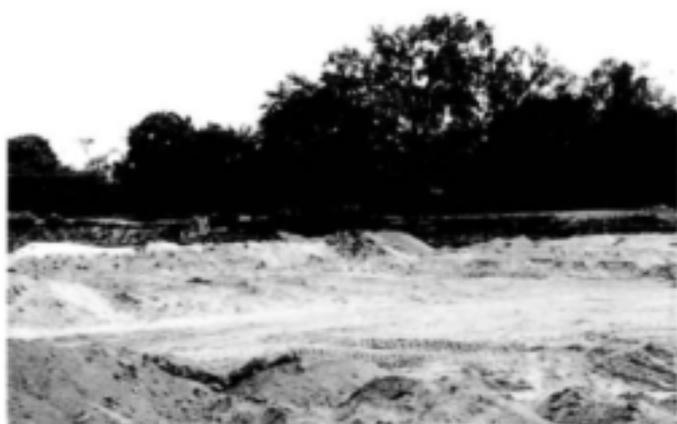
Sand mining destroys natural habitat and is unsightly.

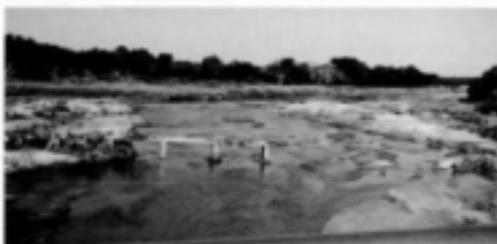
The Klein Letaba river during April 2000 (left) and July 2001 (right). In-stream biota are adapted to seasonally variable flows.

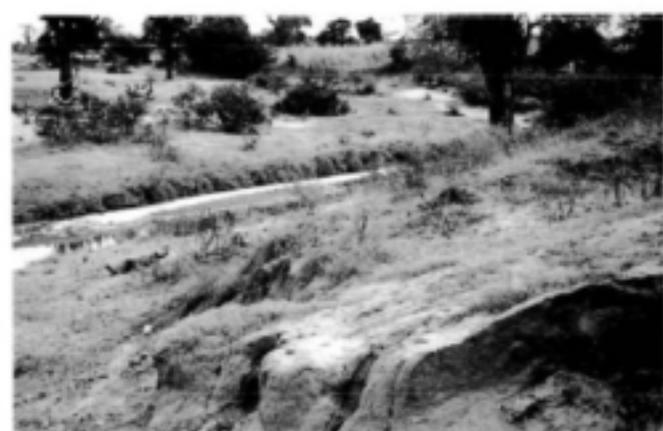
Overgrazing in the riparian zone contributes toward donga erosion.

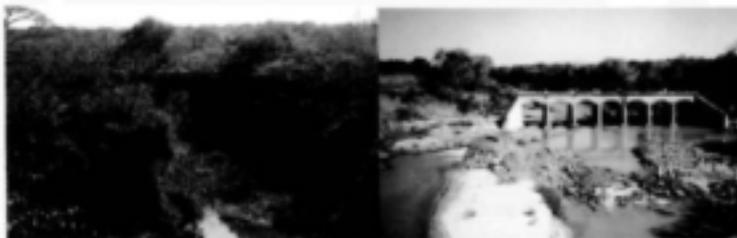
Photographs taken from the same road bridge across the Latonyanda River before the 2000 floods and after (April 2001).

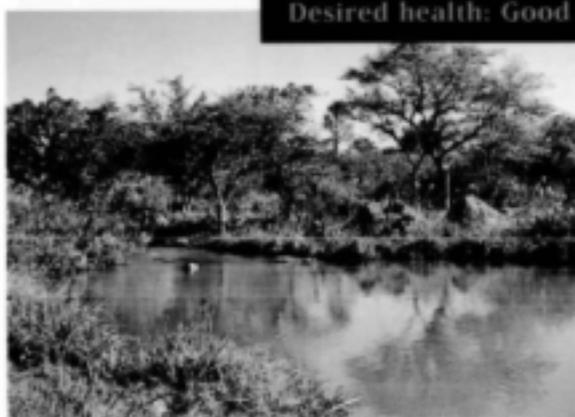
Alien vegetation such as lantana and castor-oil plant are common along the Luvuvhu River.

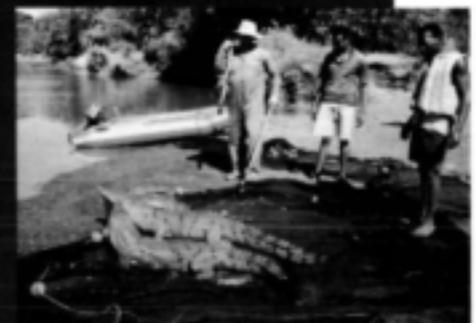
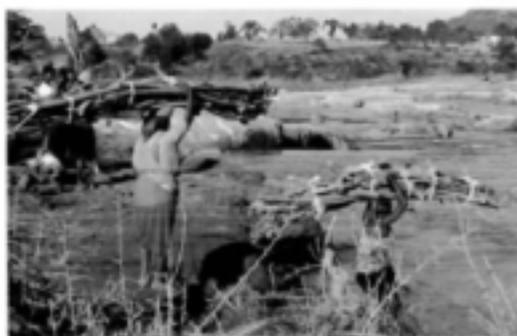
The riparian vegetation in the area of Thohoyandou has been largely destroyed for use as firewood and to provide grazing. This has led to increased donga erosion. Large, dense stands of trees occur at intervals.

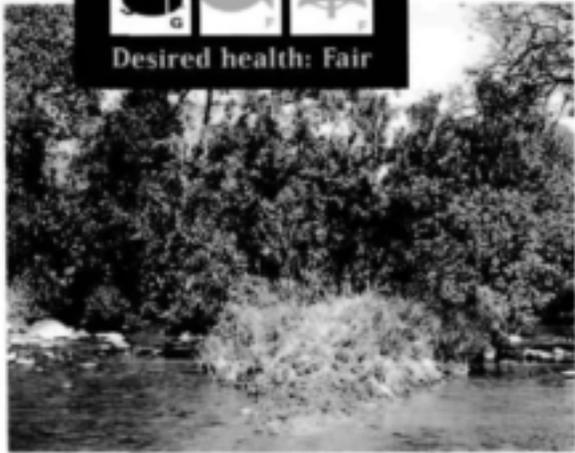
Indigenous vegetation stabilises river banks.

Cultivated lands and orchards are common along the middle section of the Mutshindudi River, and often reduce the riparian vegetation to a narrow strip.

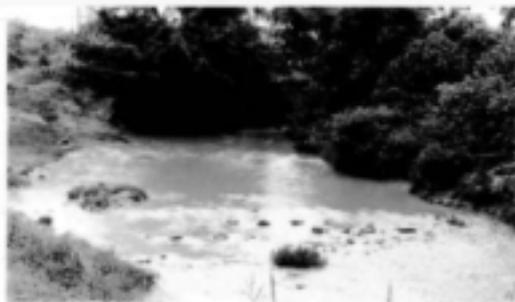
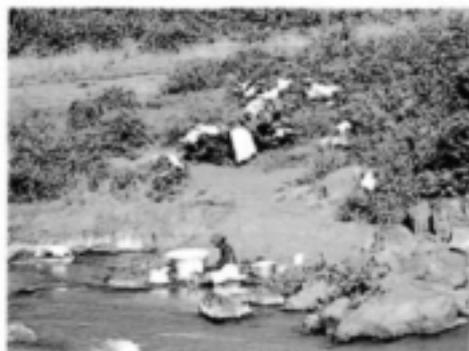
Dirt roads, bridge crossings and bridge construction lead to erosion and sediment in the river.

Local communities utilise the lower Mbwedi and lower Mutshindudi rivers for bathing, swimming and washing cars and clothes.

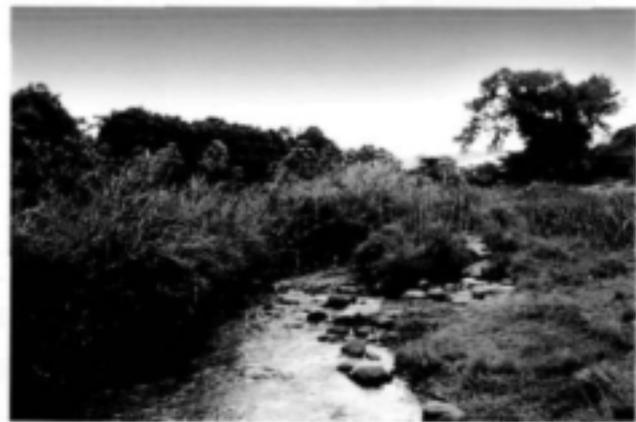
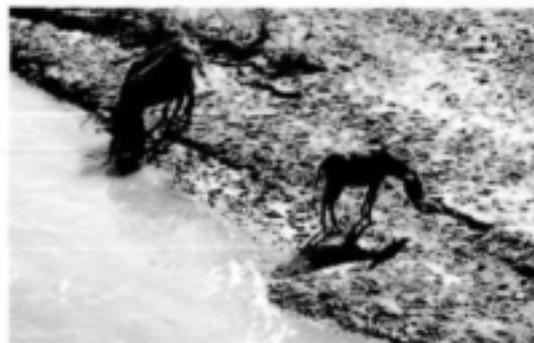
Livestock trampling occurs causing sheet and donga erosion of riverbanks.

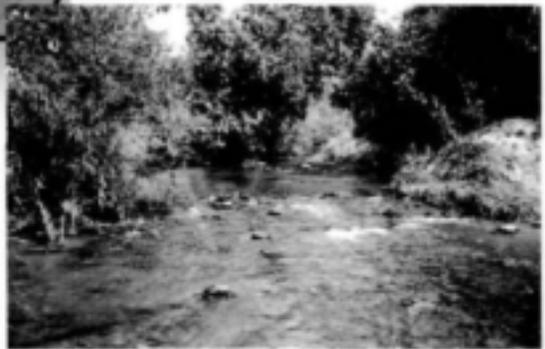
A large new weir is under construction at Xikundu as part of the Nandoni Scheme. A fish-way has been incorporated into the design of the weir, motivated by the high diversity of rare and sensitive species found in this area.

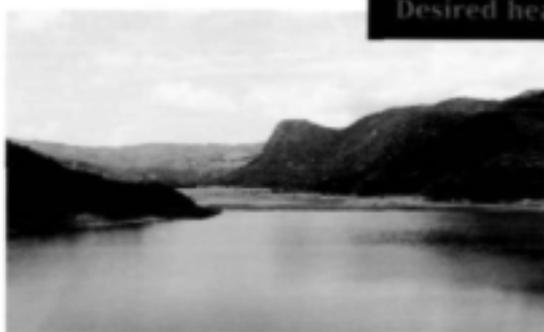
A road runs parallel to the river, sometimes within the riparian zone.

Local communities use the river for washing clothes and cars, causing erosion, sediment and solid waste.

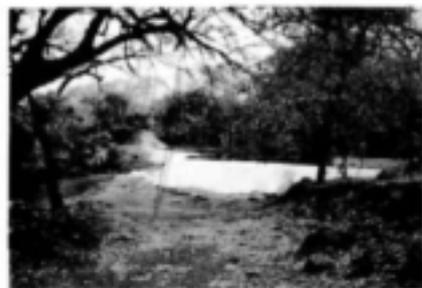
Abstraction of water from agricultural weirs reduces flow considerably, while the weirs also act as barriers to fish migration.

A road bridge and overgrazing cause erosion with resultant sedimentation in the river.

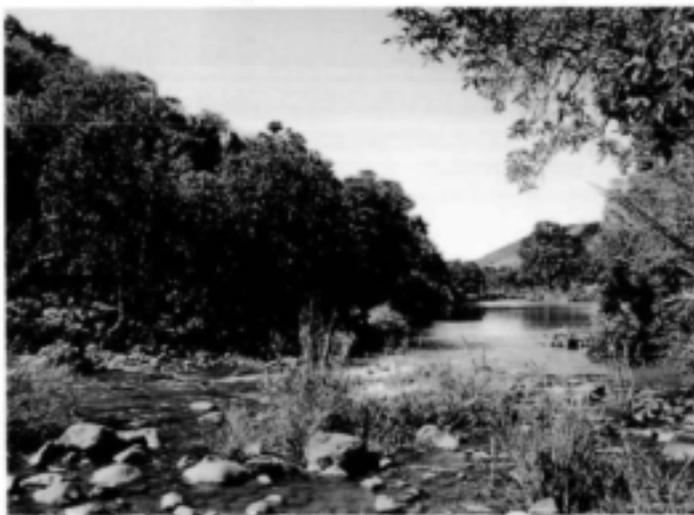
Above the gorge, Tshikundalema village is located right next to the river. The plots extend to the riverbank and little riparian vegetation remains.

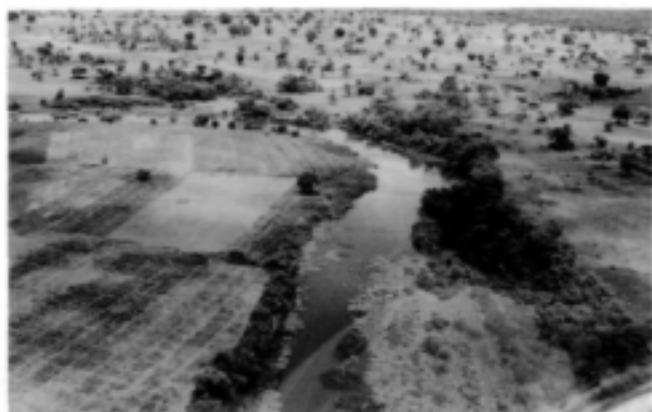
Agricultural practices right up to the river's edge and cutting of riparian vegetation reduces the riparian zone to a very narrow strip.

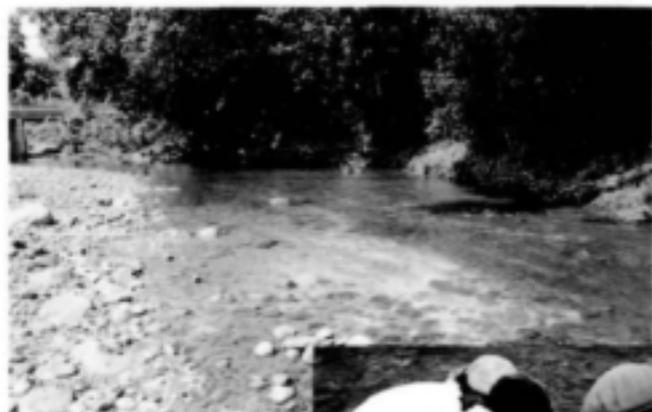
The washing of maize, clothes and cars in the river is a common activity.

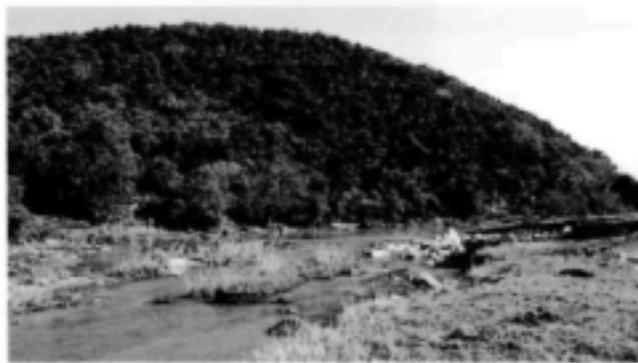
The Sambandou River after the 2000 flood.

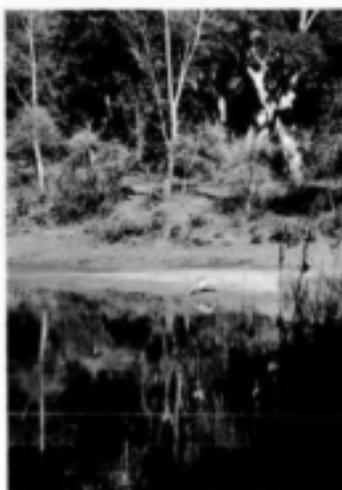
The area is largely unspoilt, but the 1993 drought compounded the effect of the upstream activities that caused low flows. The river came to a standstill, resulting in the death of many riparian trees.
