# **H<sub>2</sub>S STRIP TEST FIELD KIT FOR MICROBIAL WATER QUALITY ASSESSMENT:**

**Feedback on usefulness of a monitoring test for rural communities**

**Report on Workshop Feedback for the project: A Field Kit  
for Microbial Water Quality Assessment in Small and Rural  
Communities**

**WRC No: 1105/1/03  
ISBN No: 1-86845-984-5**

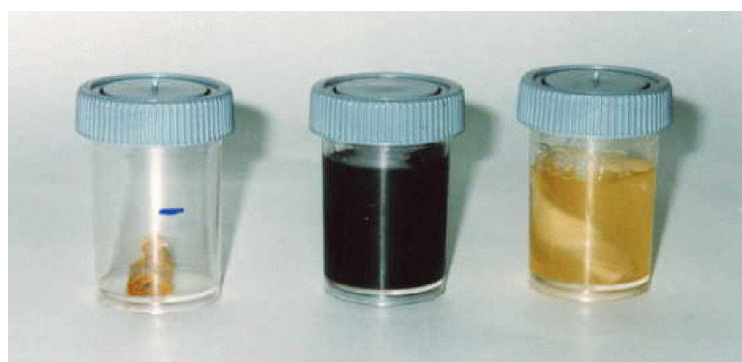
- Aseptically, fill sterile sample bottles provided (containing the paper strips) up to the black line (20ml sample volume). The colour of the water will change to a clear brownish solution. (If sample bottles are broken or damaged do not use as they may give false results)
- Keep sample bottles at room temperature (Indoors out of direct sunlight)
- Examine daily, up to 2-3 days, for **black colouration**. This is considered to be a positive result (See photo below- centre bottle)
- A negative result is considered to be a lack of black colour development. The sample may appear murky, but if no black colouration occurs, the sample is still considered to be negative. (See photo below - right hand bottle). If black colouration occurs after 3 days it is NOT considered to be positive.

Empty sample bottle      positive result      negative result

***A positive result using the H<sub>2</sub>S strip method provides an indication that the water quality is not suitable to be used as drinking water, and further investigations are recommended.***
