ESTUARIES

St Lucia at an ecological tipping point?

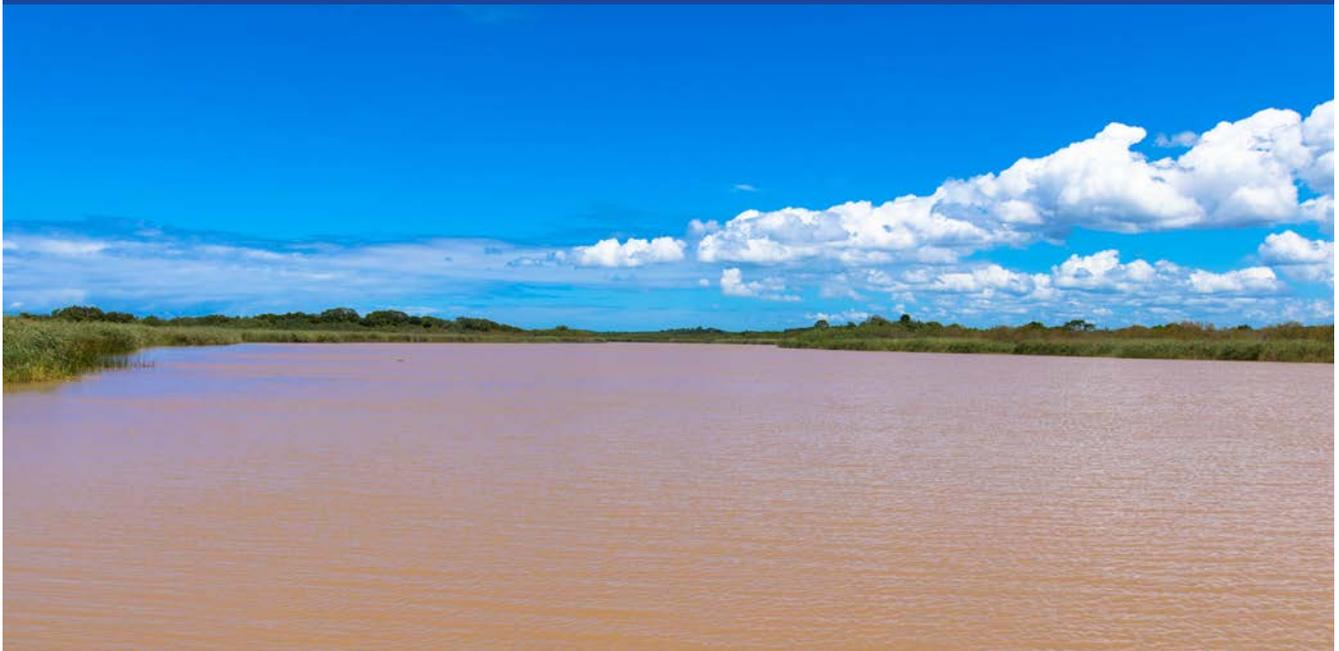
Turbid, sediment-rich uMfolozi River water in the Narrows, the indirect cause of the transformation of the St Lucia estuarine lake system into a freshwater lake system.

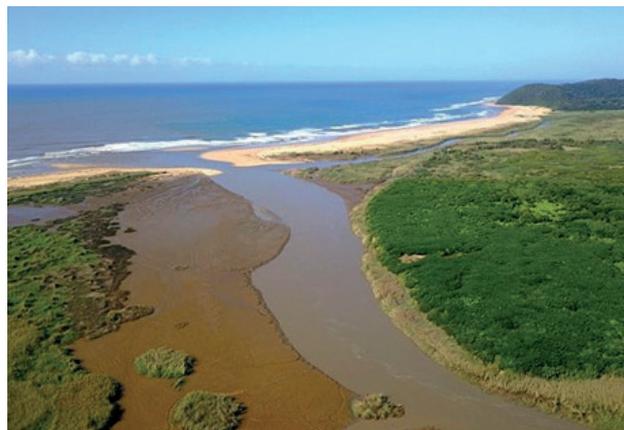
Extensive sedimentation in the St Lucia Estuary is clearly visible in this low tide aerial photo taken in 2023. These mainly compacted mud sediments effectively prevent the prevalence of a large tidal prism within the shallow estuary, and this therefore works against the retention and transport of saline water up the system.

Unimpeded uMfolozi water has been entering the St Lucia system since 2012, but the joint estuary mouth has remained predominantly closed for a continuous period between the beginning of 2015 and end of 2020. During this time, large quantities of sediment were deposited in the St Lucia Estuary and Narrows, encouraging littoral vegetation growth as well as reducing channel width and depth. This has severely reduced

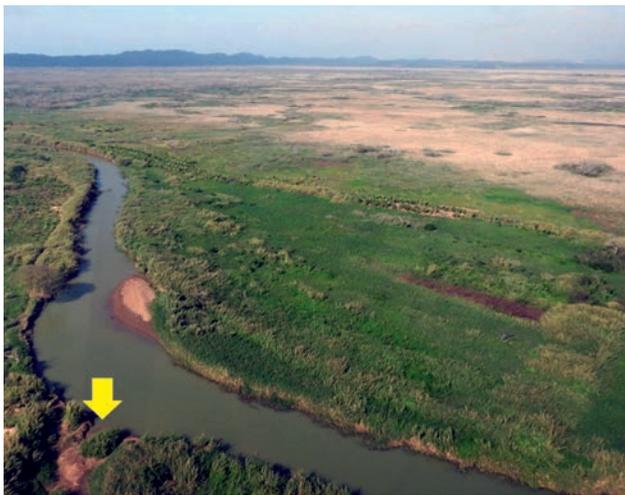
A river bank breach into the Link Canal brings large amounts of sediment-rich uMfolozi River water into the Honeymoon Bend area of the St Lucia Estuary during river flooding. This breach needs to be blocked as a matter of extreme urgency if Lake St Lucia is to retain its connection with the sea.

Two other 'problems' have come into focus during the past decade. Firstly, the decommissioned Link Canal has been breached by floods in the uMfolozi River. The canal now carries large amounts of sediment directly into the estuary near Honeymoon Bend with each flood. This sediment deposit and the growth of reeds towards the middle of the channel from the banks have formed a constriction that inhibits the inward (upstream) movement of tidal water, and thus prevents saline water from moving any distance up the Narrows. The healthy state of freshwater shoreline reeds, which cannot survive saline water that is over 12 ppt, is a testament to the lack of saline intrusion up the Estuary and into the Narrows. An urgent action that needs to be initiated by the ISWPA is the physical blocking of the two points where the uMfolozi River has broken into the relic Link Canal. Following the creation of this blockage, accumulated sediments in the Honeymoon Bend area will need to be removed.

Three adaptive management actions are required in the short term to temporarily steer St Lucia back towards an estuarine trajectory. The most important action by far is the closure of the Mfolozi-St Lucia Link Canal, which was decommissioned after the huge 1984 Domoina cyclonic flooding. This canal is a conduit that carries uMfolozi flood sediments into the Honeymoon Bend area of St Lucia and causes a major constriction in the Estuary. To restore estuarine hydrological functioning, it may then be necessary, once the canal has been blocked off, to remove the accumulated sediment at the point where this canal enters the Honeymoon Bend area. This accumulated sediment currently prevents the inflow of marine tidal water into the upper estuary and Narrows.

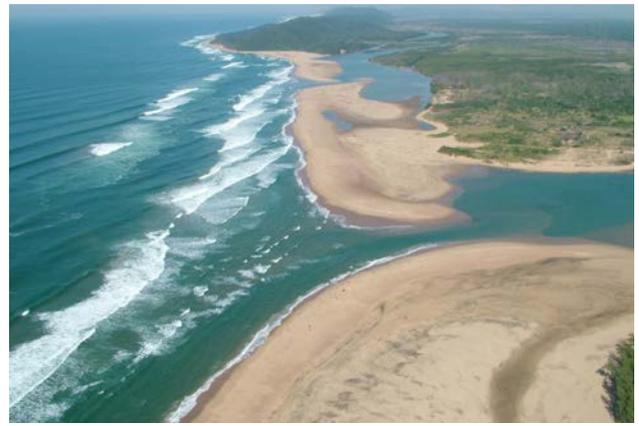
The dual estuary mouth system that was artificially maintained between the 1950s and 2012, showing both an uMfolozi Estuary mouth in the top of the photo and a St Lucia Estuary mouth in the middle of the photo.

Following on this, in 2011 the iSimangaliso Wetland Park Authority (ISWPA) altered the policy that mandated that the uMfolozi River should be kept separate from St Lucia. The Authority obtained funding from the World Bank's Global Environment Facility (GEF) to undertake studies to investigate how this could be achieved. These studies indicated that reconnection, in its original configuration, could result in a system that would function naturally and bring uMfolozi River water into St Lucia. The system would have a single estuary mouth that would breach without human intervention, i.e., when water levels overtopped the beach berm or when there was a large river flood. The concept was that the rush of water during such a river flood would increase water levels in the estuary and trigger breaching that would flush accumulated sediment from the system into the sea. GEF funding was then used to reconnect the uMfolozi with St Lucia, an intervention which was achieved in July 2012.

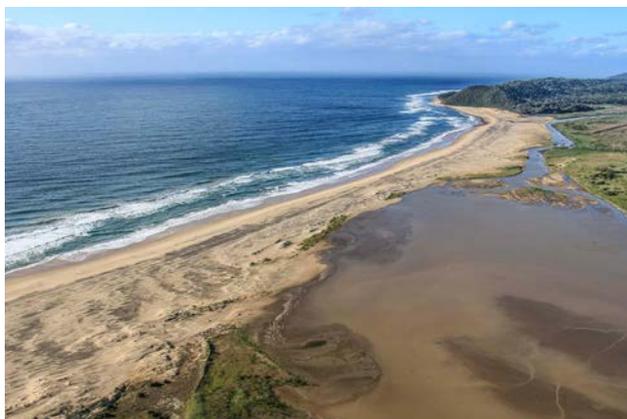
Aerial view of St Lucia Estuary berm and muddy uMfolozi waters entering from the upper right of the photo. These conditions persisted for more than five years between 2015 and 2020.

water flows within the estuary, Narrows and Potter's Channel. Part of the reason that the estuary mouth did not breach naturally during uMfolozi River flooding over this period was that Lake St Lucia had to fill up first before water levels at the Estuary could overtop the berm. Prolonged closure of the mouth meant that saline water was not entering Lake St Lucia, which was becoming increasingly 'fresh' and less 'estuarine' during this process.

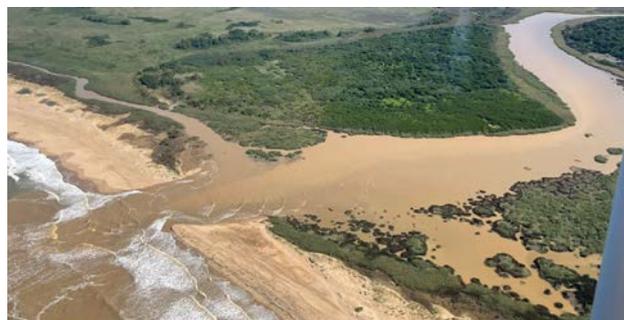
uMfolozi River floodwaters leaving the St Lucia Estuary via the Beach Channel (left) and Estuary Channel (right) after the natural mouth breach in April 2022.

In April 2022 river-flooding caused the estuary mouth to breach – this time naturally. Again, the scouring of accumulated sediments from the estuary was limited and, once the floodwaters had dissipated, only a relatively small tidal prism was recorded. No seawater was documented reaching the St Lucia Bridge in the first two years that the mouth has remained open. The estuary mouth channel has remained relatively fixed due to compacted mud remaining in place, preventing the natural northward migration of this channel. This 'fixing' of the estuary mouth may well have prolonged the 2022-2025 open phase since 'wandering' estuary mouths are more prone to closure.

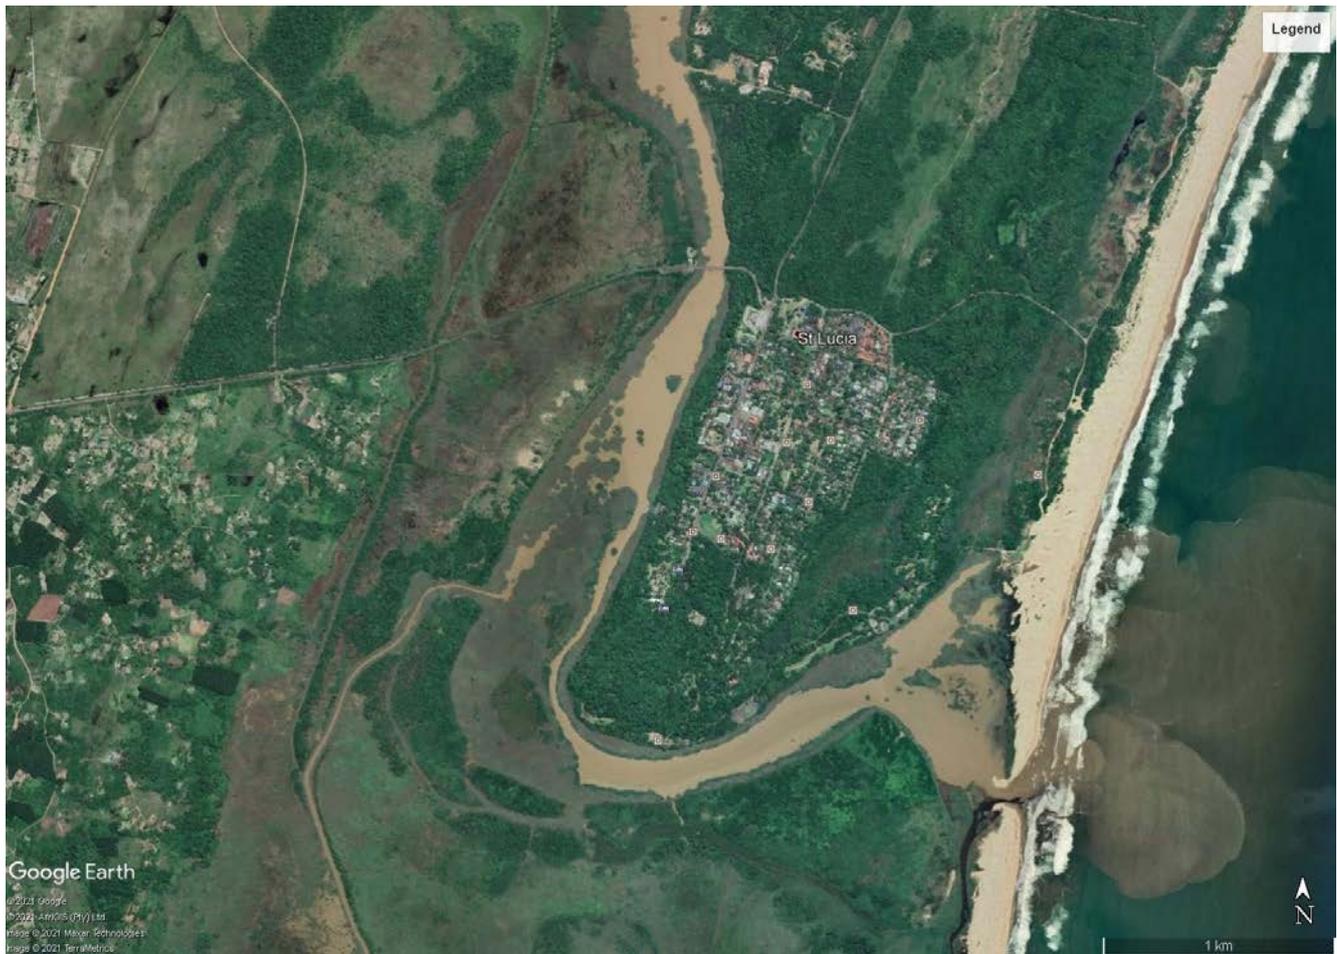
Google Earth satellite image of the Narrows (upper centre of photo), St Lucia Estuary (centre of photo) and uMfolozi River Beach Channel (lower right of photo). The introduction of turbid, sediment rich uMfolozi River water to both the estuary and Narrows by the Link Canal (bottom and centre right of photo) is clearly visible in the Honeymoon Bend area (centre of photo). A turbid water plume is visible in the sea in the bottom right of the photo. Note the clear dark water entering the joint estuary mouth from the Beach Channel, indicating that the turbid uMfolozi River water is not entering the sea via the Beach Channel but rather via the Link Canal.

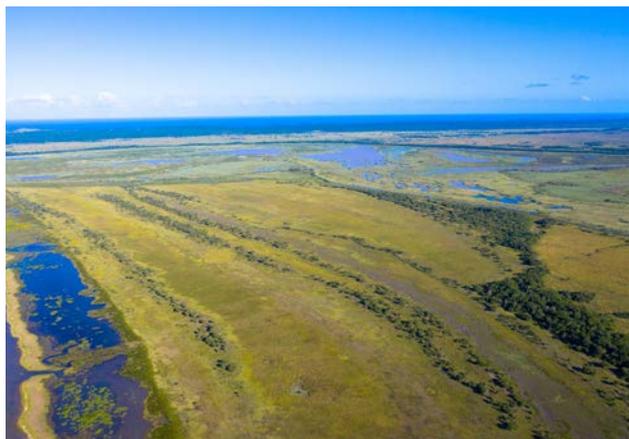
Aerial view across the Makakatana Bay southern shore towards Potter's Channel and Brodie's Shallows in the upper central portion of the photo.

In a similar manner, management action is required at the junction between the Narrows and South Lake. Currently, the quantity of water pushed into the Narrows from the Lake by wind is limited considerably by extensive and dense vegetation growth in the Potter's Channel - Brodie's Shallows area (where the Narrows meets with the Lake). As the lake level rises due to river flow into False Bay and North Lake, the result is a head of water in the lake relative to the Narrows. Currently, this lake water can only 'seep' through the dense vegetation towards the Narrows when such conditions occur. Conversely, little or no movement of saline water can occur from the Narrows into the lake due to these extensive beds of submerged and emergent floodplain vegetation in the Brodie's Shallows area. The urgent restoration of Potter's Channel is therefore required if Lake St Lucia is to receive saline water up the Narrows and therefore remain estuarine.

Another important action is to open the Potter's Channel link between the southern part of the lake and the Narrows. The emergent and submerged vegetation there prevents free water movement between the Lake and Narrows, and vice versa. Unless this constriction to flow is opened up by recreating Potter's Channel, Lake St Lucia will become a freshwater lake. To promote the lifecycles of estuary dependent fish and invertebrate species between the estuary and sea, the combined St Lucia-Mfolozi Estuary mouth will need to be artificially breached if the mouth remains closed for prolonged periods that exceed three years.
